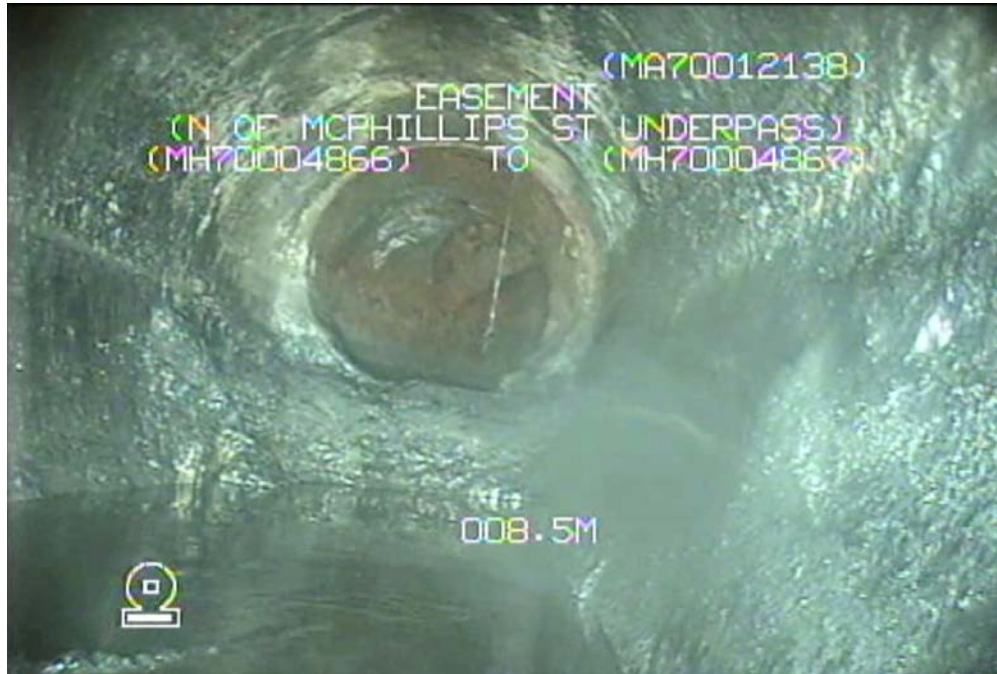
Figure 1 – Sheet 3, Dwg 12267, S-MA70012138 (McPhillips St) – Transition from 1100 mm Egg Sewer to 600 mm Fabricated Steel Elbow upstream of MH70004867.

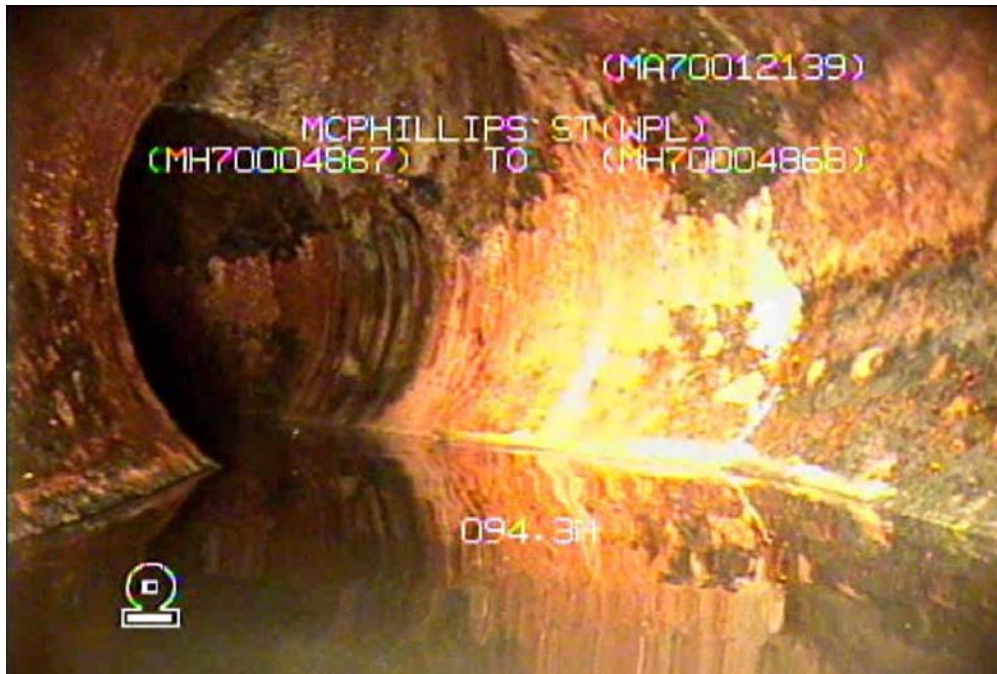
Figure 2 – Sheet 3, Dwg 12267, S-MA70012139 (McPhillips St) – Fabricated Steel Elbow at MH70004868.

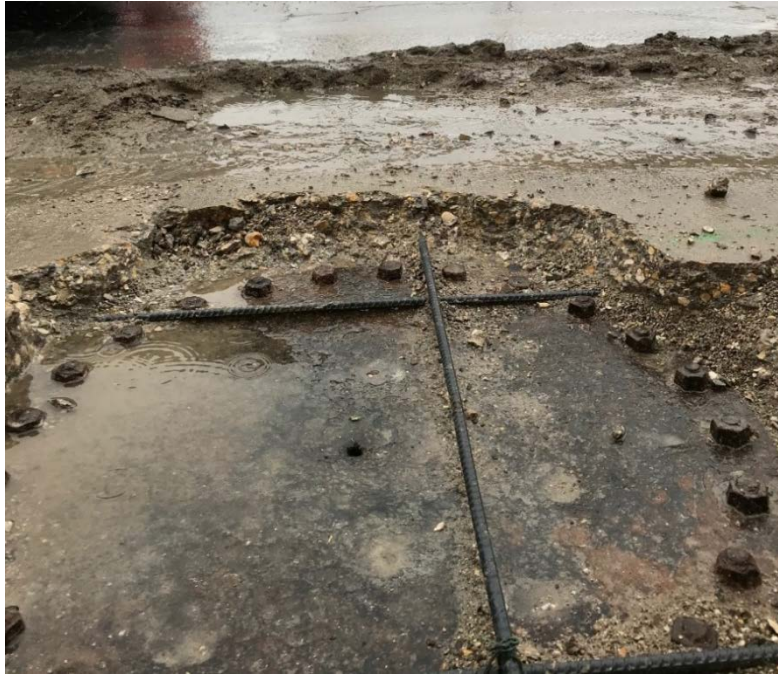
Figure 3: Sheet 3, Dwg 12267, Flanged Access Point in sidewalk on S-MA70012139 on McPhillips St.

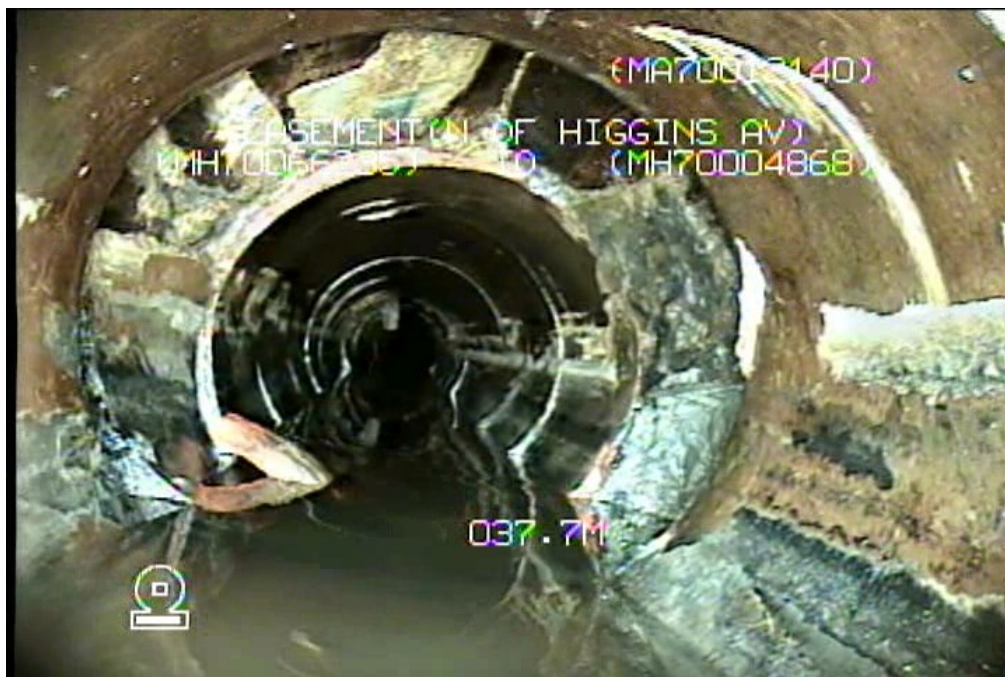
Figure 4 - Sheet 4, Dwg 12268, S-MA70012140 (Easement N. of Higgins) – Hole with Debris at 38.0m upstream of MH70066235

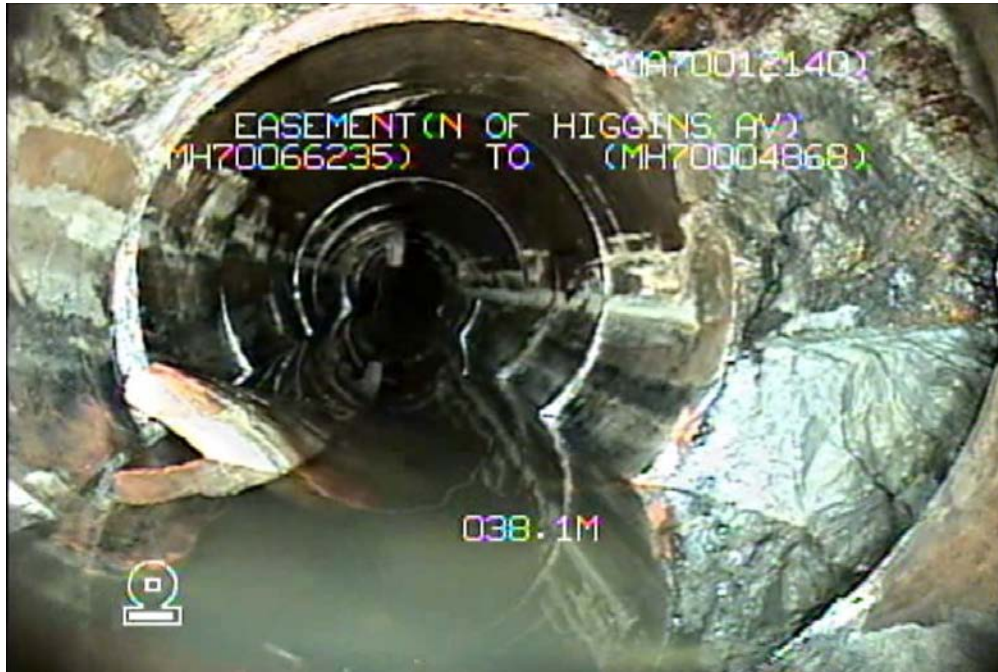
Figure 5 – Sheet 4, Dwg 12268, S-MA70012140 (Easement N. of Higgins) – Hole with Debris at 38.0m upstream of MH70066235

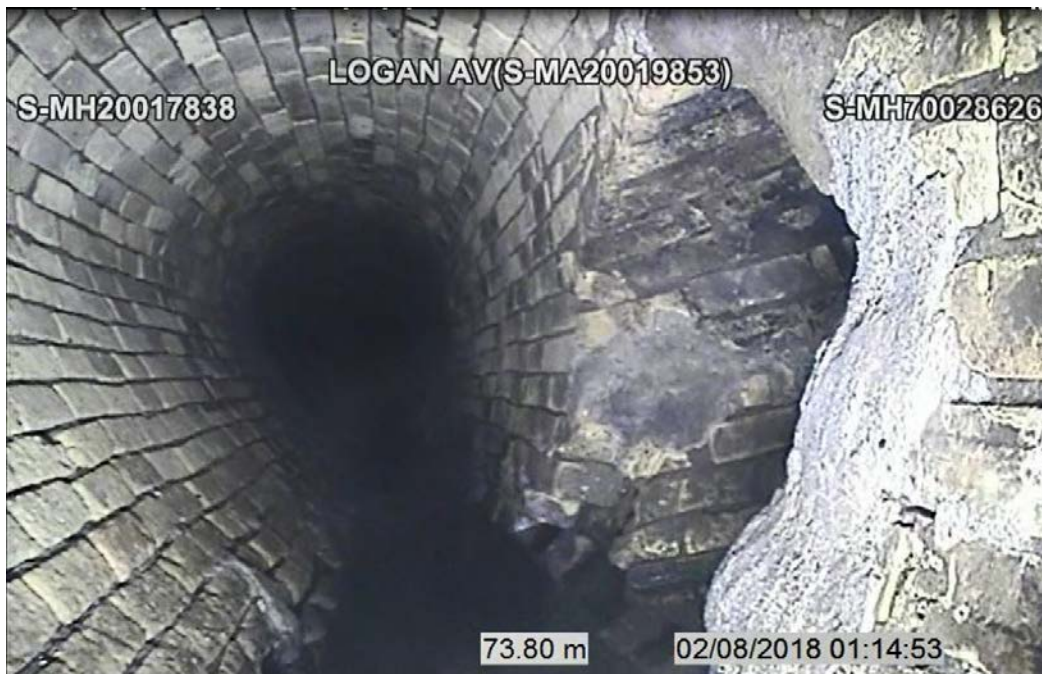
Figure 6 – Sheet 5, Dwg 12269, S-MA20018718 (Sherbrook St.) – Downstream Tee Connection on Logan Av as Seen from Asset S-MA20019853.

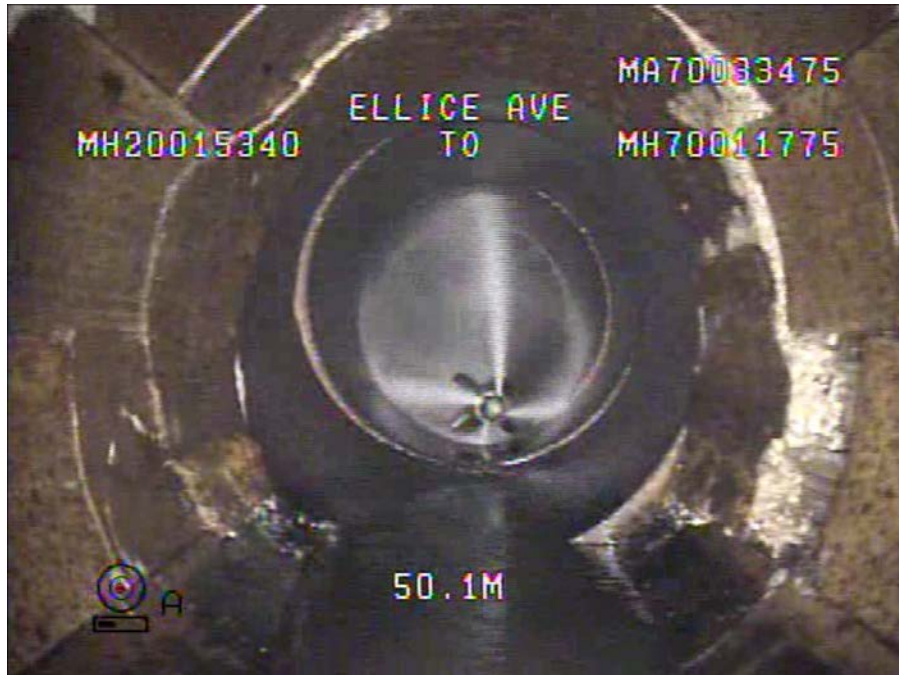
Figure 7 – Sheet 8, Dwg 12272, S-MA70033475 (Ellice Av.) – Material Change from Segmental Clay Tile to Vitrified Clay at 50.8 m Downstream.

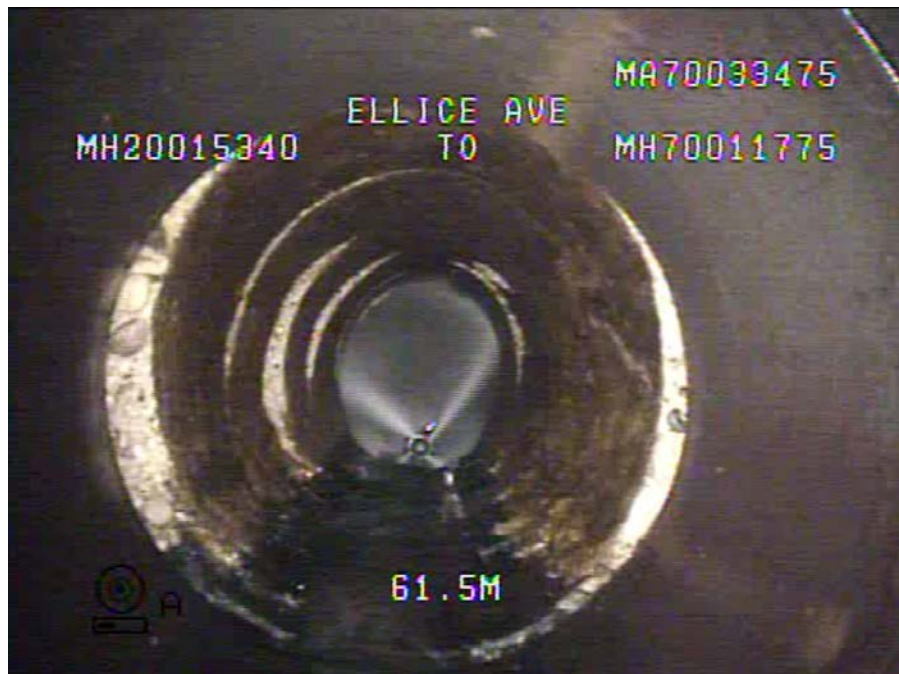
Figure 8 – Sheet 6, Dwg 12270, S-MA70033475 (Ellice Av.) – Material and Cross Section Change to Oval Precast Concrete.

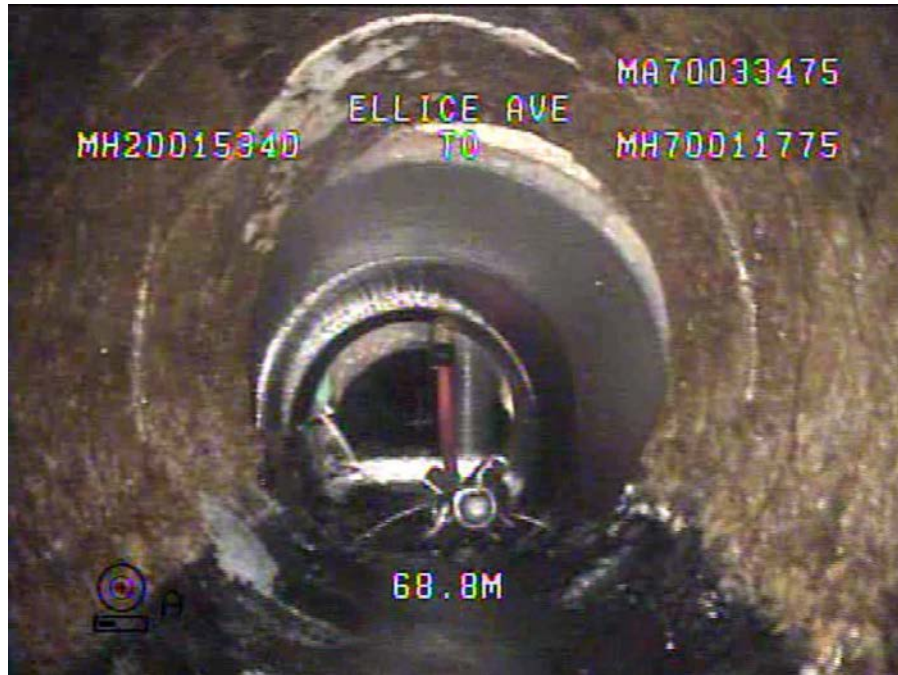
Figure 9 – Sheet 8, Dwg 12272, S-MA70033475 (Ellice Av.) – Material and Cross Section Change to Circular Vitrified Clay.

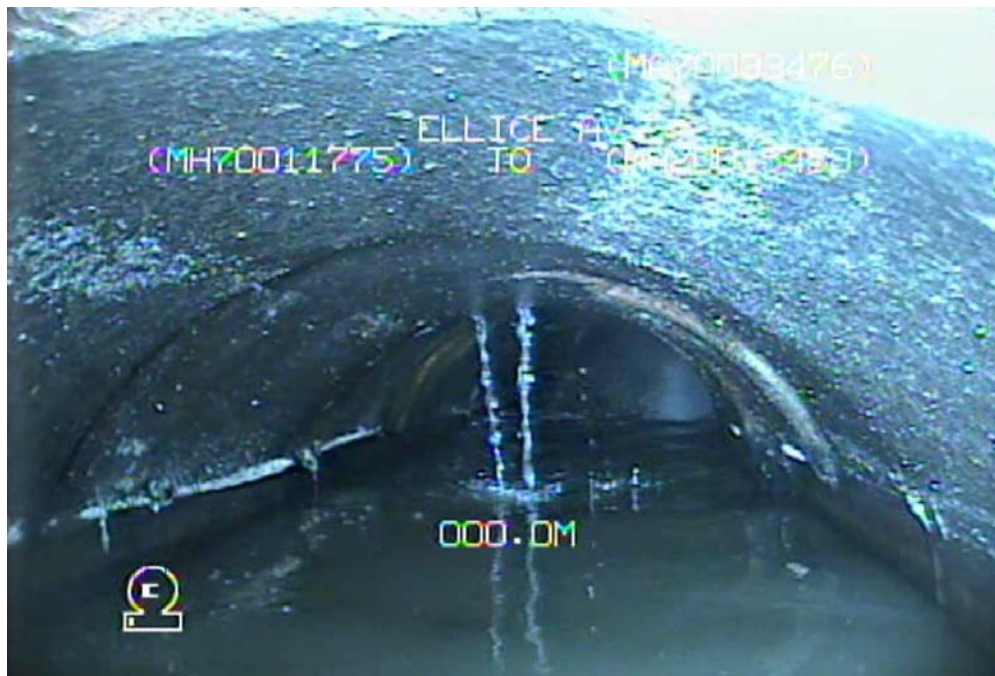
Figure 10 – Sheet 7, Dwg 12271, S-MA70033476 (Ellice Av.) – Infiltration (Gusher) at 3.0 m Downstream.

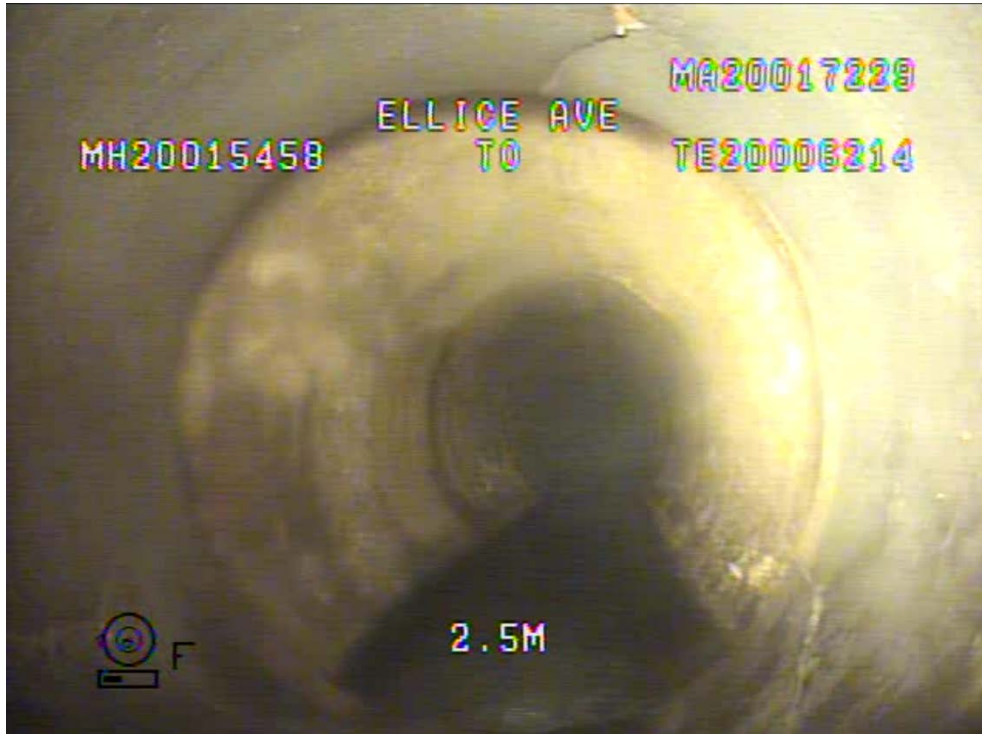
Figure 11 – Sheet 6, Dwg 12270, S-MA20017229 (Ellice Av.) – Apparent Diameter Change from 750 mm to 900 mm at 3.0 m Downstream.

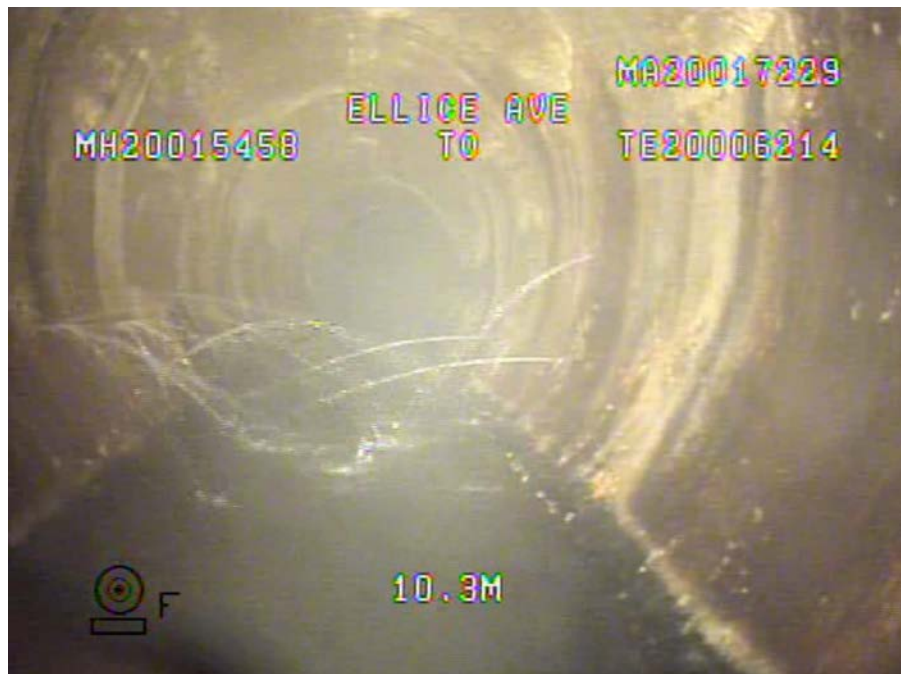
Figure 12 – Sheet 6, Dwg 12270, S- MA20017229 (Ellice Av.) – Infiltration (Gusher) at 7.6 m to 13.0 m Downstream.

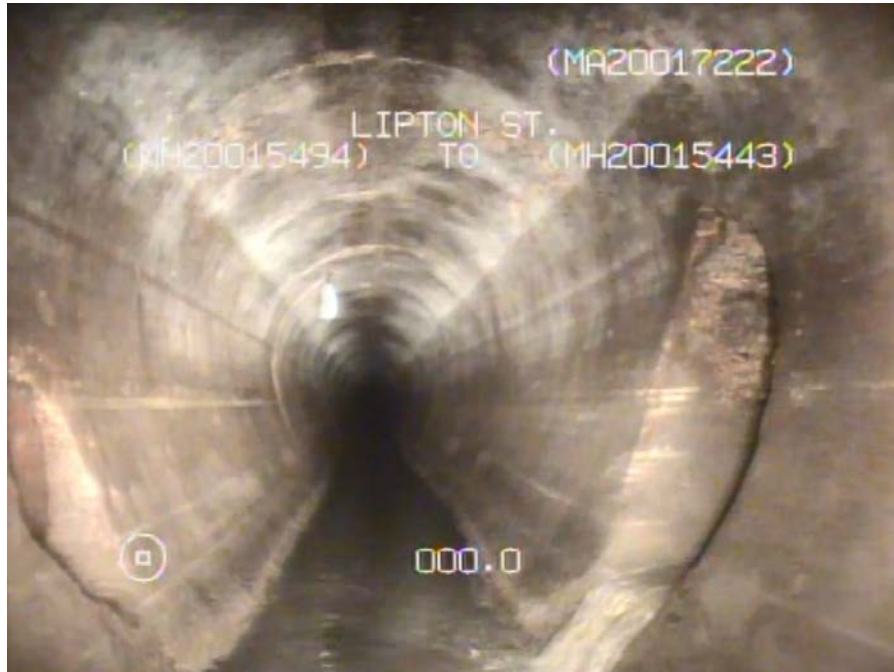
Figure 13 – Sheet 6, Dwg 12270, S-MA20017229 (Ellice Av.) – Downstream Tee Connection on Lipton St as Seen from Asset S-MA20017222.

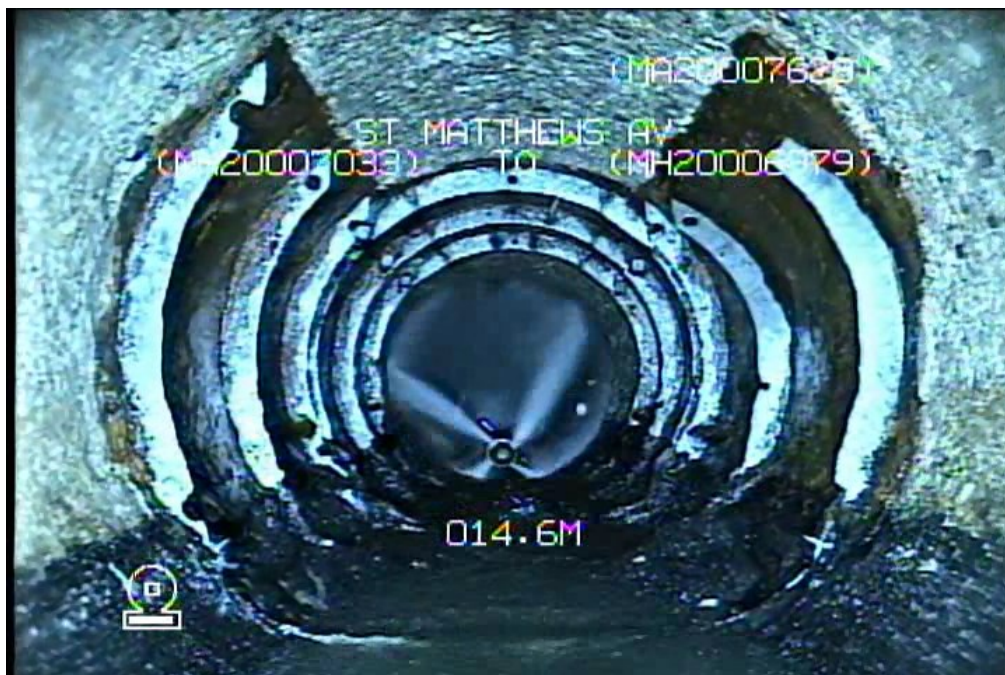
Figure 14 – Sheet 12, Dwg 12276, S-MA20007628 (St. Matthews Av.) – Existing Steel-Ribbed Repair at 14.8 m to 16.8 m Downstream.

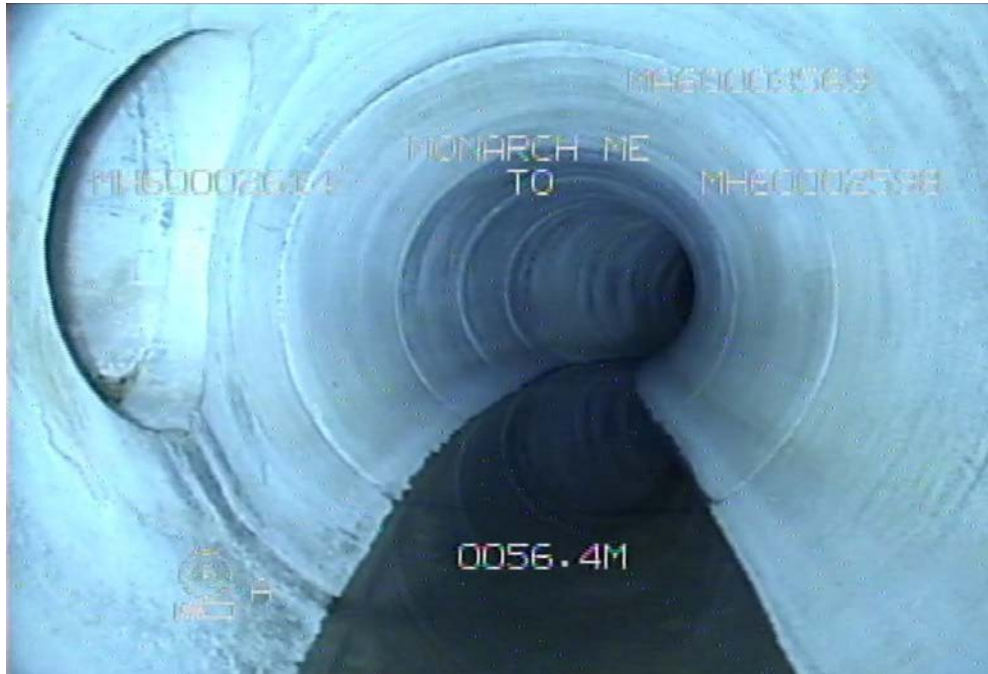
Figure 15 – Sheet 15, Dwg 12279, S-MA60003590 (Vialoux Dr.) – Downstream Tee Connection as Seen from Asset S-MA60003569.

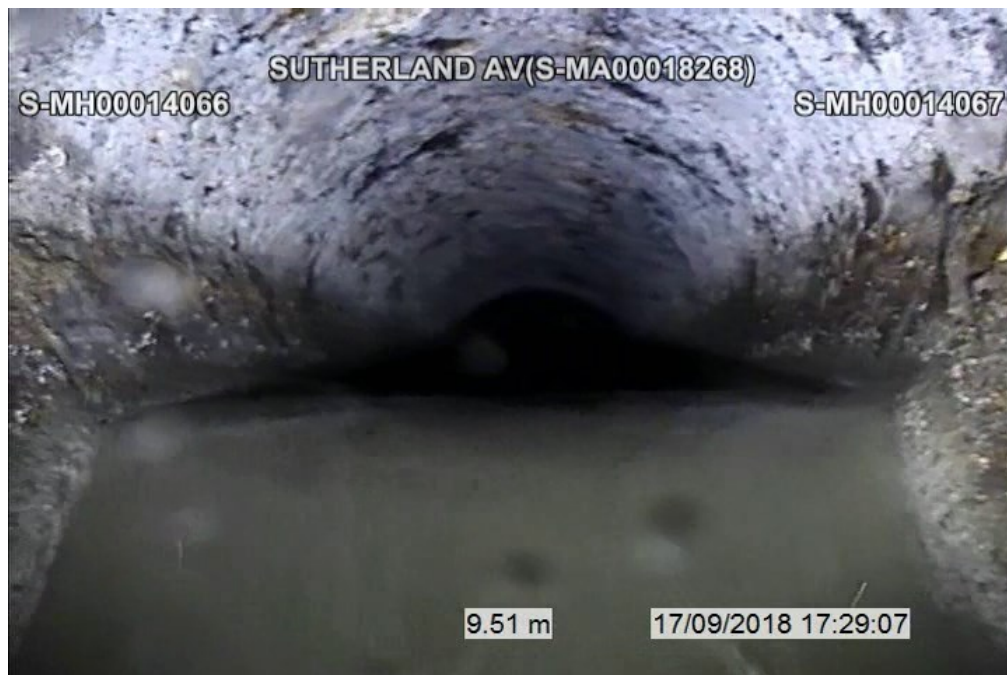
Figure 16 – Sheet 23, Dwg 12287, S-MA00018268 (Sutherland Av.) – Stepped Diameter Change from 900 mm to 1100 mm at 10.1m Downstream.

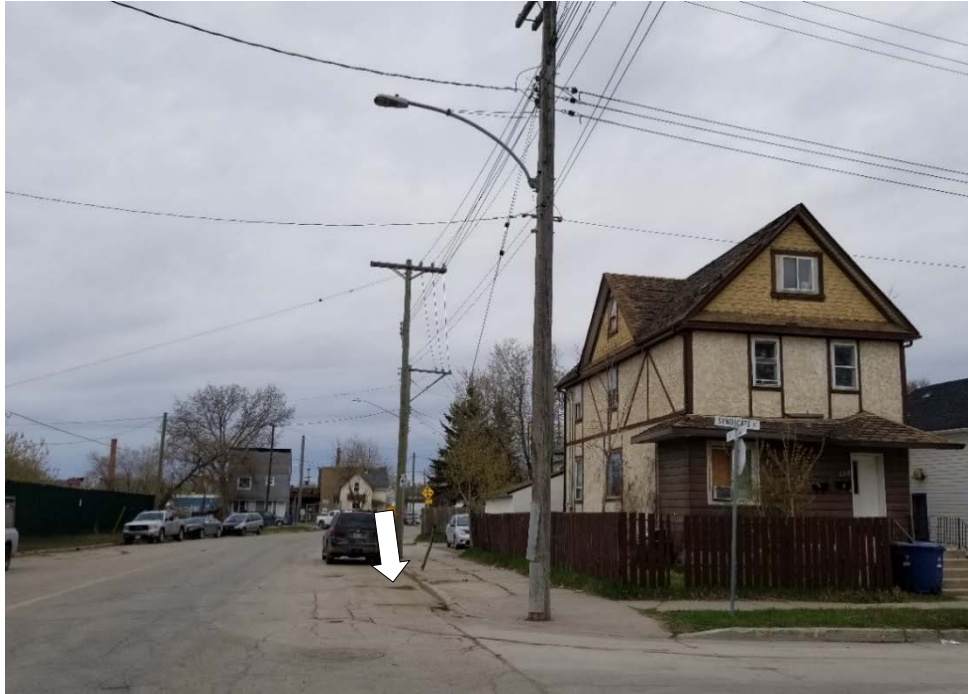
Figure 17 – Sheet 23, Dwg 12287 (Sutherland Av.) – Location of S-MH00014066 and Overhead Hydro.

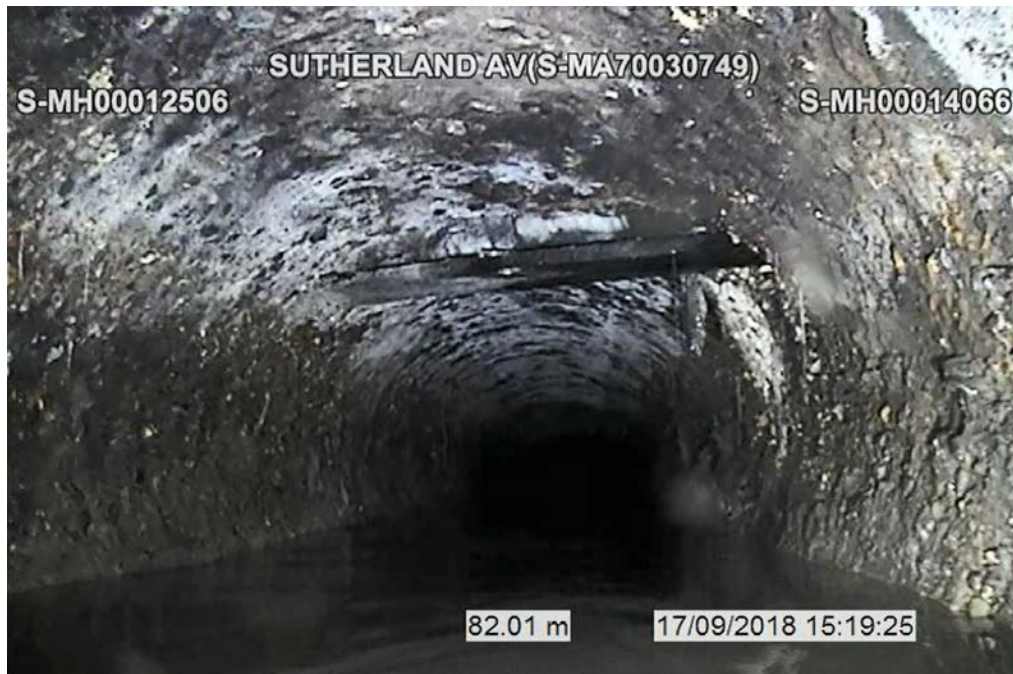
Figure 18 – Sheet 24, Dwg 12288, S-MA70030750 (Sutherland Av.) – 150 mm Watermain Crossbore at 94 m Downstream.

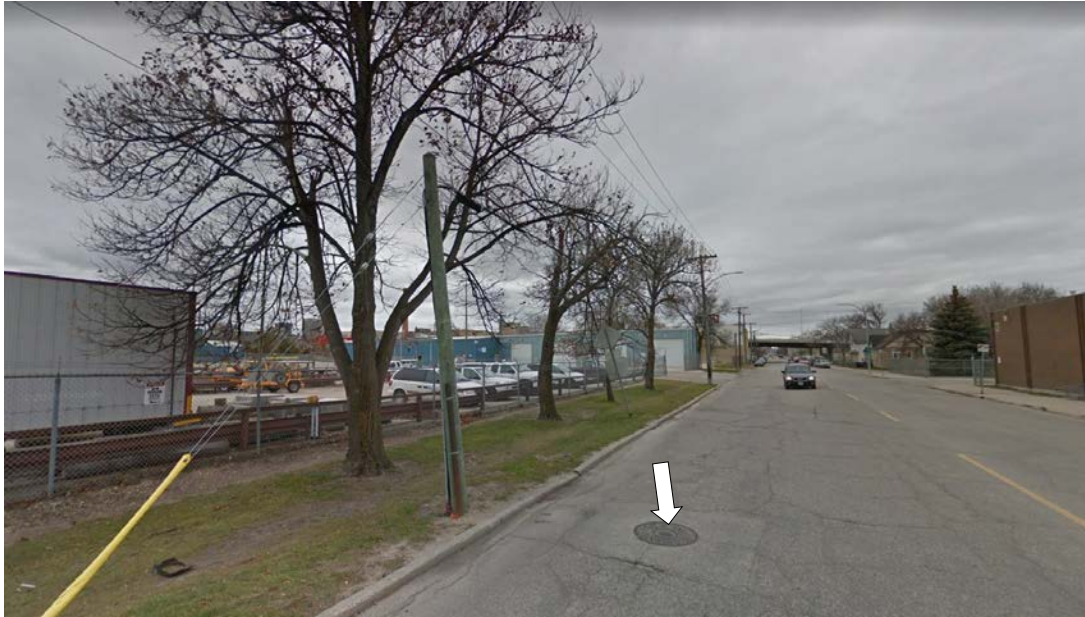
Figure 19 – Sheet 24, Dwg 12288 (Sutherland Av.) – Location of S-MH00012506 and Overhead Hydro.

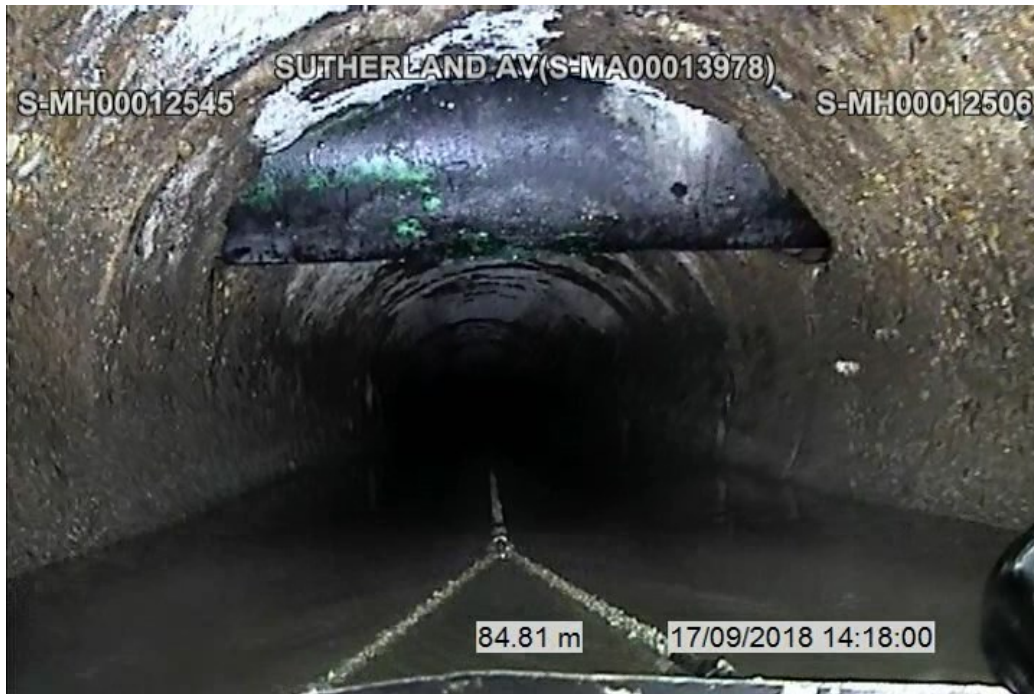
Figure 20 - Sheet 25, Dwg 12289, S-MA00013978 (Sutherland Av.) – 450 mm Sewer Crossbore at 87 m Downstream.

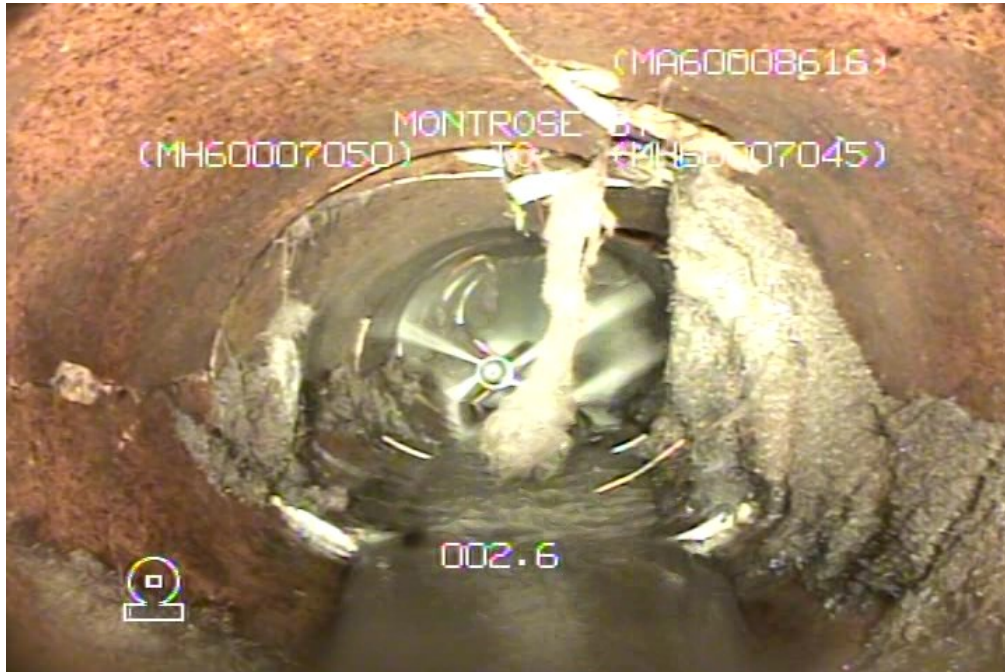
Figure 21 - Sheet 16, Dwg 12280, S-MA60008616 (Montrose St) - EPR Req'd at 1.8 - 7.7 m Downstream

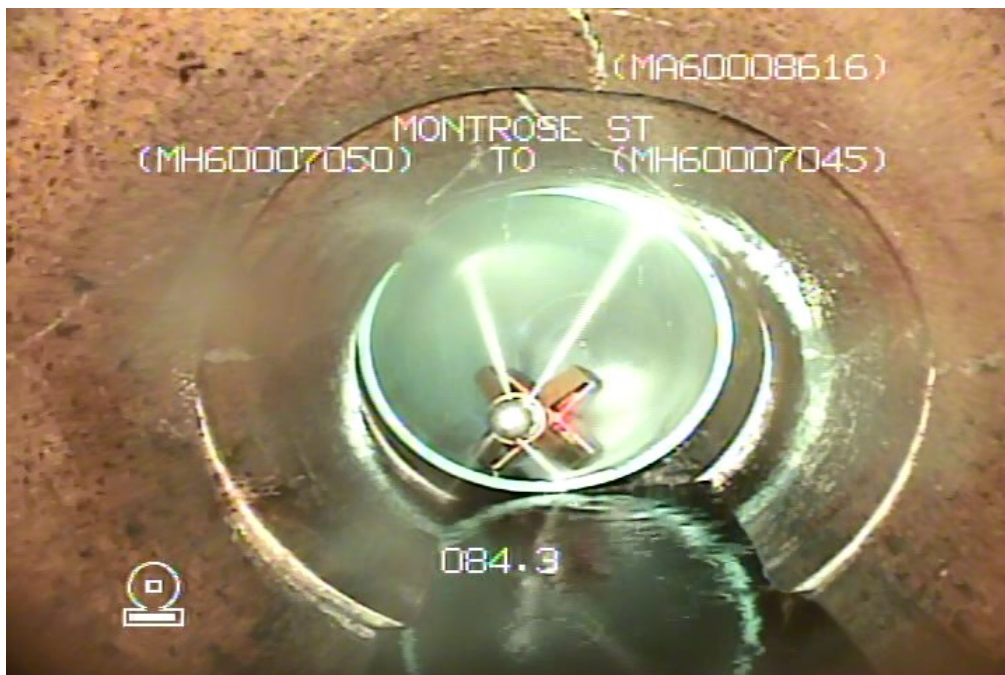
Figure 22 – Sheet 16, Dwg 12280, S-MA60008616 (Montrose St.) – PVC Repair Sleeve at 85.8 - 91.8 m Downstream.

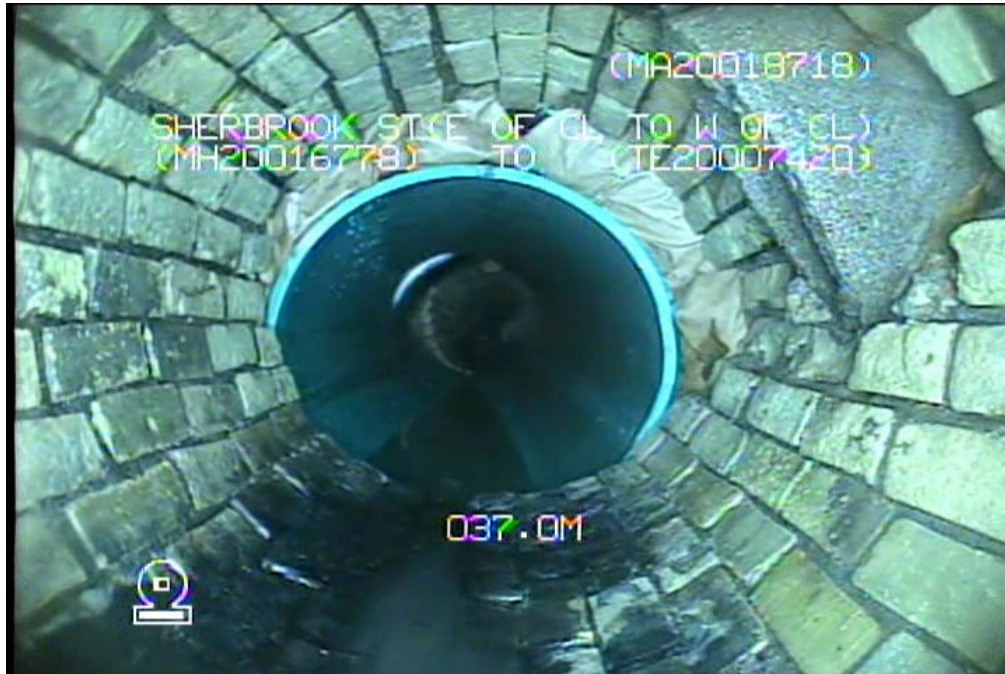
Figure 23 - Sheet 05, Dwg 12269, S-MA20018718 (Sherbrook St) - PVC Repair at 38.0 - 41.8 m  
Downstream
