CITY OF WINNIPEG

WASTEWATER LIFT STATION CONDITION ASSESSMENT PHASE II

Document VIII: Riverbend Lift Station Assessment

Date: March 16, 2020

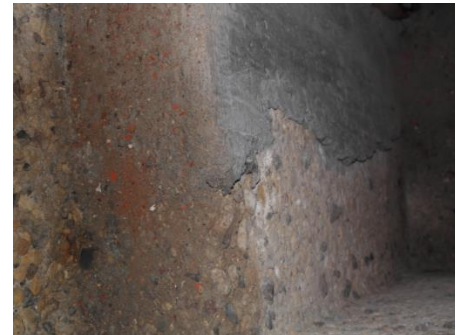
The Riverbend Lift Station foundation consists of a cast-in-place concrete dry well (a valve pit and a pump room). The base of the valve pit is approximately 11.6m below grade. The wet well and pump room bases are approximately 12.7m below grade. The valve pit was historically a comminutor room with open sewage. The open sewage pits have since been “piped over” and the structure no longer contains open sewage. A round, buried concrete wet well was cast against the side of the structure. The concrete base slab in the valve pit shows signs of surface deterioration from the previous H₂S environment. Some of the aggregate is loose. The sump pit is functional and the floor is sloped for drainage to the sump; however, minor ponding was noted near the sump during the inspection.

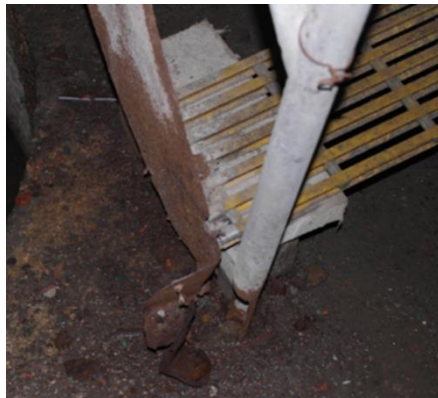
The lower level stairs and hand rail leading to the valve pit are excessively corroded and present an immediate safety risk with further usage. The handrail is no longer attached at the top. The base is propped up by a brick. Immediate replacement is recommended.

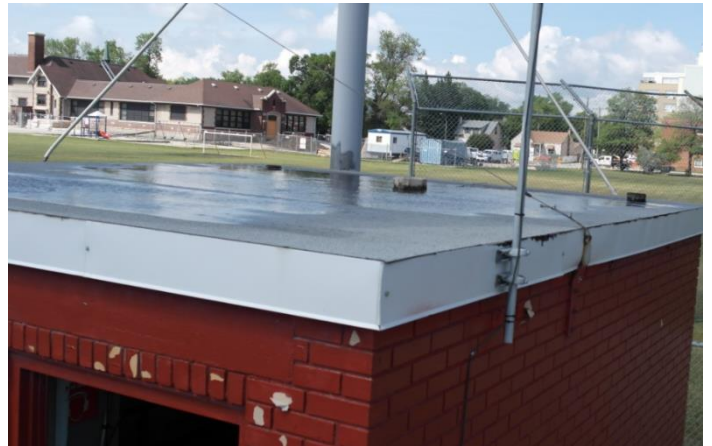
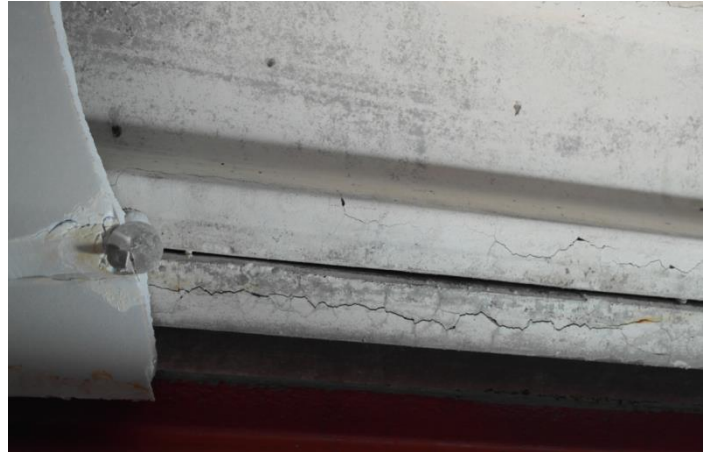
The roof membrane appears to have been replaced recently and is in good condition. The sag in the roof will continue to be problematic. Sloped insulation installed below the membrane may be sufficient to eliminate ponding and extend the life of the life of the roofing structure. At this point, it is recommended that the roof panels be replaced to ensure there is capacity to support Code required snow and rain loads. A full structural assessment on the roof panels may indicate the service life of the panels can be extended if ponding is eliminated.

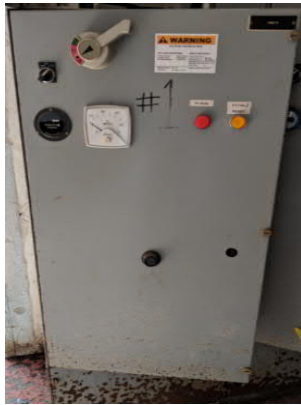
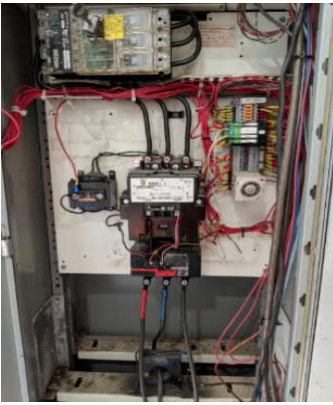
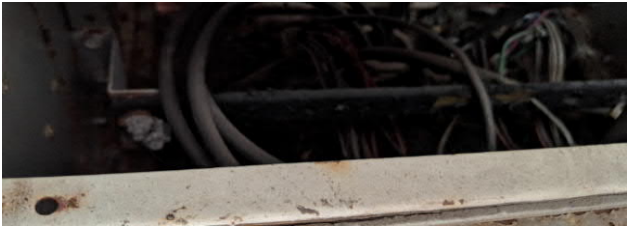
SECTION	ITEM	DATA	CONDITION RATING				AGE			
			Current Physical Condition	Fitness For Purpose			YEAR INSTALLED	EXPECTED SERVICE LIFE	REMAINING SERVICE LIFE	
Equipment Tag: E_E102_Starter Description: E_E102_Starter	GENERAL	Location: Dry Well, Main Level	3.2	3.0			1983	40	4	
		Description: E_E102_Starter								
		Manufacturer: Square D								
		Model: 8536SE01S								
		Phase: 3 Phase								
		Rated Voltage: 600 VAC								
	Rated Horsepower: 50 HP	Rating	Weight	Recommended Frequency of Review: (In years, specify between 1-15)			4			
	Current Physical Condition	Equipment Visual Inspection: Issues for Discussion:	Rating 1 (Like new) Rating 2 (Minor surface corrosion) Rating 3 (Surface & internal corrosion) Rating 4 (Severe corrosion) Rating 5 (Safety concern)	5	0.1	NOTES & COMMENTS: Although the starter it self seems to have been replaced the overall condition would be "Poor" due to the severe corrosion taking place within the Motor Control Centre. Equipment is not rated for a Zone 2 locations. Motor horsepower exceeds the starters rated horsepower RECOMMENDATIONS: Once ventilation requirements have been assesed and upgraded, it would be recommended to complete a full electrical upgrade incorporating a new starter into a new MCC.

Canadian Electrical Code Issues Identified: Issues for Discussion:	Rating 1 (No issues) Rating 3 (Non compliant - current code) Rating 5 (Non compliant - legacy code)	3	0.4					
		Wiring Terminations Visual Inspection: Issues for Discussion:	Rating 1 (Connections tight, labelled) Rating 2 (Missing labels) Rating 3 (Loose / disorganized wiring) Rating 4 (Inappropriate wiring) Rating 5 (Combination of above)	3	0.1					
Occurrences of Maintenance Issues: Issues for Discussion:		Rating 1 (None) Rating 2 (Intermittent) Rating 3 (Consistent but occasional) Rating 4 (Frequent) Rating 5 (Constant)	3	0.4						
Fitness for Purpose	Meets City Electrical Design Standards: Issues for Discussion:	Rating 1 (Yes) Rating 3 (No - current standards) Rating 5 (No - legacy standards)	1	0.25	COST ESTIMATE \$ 10,000.00					
	Has the Breaker Capactiy been Reached? Issues for Discussion:	Review starts per hour vs. recommendation Rating 1 (< 80% rec. starts / hour) Rating 3 (80% - 95% rec. starts / hour) Rating 5 (>95% rec. starts / hour)	3	0.25
