Water and Waste Department • Service des eaux et des déchets

September 7, 2005

Inspection: Avenue Lemay Land Drainage Sewer, Rue Landry to the Red River

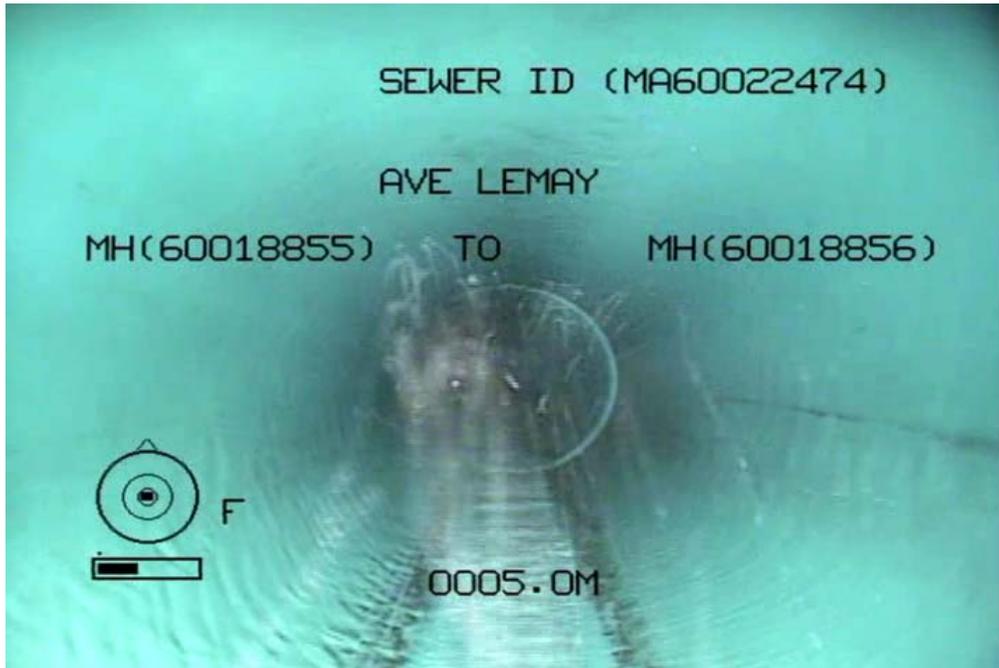
The assessment shows that, overall, all sections of the sewer system are in good working condition (see Figures 1 – 4).

Figure 1 – 300 mm PVC land drainage sewer pipe in good condition.

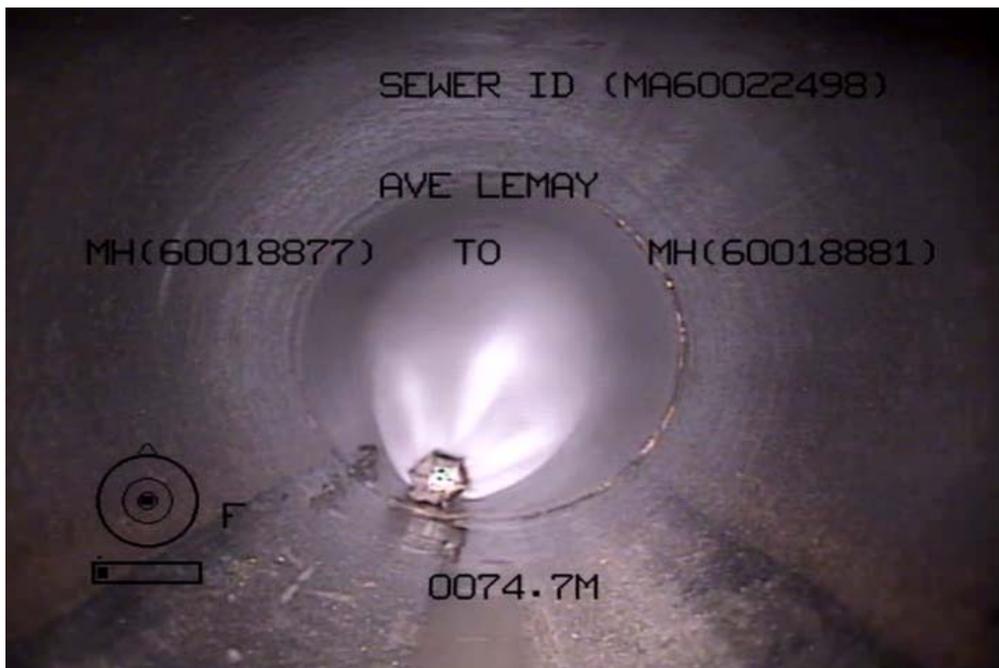
Figure 2 – 750 mm concrete land drainage sewer pipe in good condition.

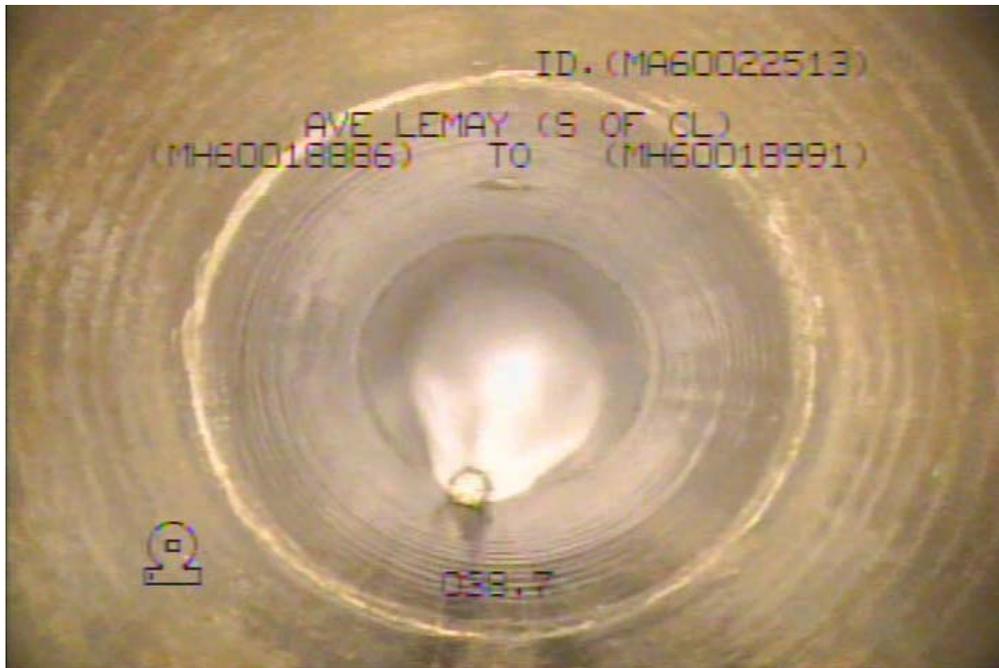
Figure 3 – 900 mm concrete land drainage sewer pipe in good condition.

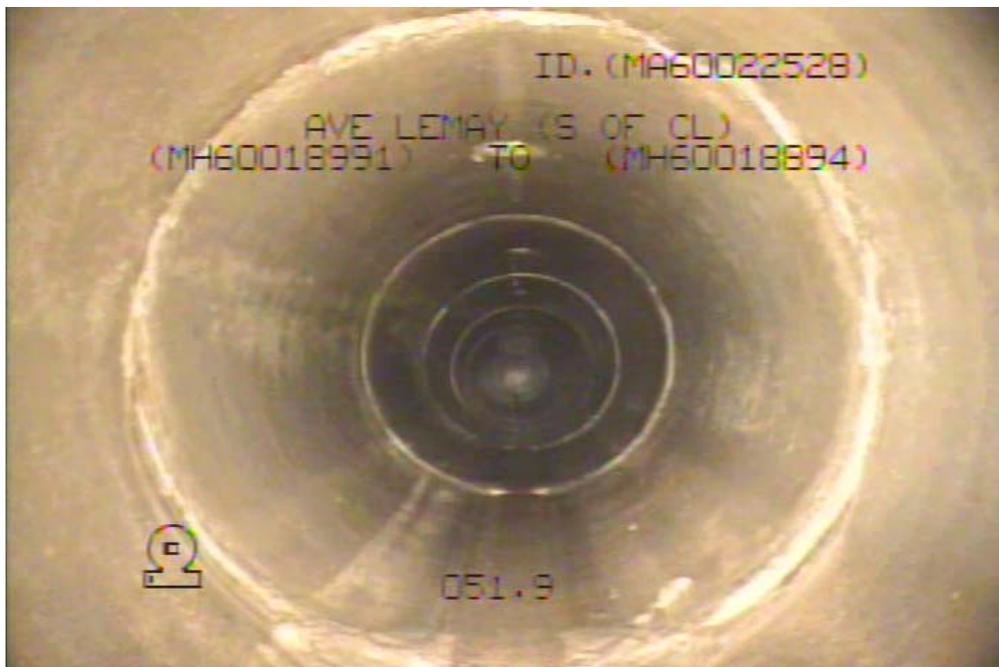
Figure 4 – 900 mm concrete land drainage sewer pipe in good condition.

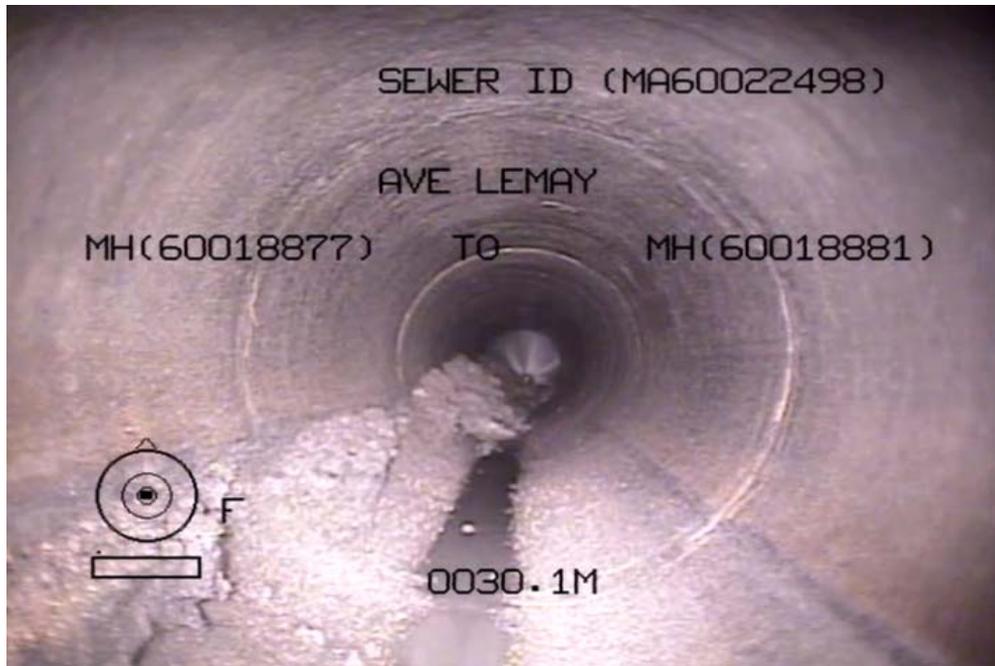
2. Debris had built up in a 30-metre stretch about the midpoint of the 107 metre section between the second manhole east of Rue La Barriere and the manhole at Rue St. Pierre. The debris had filled 20 to 25% of this section of the sewer (see Figure 5).

It is not unusual to get some debris accumulation in sewers. All the debris has been removed.

Figure 5 – Silt debris in 750 mm diameter land drainage sewer on Avenue Lemay. Before cleaning, there was an estimated 20 to 25% build-up of debris in the pipe.

These unique conditions do not place the sewer system in any immediate danger. The sewer continues to perform. Until we can make the repairs, we will monitor and clean the section of sewer that is accumulating debris. We will do this annually.

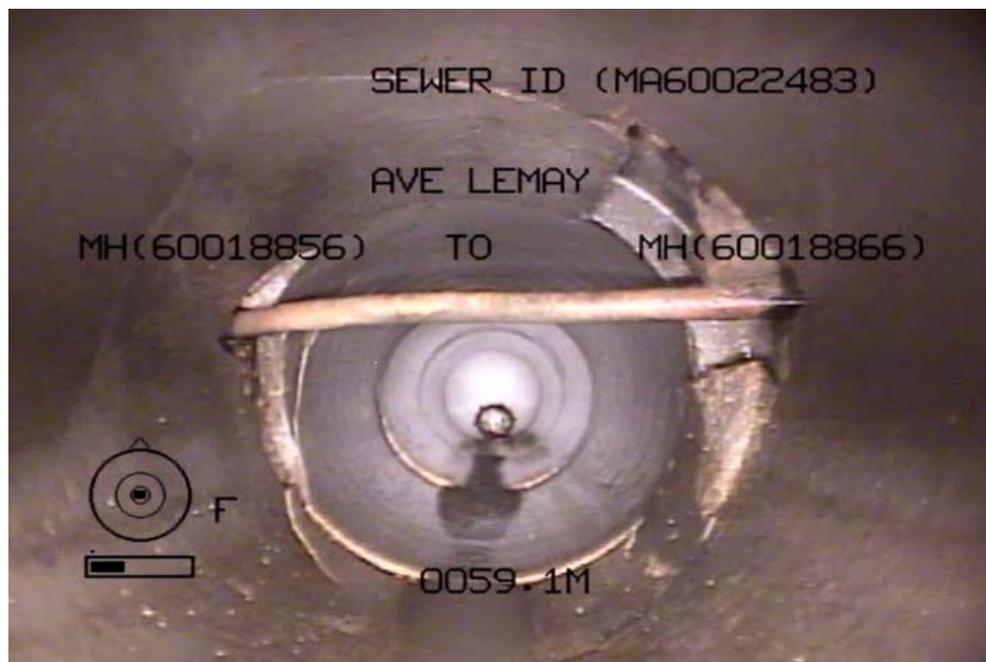
- A 19 mm diameter copper water service was installed through a section of 300 mm diameter sewer between the manhole at Rue Landry and the first manhole east of Rue Landry (see Figure 6). Missing pipe segment and holes can be seen. The holes indicate the service was unintentionally installed through the land drainage sewer. The water pipe would have been installed using trenchless technology, which allows the pipe to be installed with minimal disruption to the ground. The workers have a general idea of where the pipe is travelling, but aren't able to track the exact path of the pipe. This likely occurred during a 1995 water main renewal project.

The sewer still works properly, but there is a structural weakness at this point in the sewer pipe. It is also a point of entry for debris.

Figure 6 – 19 mm water service through 300 mm diameter land drainage pipe on Avenue Lemay.

3. Other pipes pass through the sewer system in several places. This is unusual but does not affect the operation of the sewer system. However, these are areas of structural weakness of the pipe, and we plan to repair these parts of the sewer to prevent a structural failure in the future.

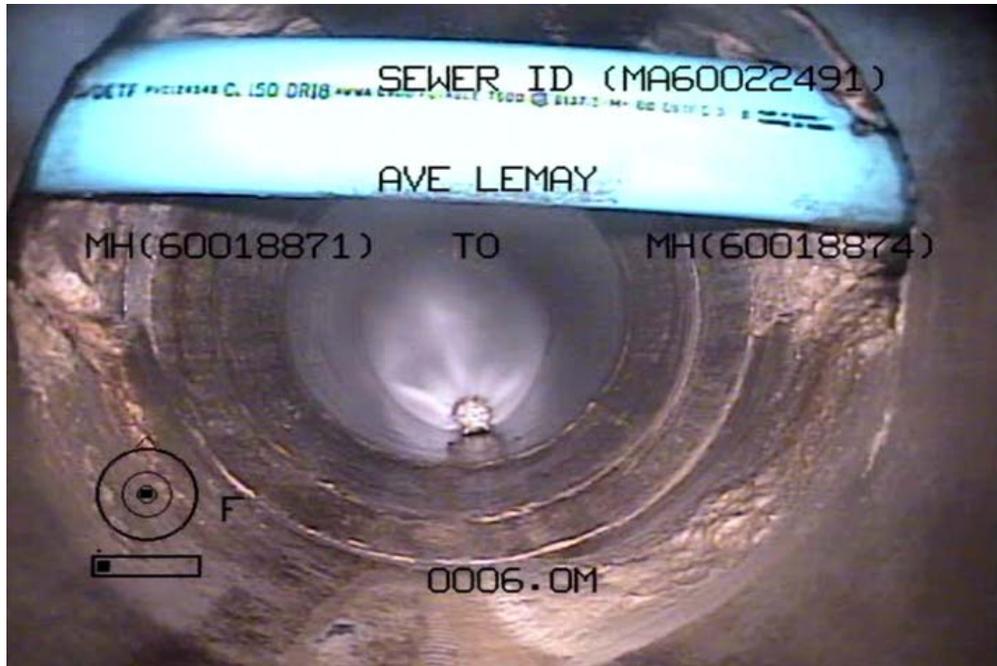
- A 150 mm diameter PVC water main was installed through a section of 750 mm diameter sewer between the manhole at Rue La Barriere and the first manhole east of Rue La Barriere (see Figure 7). Missing pipe segments and holes in the land drainage pipe are visible. The construction indicates that the water main was unintentionally installed through the land drainage sewer. This was likely done as part of a 1986 water main renewal project.

The sewer still works properly, but there is a structural weakness at this point in the sewer pipe. It is also a point of entry for debris.

Figure 7 – 150 mm diameter PVC water main through 750mm diameter land drainage sewer on Avenue Lemay.

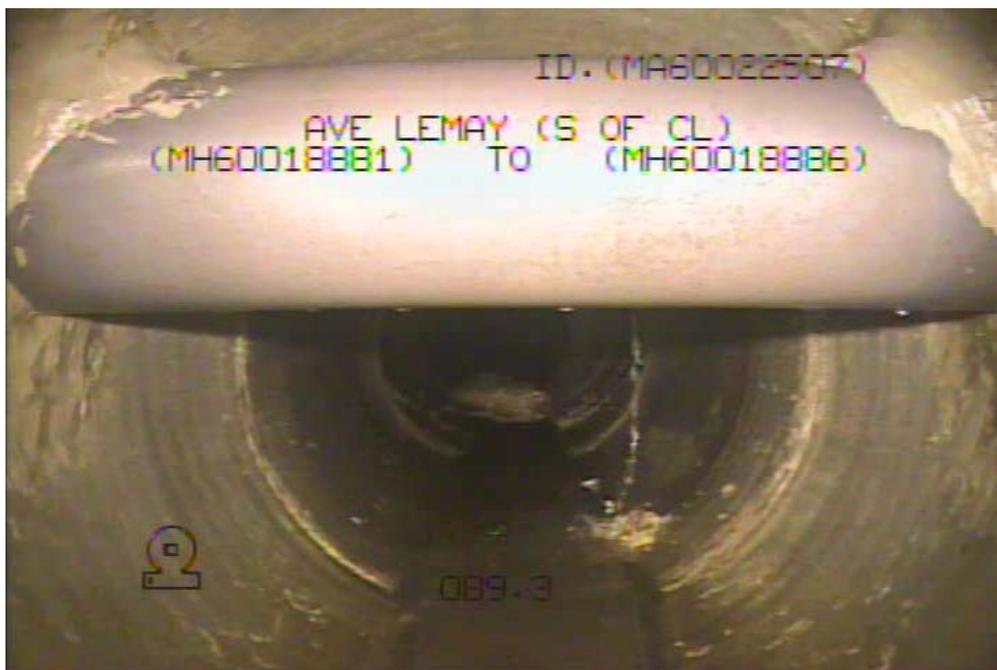
- A 200 mm diameter wastewater sewer was installed through the 900 mm land drainage sewer on Avenue Lemay at Rue La Grave (see Figure 8). The wastewater sewer was installed through the land drainage sewer. The holes are grouted and sealed, indicating this was done intentionally. It was installed as part of work done on the land drainage sewer for the Rural Municipality of Fort Garry in 1961.

This installation was acceptable in unique situations back in the 1960s, but it would likely not occur in present day designs.

Figure 8 – 200 mm diameter wastewater sewer through 900 mm diameter land drainage pipe on Avenue Lemay.
