# **Appendix F: SUBSTRUCTURE CONDITION SURVEY REPORT**

# MEMORANDUM

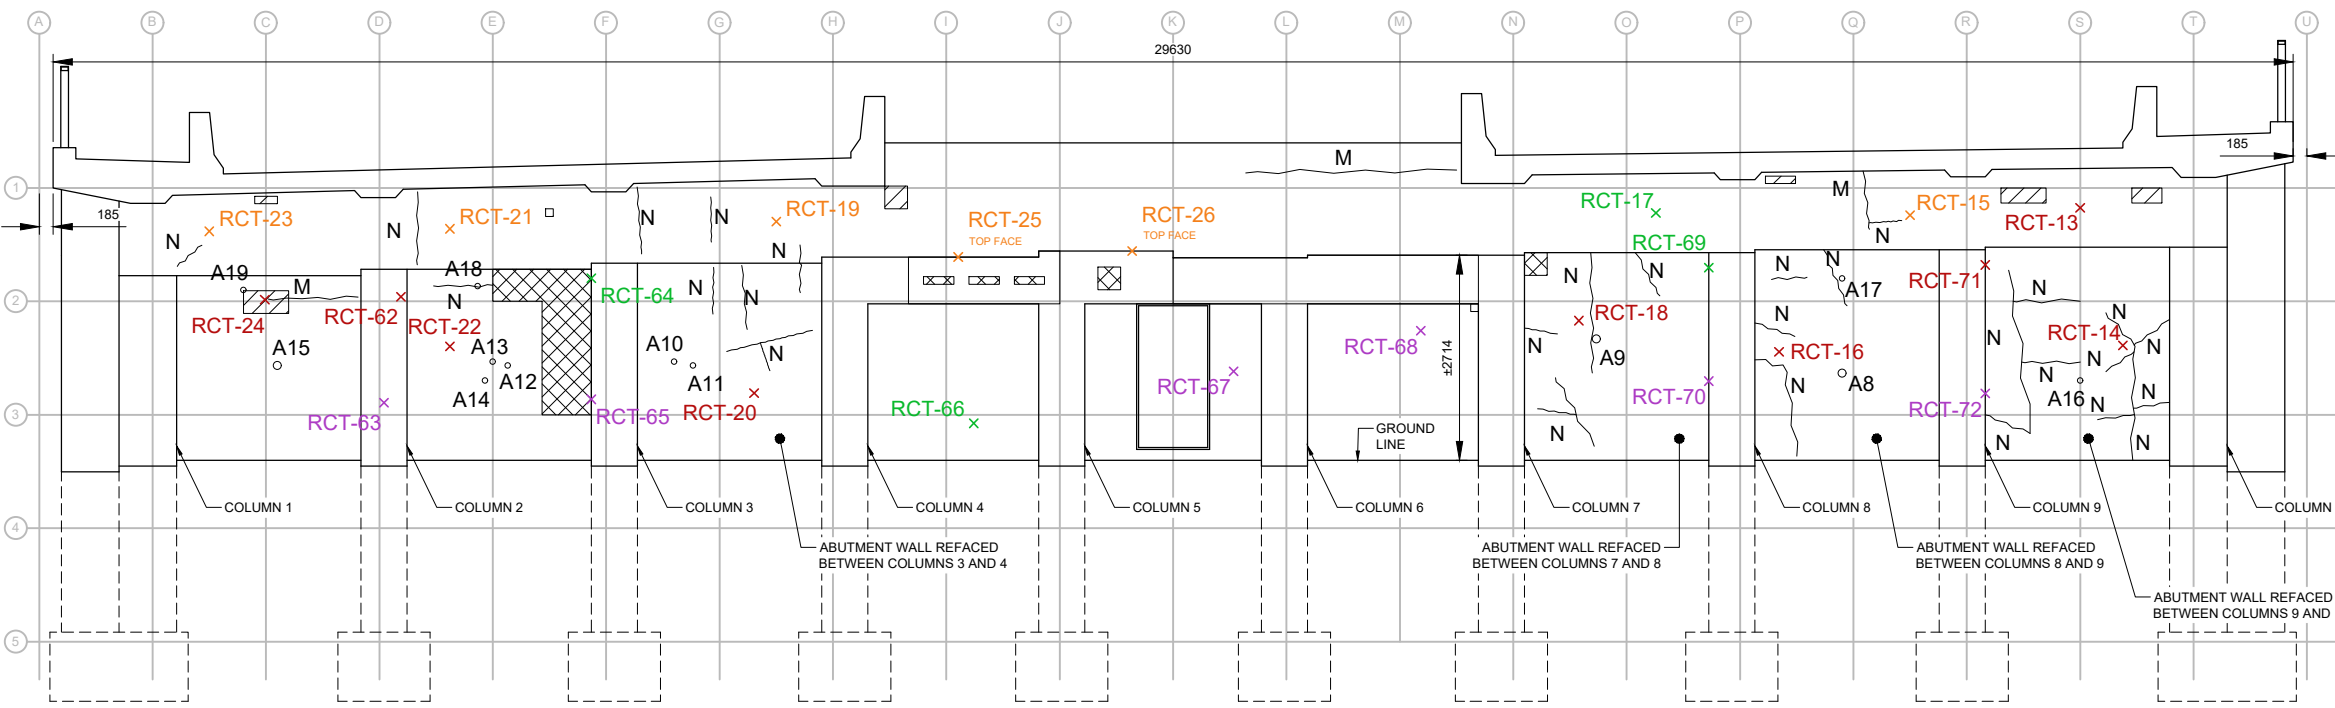
**APPENDIX O.1: SUBSTRUCTURE CONDITION ASSESSMENT  
DETAILED CONDITION SURVEY DRAWINGS**

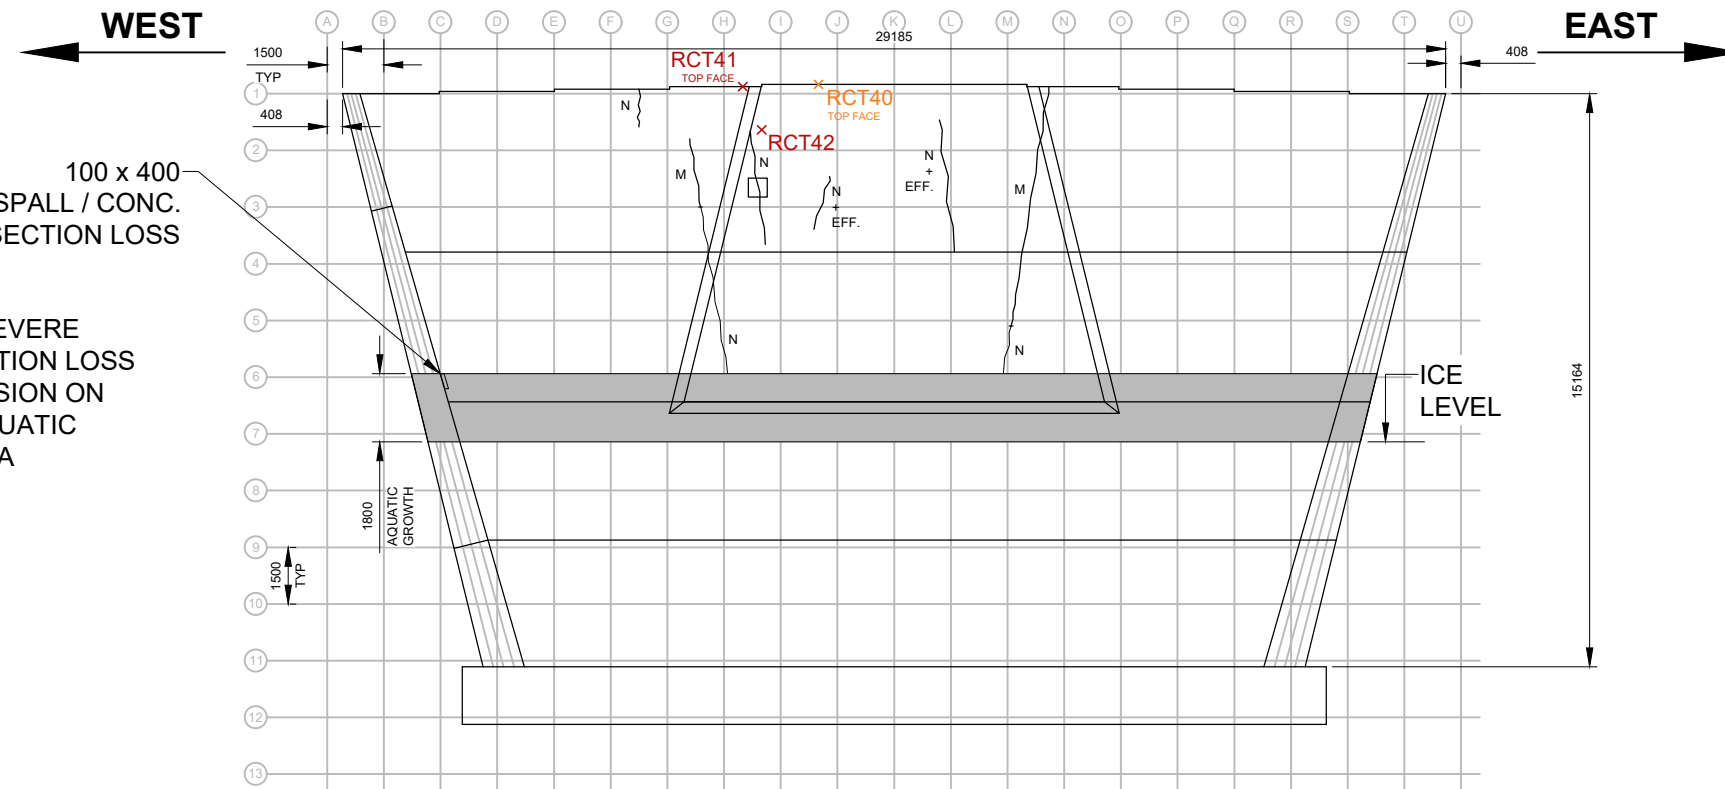
**PIER 4 SOUTH FACE**

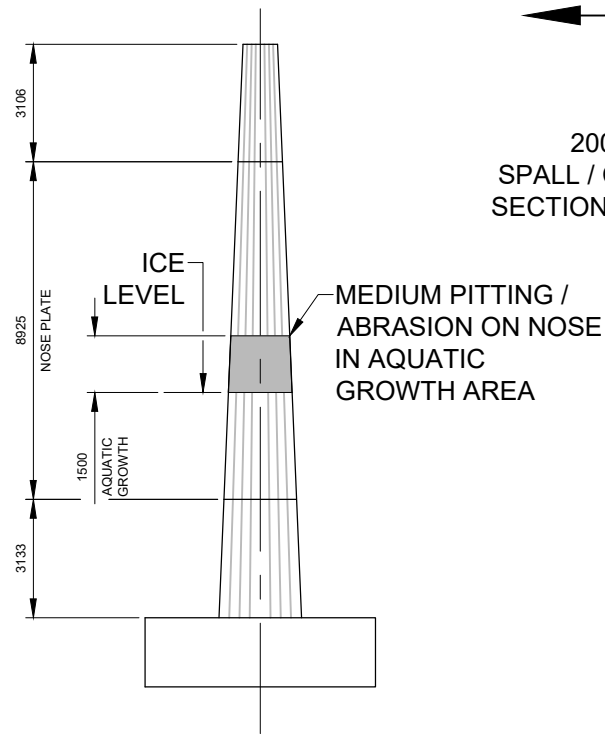
PIER 4  
DEFECTS AND TESTING LOCATIONS  
SCALE = AS SHOWN  
DRAWN BY: ALP

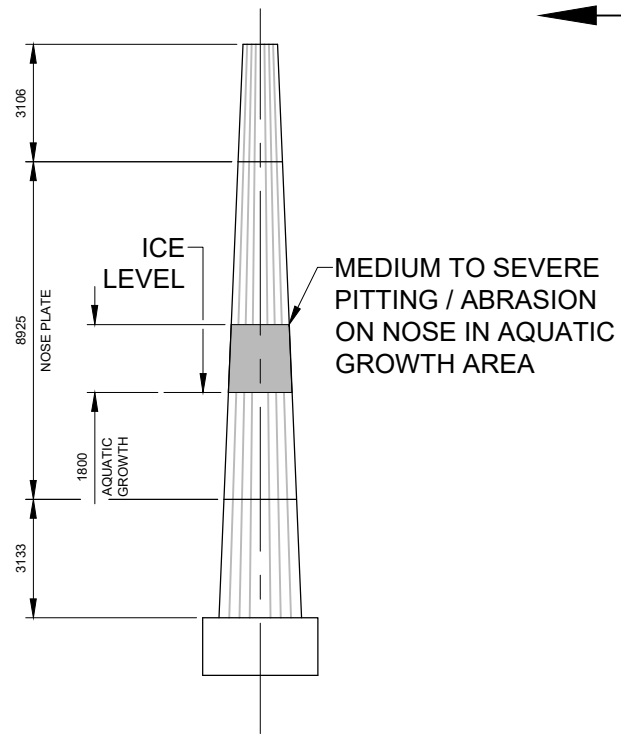
PIER 5  
DEFECTS AND TESTING LOCATIONS  
SCALE = AS SHOWN  
DRAWN BY: ALP

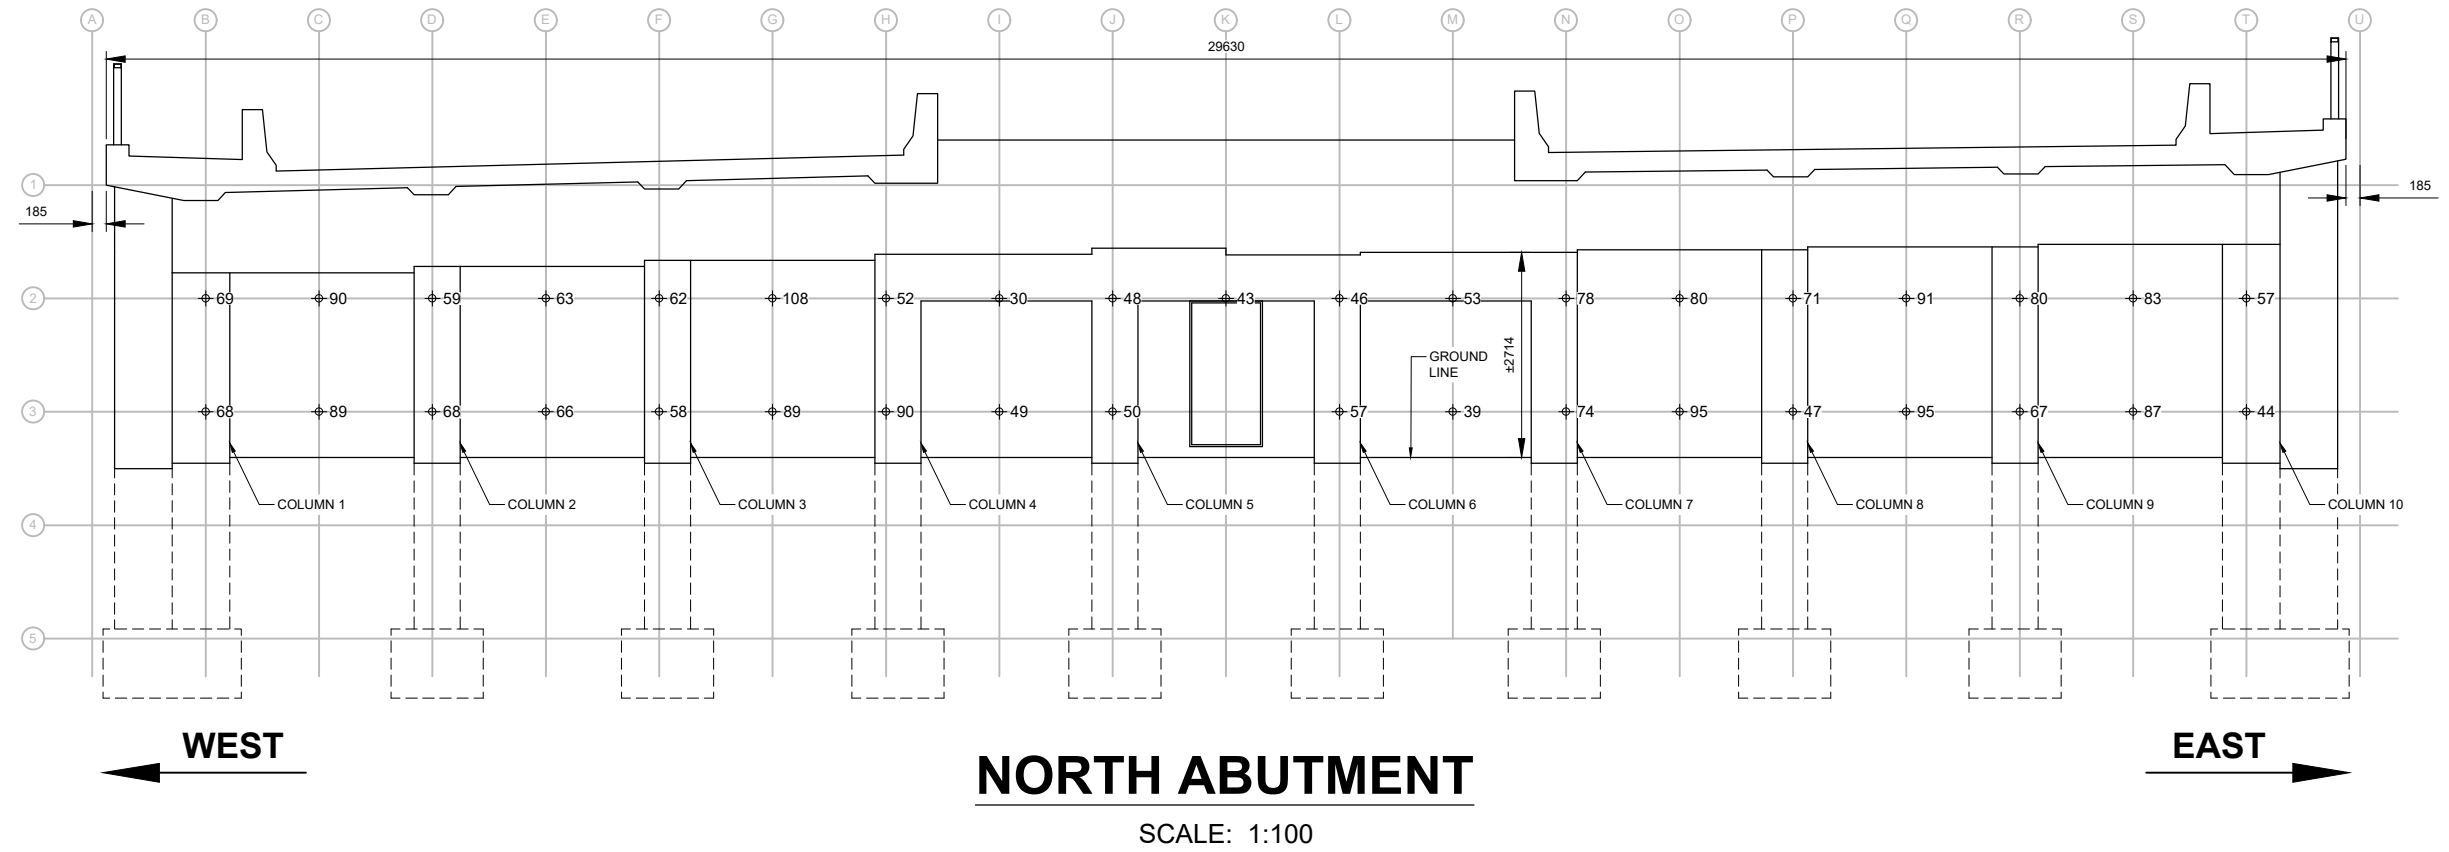
NOTES:  
1. COVER SURVEY COMPLETED IN JUNE 2022.

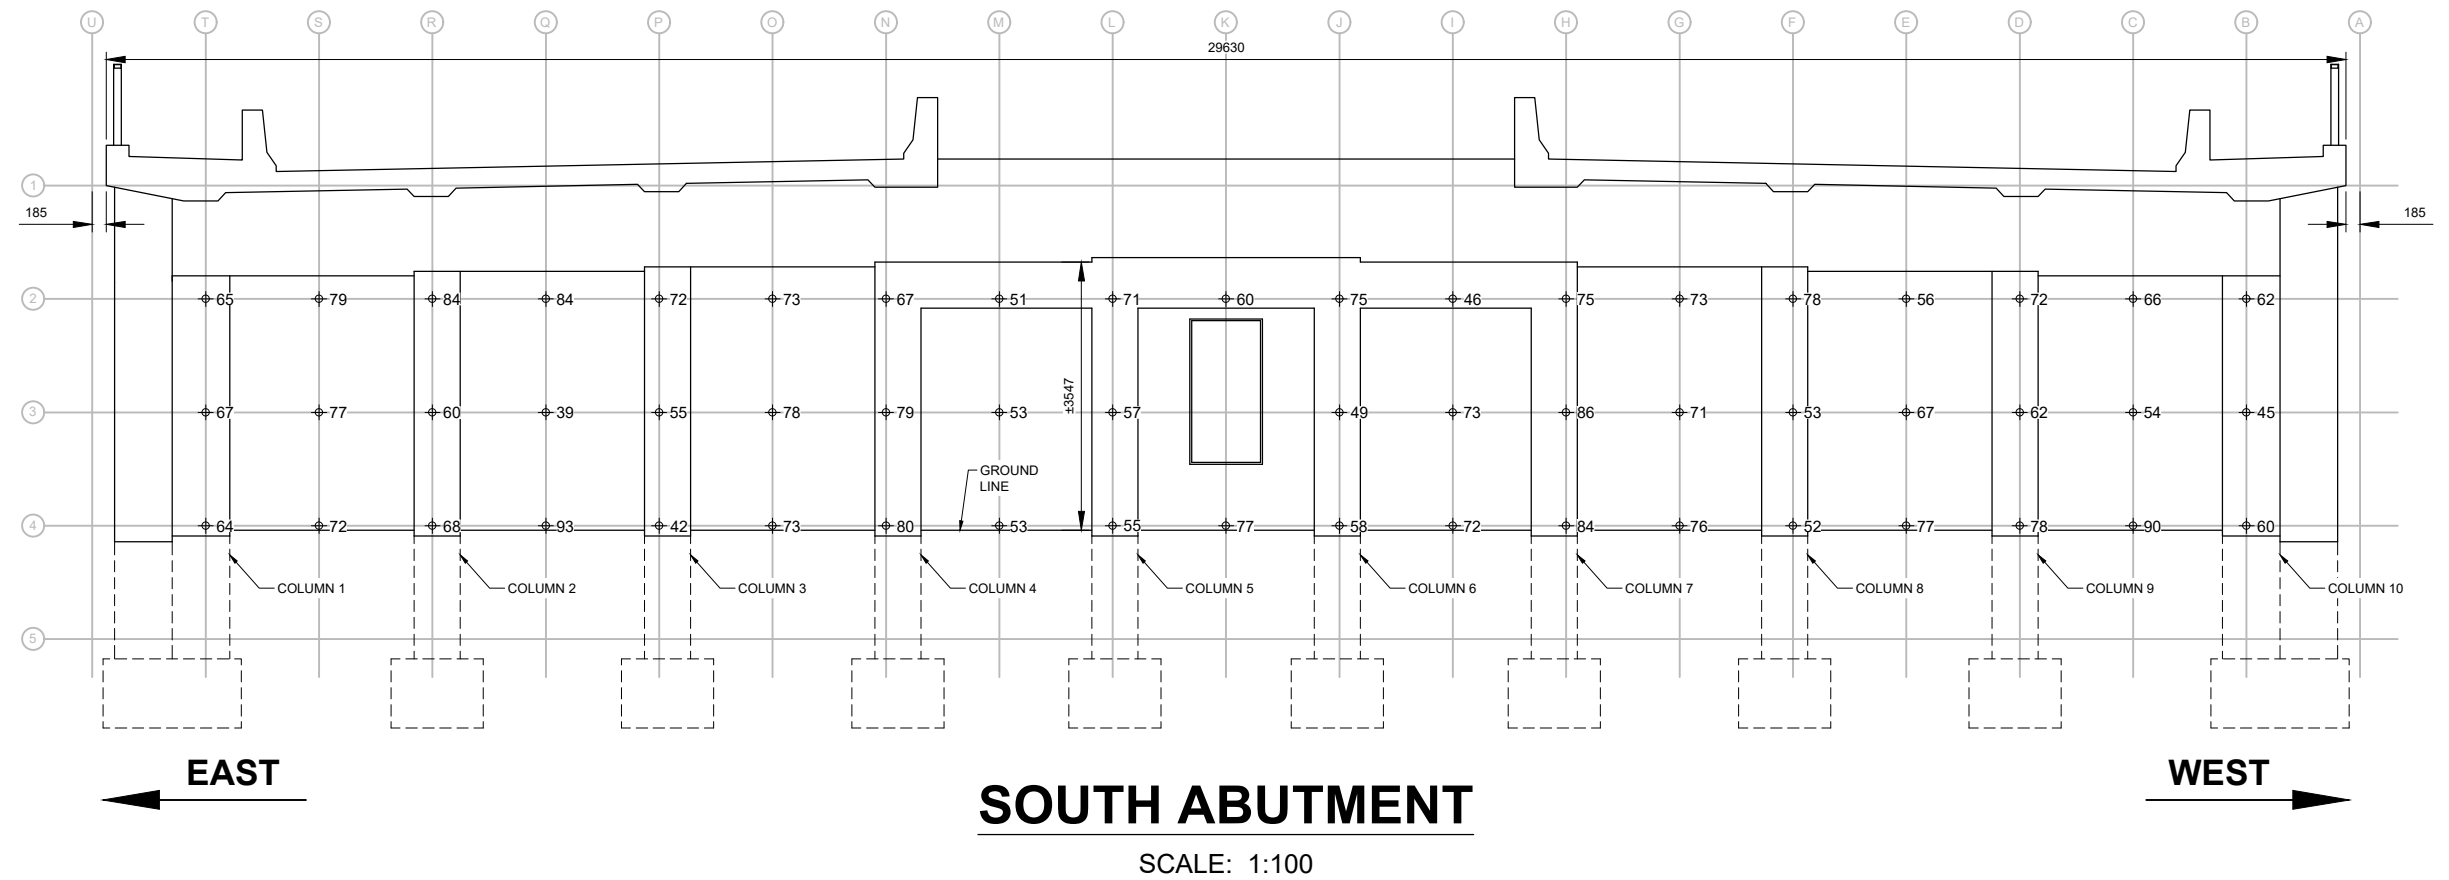
NOTES:  
1. COVER SURVEY COMPLETED IN JUNE 2022.

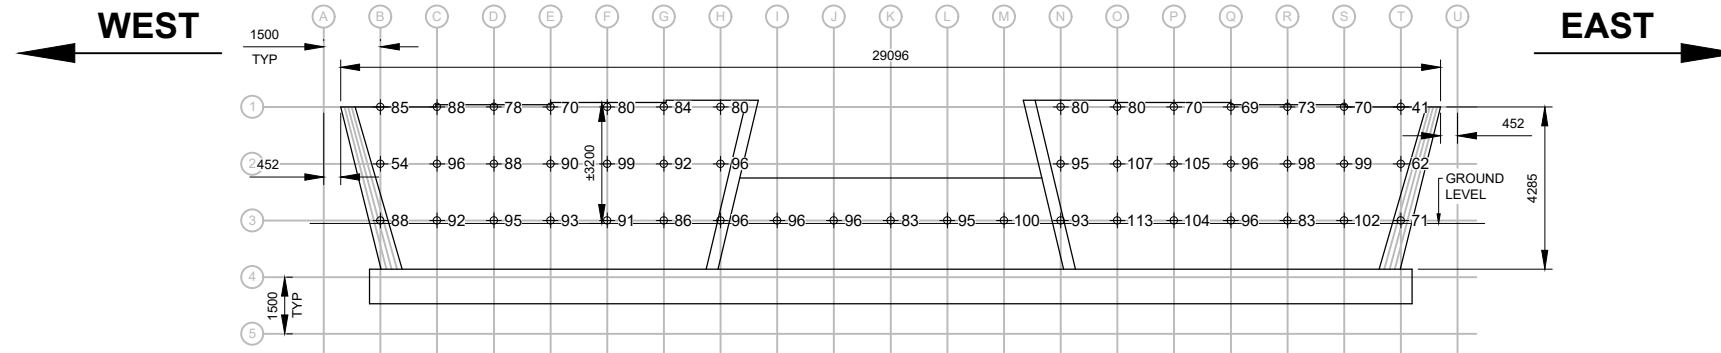
PIER 7  
 COVER SURVEY  
 SCALE = AS SHOWN  
 DRAWN BY: KMB

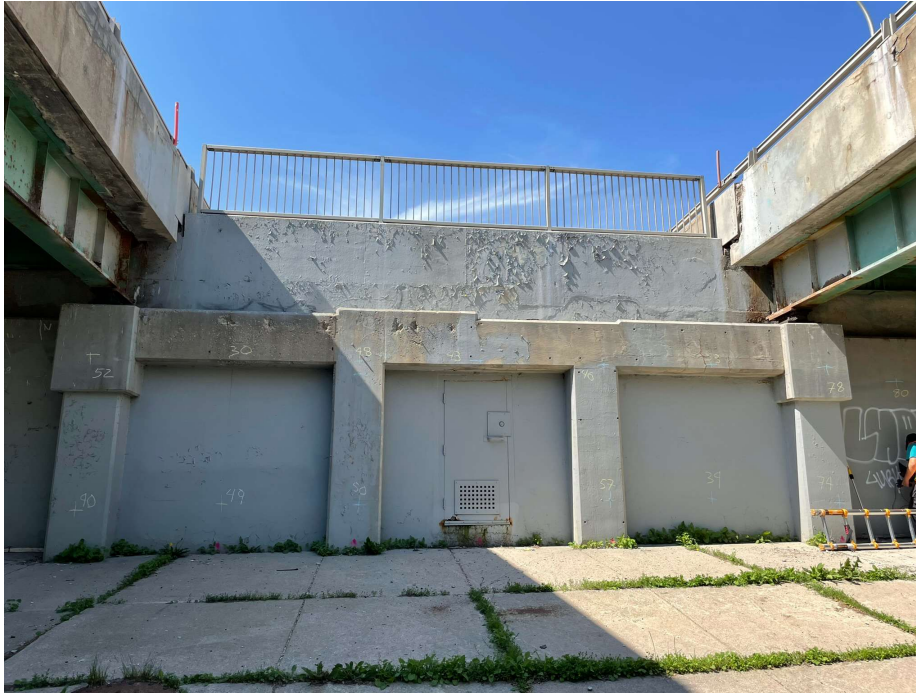
**Photo 01 - North abutment wall, between NB and SB lanes**

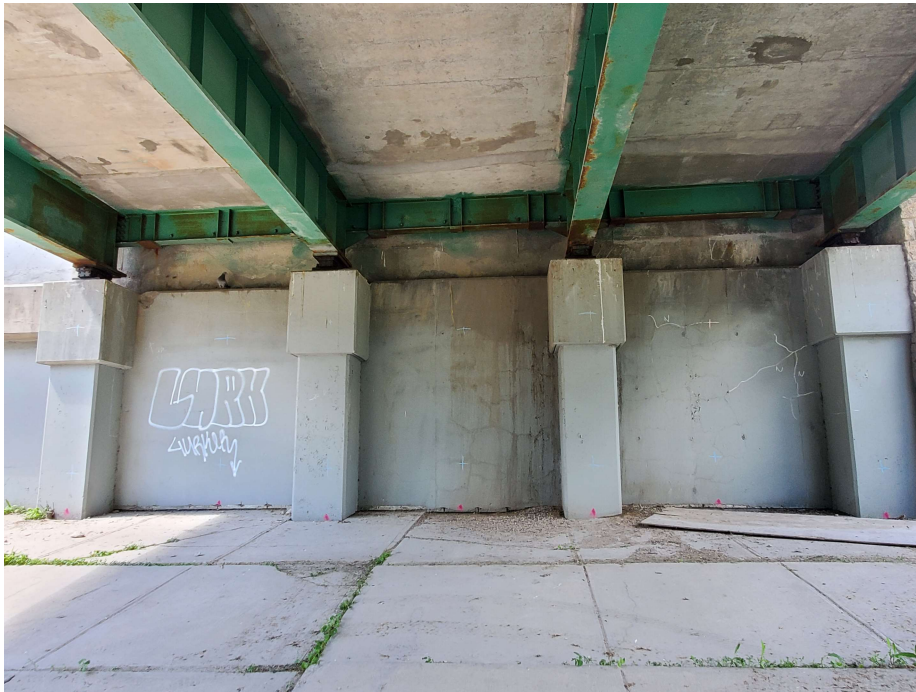
**Photo 02 - North abutment NB Lanes**

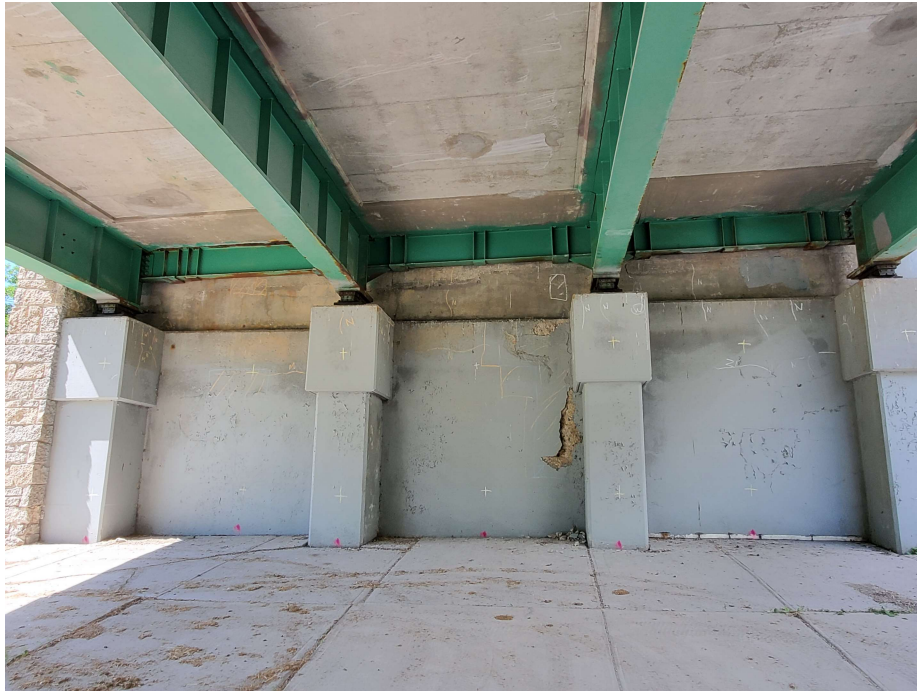
**Photo 03 - North abutment SB Lanes**

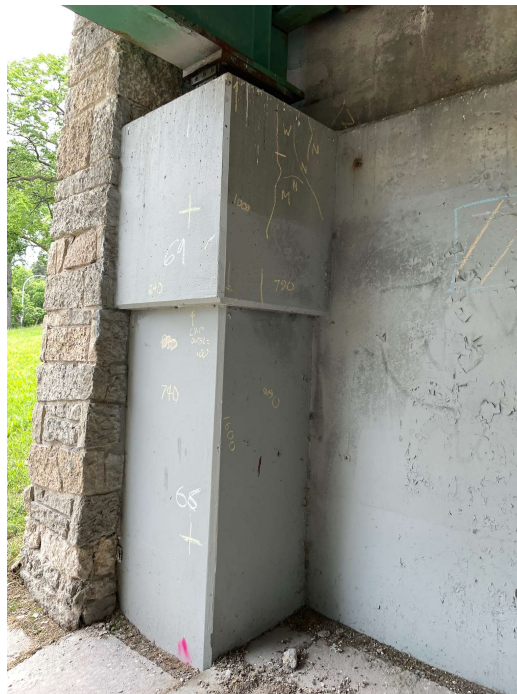
**Photo 04 - North abutment NB, Column 1 cap, narrow to wide cracking**

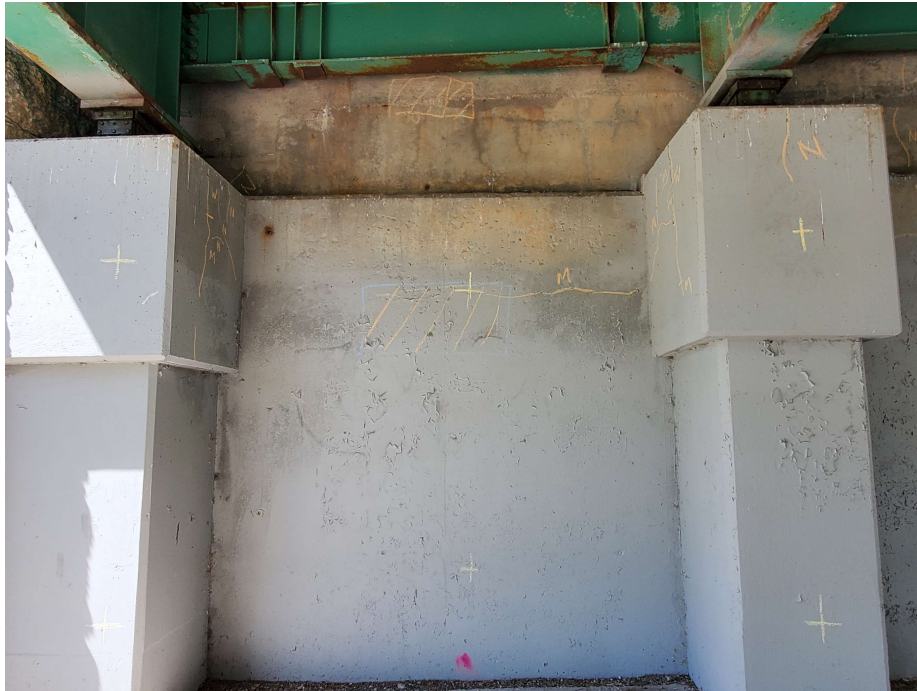
**Photo 05 - North abutment wall, between Column 1-2, medium horizontal crack and localized delamination**

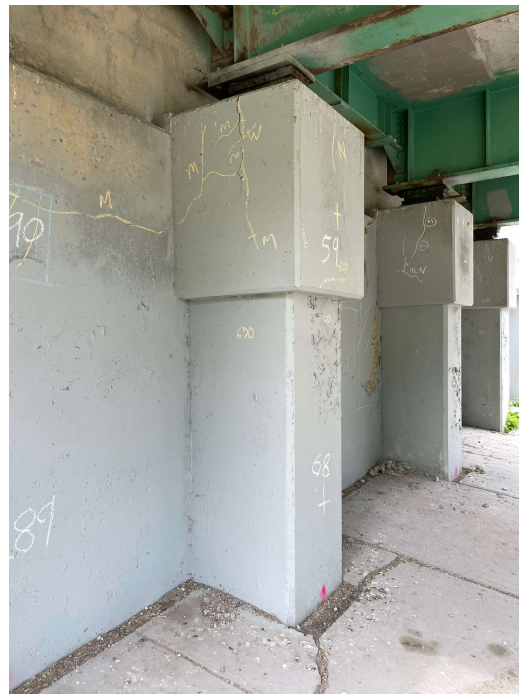
**Photo 06 - North abutment NB, Column 2 cap west face, medium to wide cracking**

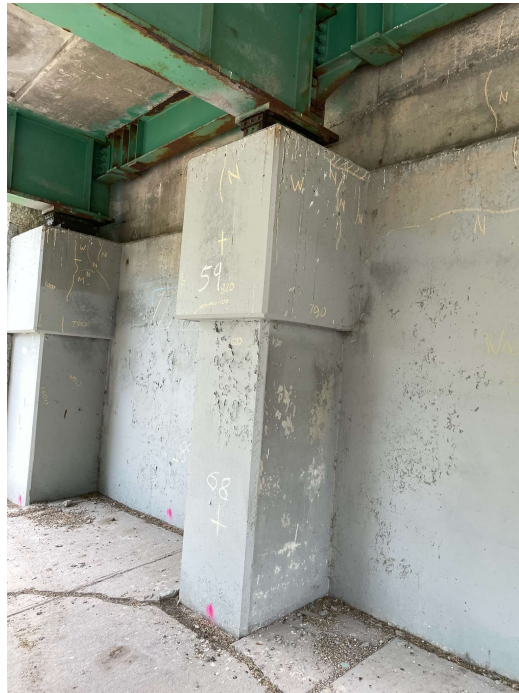
**Photo 07 - North abutment NB, Column 2 cap east face, medium to wide cracking**

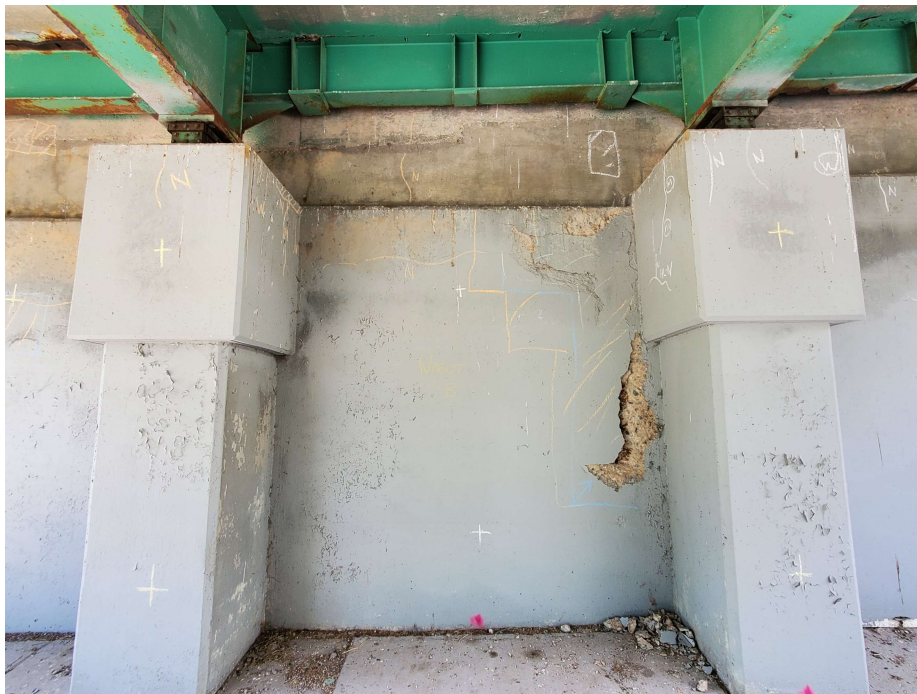
**Photo 08 - North abutment wall, between Column 2-3, large delaminations and spalling**

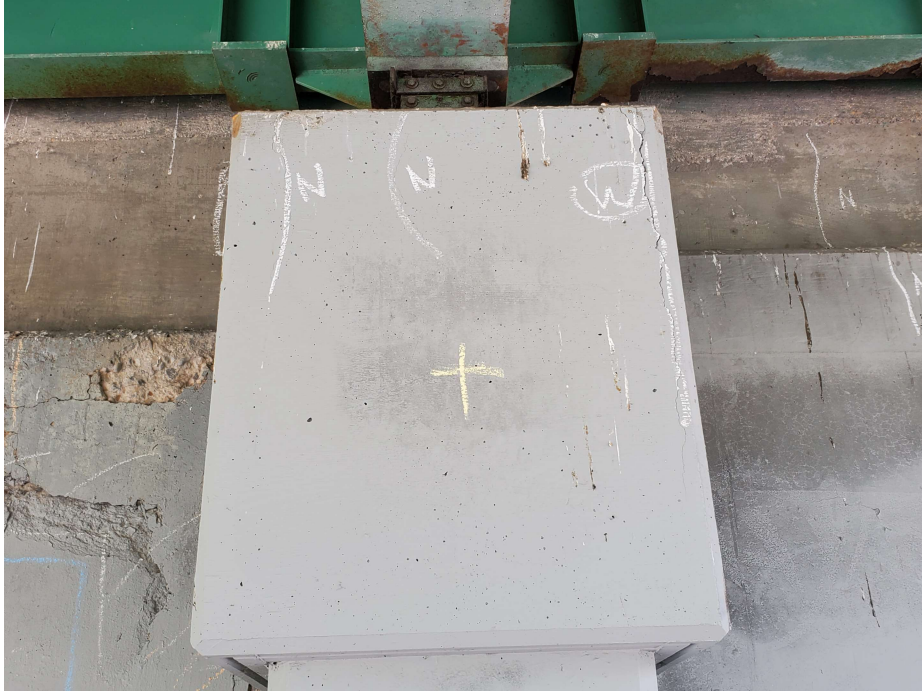
**Photo 09 - North abutment wall, Column 3 cap south face, narrow to wide cracking**

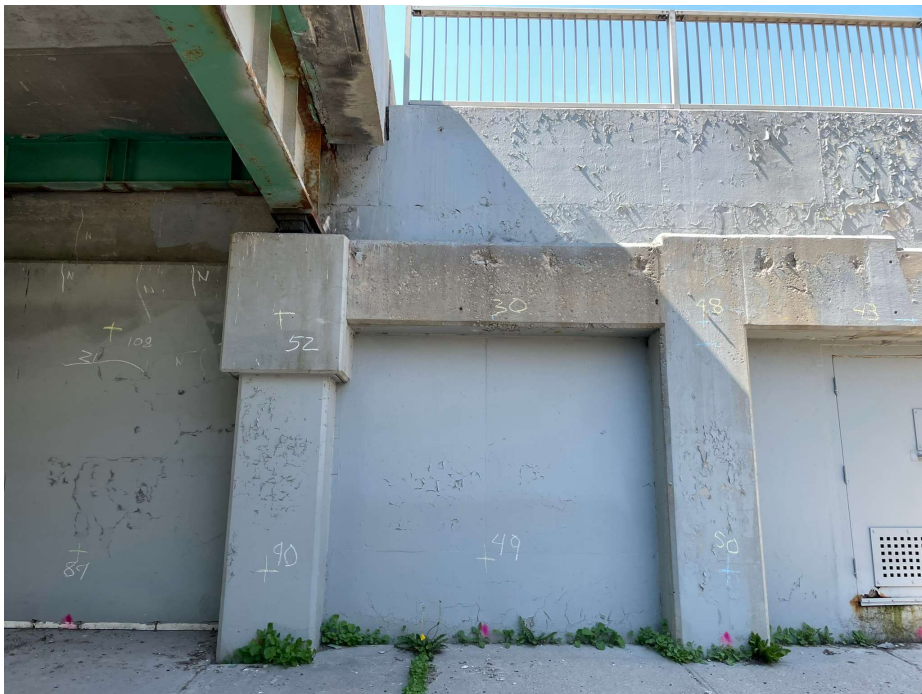
**Photo 10 - North abutment wall between NB and SB – localized spalls, light scaling, and medium honeycomb on cap beam between Column 4 – 6**

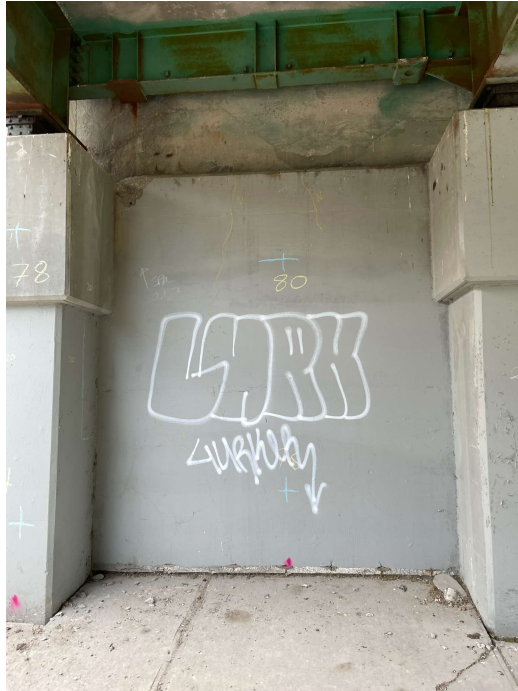
**Photo 11 - North abutment, Column 7-8 (under NB lanes), narrow vertical cracking on abutment wall refacing and small localized spall near top of Column 7**

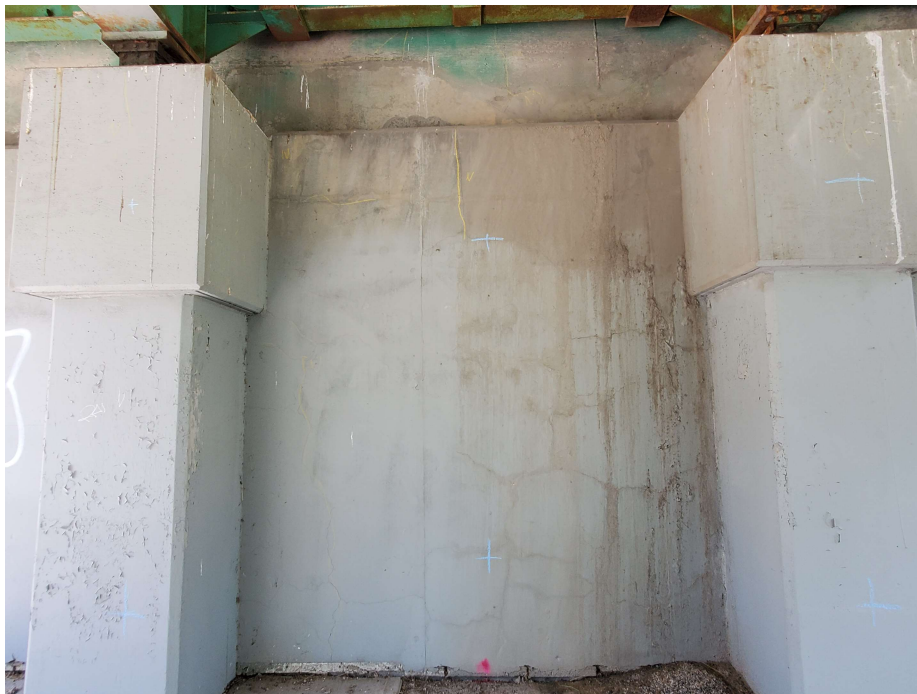
**Photo 12 - North abutment Columns 8-9 (under NB lanes), joint leakage staining and narrow cracking in concrete refacing**

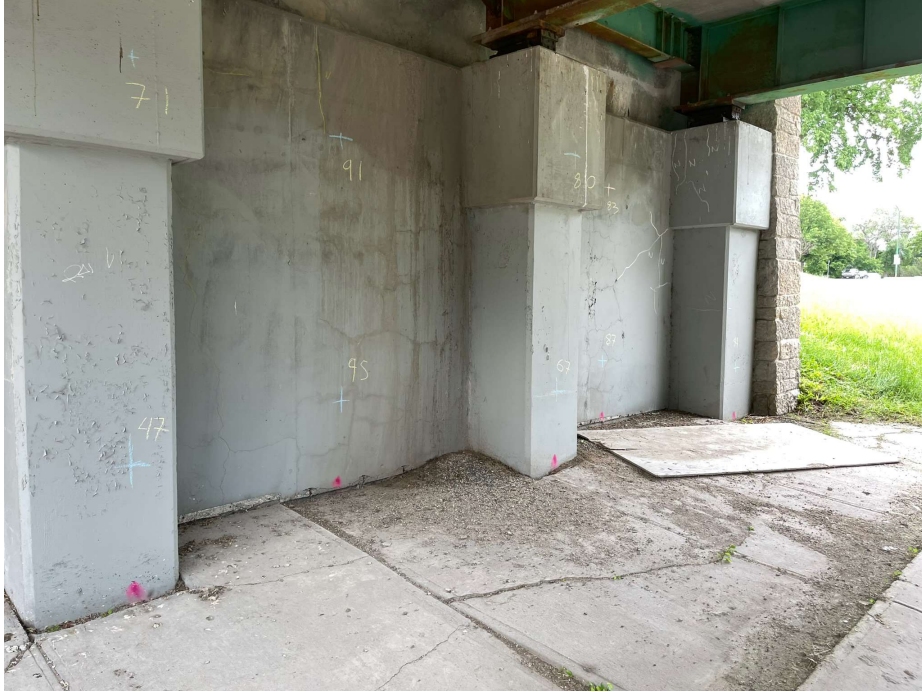
**Photo 13 - North abutment, Column 8-10, narrow vertical and horizontal cracking on abutment wall refacing**

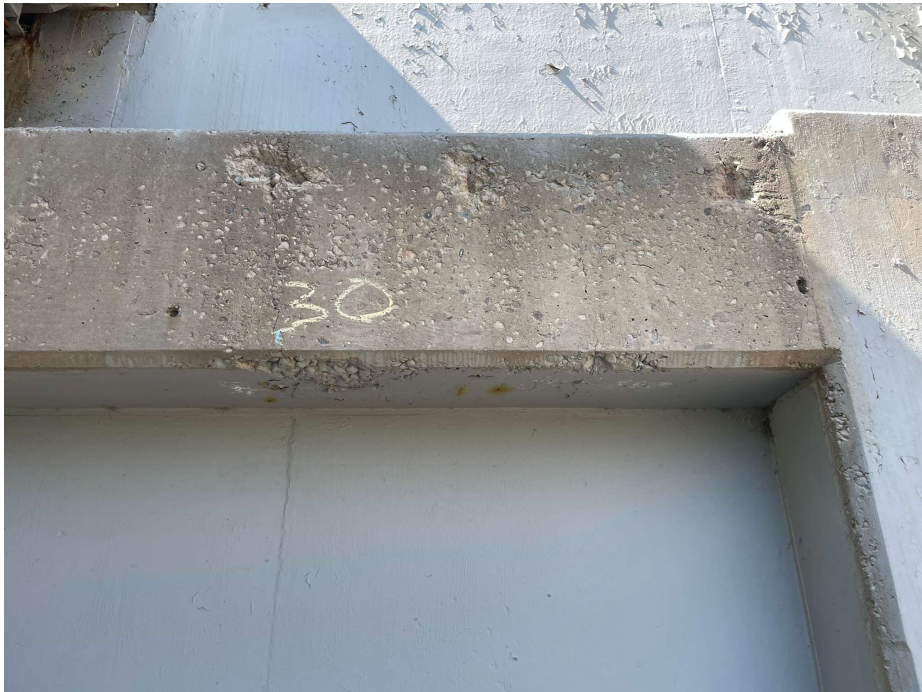
**Photo 14 - North ballast wall – localized delamination at east end of SB lanes**

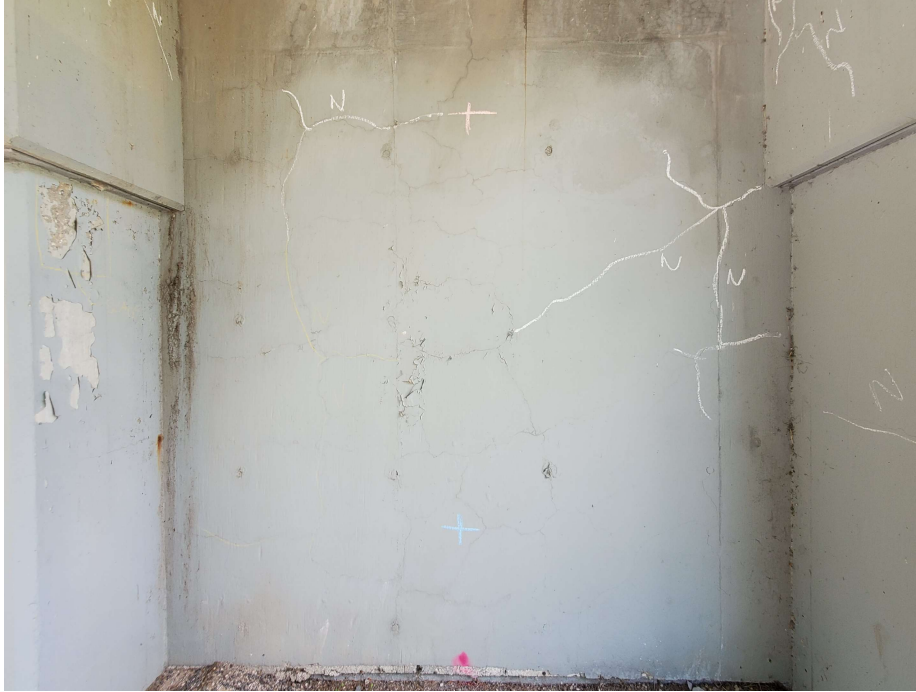
**Photo 15 - North abutment wall refacing locations, narrow cracking is partially obscured by anti-graffiti coating**

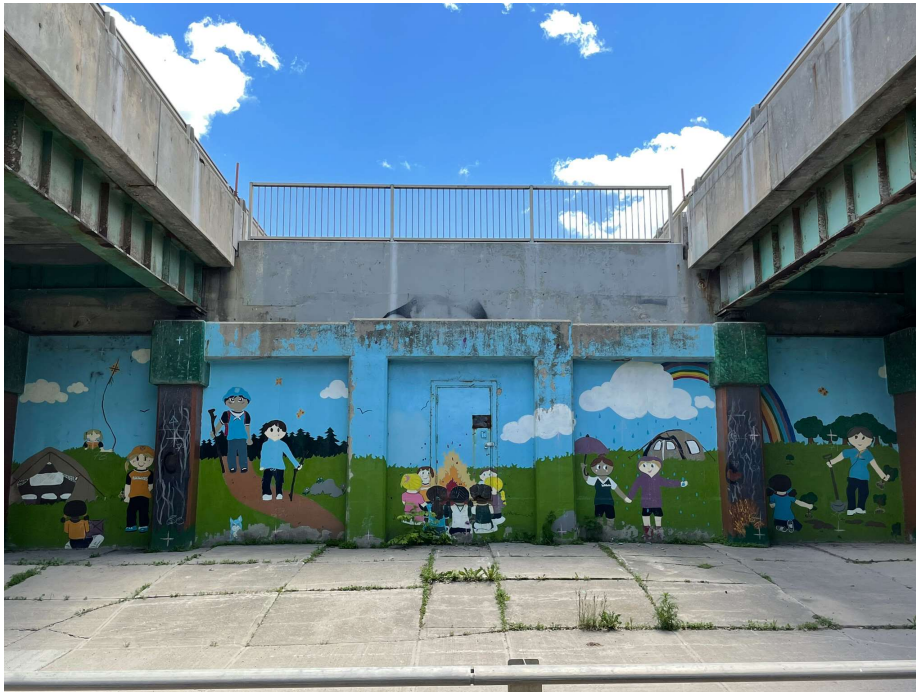
**Photo 16 - South abutment wall, between NB and SB lanes**

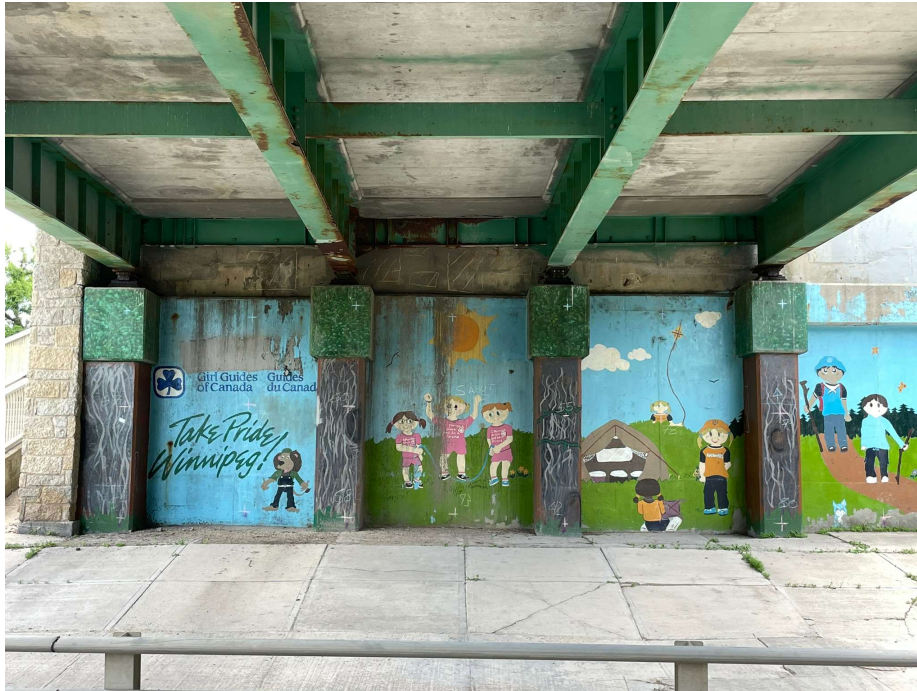
**Photo 17 - South abutment wall, NB**

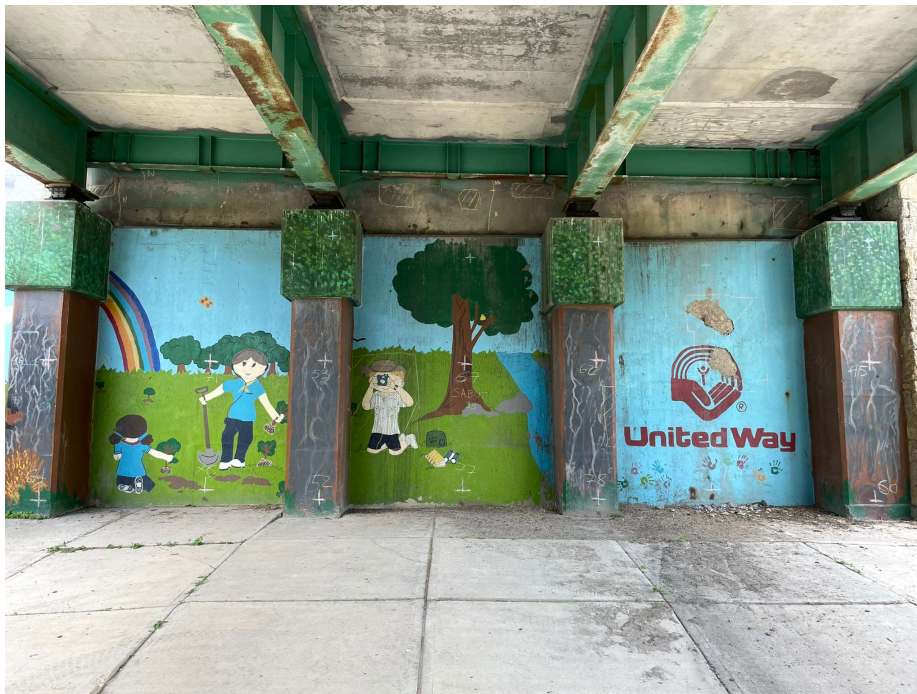
**Photo 18 - South abutment wall, SB**

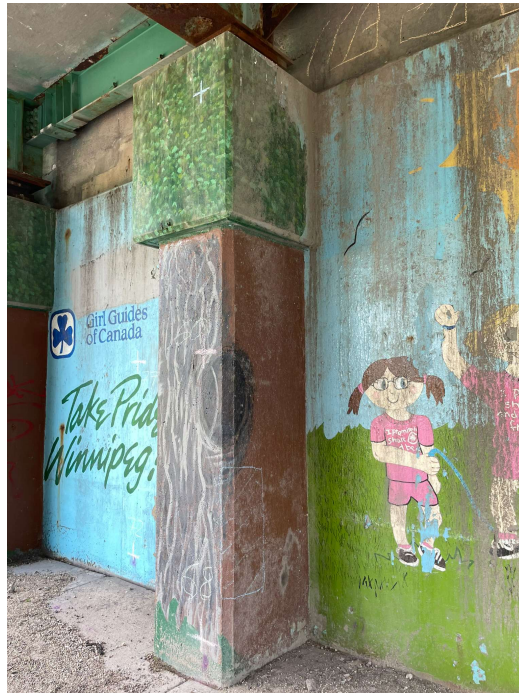
**Photo 19 - South abutment wall, NB, at Column 2, localized delamination**

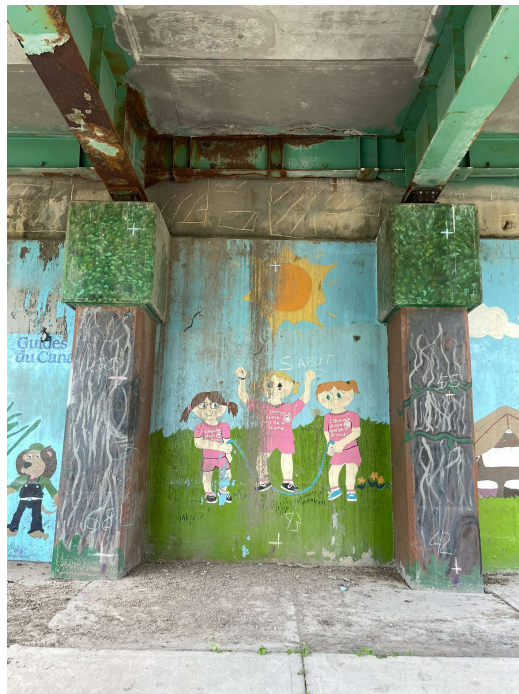
**Photo 20 - South abutment wall, NB, between Columns 2 and 3, joint leakage / staining, and large areas of delamination on ballast wall**

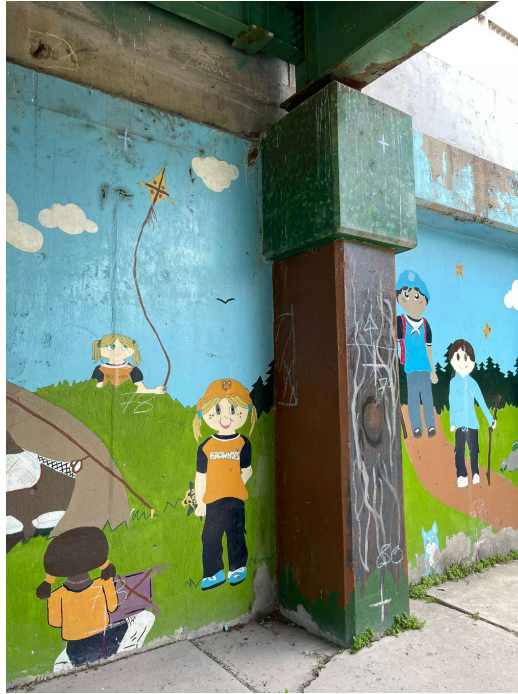
**Photo 21 - South abutment wall, NB, at Column 4, localized small delaminations**

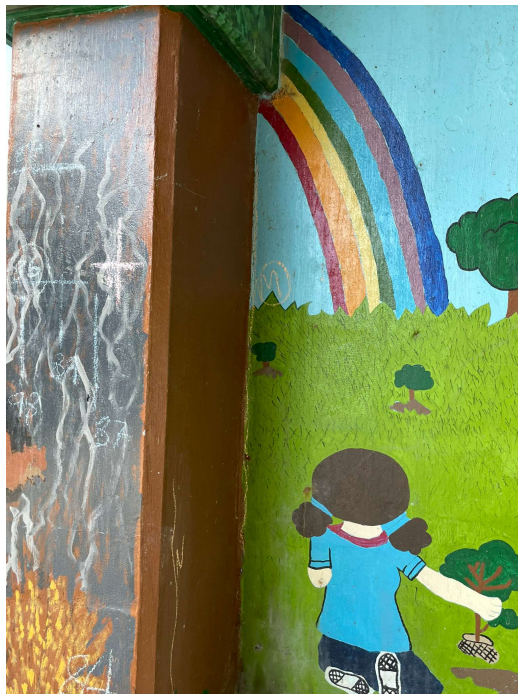
**Photo 22 - South abutment wall, SB, near Column 7, medium cracking between column**

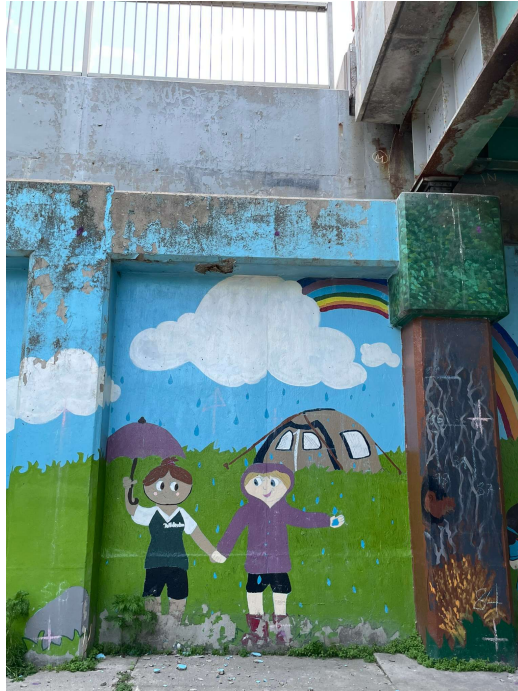
**Photo 23 - South abutment wall, between NB and SB lanes, Column 6 – 7, localized spall on the underside of cap beam**

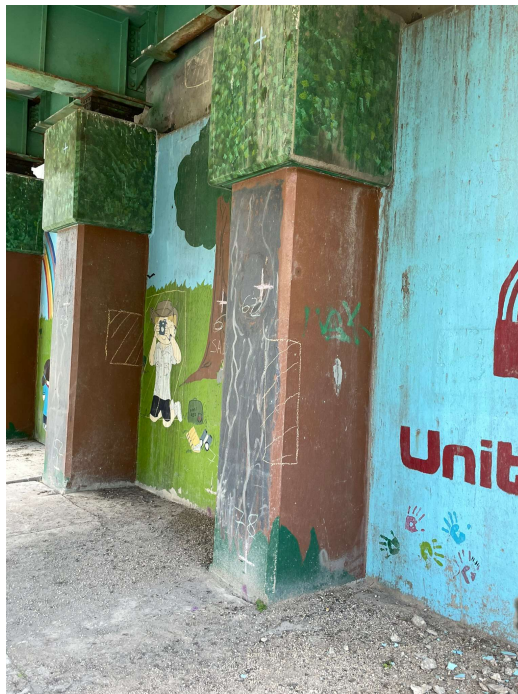
**Photo 24 - South abutment wall, SB, between Column 8 and 9, localized delaminations on column bottoms**

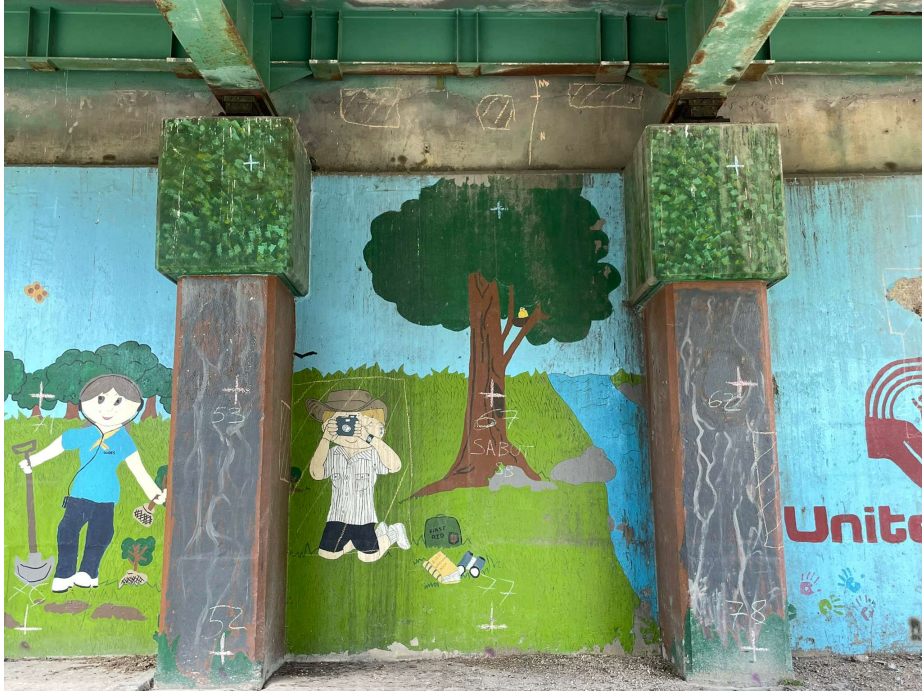
**Photo 25 - South abutment wall, SB, between Column 8 and 9, large delamination and spalling near Column 8**

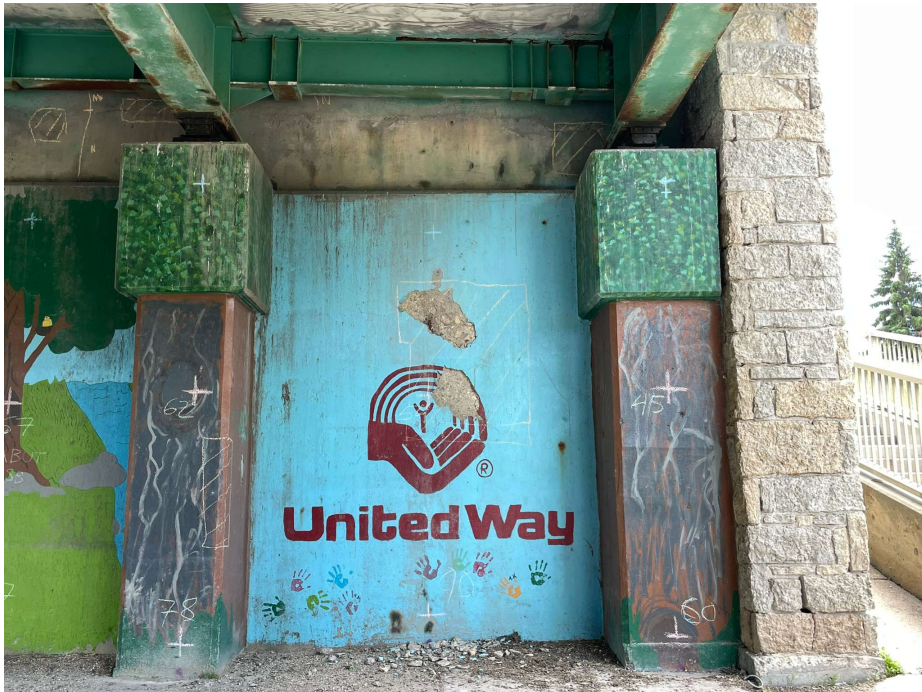
**Photo 26 - South abutment wall, SB, between Column 9-10, large delamination and spalling**
