# **Appendix F: SUBSTRUCTURE CONDITION SURVEY REPORT**

# MEMORANDUM

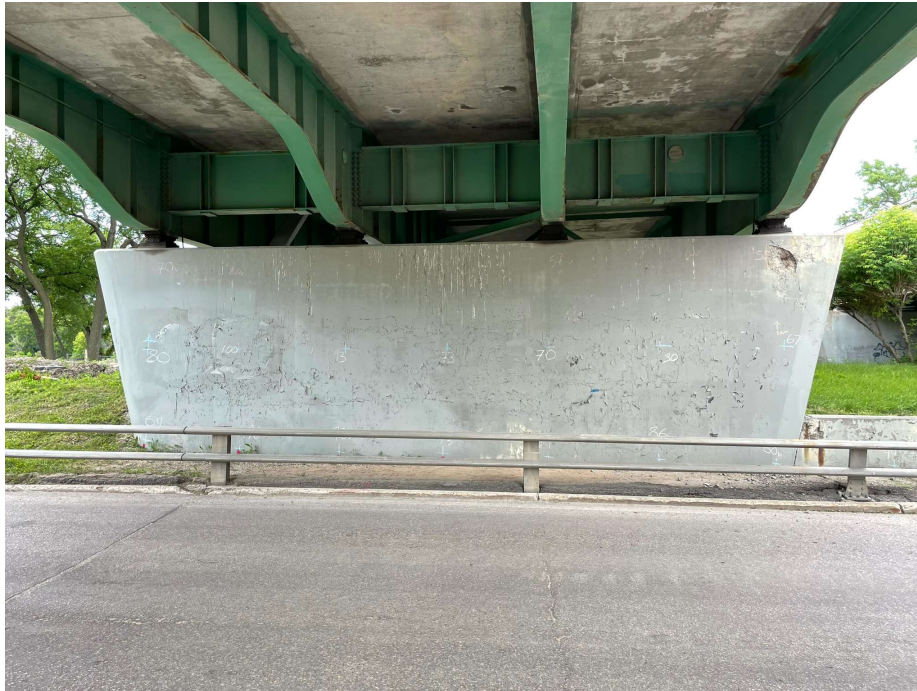
**Photo 27 - Pier 1 NB, north face**

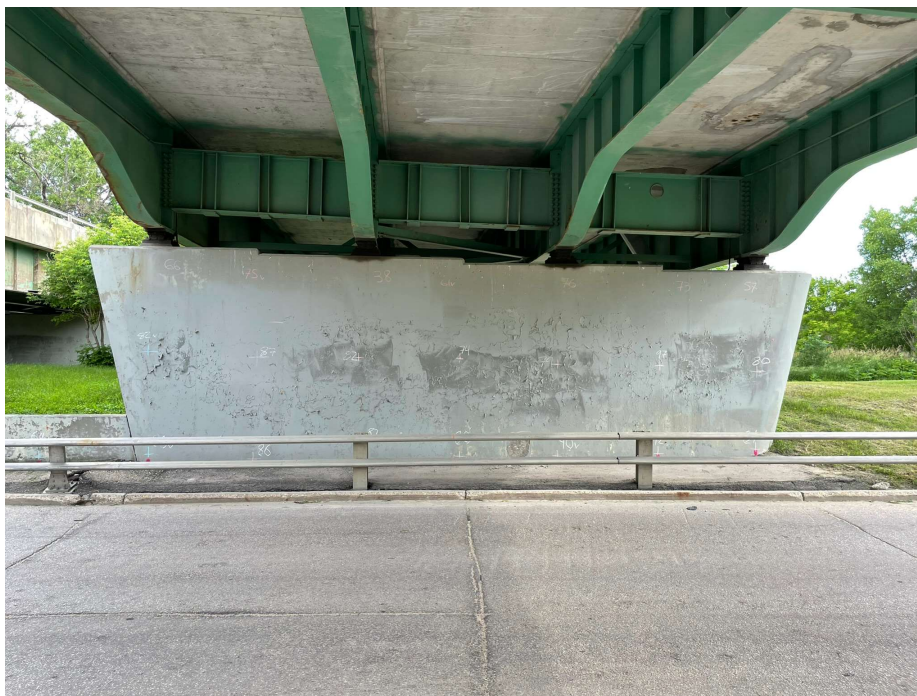
**Photo 28 - Pier 1 SB, north face**

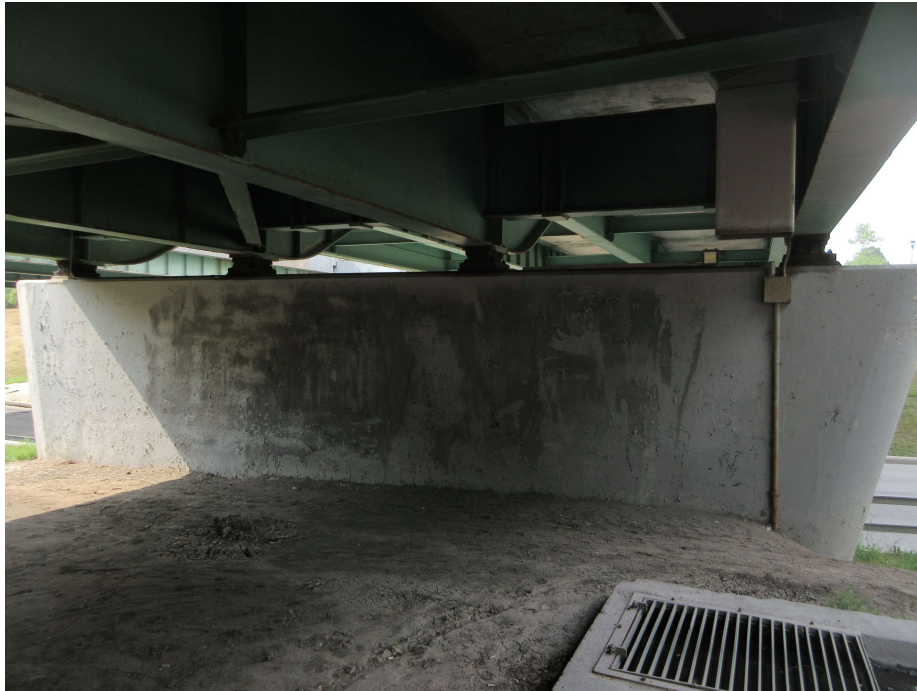
**Photo 29 - Pier 1 NB South Face**

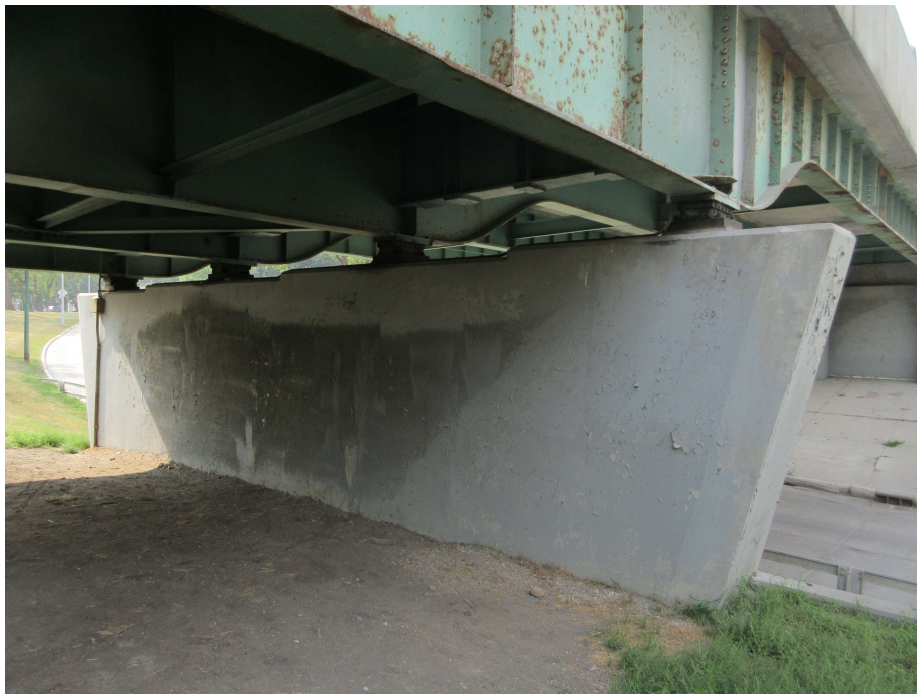
**Photo 30 - Pier 1 SB South Face**

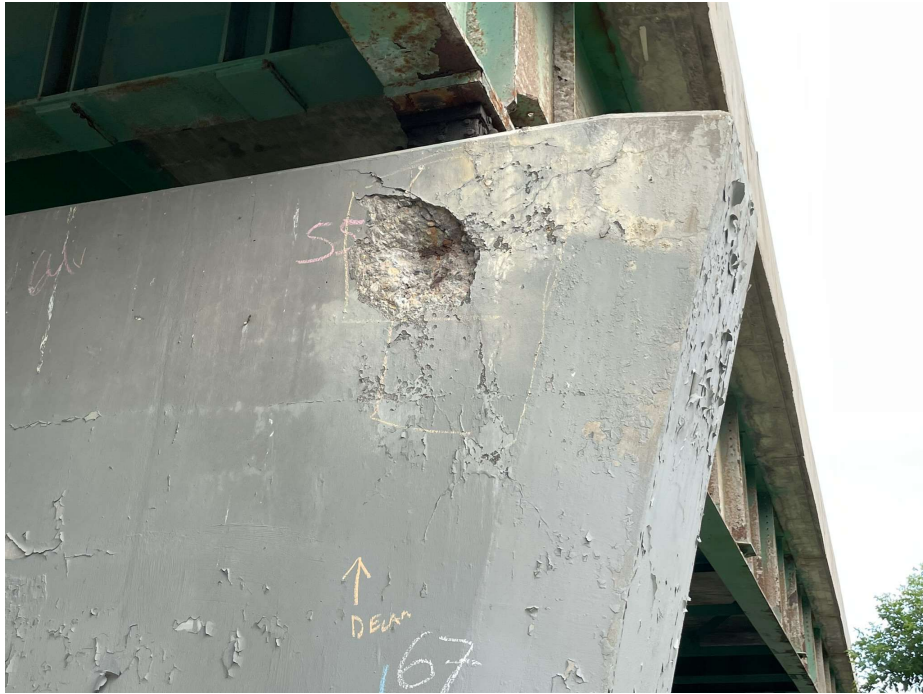
**Photo 31 - Pier 1 NB, north face, localized spall at top of pier near west end**

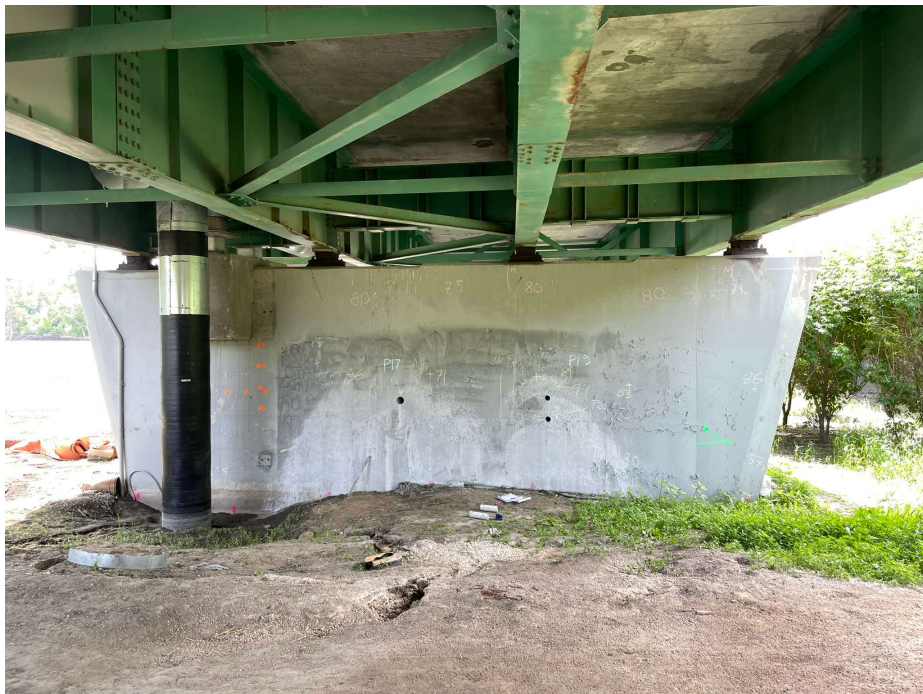
**Photo 32 - Pier 2 NB, north face**

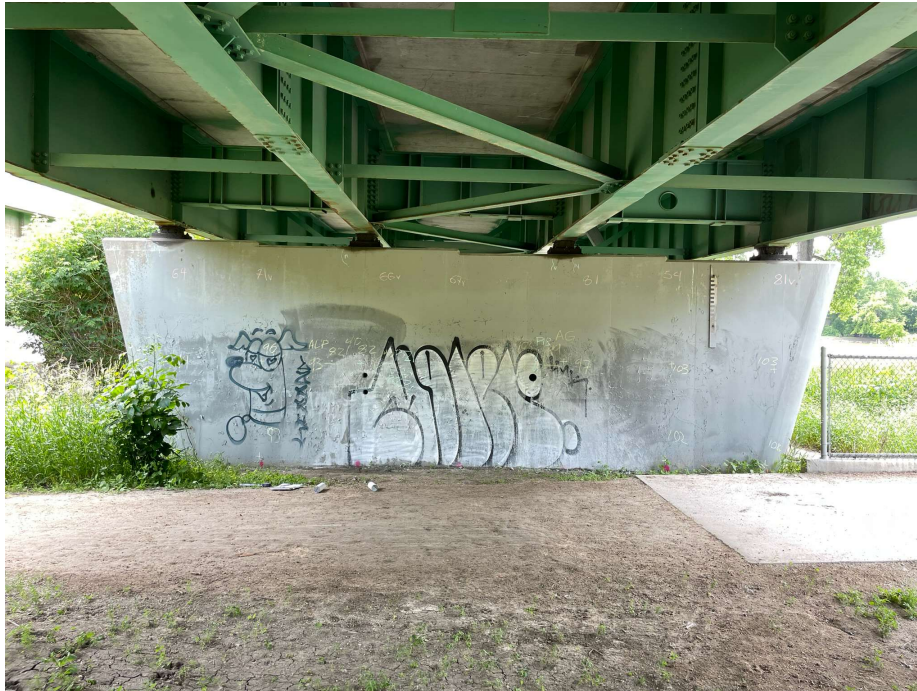
**Photo 33 - Pier 2 SB, north face**

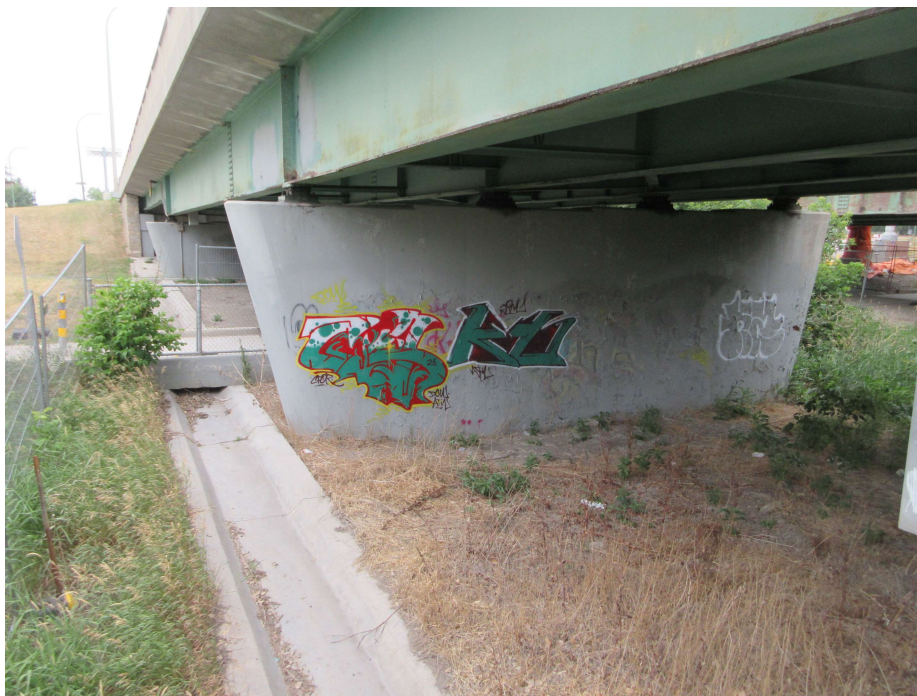
**Photo 34 - Pier 2 SB South face**

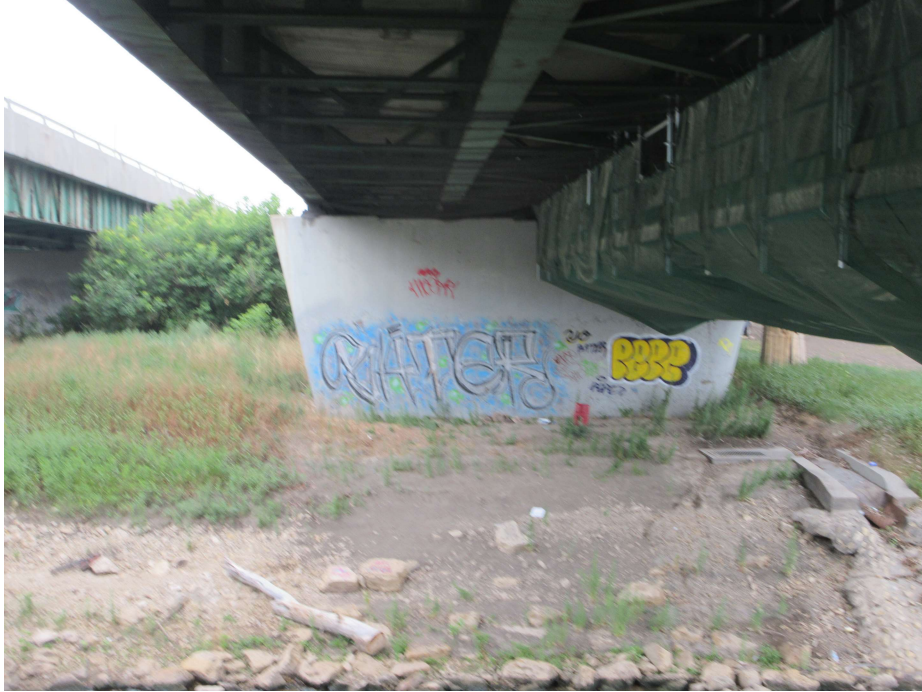
**Photo 35 - Pier 3 NB South Face**

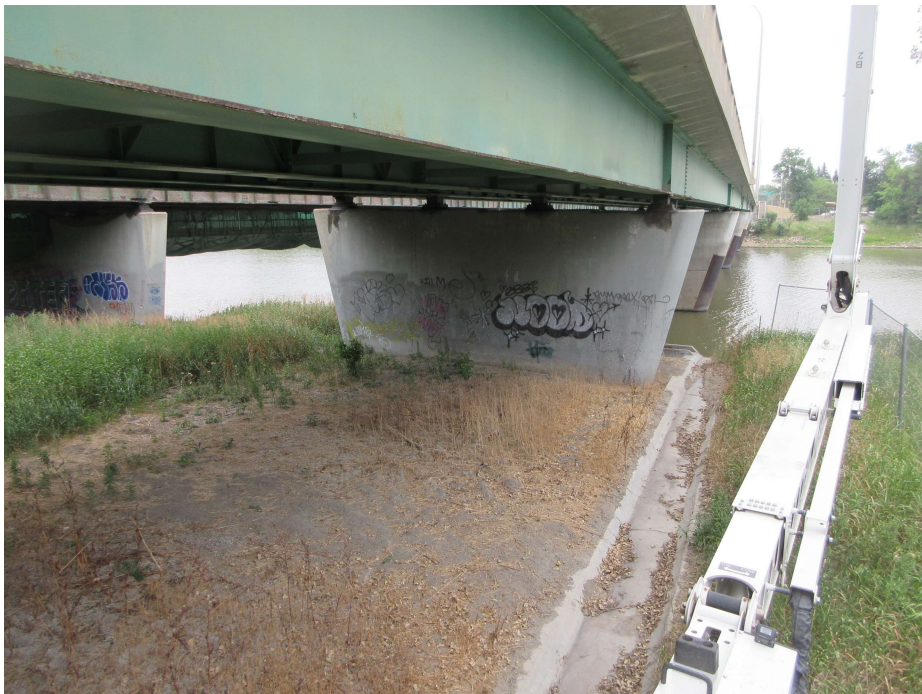
**Photo 36 - Pier 3 SB North Face**

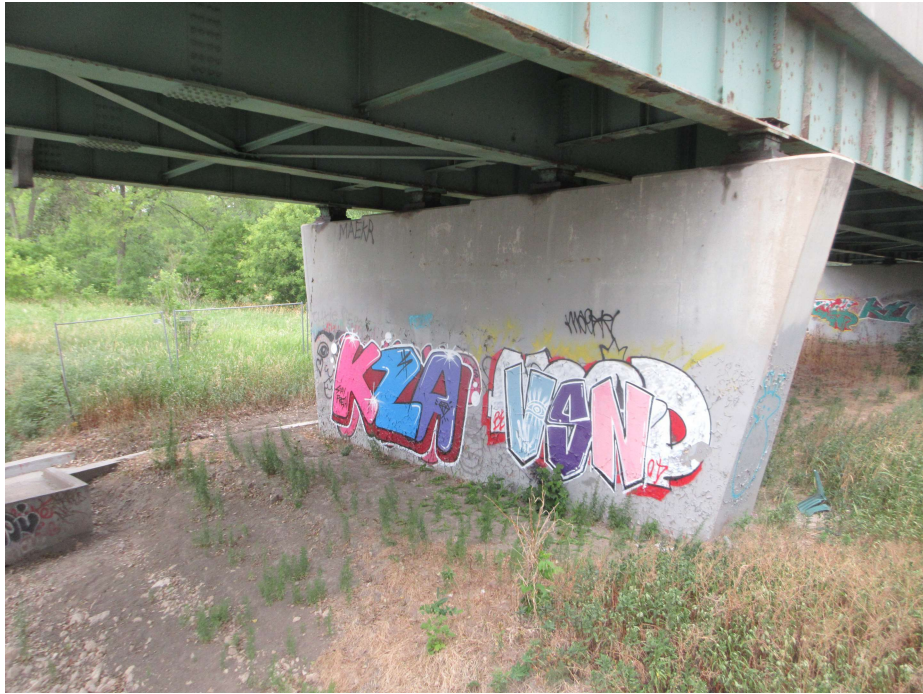
**Photo 37 - Pier 3 SB South Face**

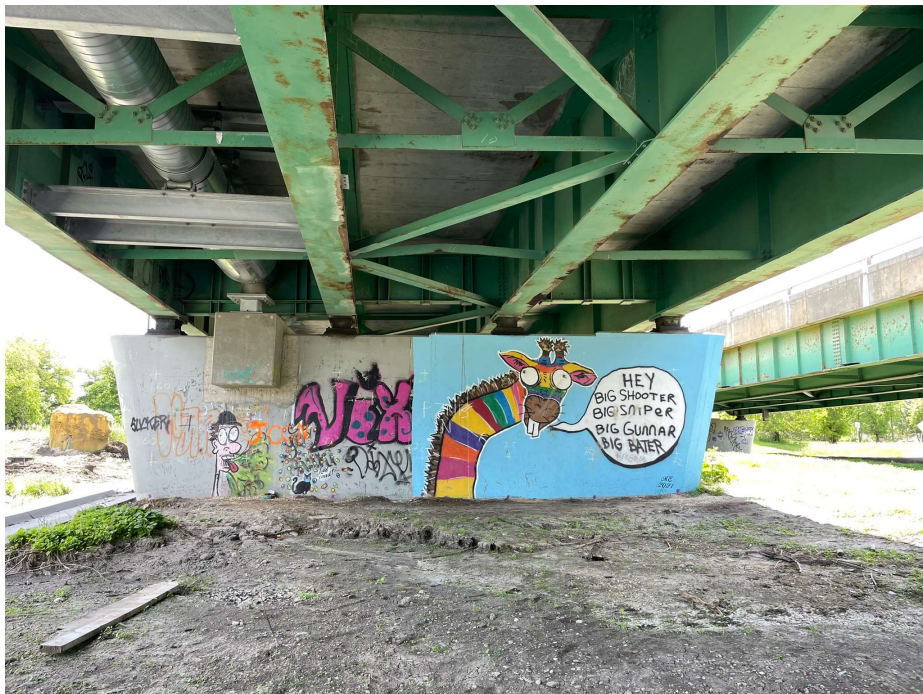
**Photo 38 - Pier 7 NB, north face, note recent modification from forced main sewer**

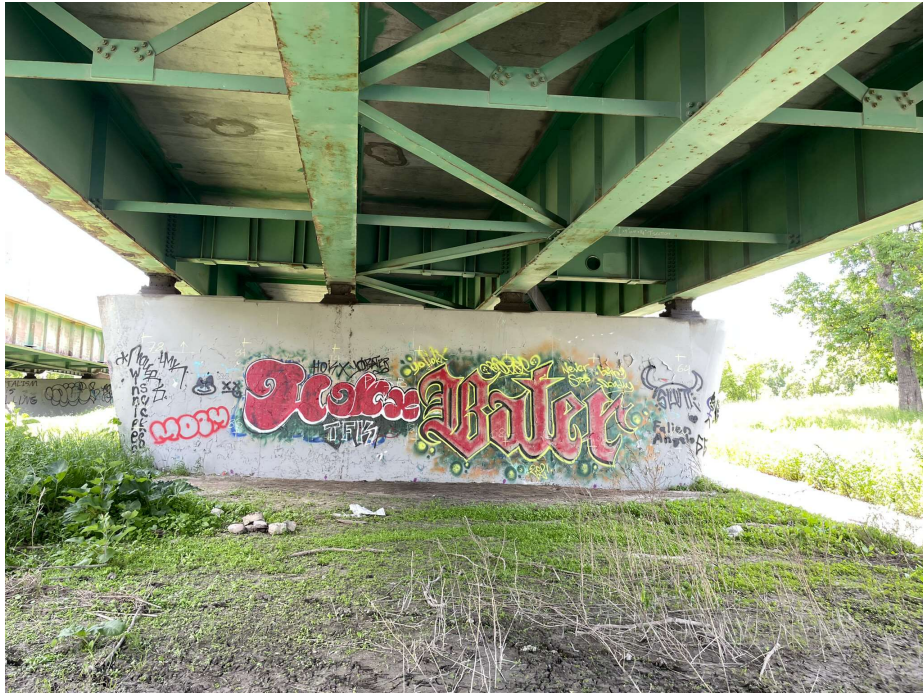
**Photo 39 - Pier 7 SB, north face**

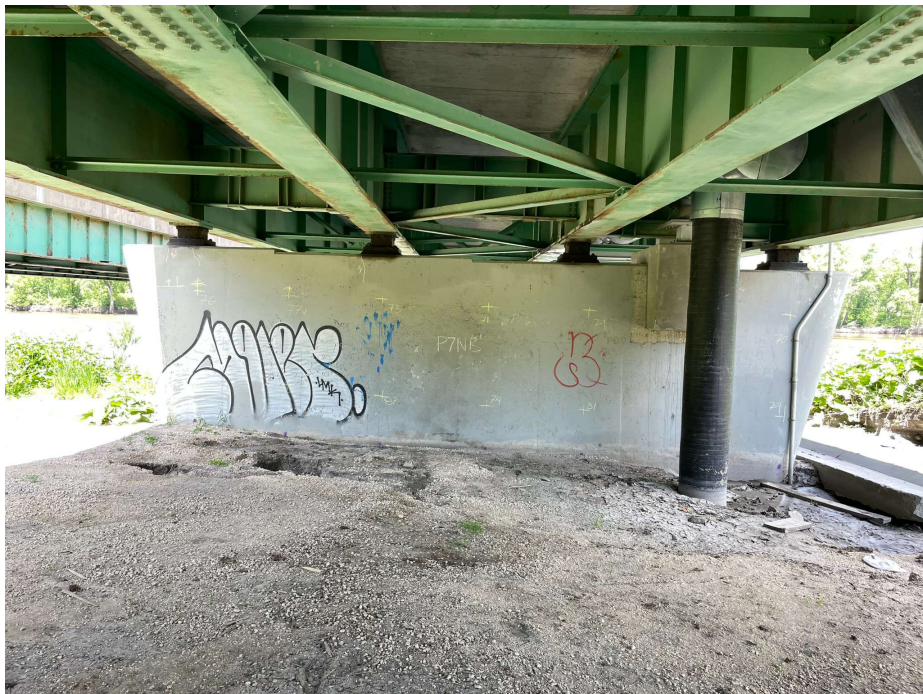
**Photo 40 - Pier 7 NB, south face, note recent modification from forced main sewer**

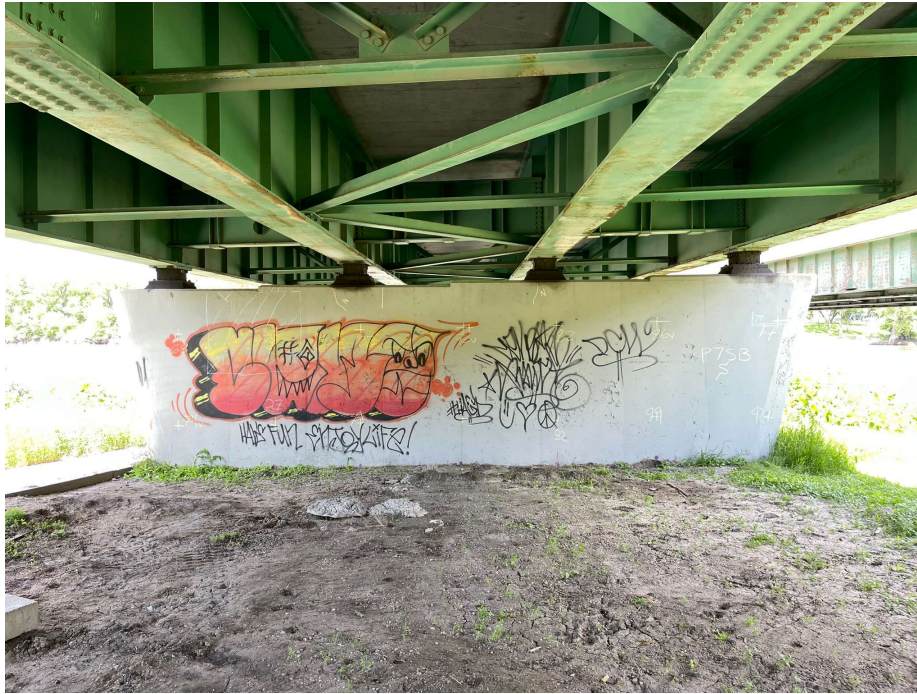
**Photo 41 - Pier 7 SB, south face**

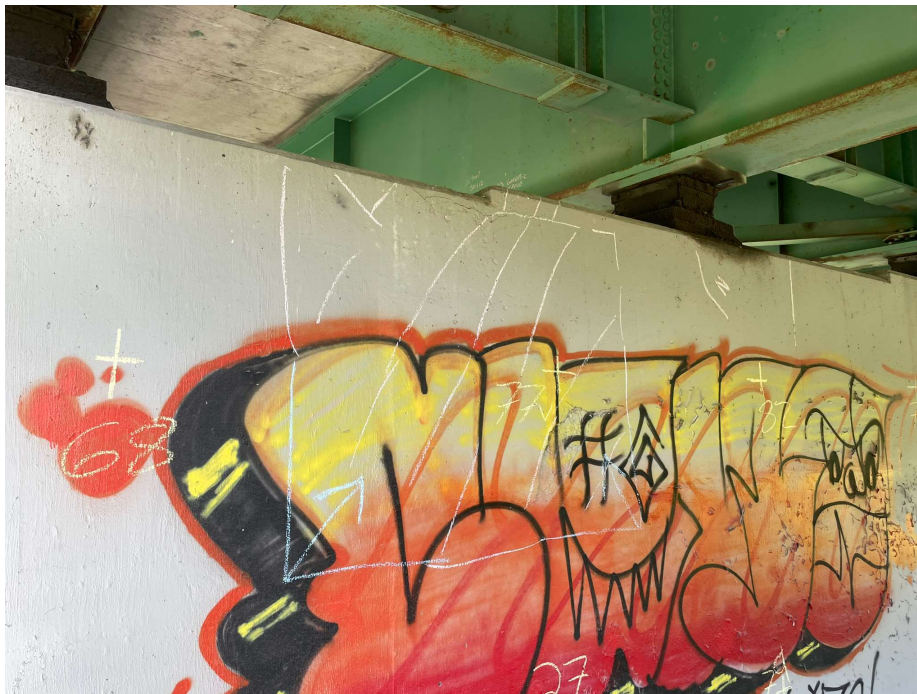
**Photo 42 - Pier 7 SB, south face, localized delamination near west end at top of pier**

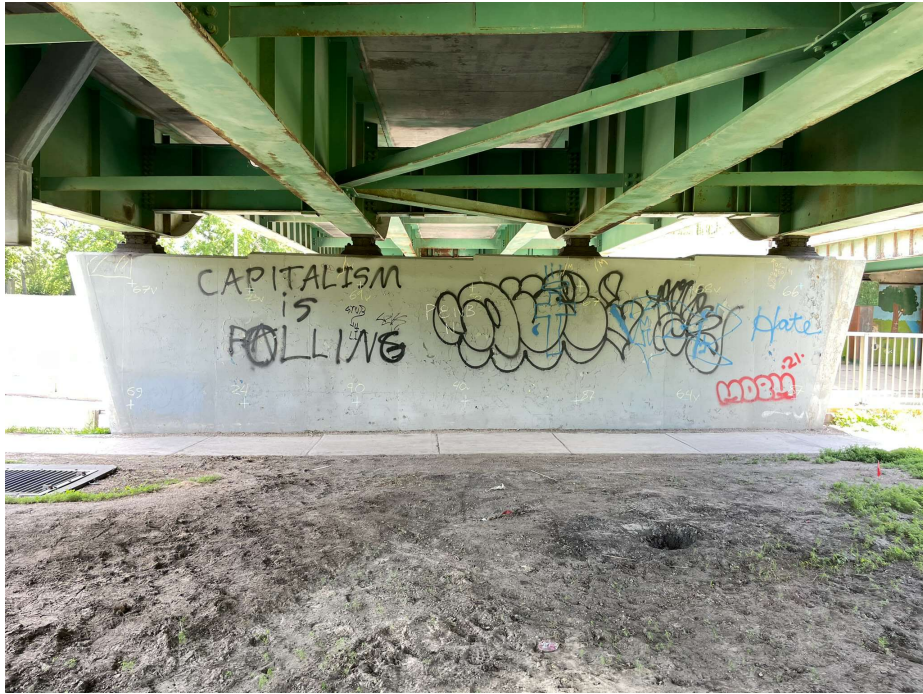
**Photo 43 - Pier 8 NB, north face**

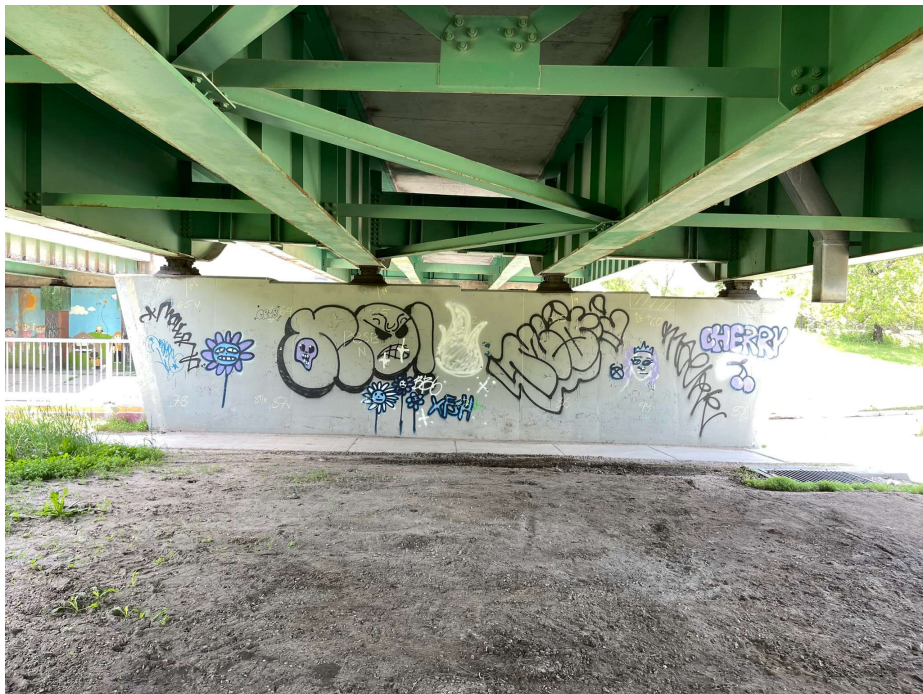
**Photo 44 - Pier 8 SB, north face**

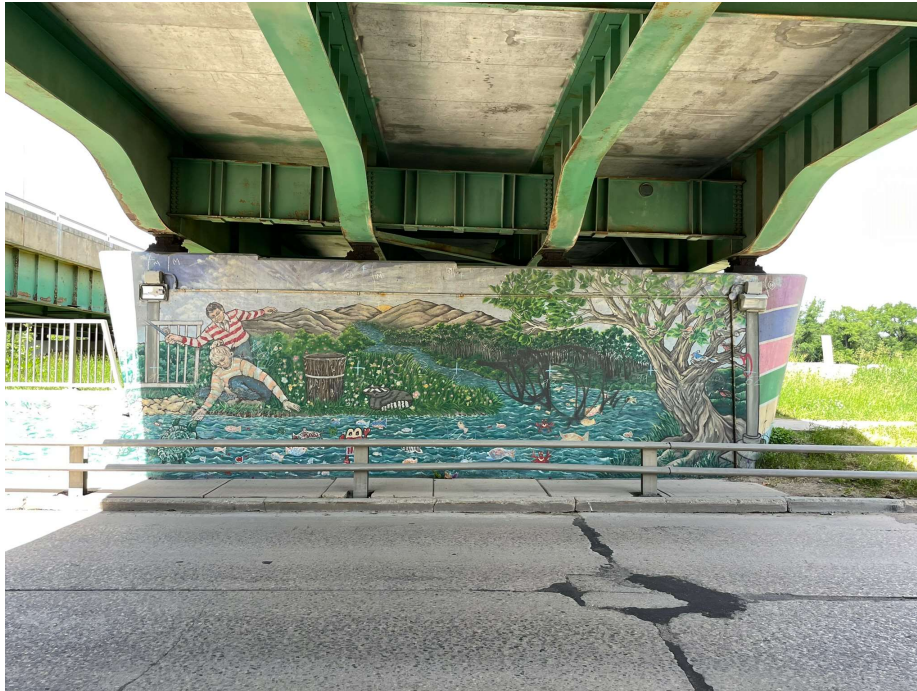
**Photo 45 - Pier 8 NB, south face**

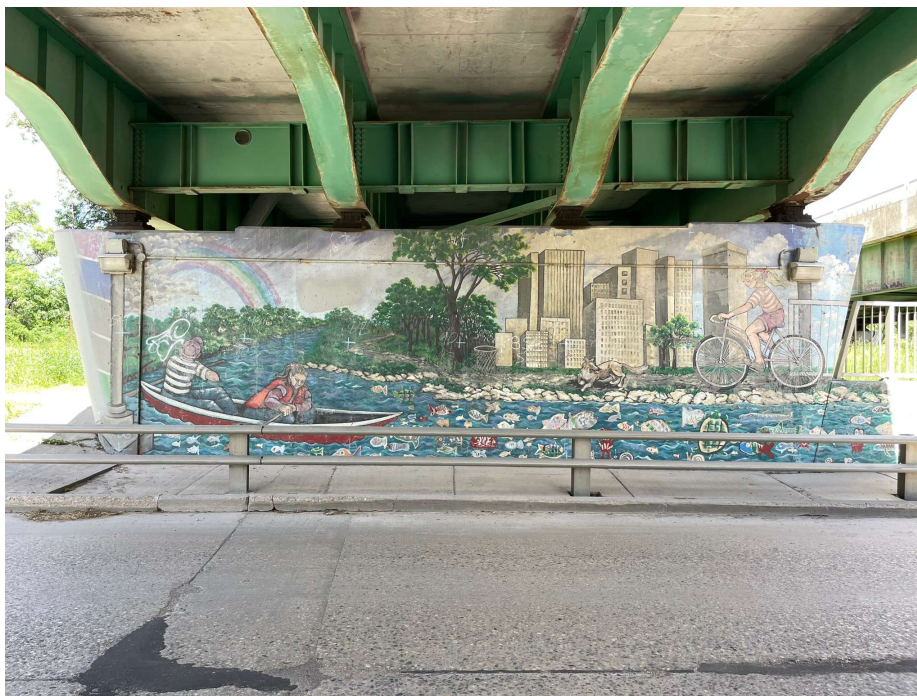
**Photo 46 - Pier 8 SB, south face**

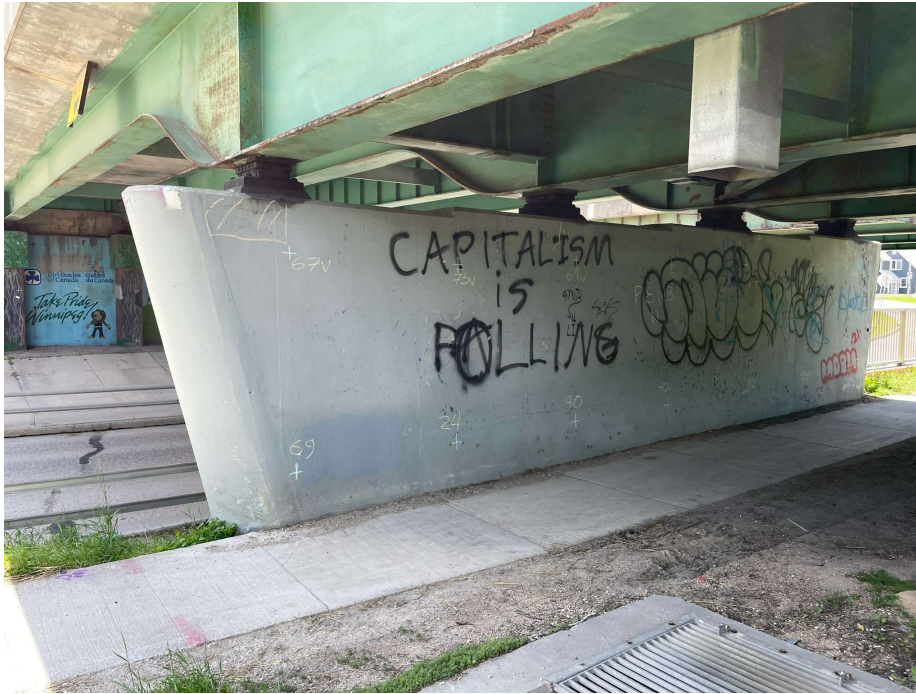
**Photo 47 - Pier 8 NB, north face, localized delamination under eastmost bearing**

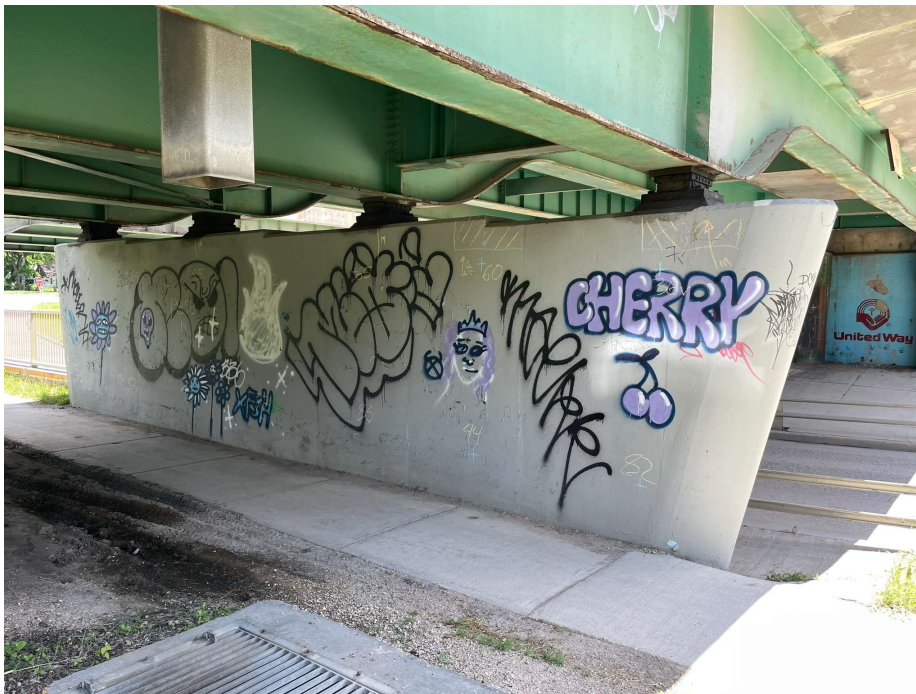
**Photo 48 - Pier 8 SB, north face, localized small delaminations near top of pier at west end and at 1st bearing seat step from West end**

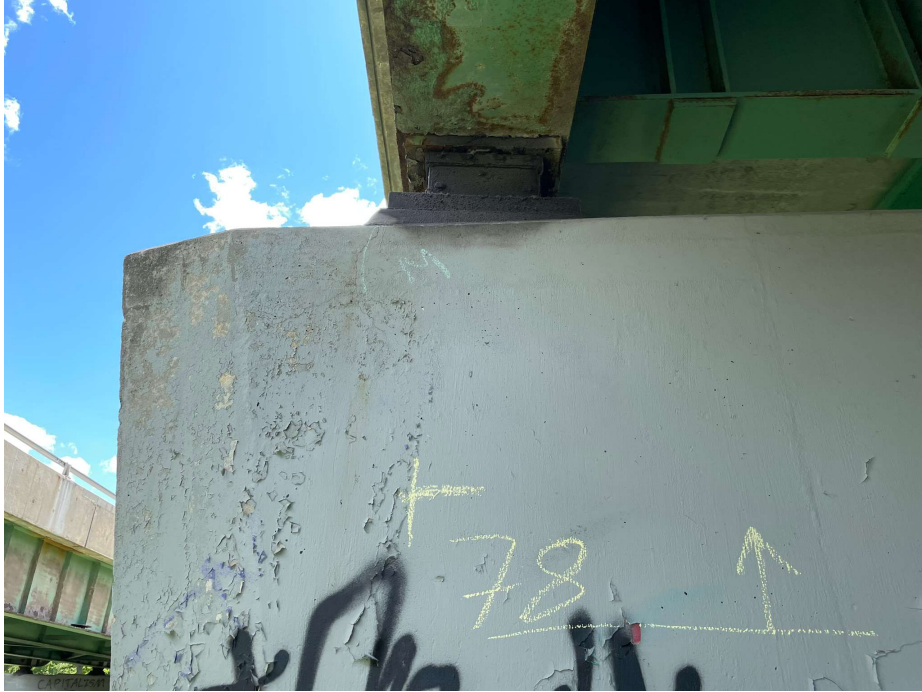
**Photo 49 - Typical medium vertical cracks under bearing locations**

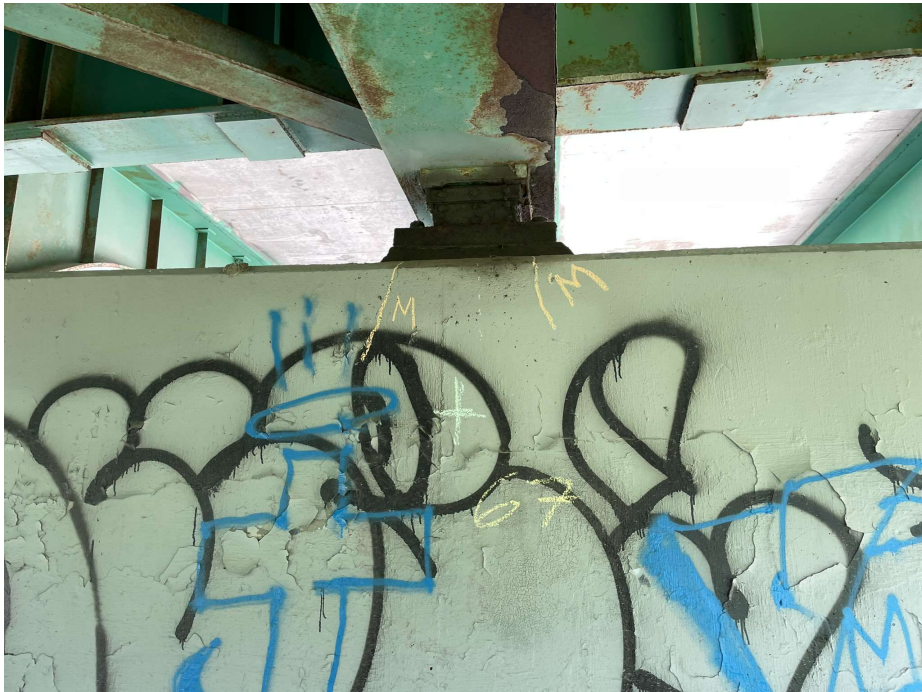
**Photo 50 - Typical medium vertical cracks under bearing locations, additional view**

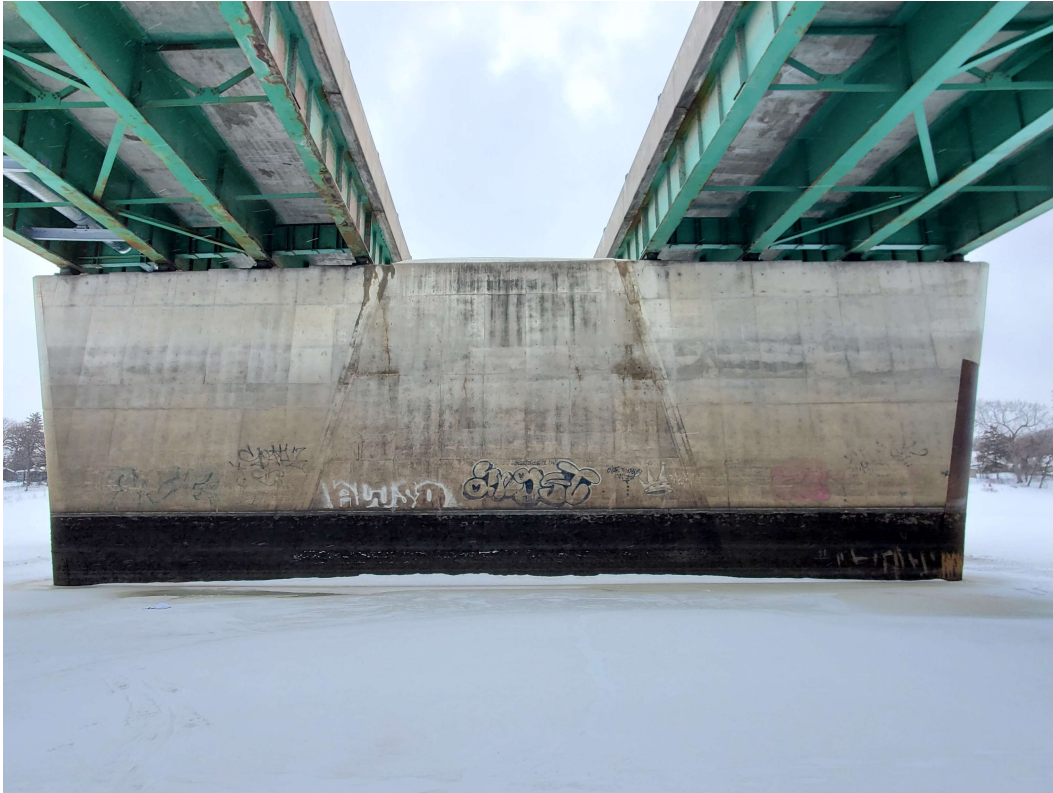
**Photo 01 - Pier 4 North Face**

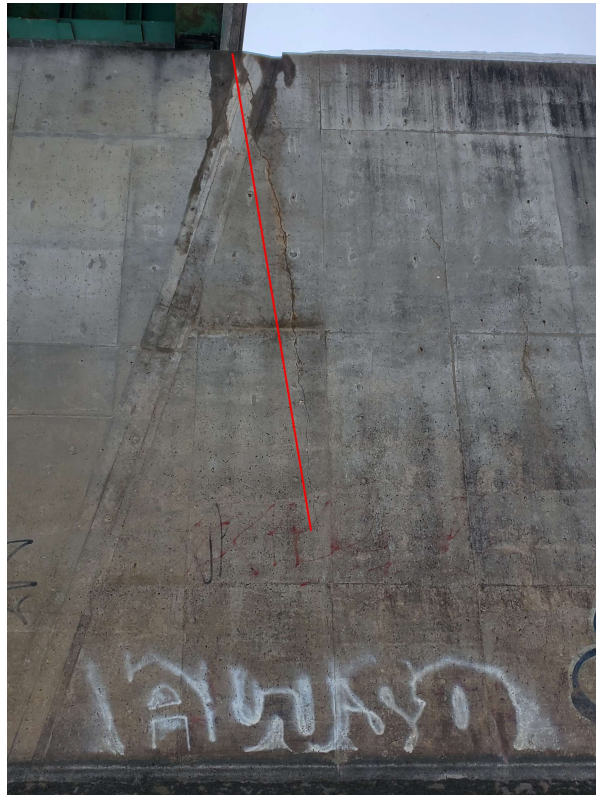
**Photo 31 - Pier 4 North Face Wide Crack**

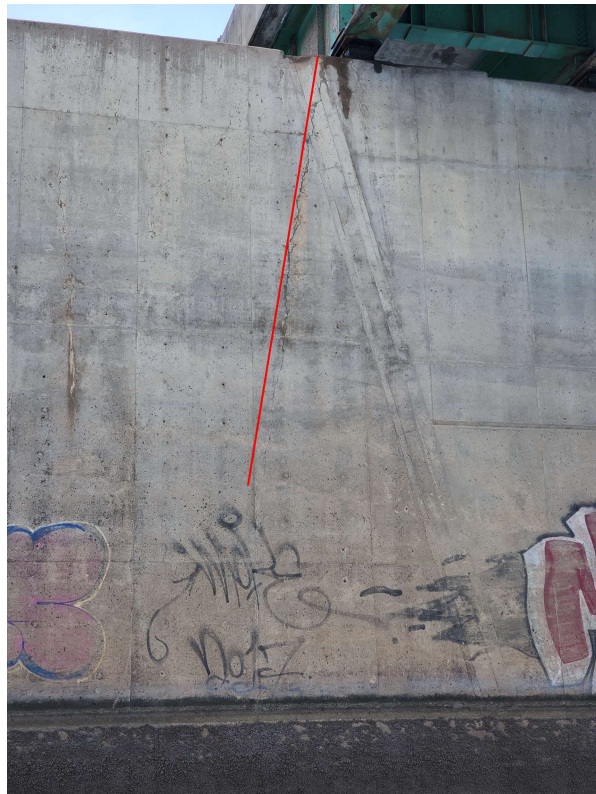
**Photo 32 - Pier 4 South Face Medium Crack**  
16 of 22

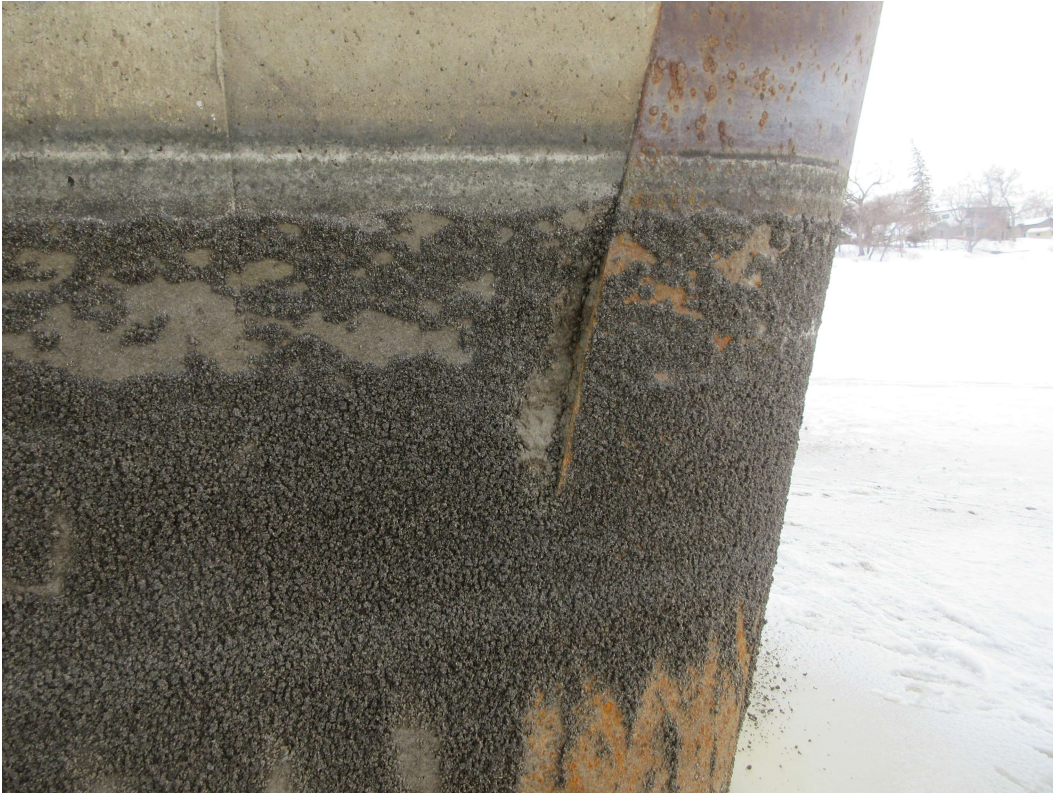
**Photo 33 - Pier 4 North Face Spall**

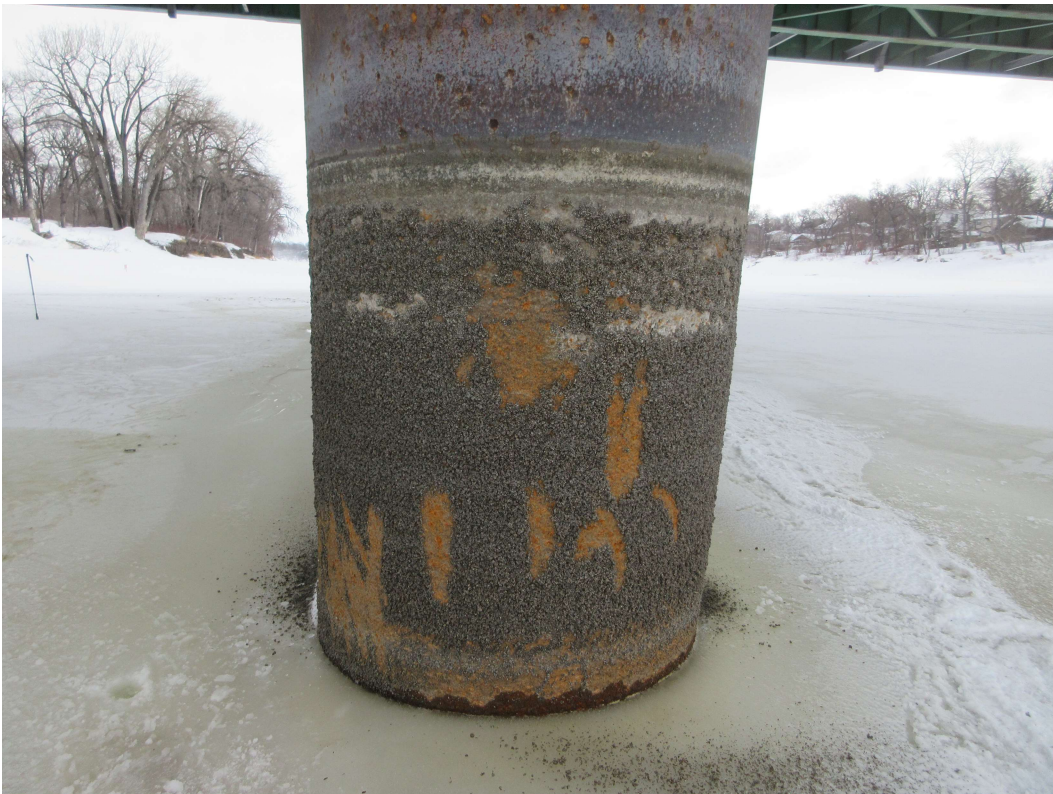
**Photo 34 - Medium to Severe Pitting on Pier 4 Nosing**  
17 of 22

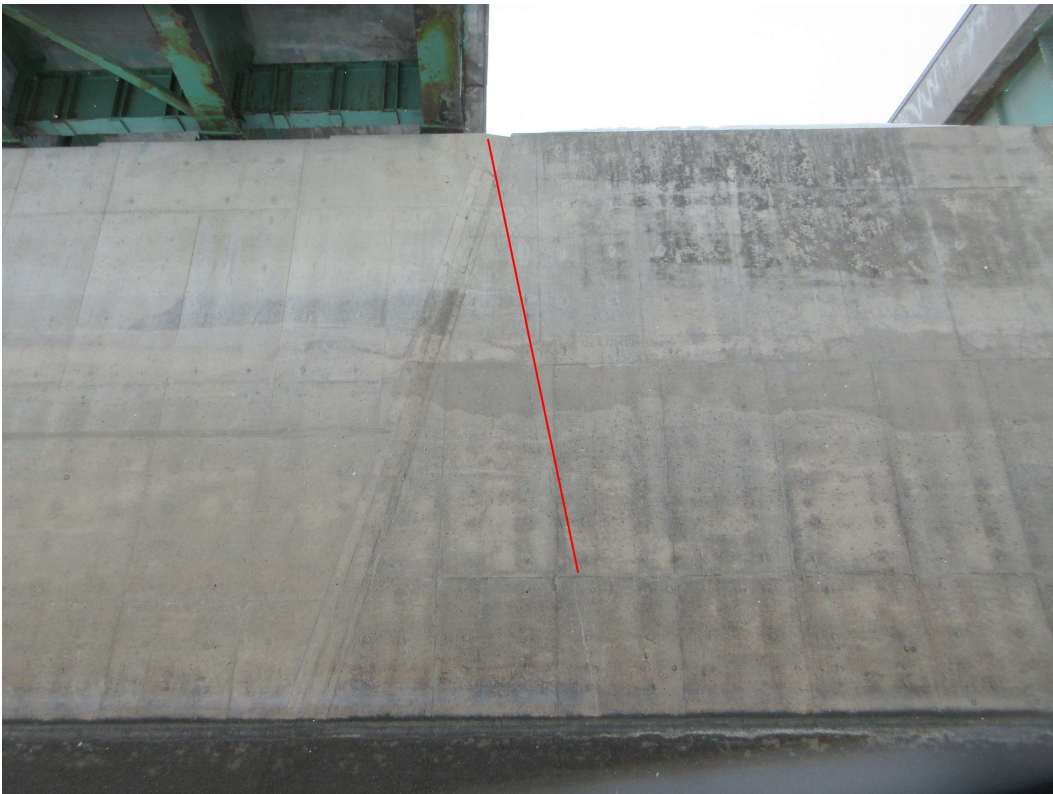
**Photo 36 - Pier 5 North Face Medium Crack  
18 of 22**

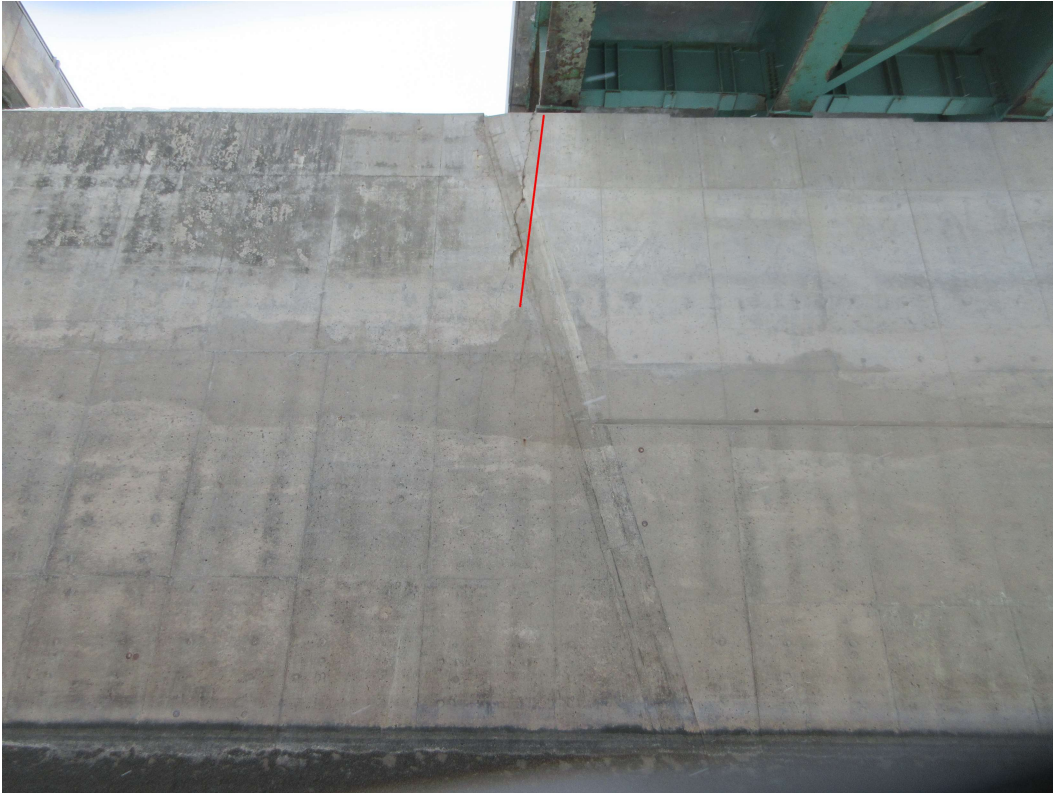
**Photo 37 - Pier 5 North Face Medium Crack**

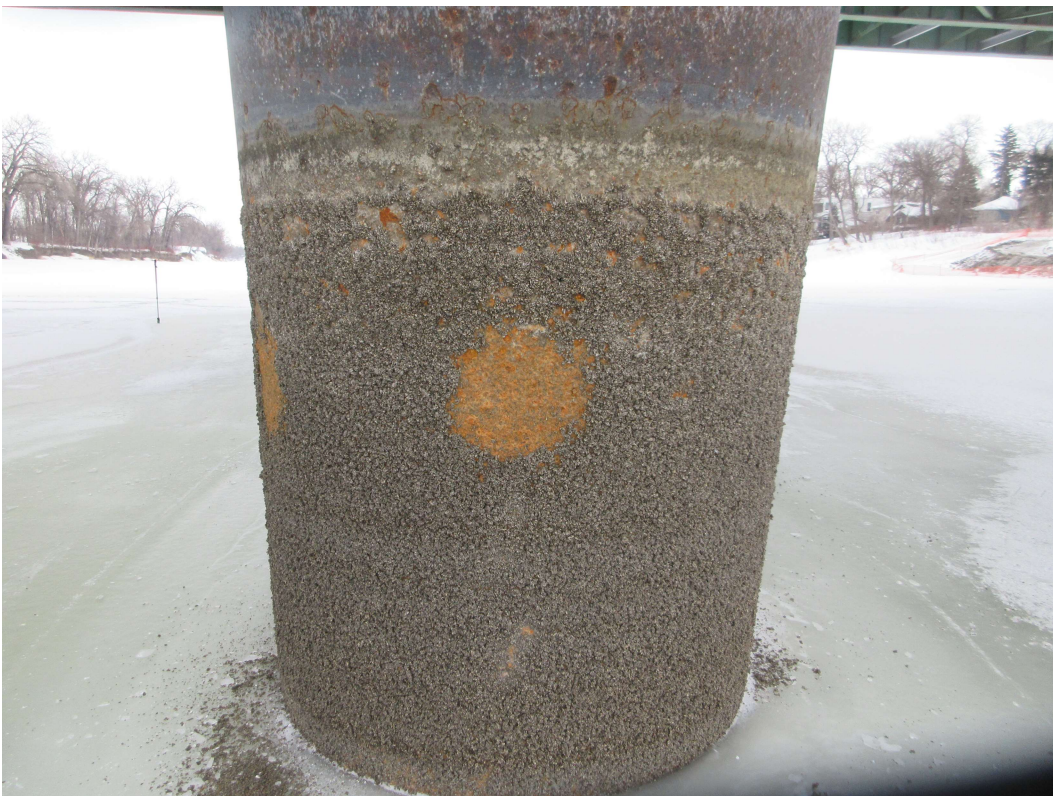
**Photo 38 - Medium Pitting on Pier 5 Nosing**  
19 of 22

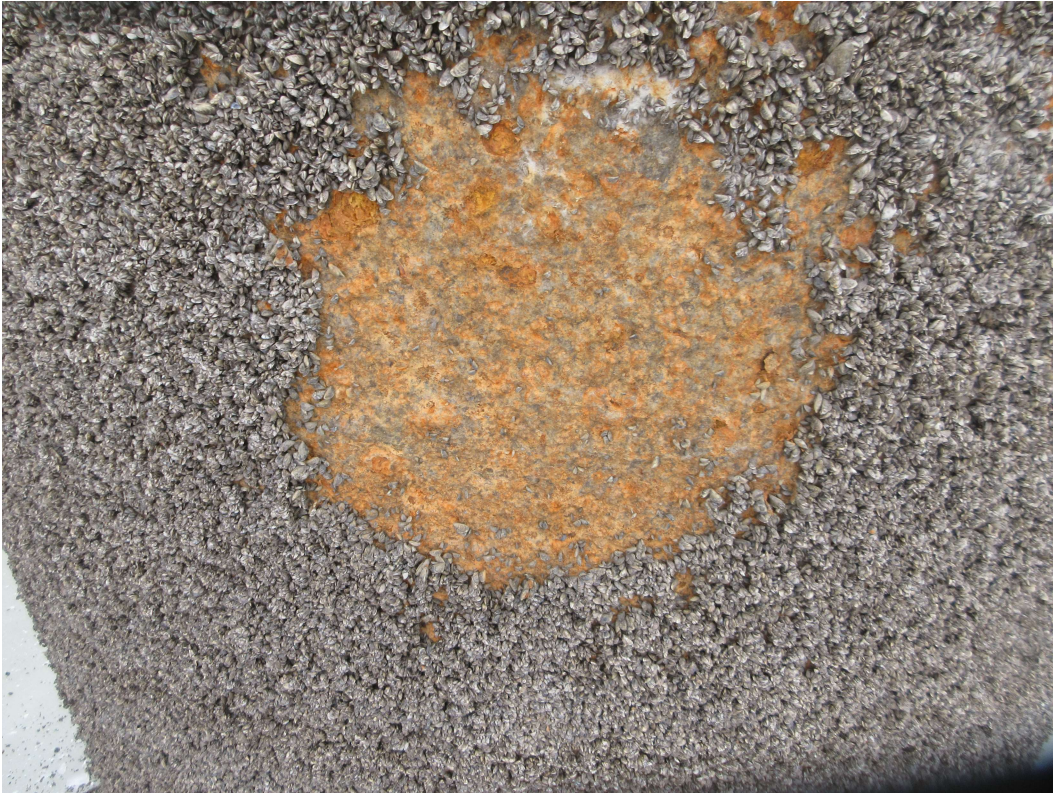
**Photo 39 - Medium Pitting on Pier 5 Nosing, Close up View**
