# **Appendix F: SUBSTRUCTURE CONDITION SURVEY REPORT**

# MEMORANDUM

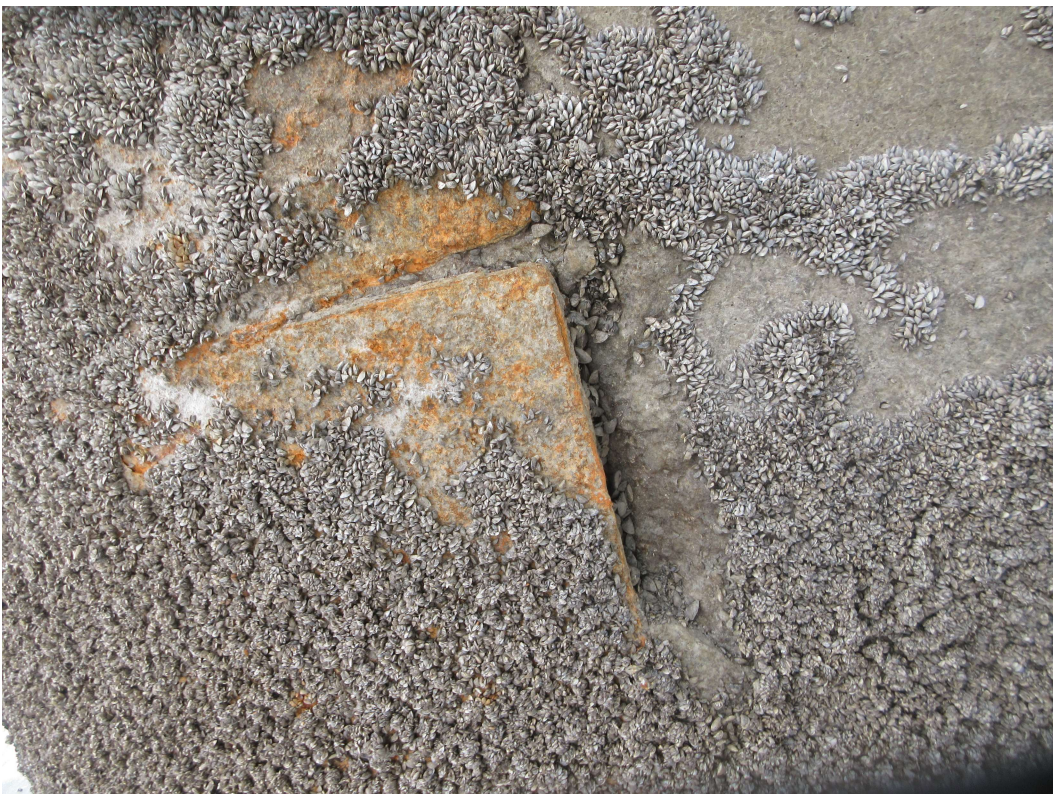
**Photo 40 - Pier 5 South Face Spall  
20 of 22**

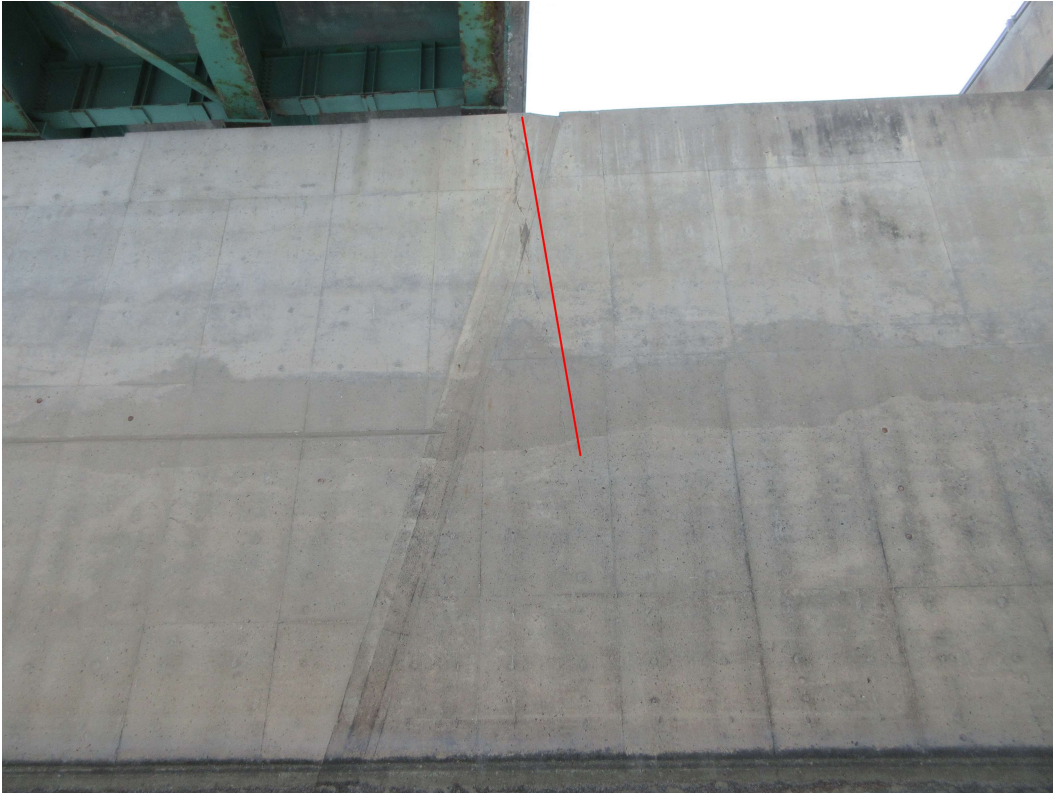
**Photo 41 - Pier 5 South Face Medium Crack**

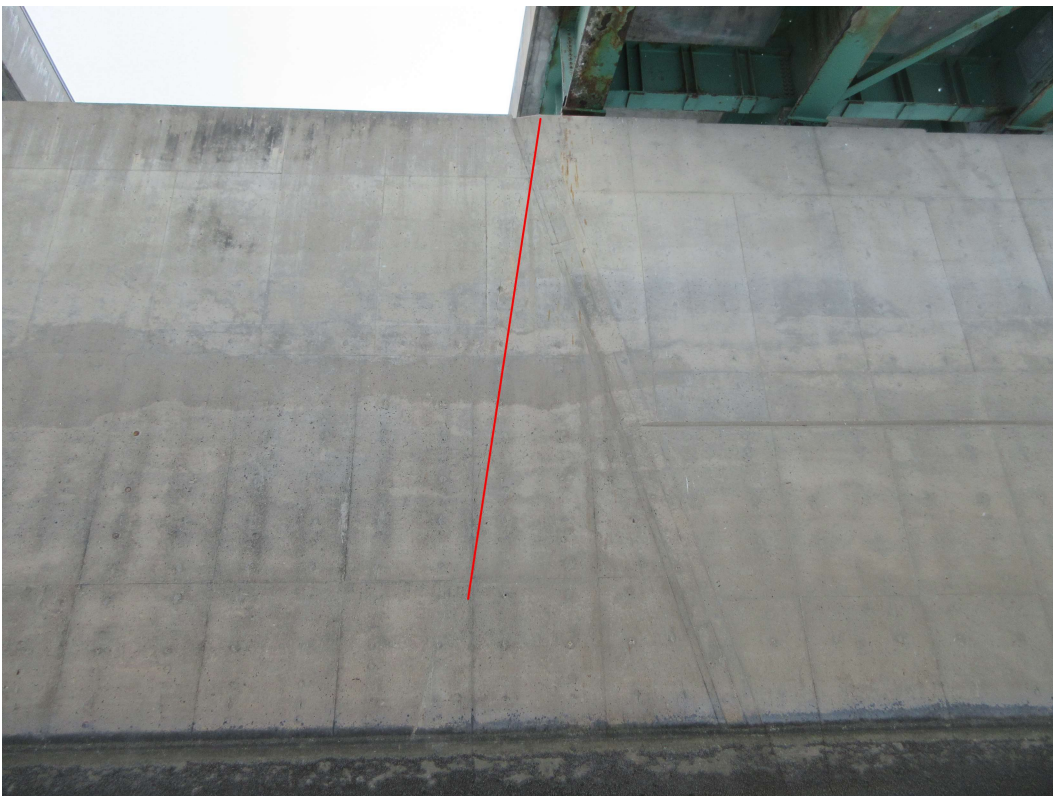
**Photo 42 - Pier 5 South Face Medium Crack**  
21 of 22

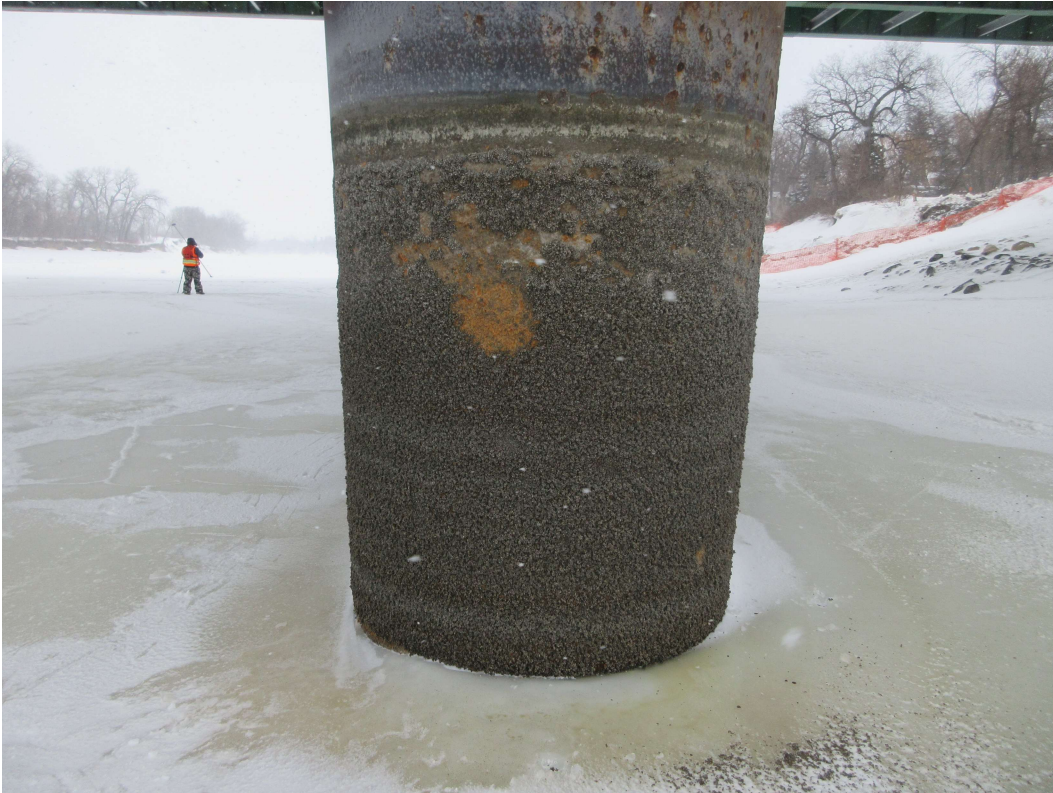
**Photo 43 - Medium to Severe Pitting on Pier 6 Nosing**

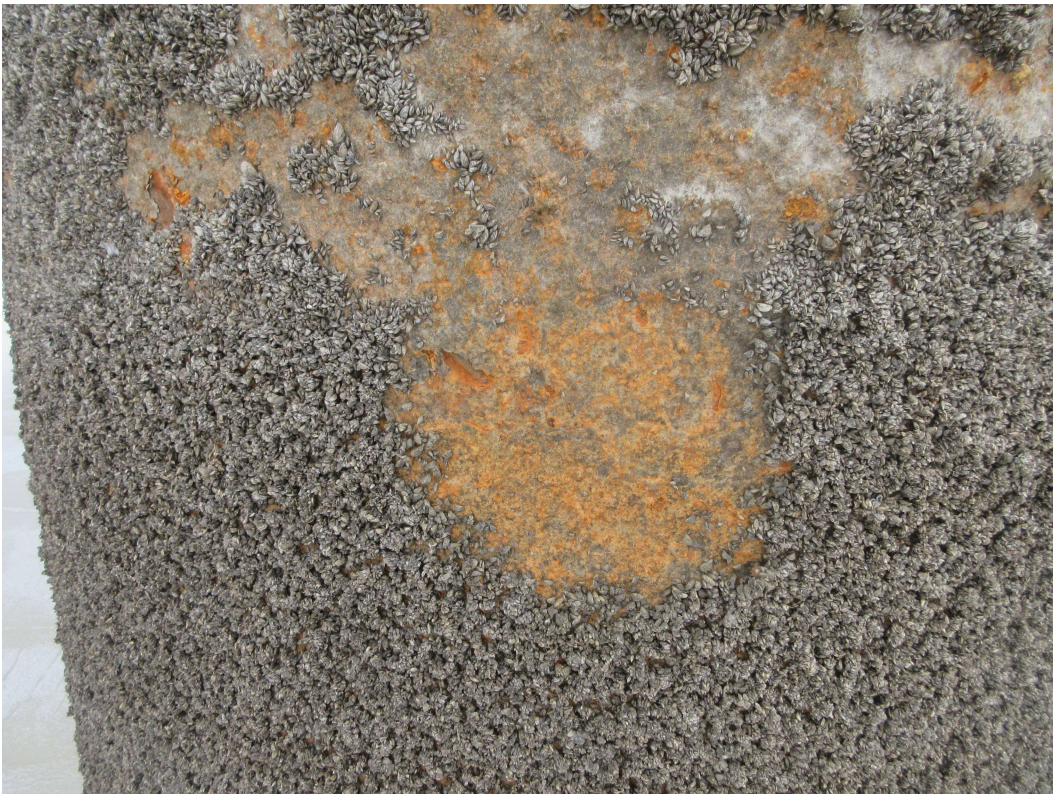
**Photo 44 - Medium to Severe Pitting on Pier 6 Nosing, Close up View**  
22 of 22

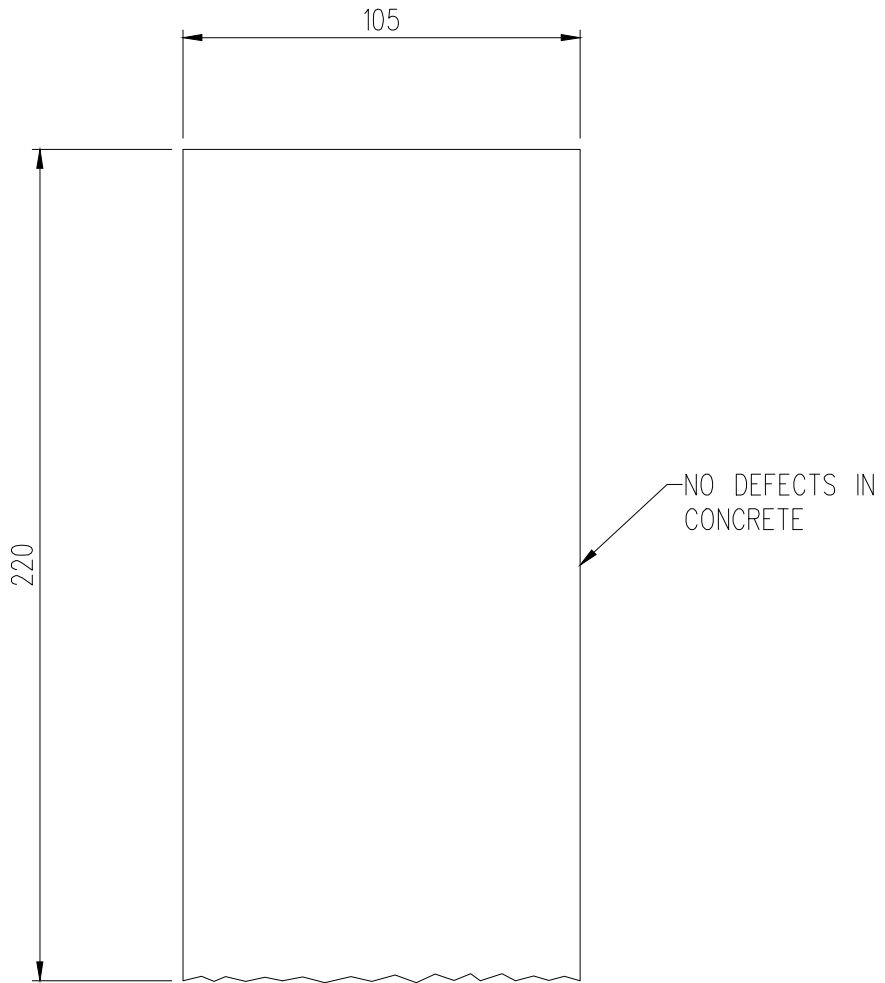
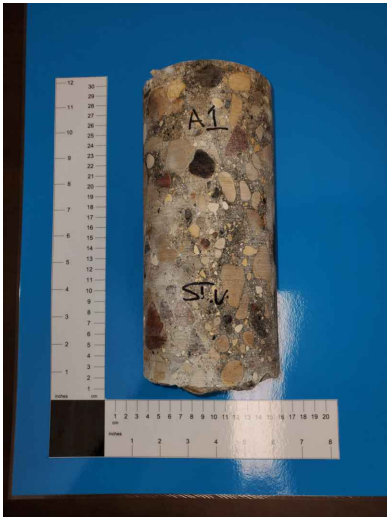
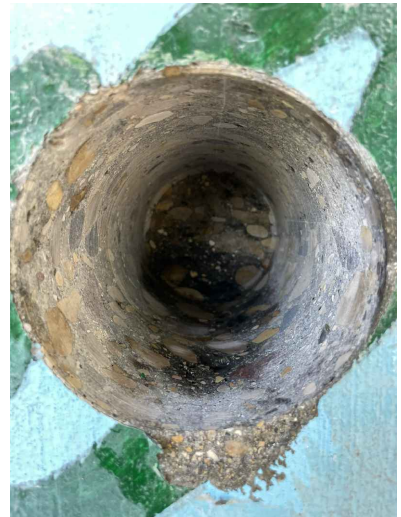
**APPENDIX O.3: SUBSTRUCTURE CONDITION ASSESSMENT  
CORE SKETCHES**

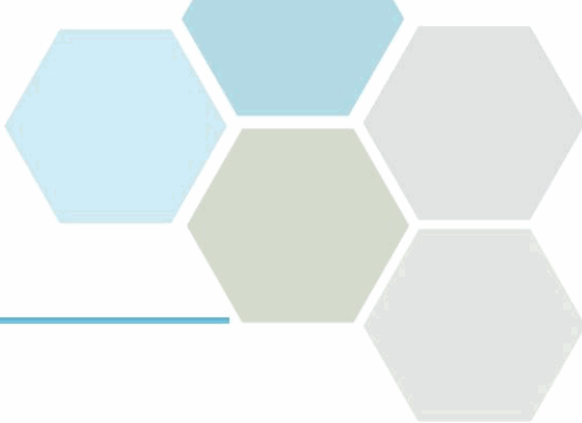
**CERTIFICATE OF ANALYSIS**

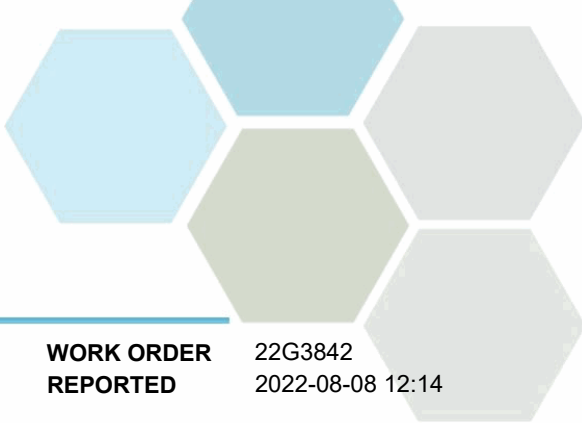
#110 4011 Viking Way Richmond, BC V6V 2K9 | #102 3677 Highway 97N Kelowna, BC V1X 5C3 | 17225 109 Avenue Edmonton, AB T5S 1H7 | #108 4475 Wayburne Drive Burnaby, BC V5G 4X4

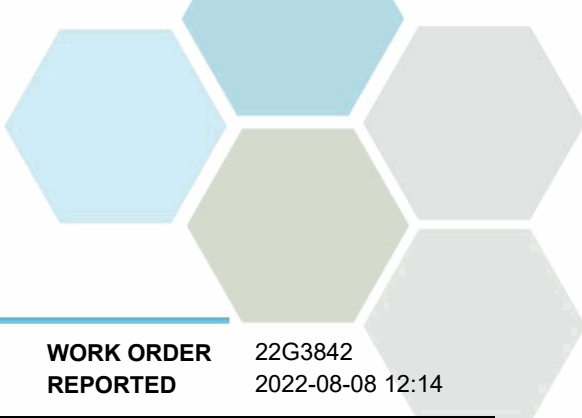
## APPENDIX 2: QUALITY CONTROL RESULTS

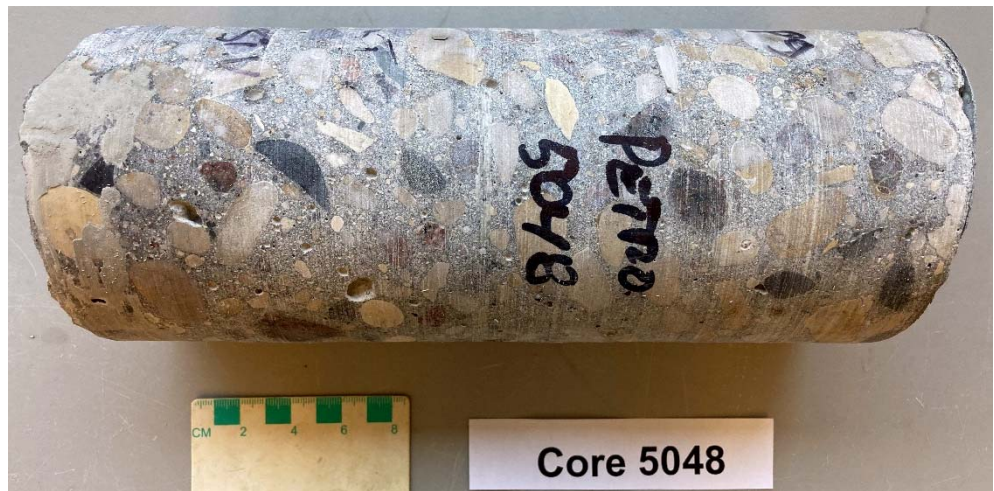
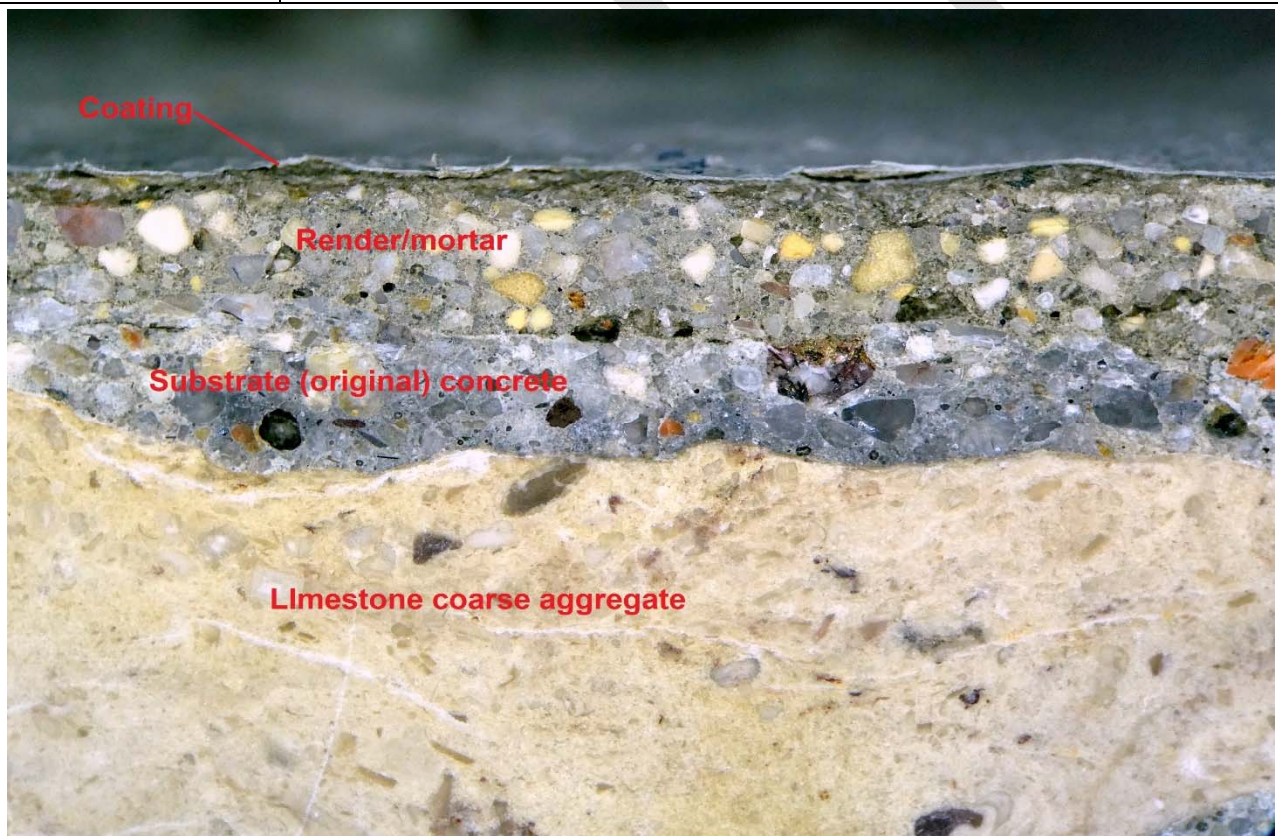
Profile view at the top/outer surface of the sample coating and render applied at surface. 10x magnification, field of view is about 16 mm across.

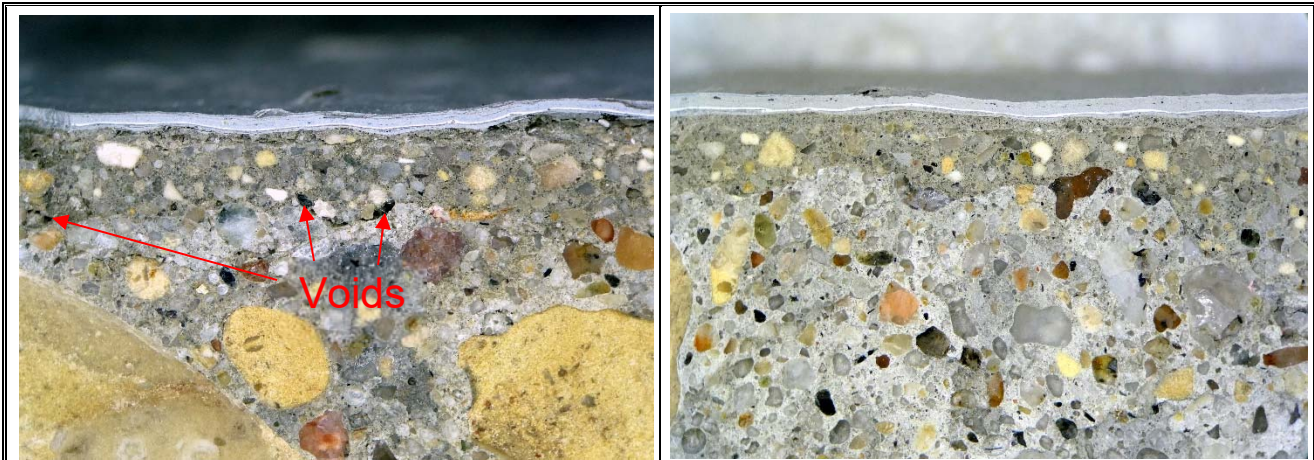
Variable thickness of render is observed. Left image depicts a few voids within and at bottom of render. Magn. 10x, fov = 14 mm

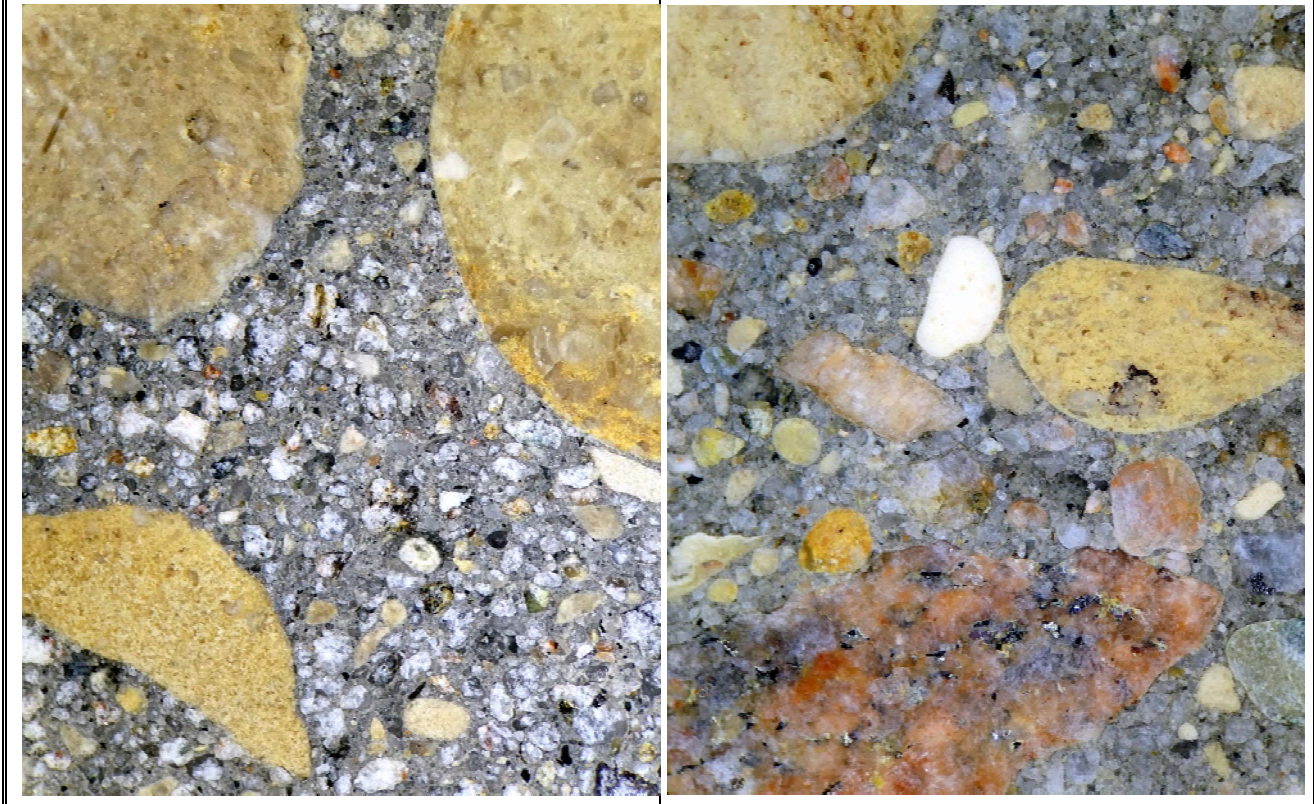
Views at 10x magnification illustrating general condition of paste and aggregates. Field of view is about 13 mm across.

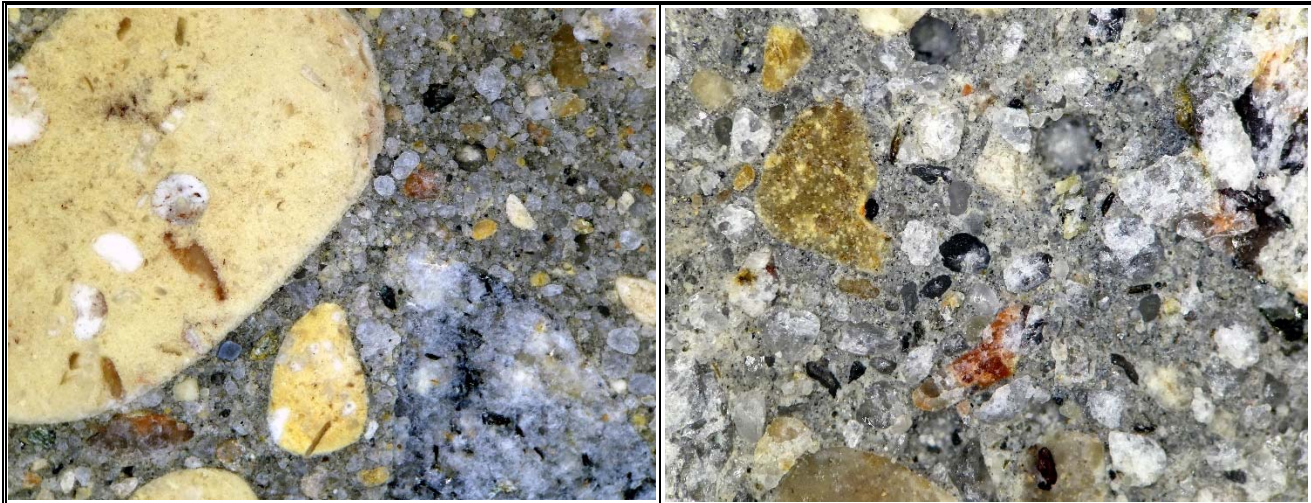
Views at 10x magnification (left) and 30x magnification (right) showing dense paste and good encapsulation of aggregates. Fields of view 13 mm and 2.75 mm across.

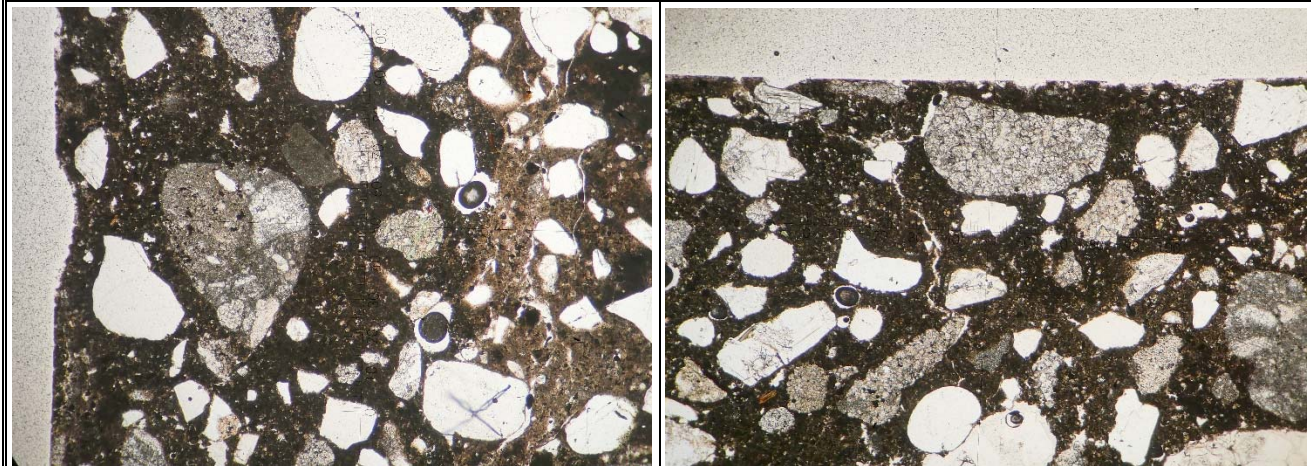
Profile views in thin-section (plane polarized light). Left image (top at far left) shows dense paste of render coating over lighter-coloured paste of substrate (lighter brown, cracked). Right image depicts vertical crack passing through render. Both images at 50x magnification, fov = 3 mm.

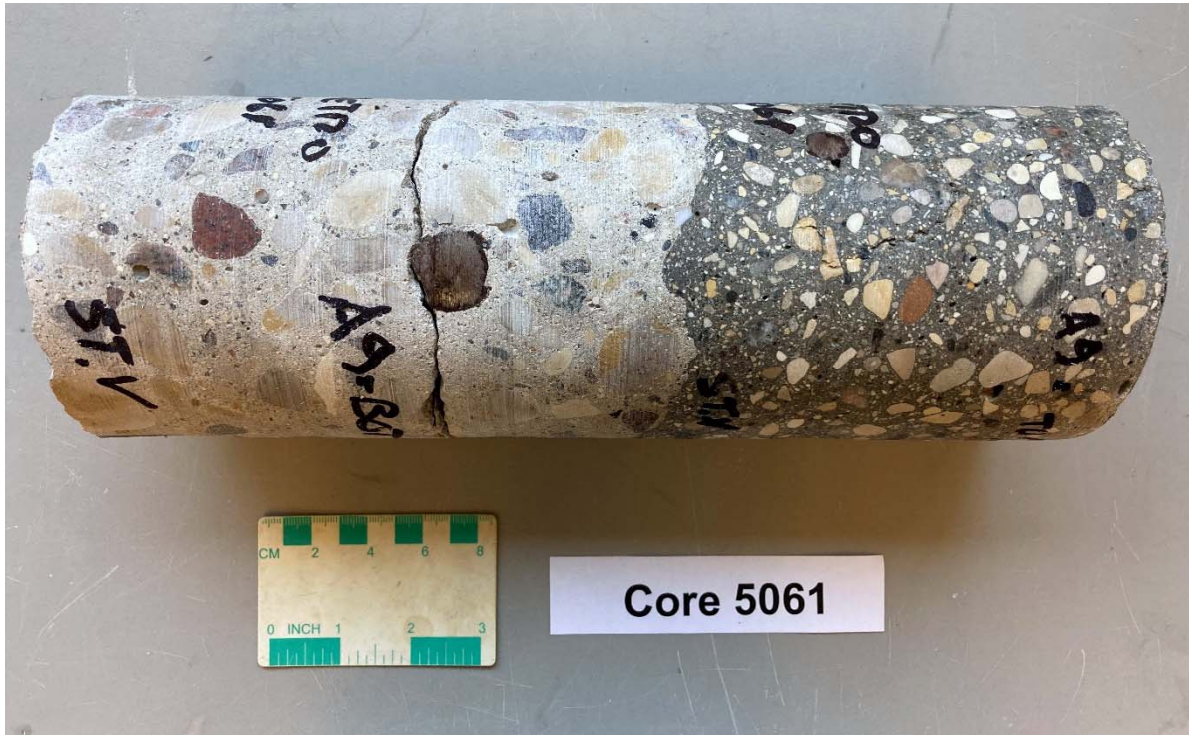
Dark grey paste and small-size aggregate characterize the overlay concrete; the lighter beige paste and larger-size aggregate typify the substrate concrete. Crack at the rebar.

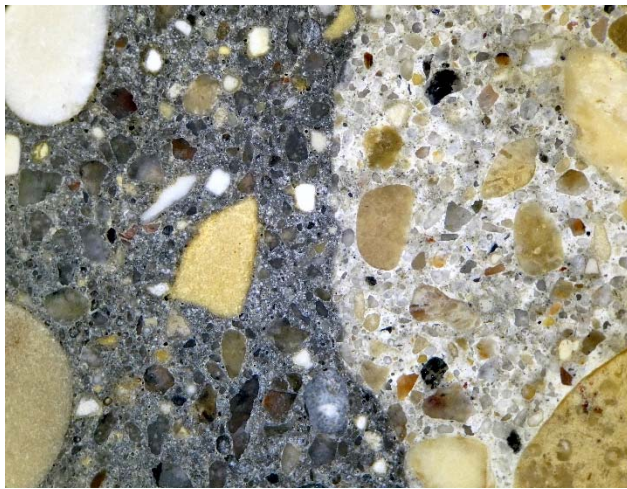
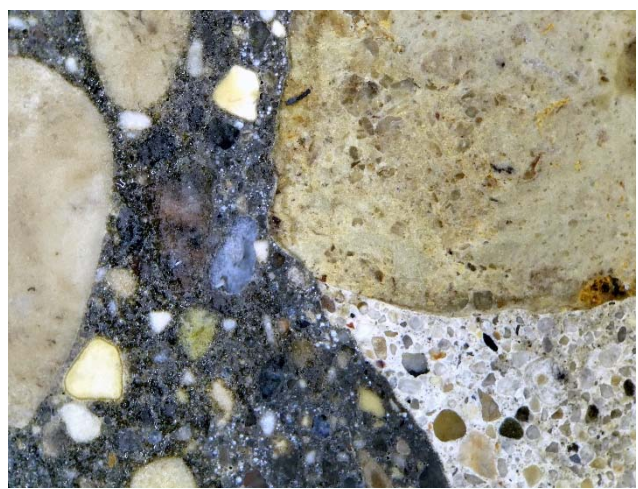
Interface of topping and substrate mixes in both images. Left image at 10x magnification, field of view about 13 mm across, while the right image is at 20x magnification with a field of view of about 8 mm.

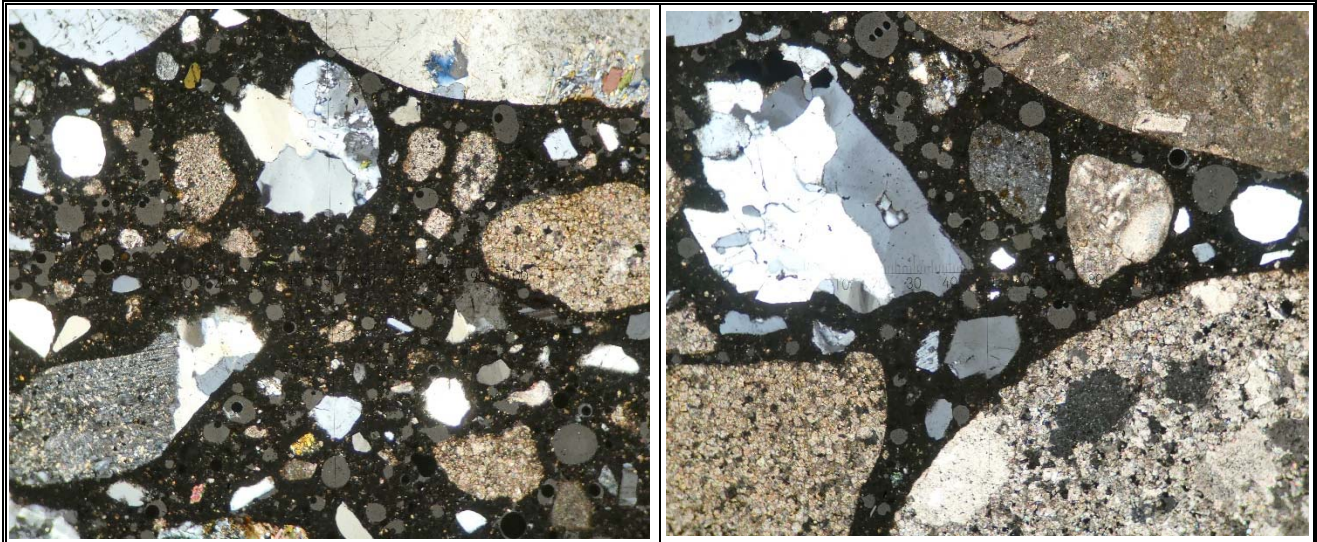
Thin-section views, seen in cross-polarized light, illustrating dense paste and an array of rock and mineral types comprising the aggregates. Magn. 50x, fields of view about 3 mm across.

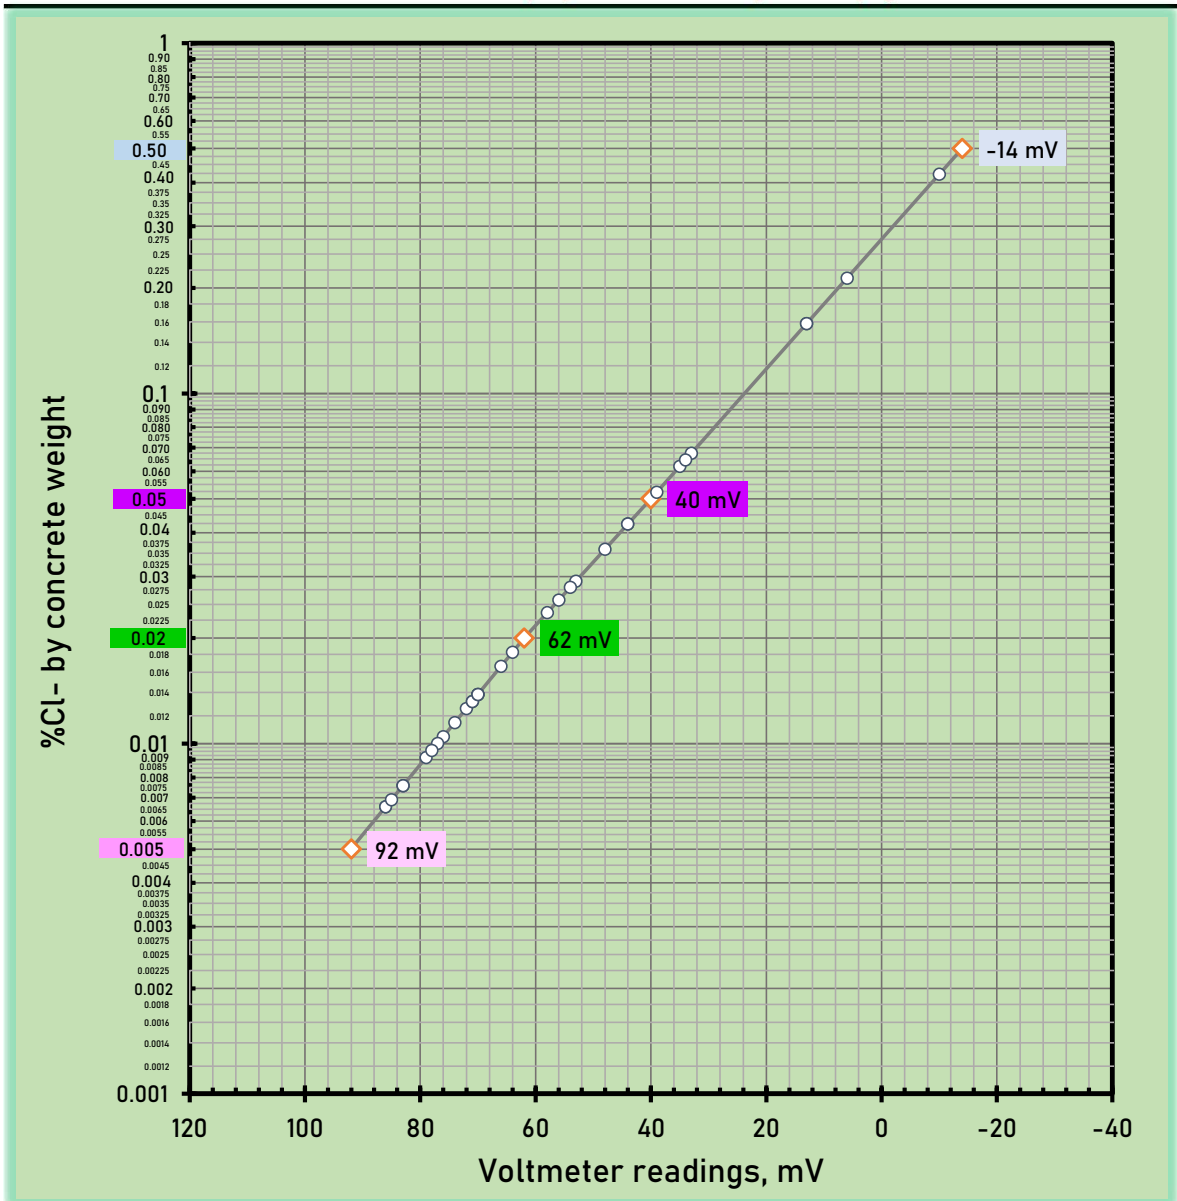
**APPENDIX O.7: SUBSTRUCTURE CONDITION ASSESSMENT  
CORROSION POTENTIAL SURVEY RESULTS**

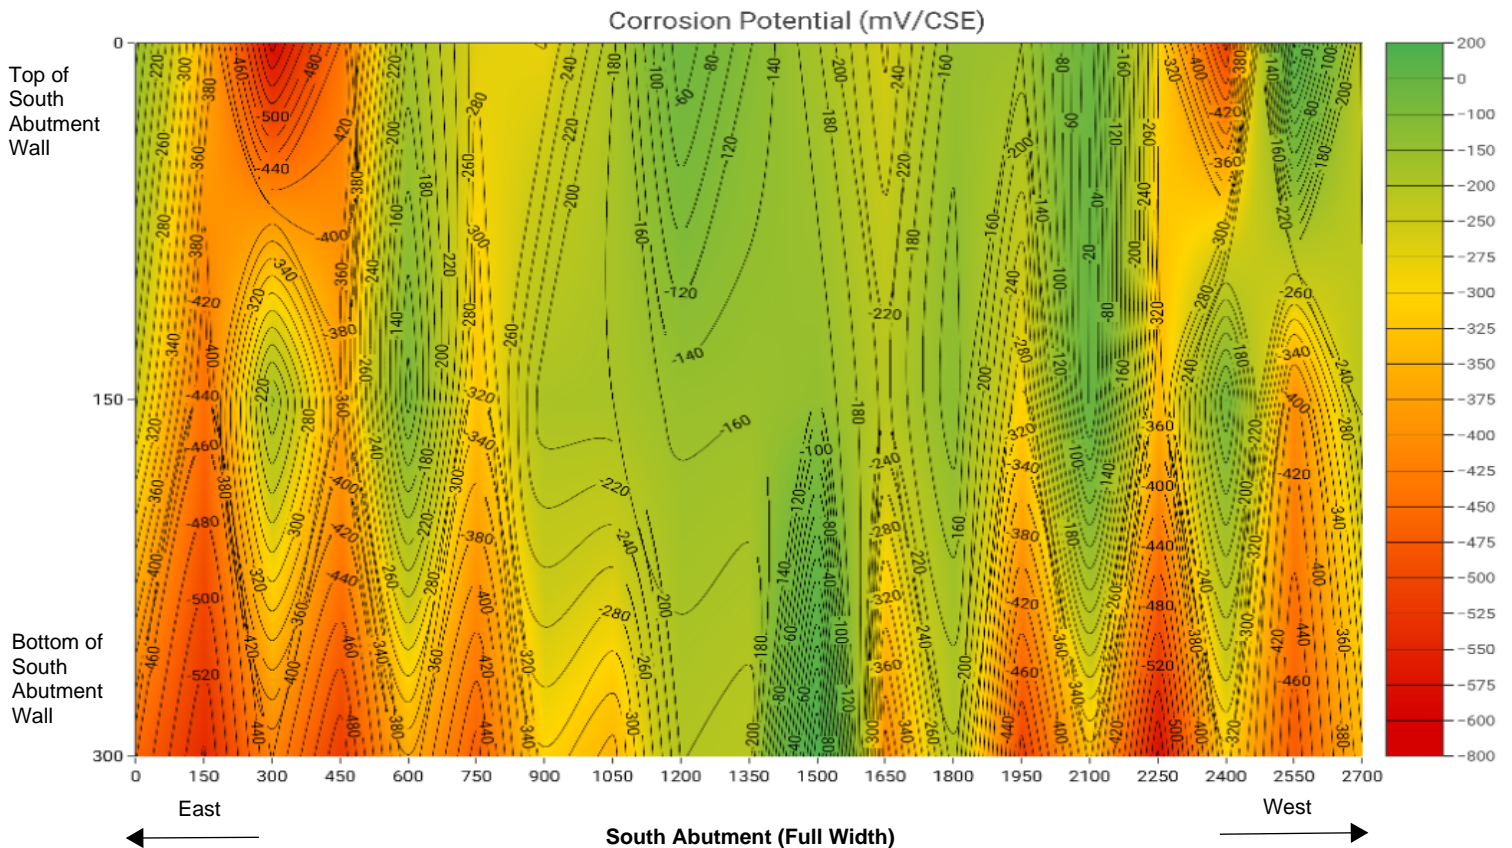
Report Generated by Giatec iCOR™

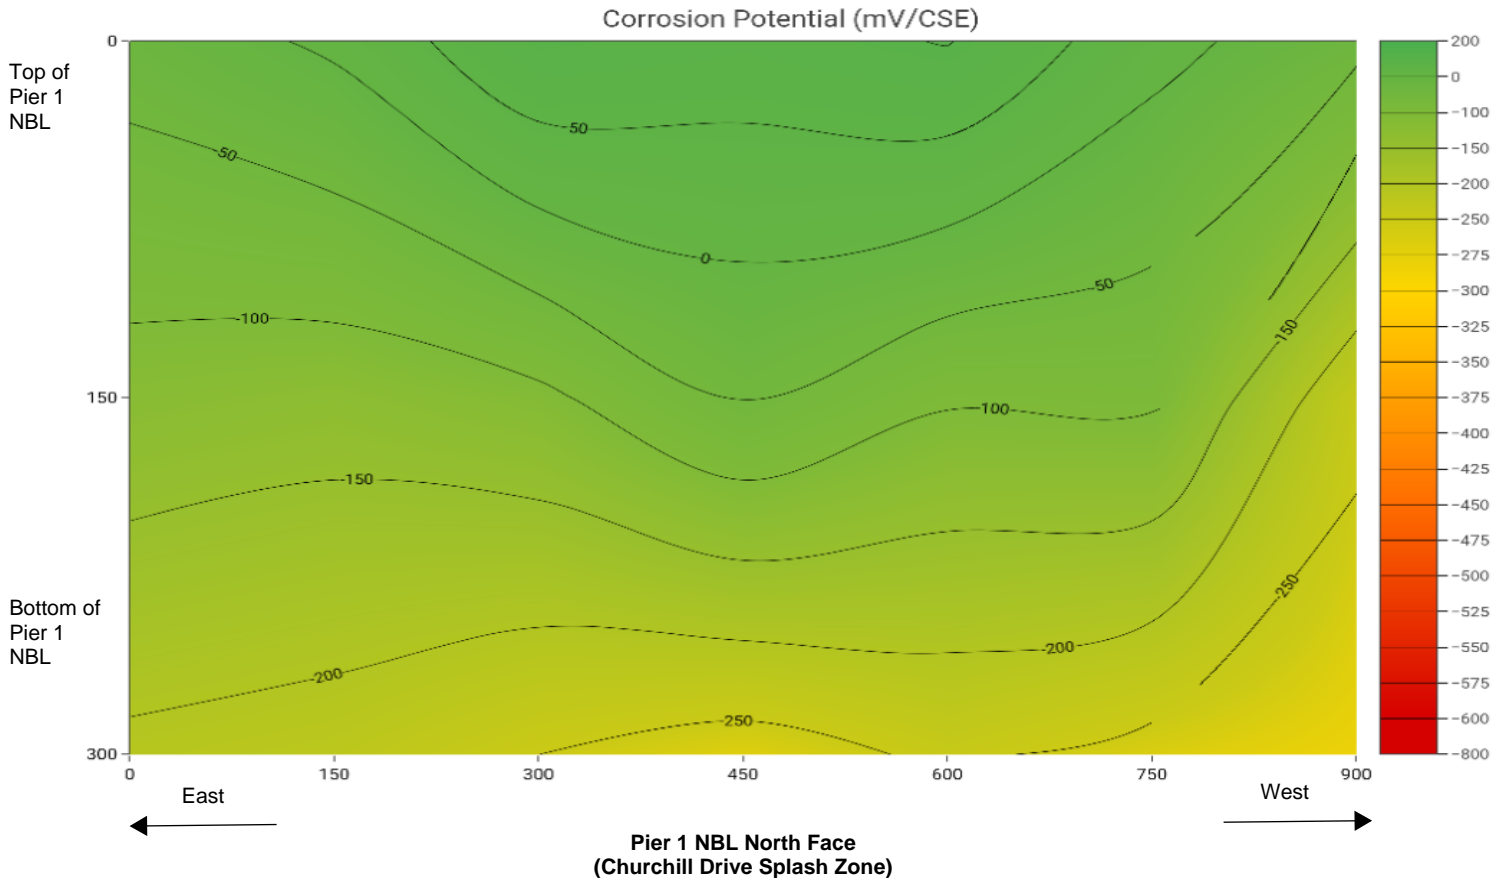
Report Generated by Giatec iCOR™

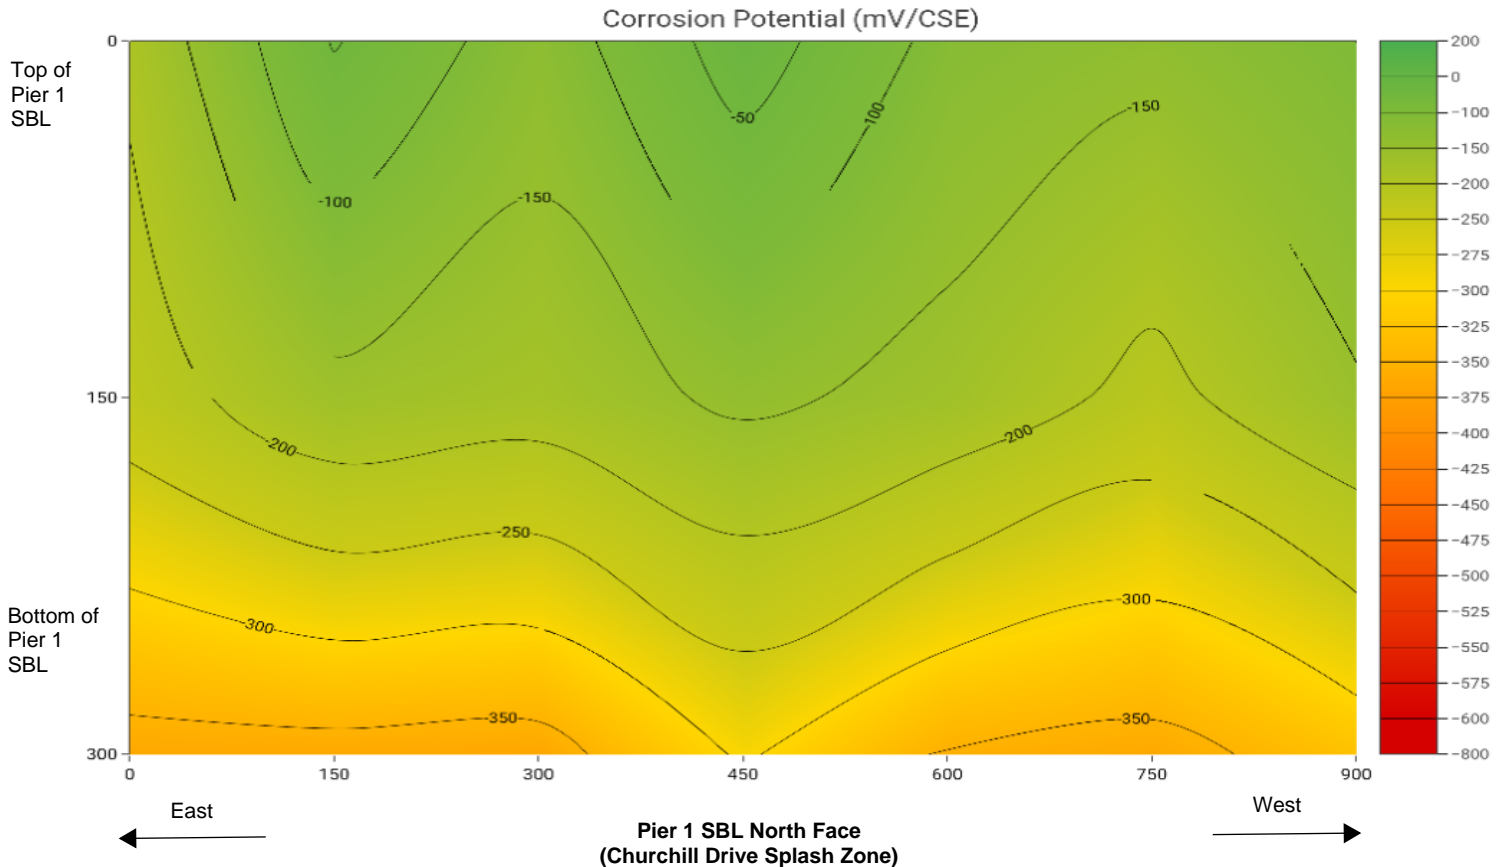
Report Generated by Giatec iCOR™

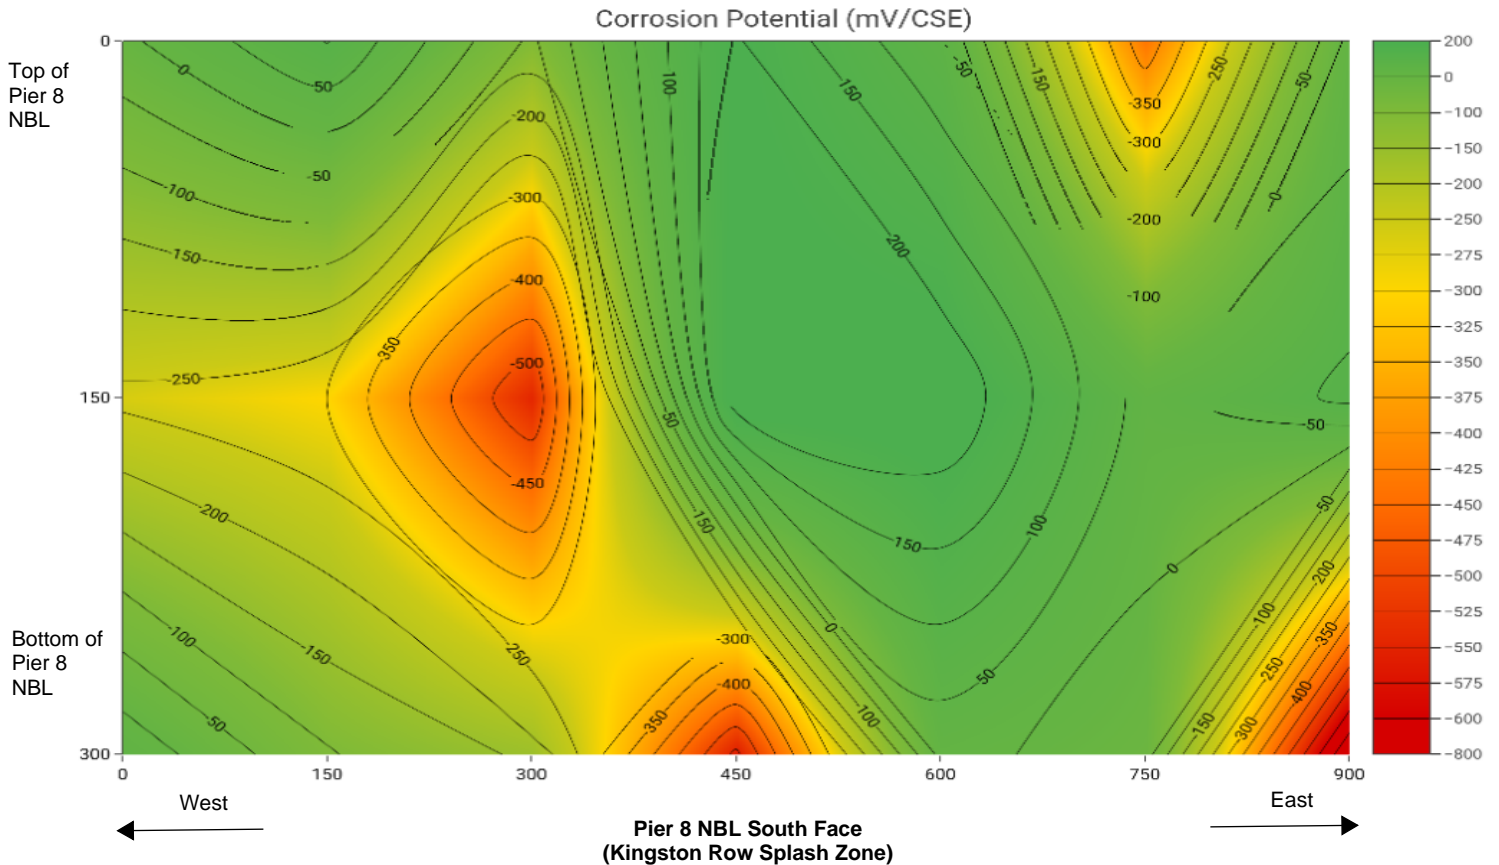
Report Generated by Giatec iCOR™

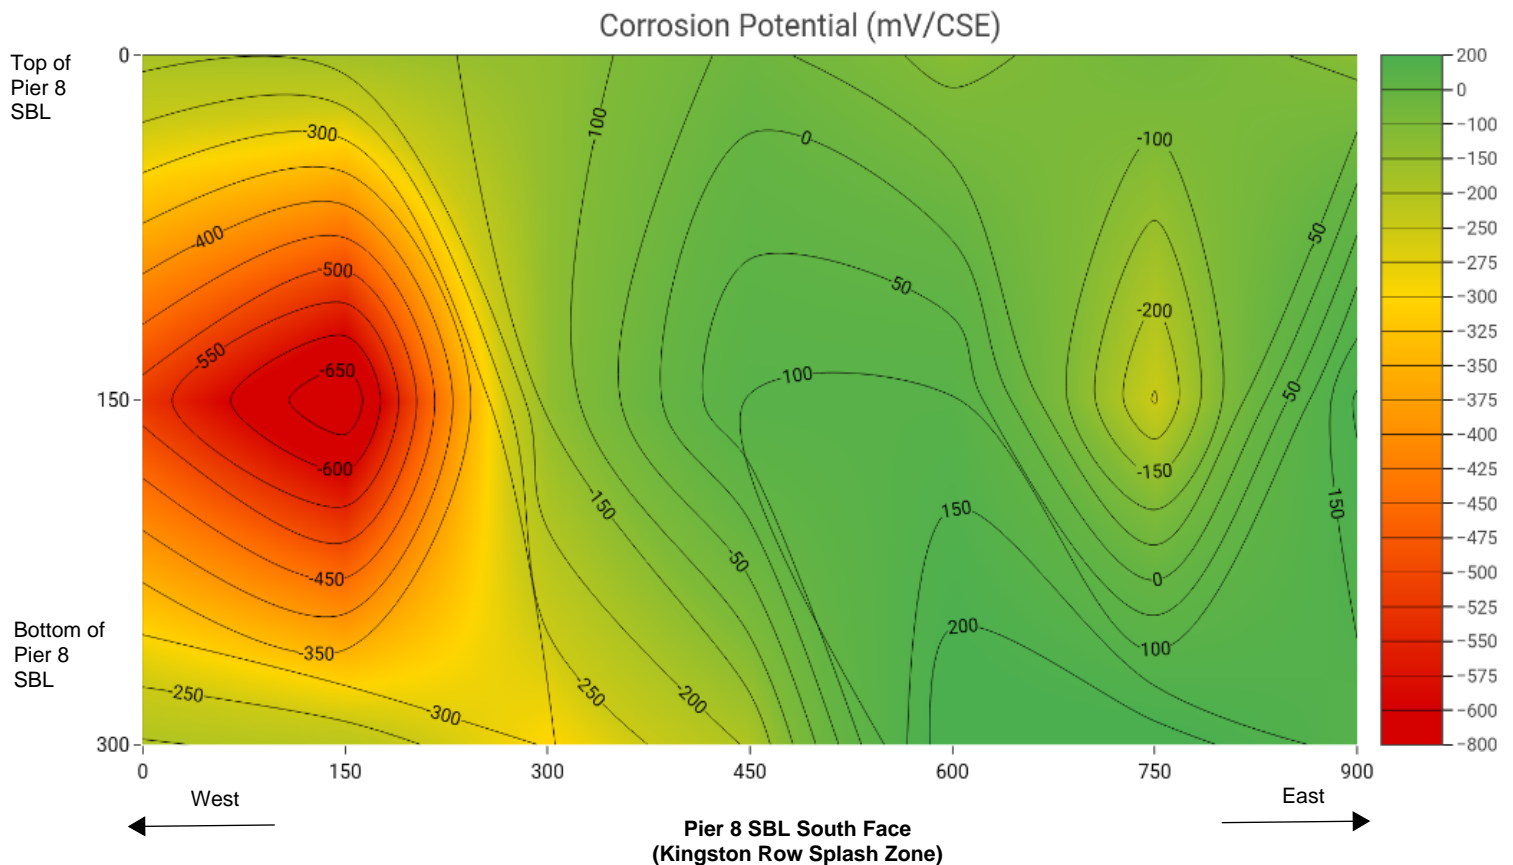
Report Generated by Giatec iCOR™
