**– FEASIBILITY STUDY TO RELOCATE THE ST. JAMES ASSINIBOIA 55+ CENTRE
TO THE ST. JAMES CIVIC CENTRE**

– PREPARED BY 1X1 ARCHITECTURE INC. – SEPTEMBER 21, 2012

Winnipeg, Manitoba
September 21 2012

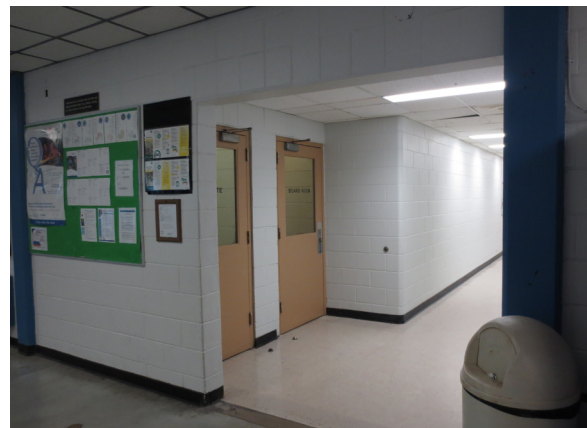
West stair at main floor. Stair door exits
into lobby/corridor

the 2010 NBC requirement of an exit as the stair exits into a fire rated corridor that leads straight to the exterior of the building. With the addition of the staff room and a new entry from this corridor into the boardroom, this corridor is now used to access programmed space and does not meet the intent of the NBC.

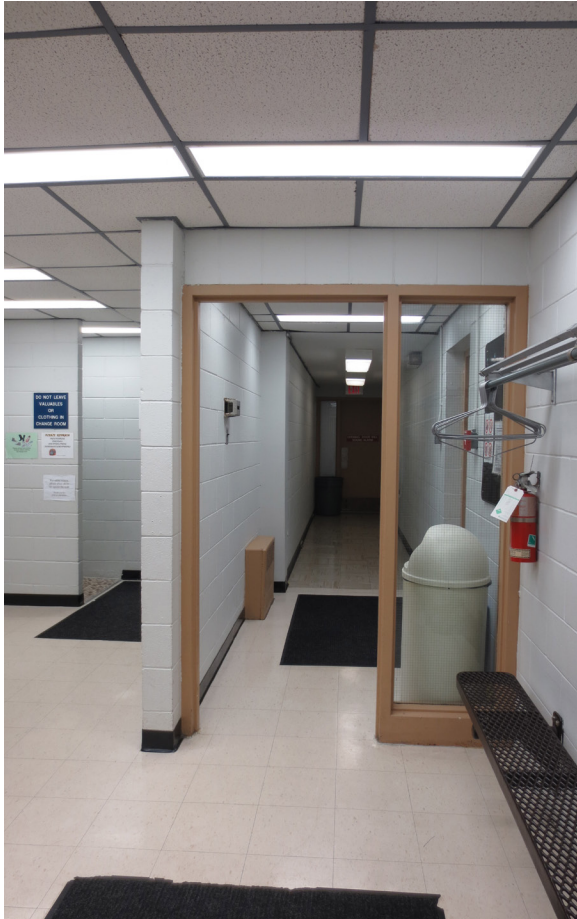
Corridor to weight room. The door has been removed from the steel frame

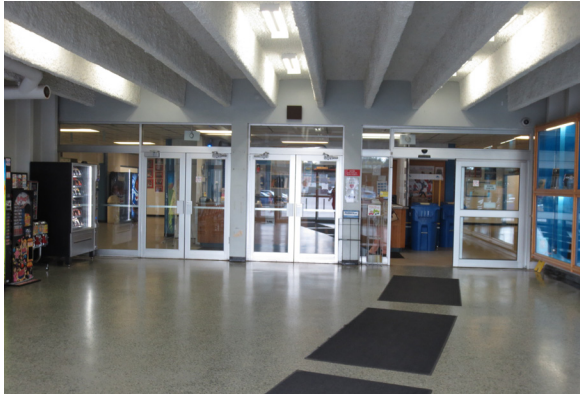
Lower: Lobby showing the doors and trophy shelf that City of Winnipeg staff recommended be demolished. Reception desk beyond

City of Winnipeg staff recommended removing the doors between the lobby (E05) and the waiting area (E04) as it does not provide ease of access between spaces. The original design did not have a vestibule at the front entrance, thus these doors would have acted as a wind block. Opening these spaces to one another will allow for more visibility of the reception desk and better flow from one space to another.

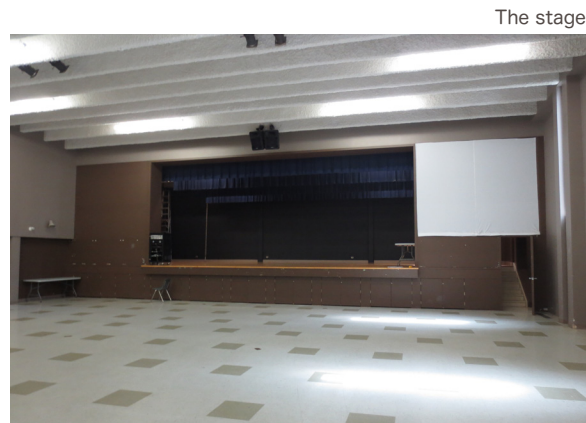
The stage is accessible on both the east and west side with stairs. The stage does not have a ramp or lift to make it

barrier free accessible.

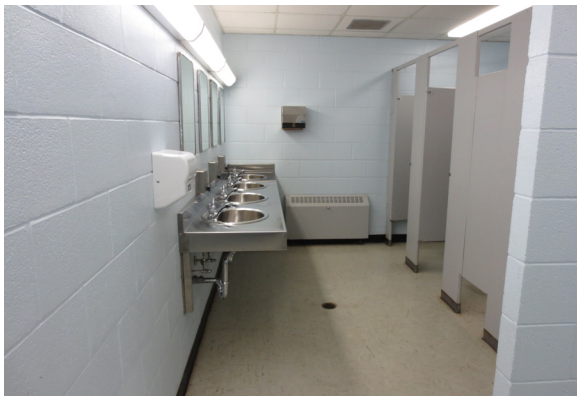
Female W/C

A review of the space using the National Building Code and the 2010 City of Winnipeg Accessibility Design Standards (CWADS) has revealed numerous shortcomings. It is recommended that these washrooms be re-configured to meet current standards.

It is anticipated that the floor tiles may contain Asbestos Containing Materials.

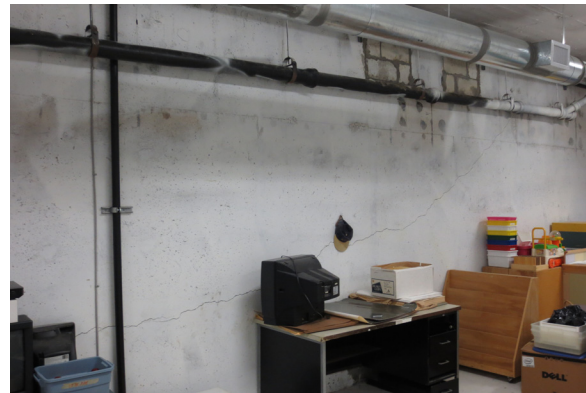
For the most part, the structural condition of this front portion of the building (arena excluded) is in good condition with very few cracks or other signs of deterioration. The only area of concern was the north basement wall of the former rifle range where there is a significant horizontal crack about half way up the wall. It is our opinion that this crack should be repaired as part of this redevelopment.

Crack in the basement wall

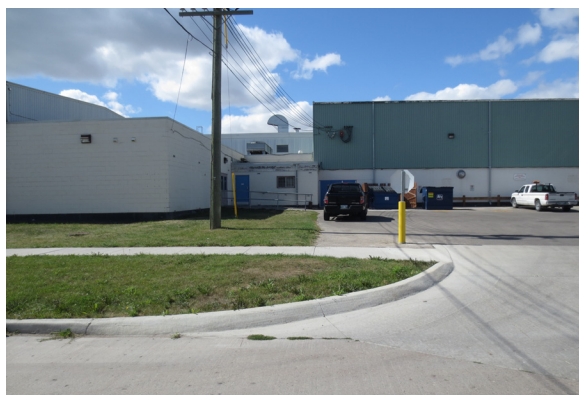
Main distribution to the building and Hydro pole

The building has one 800A-120/208V-3ph-4w service, one 600A-600V-3ph-3w service and one 60A-600V-3ph-3w service. The 60A service is labelled to feed “golf course pump house”. The main distributions are located at the SE corner of the arena, at the top of the bleachers. Main disconnects and distribution panels are made by Amalgamated Electric and appear to be original equipment. The meters are located inside.
