COVER PAGE

1.0 LIFT STATION INFORMATION

Station Name:	Hawthorne Lift Station		
Location of Station:	1178 Kildonan Drive		
Date of Inspection:	January 20, 2010		
Inspected By:	Damir Muhurdarevic, EIT		
Inspecting Firm:	MMM Group Limited (MMM)		
Client:	City of Winnipeg – Water and Waste Department

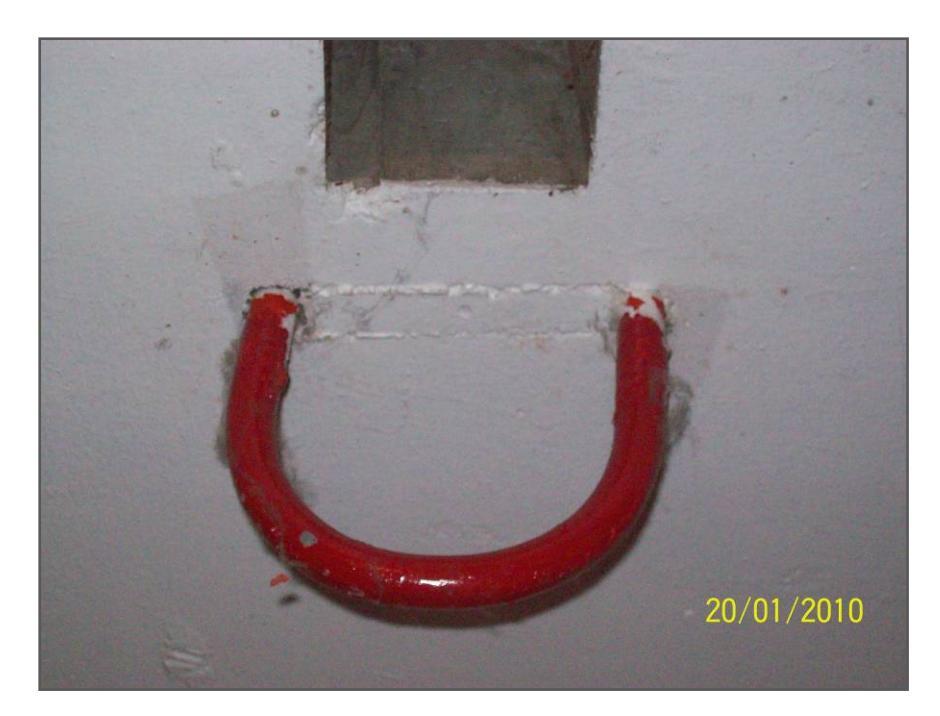
Photograph No. 1

The third floor motor room and the fourth floor pump room each have three (3) U-shaped hooks, fabricated of 19.4mm diameter steel rod embedded into the underside of the cast-in-place concrete floor above. The second floor chamber has four (4) similar hooks, which are embedded into the underside of the concrete floor beams above.

The ten (10) U-shaped hooks were analyzed for pullout resistance of the embedment and the tension resistance of the hook. The thickness of the ceiling was unable to be observed therefore; a concrete thickness of 200mm and an embedment length of 150mm were assumed. The governing factor in the hooks was the pullout resistance, which was calculated to be 6.8 tons. However, due to assumptions in the calculations, it is recommended that a safety factor of 4.5 be applied to yield a **load rating of 1.5 tons.**

Pump and motor room U-shaped lifting hooks

MMM, through this inspection, does not warrant the lifting devices installation or warrant that the design complies with current codes or standards. As per MMM's analysis it was found that the hooks should be rated at **1.5 tons**, and the main floor wide flange lifting beam is to be rated at **1.5** tons as well.

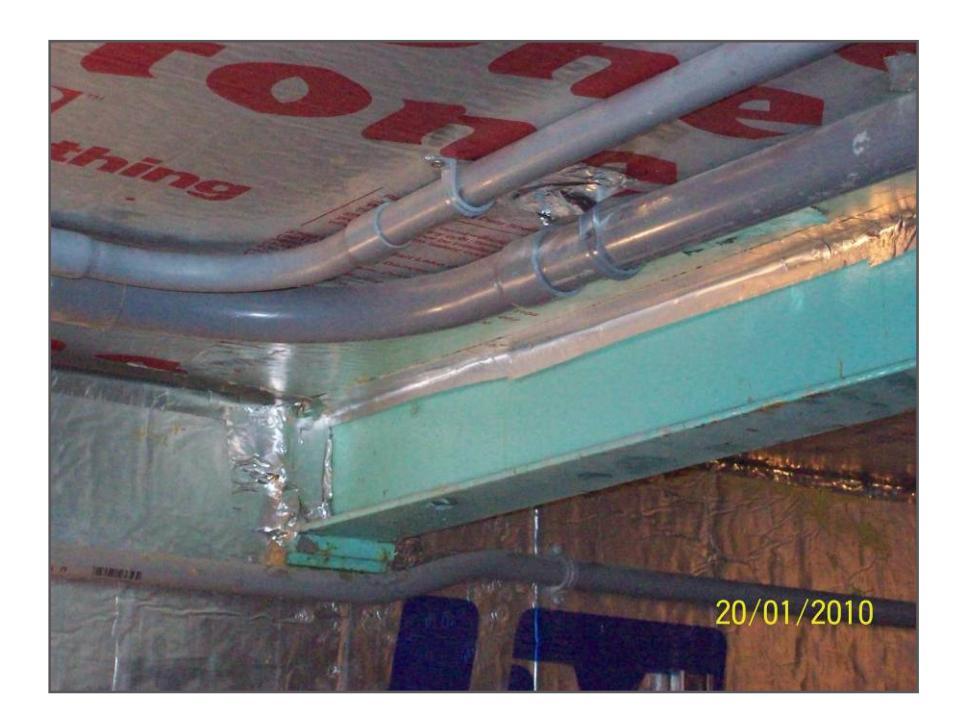
Photograph No. 2

The main floor has a wide flange lifting beam (175mm high by 93mm wide) that spans the length of the room with an attached sliding hook. No posted rating was observed on the lifting beam. The wall supports connections were unable to be observed due to Styrofoam wall insulation.

The beam on the main floor was analyzed for bending resistance of the beam and shear resistance of the assumed bolted clip angle wall connections. The resistance of the assumed wall connection was the governing factor, which was calculated to be 3.0 tons. However, due assumptions of the wall connections, it is recommended a safety factor of 2.0 be applied to yield a **load rating of 1.5 tons**.

Lifting beam located on the main floor
