**PHASE I ENVIRONMENTAL SITE
ASSESSMENT
Public Works Yard & Bonivital Pool
1201 & 1215 Archibald Street
Winnipeg, Manitoba**

THE CITY OF WINNIPEG

CONCENTRIC ASSOCIATES INTERNATIONAL INCORPORATED

JUNE 24, 2013

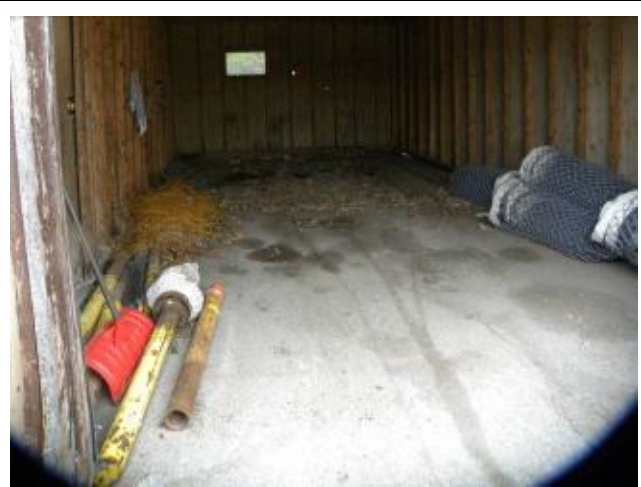
Photo #6 – View of interior of second storage shed at Public Works Yard. Note dark staining on asphalt surface.

Concentric recommends that a Phase II Environmental Site Assessment be conducted to further assess above-noted issues of potential environmental concern 1-5.

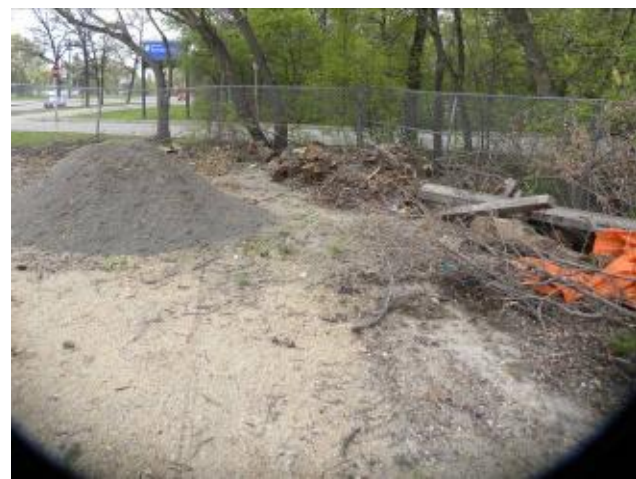
Photo #11 – View of fill material and miscellaneous wood located near the southern portion of the Public Works Yard.

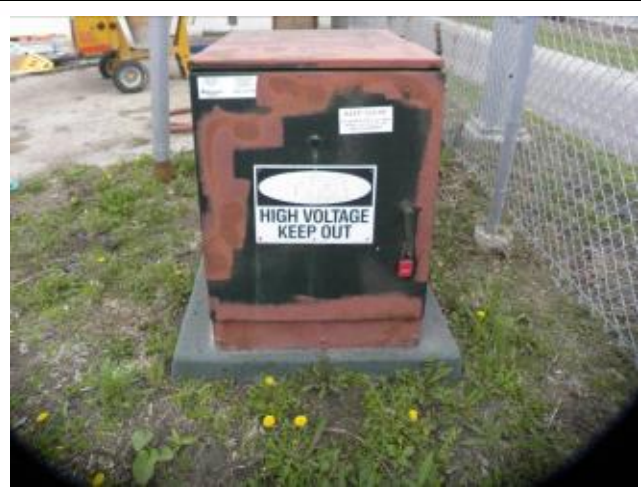
A review of the site was conducted to evaluate the potential presence of PCB containing equipment in use or stored at the site. One pad mounted transformer was observed located near the northeast corner of 1201 Archibald Street. No leaks or staining were observed in the vicinity of the transformer. Signage posted on the transformer did not indicate whether the transformer liquids were PCB or non-PCB containing. As well, fluorescent light ballasts were observed throughout the main building and their PCB status is unknown. The on-site operation of potentially PCB containing fluorescent light ballasts is typically not interpreted

Photo #14 – View of padmounted transformer located near the northeast corner of the Public Works Yard.

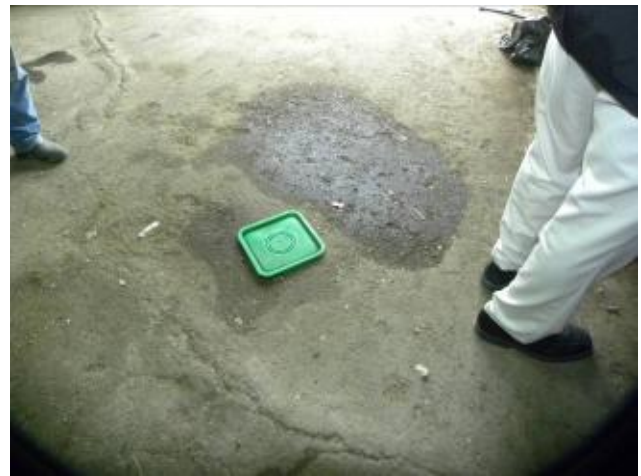
3. Prior to 1998, operations at the Public Works Yard included maintenance of city owned vehicles and equipment. Dark staining was noted on the concrete floor in the area where vehicle maintenance was formerly undertaken. A floor drain that is reported to eventually discharge to the sanitary sewer system was also located in this area. This historical operation and possibility for release of petroleum-based and other products associated with vehicle maintenance to the environment is a potential concern.

Several areas of dark staining were noted on the concrete floor within the building. Concrete flooring within the building was in poor shape with several areas of pitting and cracking.

Photo #16 – View of dark staining on concrete flooring within the main Public Works building. Note cracking and pitting.

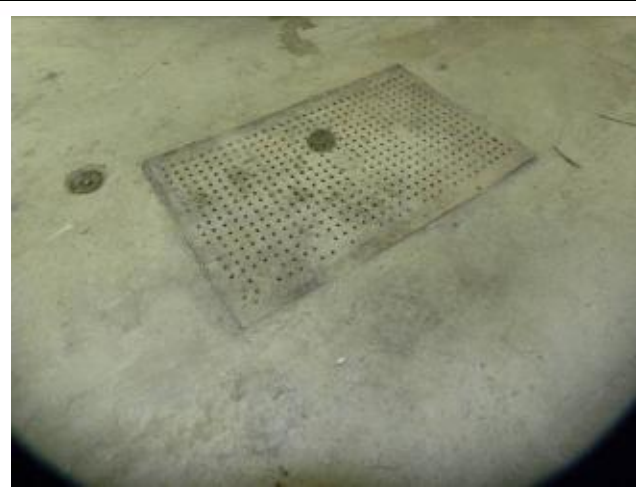
Several floor drains were identified within the site building. One large floor drain was observed located centrally within the building. As previously mentioned, the site representative indicated that prior to 1998 vehicle maintenance was historically conducted within the building. Any dripped or spilled fluids in association with vehicle maintenance could have been washed down this drain which is reportedly connected to a catch basin located east within the building. This eastern catch basin discharges to an exterior catch basin. The site representative indicated that periodically these interior drains develop a pungent odour and a biocide is poured into the drain to get rid of the odour. No oil water separator was currently or historically operated on site.

Photo #17 - View of floor drain located centrally in the main Public Works building.

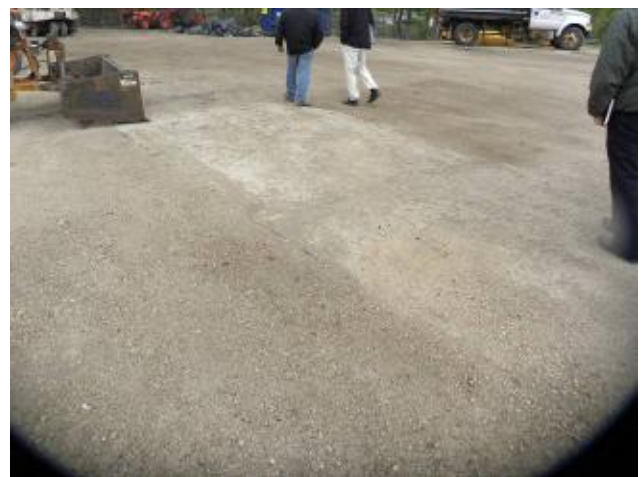
Photo #20 – View of concrete pad – former location of pump island at the Public Works Yard.

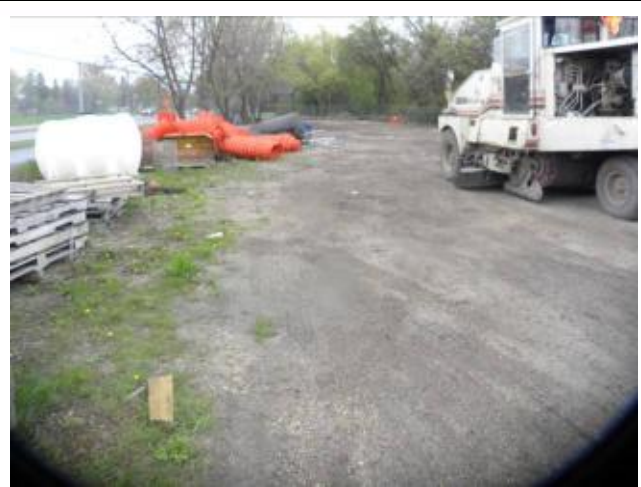
Photo #22 – View of storage of miscellaneous materials and plastic AST used for herbicides at the Public Works Yard.

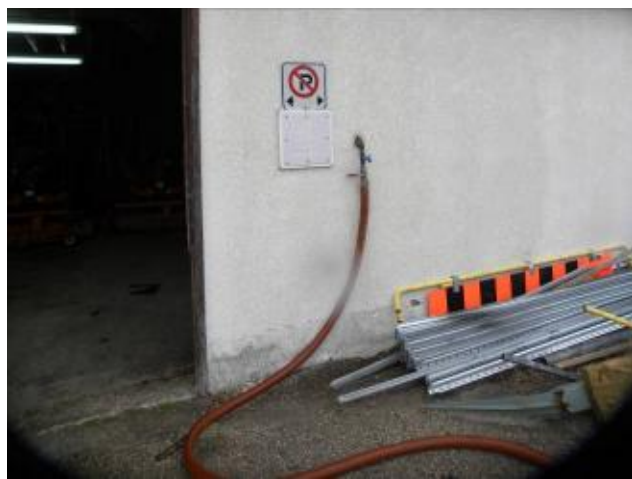
Photo #23 – View of chemical fill station located near the southeast corner of the main Public Works building.

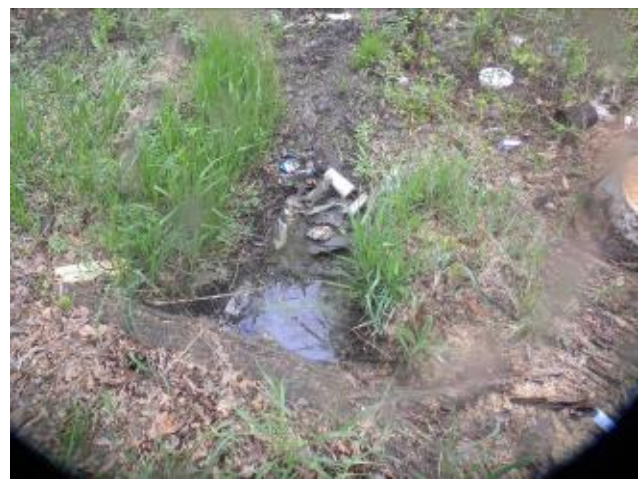
A creek (a tributary to the Seine River) was observed along the western property boundary of 1201 Archibald Street and runs diagonally and appears to end near the southeast portion of 1215 Archibald Street. Debris and loose garbage was noted in the wooded area near the pathway between 1201 and 1215 Archibald. As well, a slight sheen was visible on the water next to the pathway.

Photo #24 – View of creek area located next to walkway between 1201 and 1215 Archiblad Street.

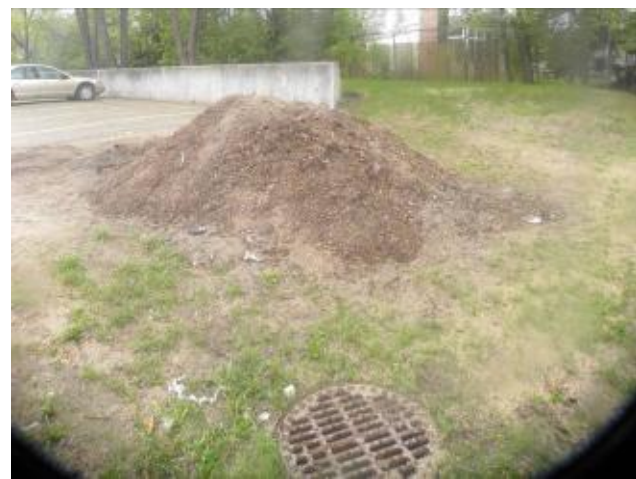
Photo #31 – View of debris pile located near the southwest corner of the Bonivital Pool western parking lot.

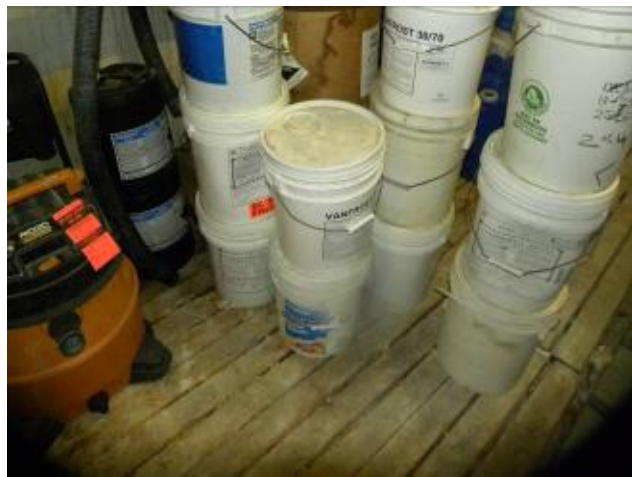
These chemicals were stored at various locations in the basement area surrounding the underside of the pool mainly on shelving. No staining was noted in the vicinity of the chemical storage. Basement area flooring was a mix of concrete and gravel materials. There are no significant potential environmental concerns related to the storage of pool-chemicals at the site.

Photo #33 – View of chemical storage in the basement of the main Bonivital Pool building.
