CAR RAC DOCK PROJECT
OSBORNE STREET BRIDGE DOCK SITE
RIVERBANK STABILITY EVALUATION
SUMMARY REPORT

August 27, 2002

RE: CAR RAC Dock Project
Osborne Street Bridge Dock Site
Riverbank Stability Evaluation

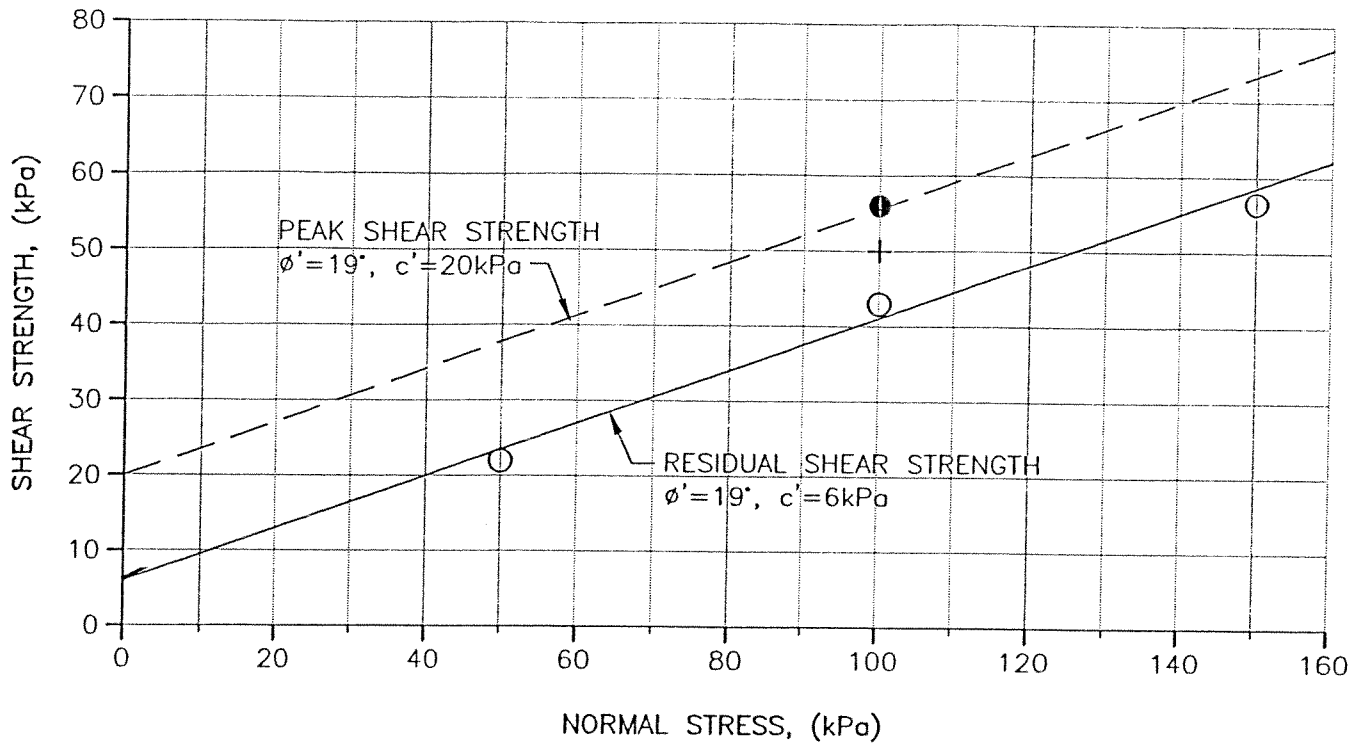
A direct shear test was performed at the Manitoba Hydro soils testing laboratory on an alluvial silty clay sample taken by KGS Group from a test hole at One Evergreen Place (TH-1 at 4.3 m depth), located immediately upstream of the Osborne Street Bridge. Results of the direct shear testing indicated that the clay sample had a liquid limit of 41%, plasticity index of 22% (CI) and contained 3.5% sand, 62.3% silt and 34.2% clay. As residual shear strength of $\phi' = 19^\circ$ and $c' = 6$ kPa were obtained from the direct shear test. Results from the direct shear test are shown on Figure B-4 in Appendix C.

TEST HOLE	SAMPLE NO.	DEPTH (m)	Symbols			LL (%)	PL (%)	PI (%)	MC (%)	SAND (%)	SILT (%)	CLAY (%)
			Peak	Post Peak	Residual							
TH1	9	4.3(EL.223.2)	●	+	○	41	19	22	39	3.5	62.3	34.2
