GEOTECHNICAL REPORT

Geotechnical Report for Fort Street West Alley

<p>THE NATIONAL TESTING LABORATORIES LIMITED <i>Established in 1923</i></p>	Testhole Location Plan Fort Garry Alley, Portage Ave. to Graham Ave. City of Winnipeg 2009 Alley Renewal Program		
	Project No.: KGS-863	Drawn by: KK	Figure: 1
	Date: Feb. 25, 2009	Reviewed by: DF	Scale: NTS

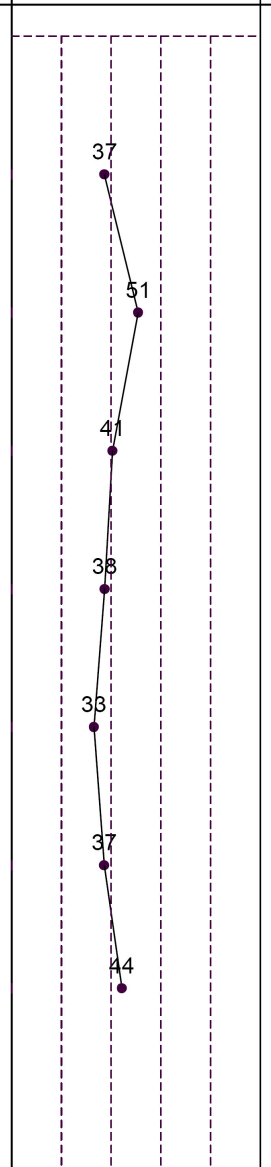
Test Hole Log #10 for Sherburn / Ingersoll Alley

Subsurface Profile			Laboratory Testing																
Depth (m)	Symbol	Description	Water Content (%)																
0.0		Ground Surface																	
0.0 - 0.4

Fill - mixture of black/brown, firm, high plasticity clay with fine to coarse grained sand, trace fine gravel																	
0.5 - 2.1

Clay - black, stiff, moist, high plasticity - grey below 0.8 m - brown below 1.0 m - layers of silt between 1.0 to 1.7 m
