GEOTECHNICAL REPORT FOR:

GEOTECHNICAL INVESTIGATION RESIDENTIAL STREETS RECONSTRUCTION WINNIPEG, MANITOBA

AMEC File No. WX10364

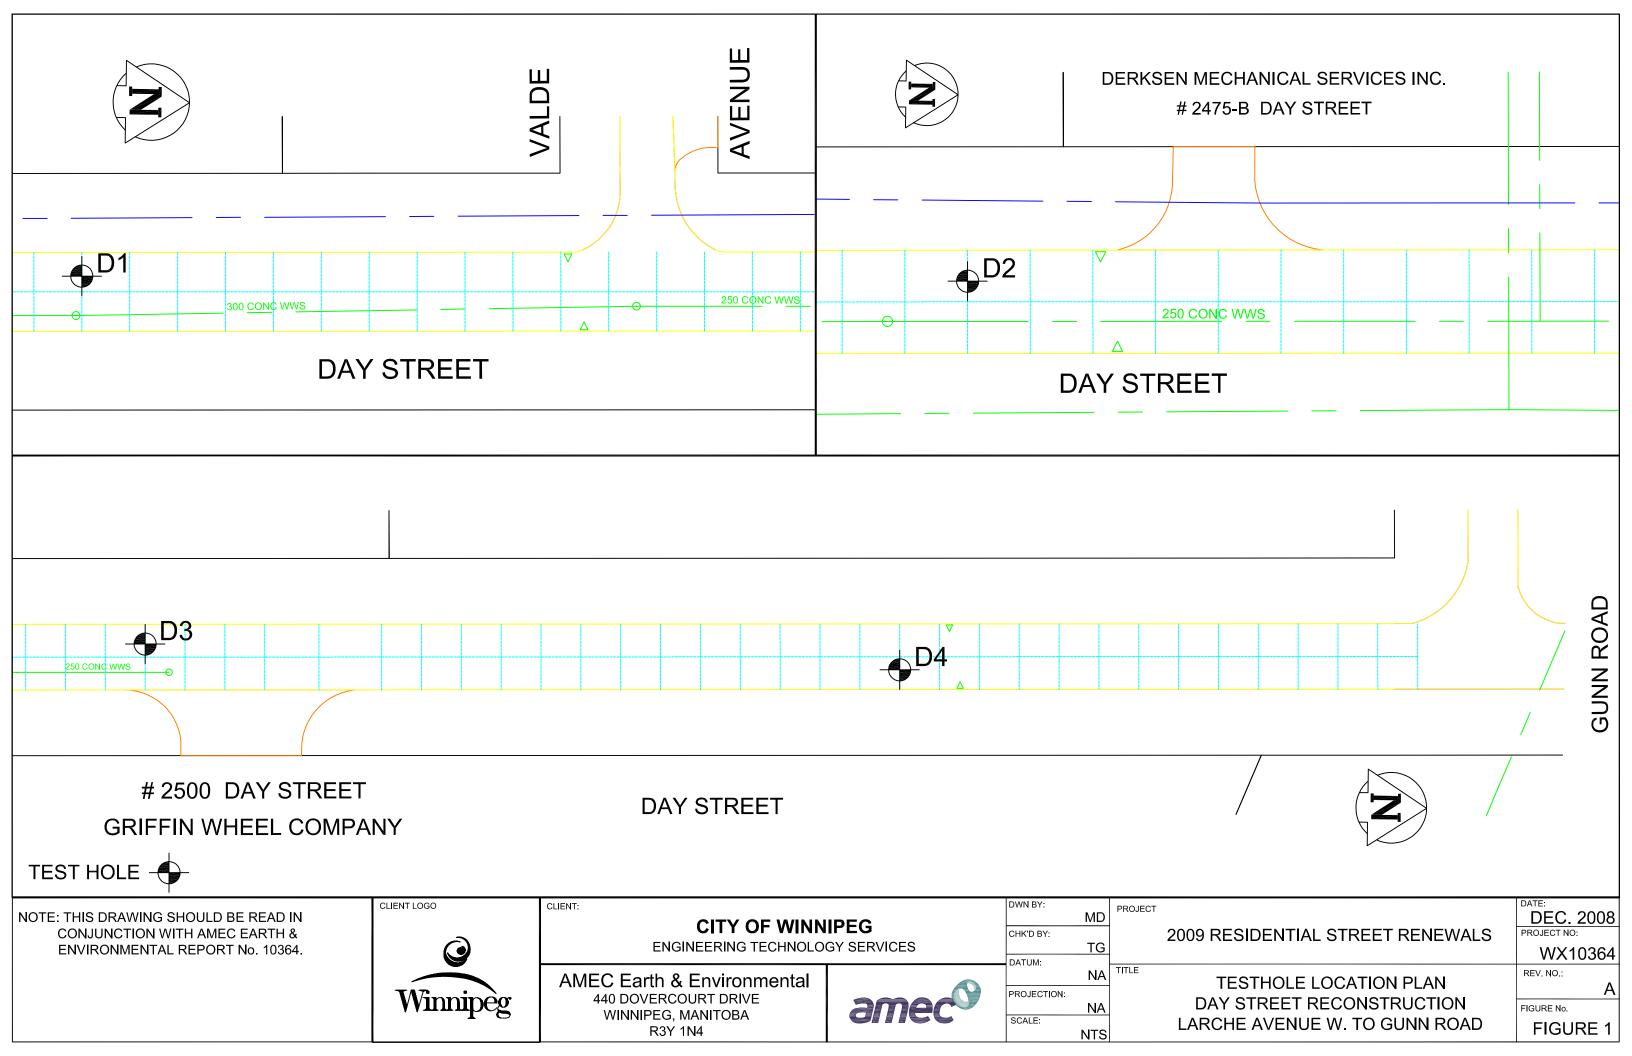
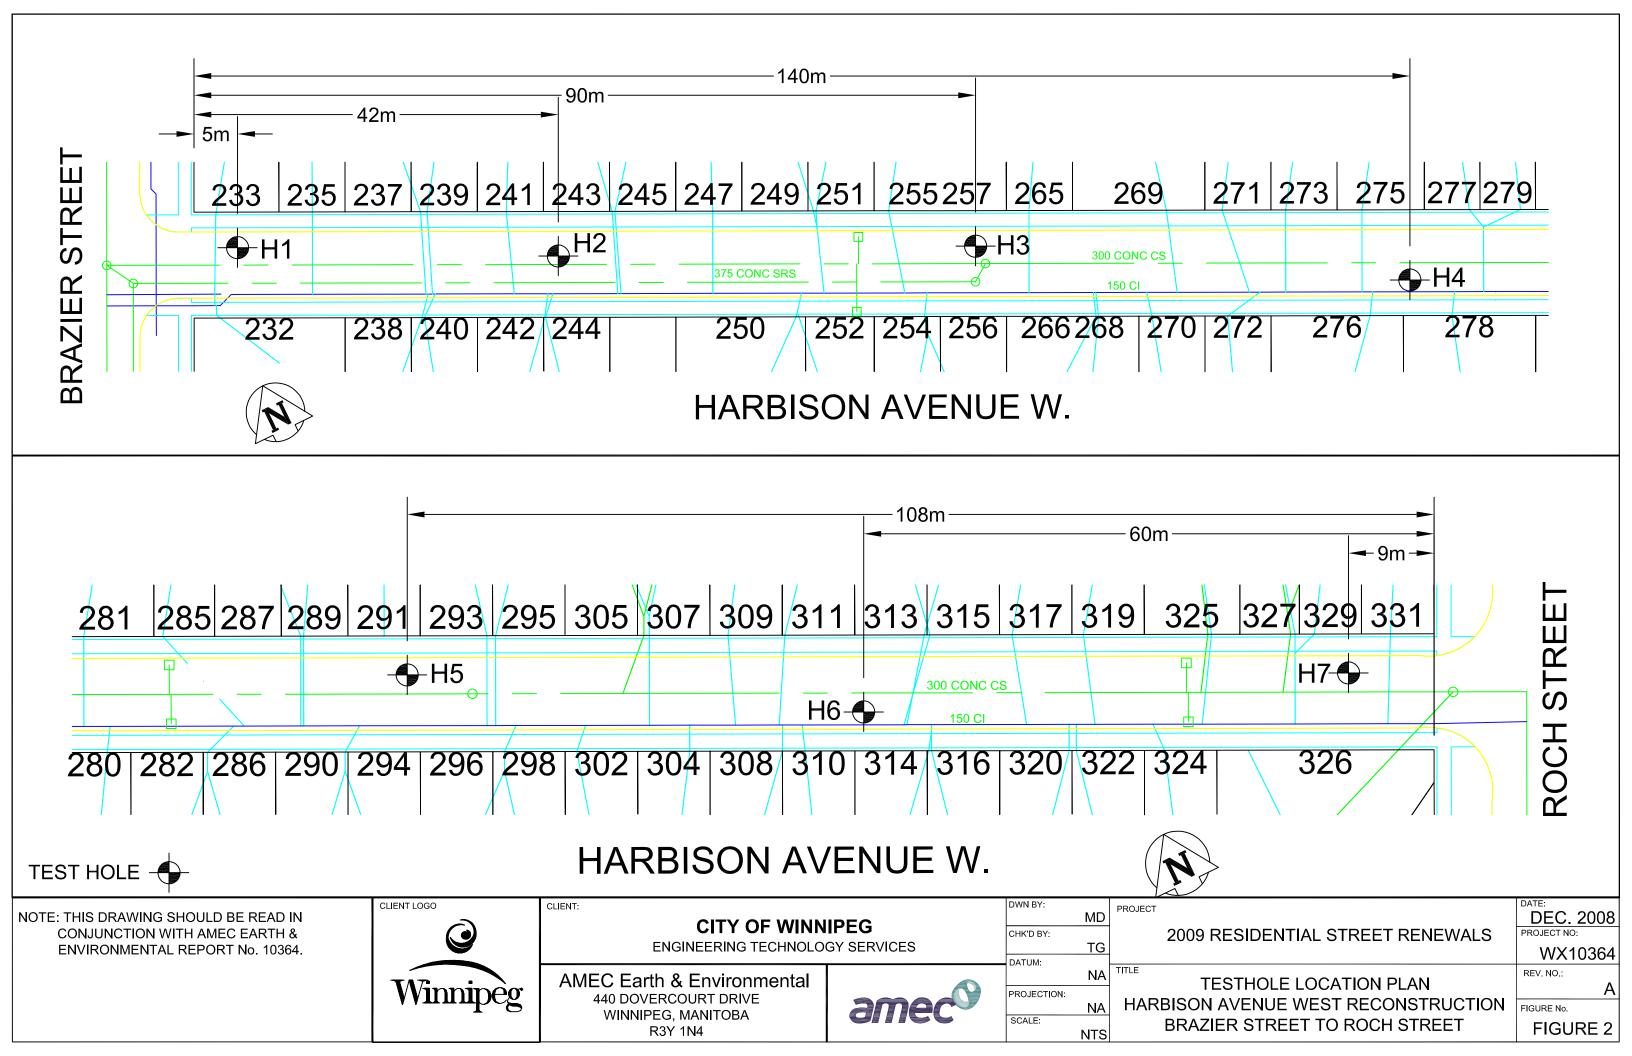
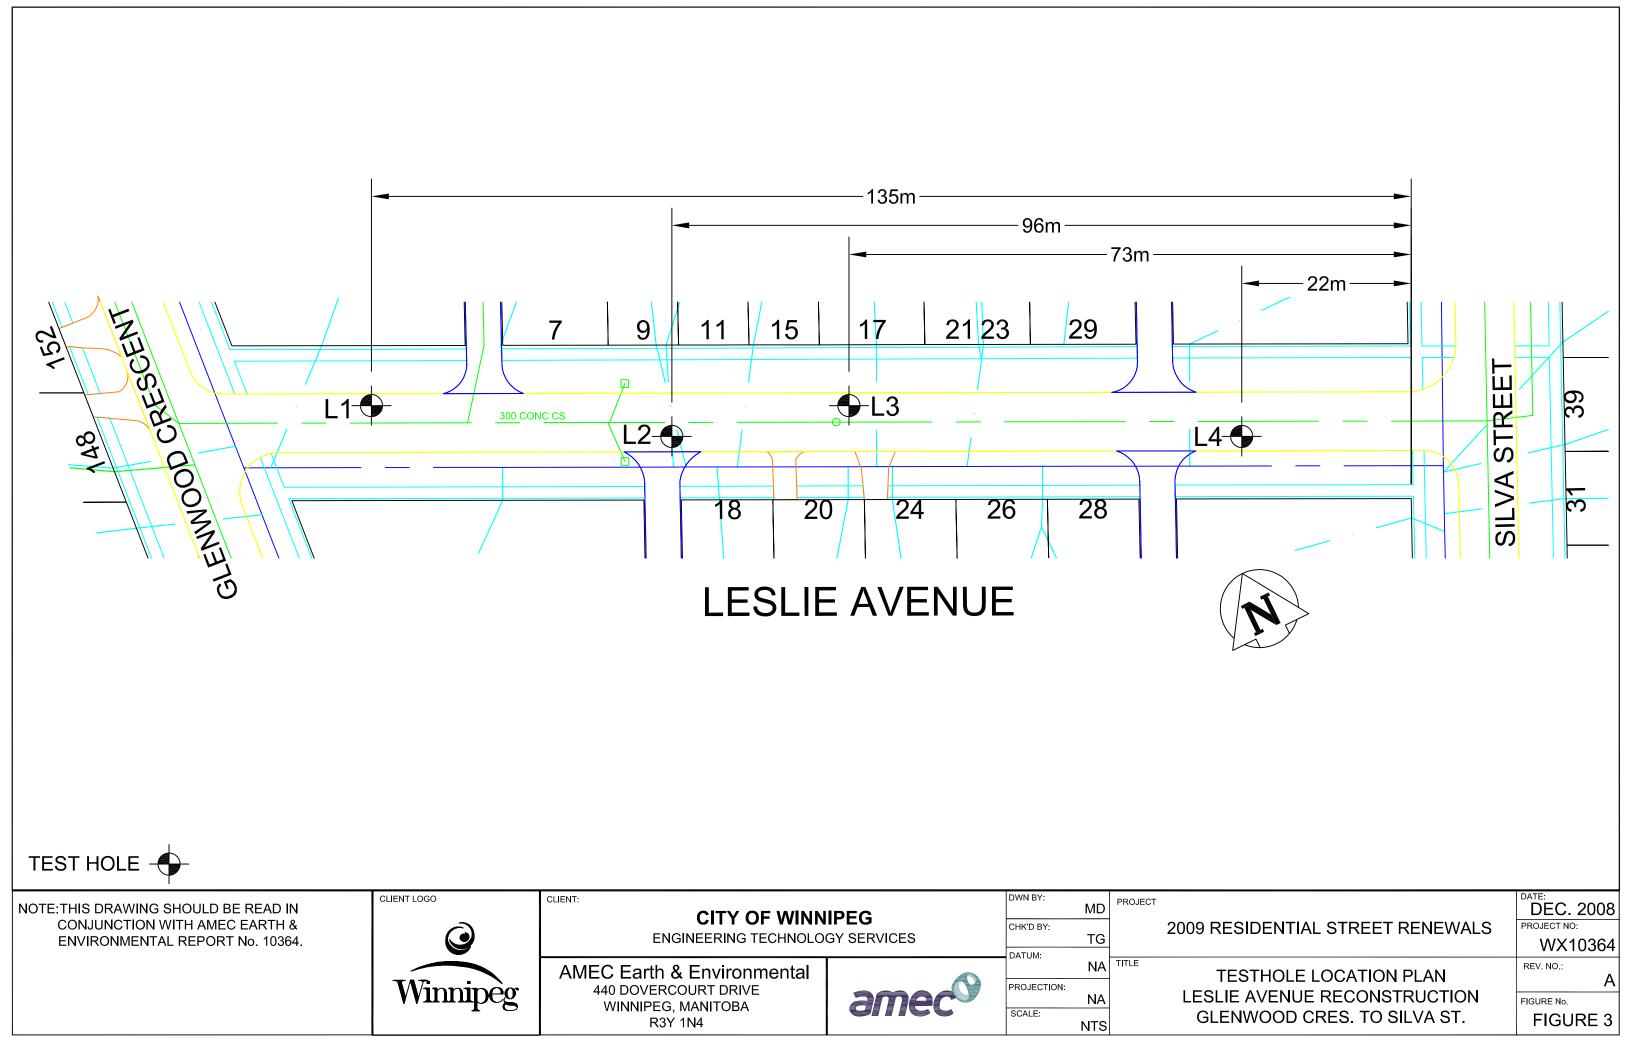
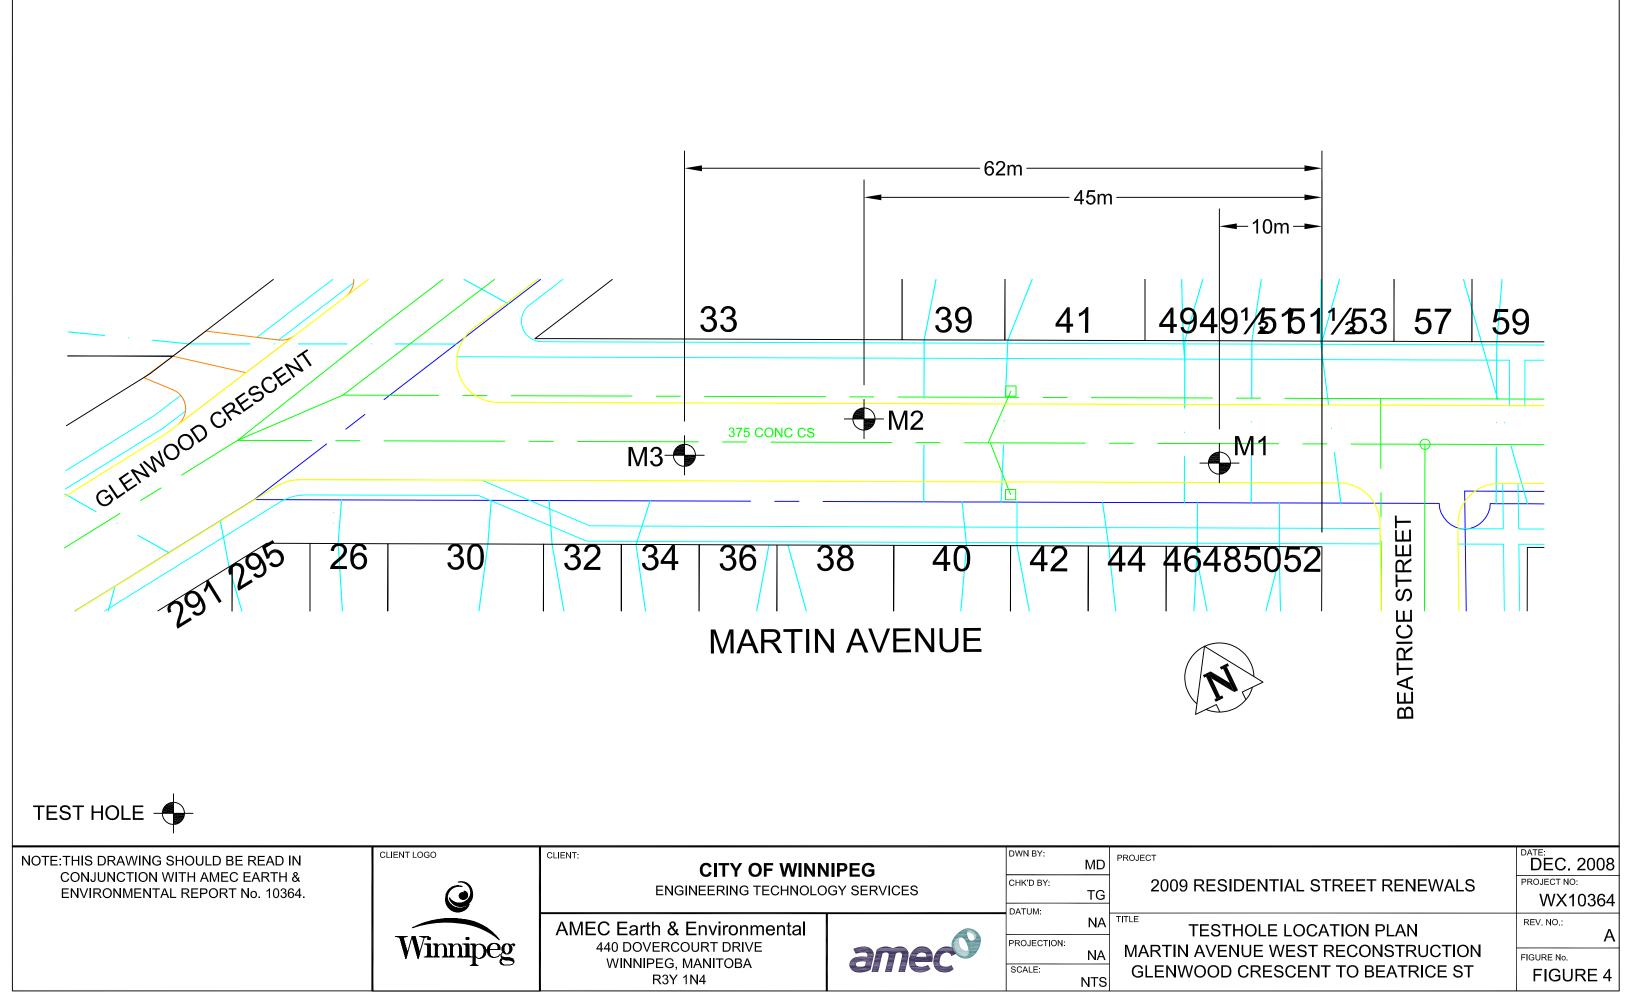
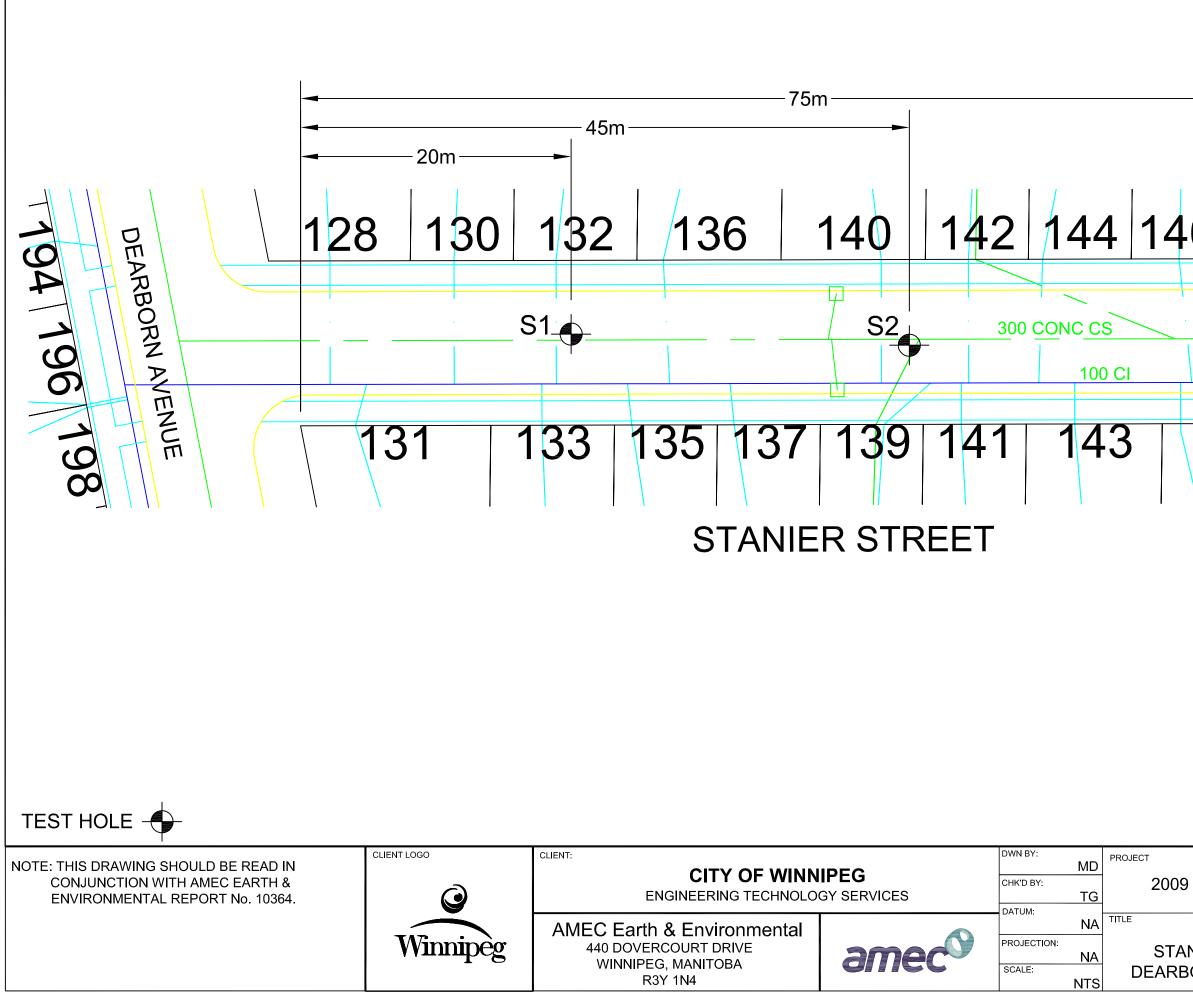
FIGURES 1 to 5

On 1 and 2 December 2008, a total of twenty one (21) test holes were drilled on the streets noted, using a truck mounted Acker MP5T drill rig operated by Paddock Drilling Ltd. of Winnipeg, and equipped with 125 mm continuous flight solid stem augers. The test hole locations are shown on Figures 1 to 5.

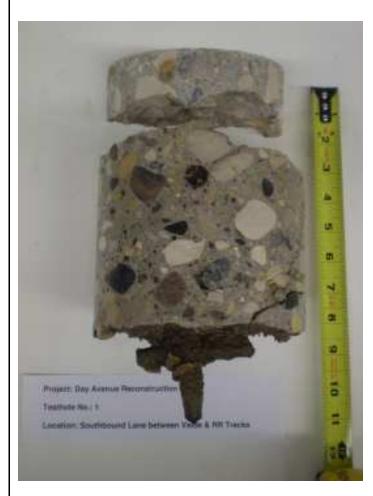
Photo 1: Testhole D1: Southbound Lane between Valde & RR Tracks

Asphalt pavement was present at the surface at test hole D3 only and was 67 mm thick. Below the asphalt, and at the surface at the remaining test holes, concrete pavement was observed and varied from 137 to 178 mm thick.

Granular fill was present below the concrete pavement at every test hole (D1 to D4) and was about 130 to 280 mm thick. The gravel consisted of 20 mm granular fill and was frozen, sandy, poorly graded and moist.

A 305 mm thick layer of clay fill was present below the gravel fill in test holes D1 and D2 and was generally silty, medium to high plastic, moist, stiff to very stiff and contained trace amounts of sand.
