GEOTECHNICAL INVESTIGATION FOR BUS RAPID TRANSIT SYSTEM SOUTHWESTERN TRANSIT CORRIDOR

Prepared for
DILLON CONSULTING LTD.
SUITE 200, 895 WAVERLEY STREET
WINNIPEG, MANITOBA
R3T 5P4

Prepared by
THE NATIONAL TESTING LABORATORIES LIMITED
199 HENLOW BAY
WINNIPEG, MANITOBA
R3Y 1G4

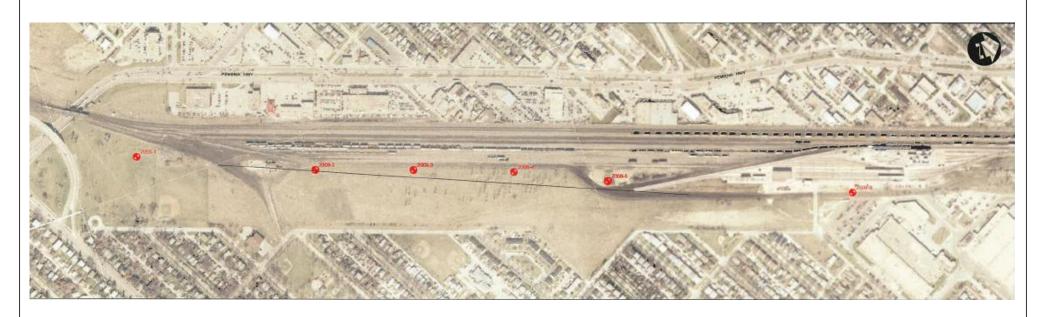
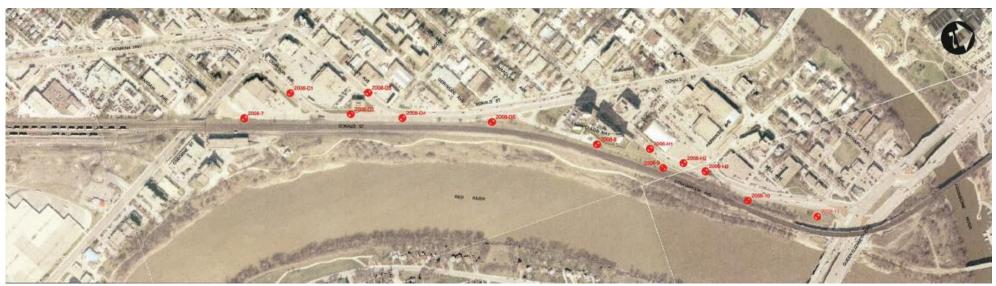
Project No.:DIL-812	Drawn by: KK	Figure: 1
		İ

Testhole Location Plan
Bus Rapid Transit System
Southwestern Transit Corridor
Winnipeg, MB

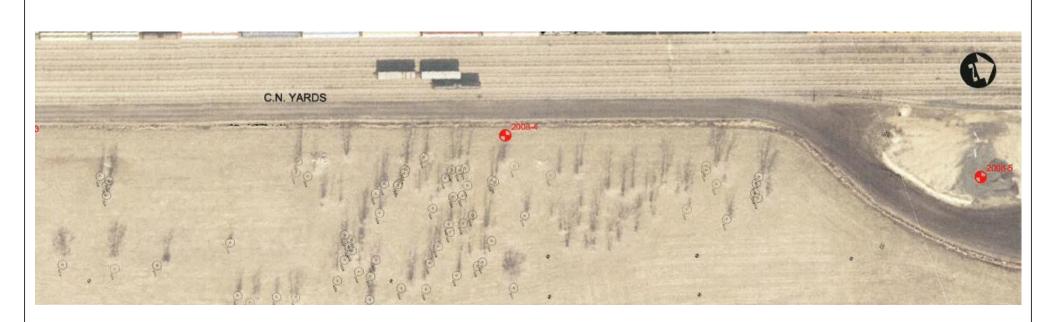
Project No.:DIL-812 Drawn by: KK Figure: 3

Testhole Location Plan Bus Rapid Transit System Southwestern Transit Corridor Winnipeg, MB
