**GEOTECHNICAL INVESTIGATION**  
**PORTAGE AVENUE AT TRURO CREEK REHABILITATION**

**Prepared for**  
**CITY OF WINNIPEG**  
**PUBLIC WORKS DEPARTMENT**  
**ENGINEERING DIVISION**

**August 2011**

**Project No. 113321**

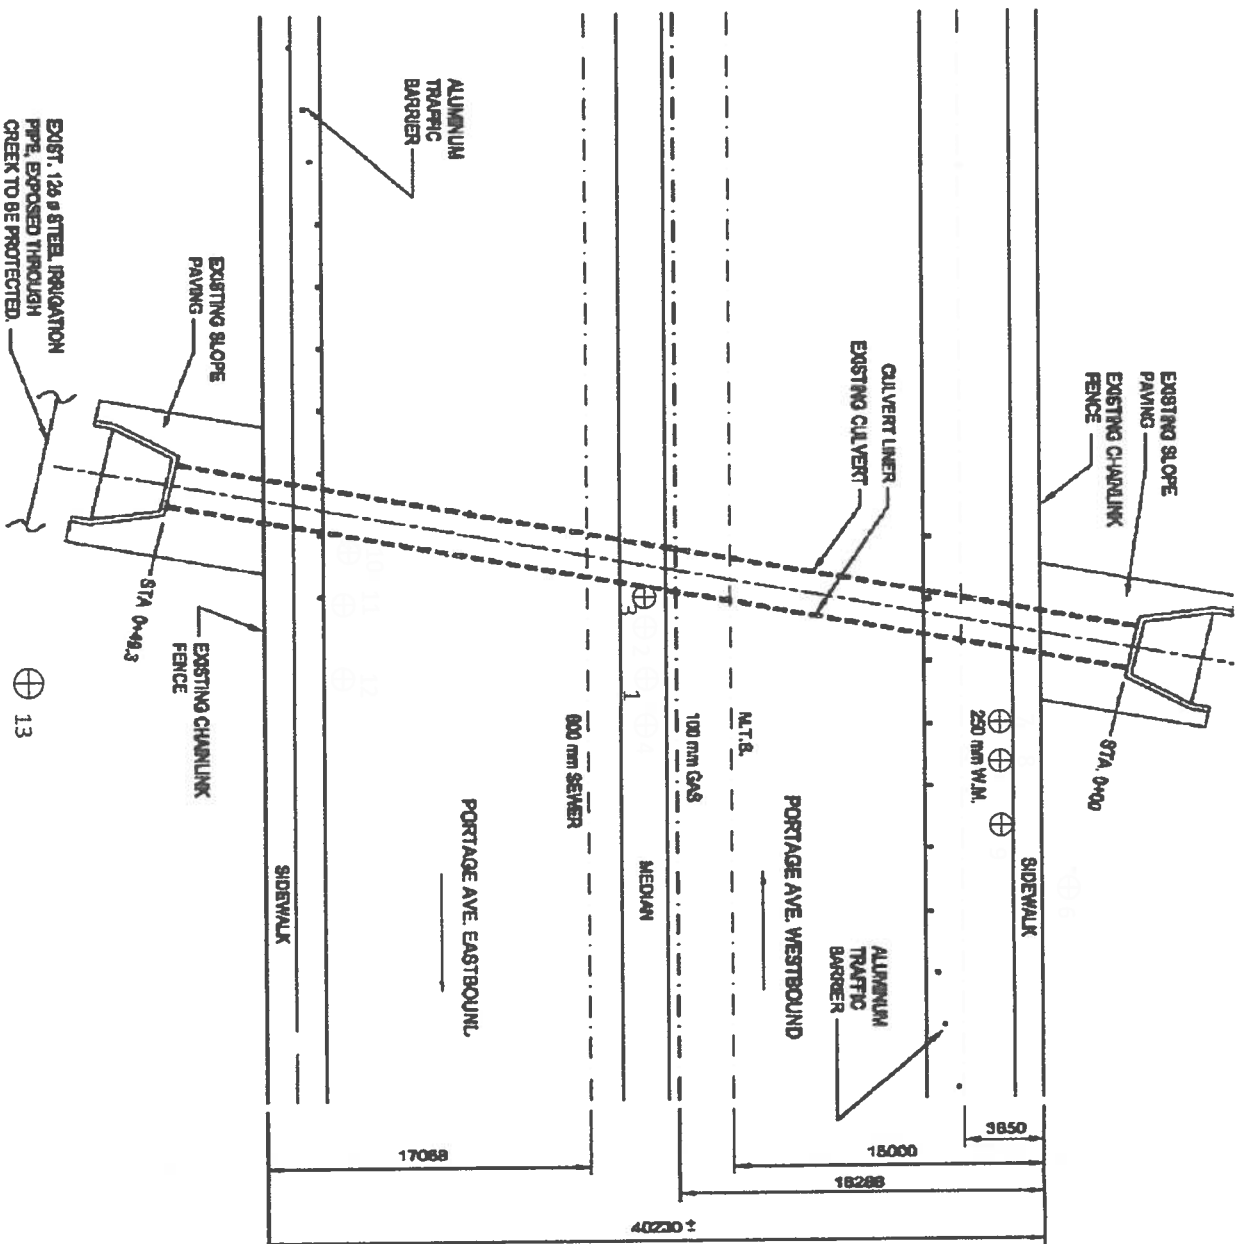
**SITE PLAN**

Test Holes 1 to 4 and 7 to 12 were drilled to evaluate the subsurface conditions for the installation of the proposed culvert. Test Holes 5 and 6 were drilled on the northeast Creek bank and Test Hole 13 on the southeast bank. Representative disturbed off auger samples were obtained at frequent depth intervals in all of the test holes and undisturbed Shelby tube samples were recovered in Test Holes 5, 11, 12 and 13. Standpipe piezometers were installed in Test Holes 5 and 13. The test holes were backfilled with auger cuttings. Where the test holes were drilled in the east curb lane, the pavement surface was patched by placing the concrete cores into the backfilled test hole and adding a layer of cold mix asphalt to the surface. The locations of the test holes are illustrated on Figure 1.

**TEST HOLE LOCATION**

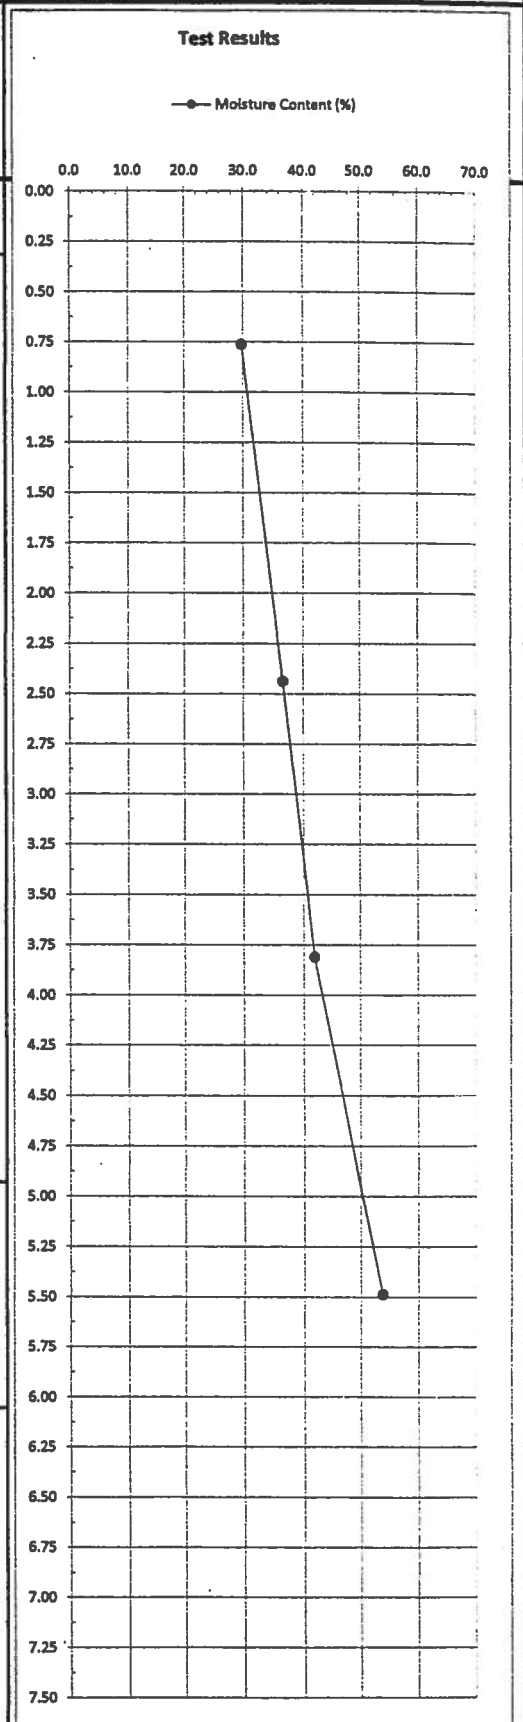
Figure No.: 4

<b>DYREGROV ROBINSON INC.</b> CONSULTING GEOTECHNICAL ENGINEERS		PROJECT # 113321	TEST HOLE NO. 4
PROJECT: City of Winnipeg		LOGGED BY: RB	
LOCATION: Medlan, 5.8 m East of Culvert		REVIEWED BY: AOD	
CONTRACTOR: Paddock Drilling Ltd.		DRILL DATE: May 5, 2011	
METHOD: Mobile S-61, 125 mm Solid Stem Auger		DRILL DEPTH (m): 2.3

DEPTH (m)	ELEVATION (m)	SOIL SYMBOL	SOIL DESCRIPTION	COMMENTS
0.00	232.40	[Symbol]	0 - 0.3 m GRANULAR BASE	
0.25	232.15		0.3 - 2.3 m CLAY (Fill) - silty - some sand, some gravel - trace organics - dark grey to black - firm to stiff, moist, intermediate plasticity	
0.50	231.90	[Symbol]		
0.75	231.65			
1.00	231.40			
1.25	231.15			
1.50	230.90			
1.75	230.65			
2.00	230.40			
2.25	230.15			- cobbles/boulders below 2.1 m
2.50	229.90			2.3 m END OF TEST HOLE AT REFUSAL AT 2.3 m IN CLAY FILL
2.75	229.65			Notes: 1. Test hole backfilled with auger cuttings.
3.00	229.40			
3.25	229.15			
3.50	228.90			
3.75	228.65			
4.00	228.40			
4.25	228.15			
4.50	227.90			
4.75	227.65			
5.00	227.40			
5.25	227.15			
5.50	226.90			
5.75	226.65			
6.00	226.40			
6.25	226.15			
6.50	225.90			
6.75	225.65			
7.00	225.40			
7.25	225.15			
7.50	224.90

It should be noted that the 125 mm auger met refusal in Test Hole 4 at a depth of 2.3 metres (elevation 230.1 metres) and in Test Hole 7 at a depth of 3.4 metres (elevation 228.7 metres). In Test Hole 3, some timber was encountered at a depth of 4.8 metres (elevation 227.6 metres). The test hole

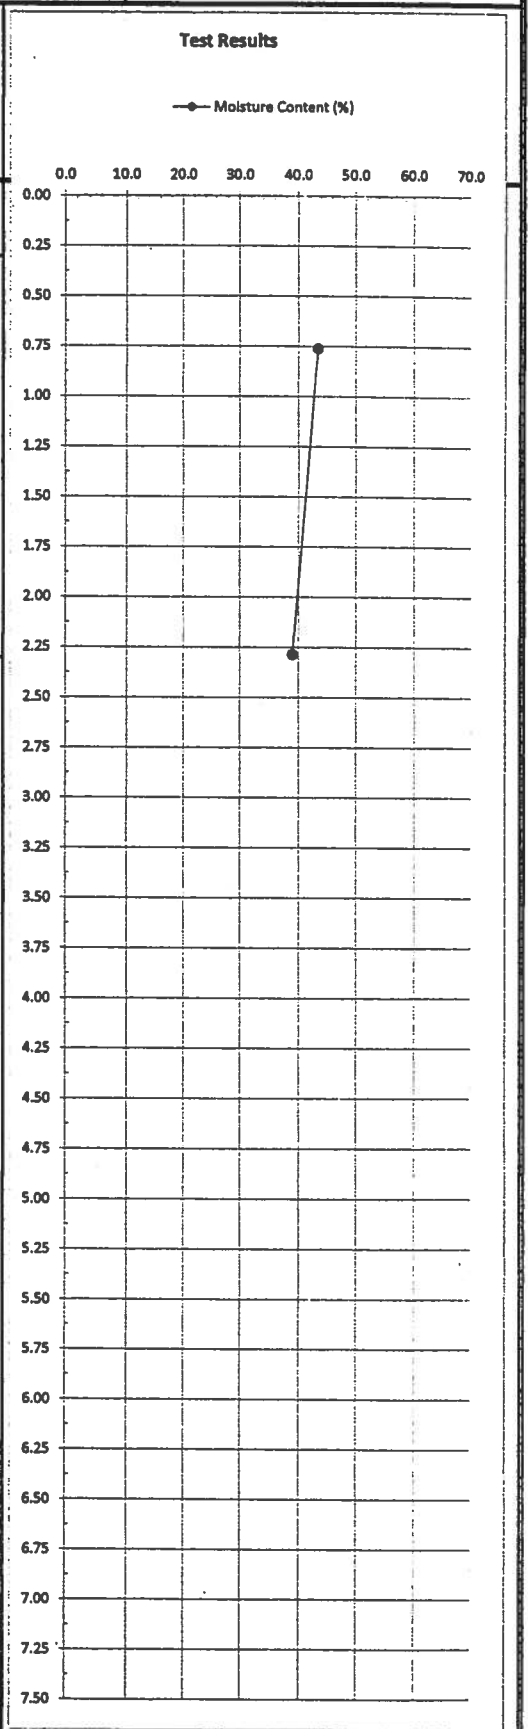
Figure No.: 5

PROJECT: City of Winnipeg  
LOCATION: Inlet, Toe of Creek Bank, 8.5 m North and 7.3 m East of East Wing Wall Edge  
CONTRACTOR: Paddock Drilling Ltd.  
METHOD: Mobile S-61, 125 mm Solid Stem Auger

1.00	229.40		- firm, moist, intermediate plasticity			
1.50	228.90		- some organics, organic odor below 1.5 m			
2.00	228.40					
2.50	227.90		2.4 - 7.0 m CLAY - silty - trace sand, trace silt inclusions (< 10 mm dia.) - trace gravel

3.00	227.40		- mottled brown and grey - firm, moist, high plasticity		Qu = 26.9 kPa TV = 41.7 kPa PP = 43.5 kPa γbulk = 16.9 kN/m <sup>3</sup>	
3.50	226.90

6.50	223.90					
7.00	223.40		7.0 - 9.1 m SILT (Till) - trace clay, some sand, some gravel - light grey - loose, wet, low plasticity			
7.50	222.90					
8.00	222.40

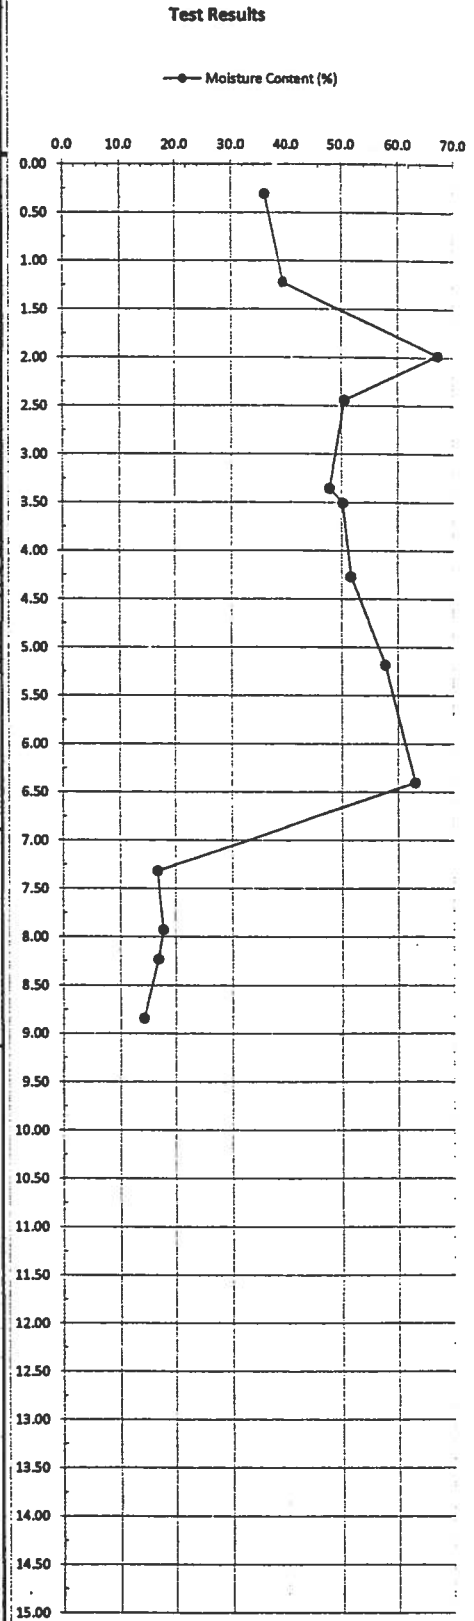
<b>DYREGROV ROBINSON INC.</b> CONSULTING GEOTECHNICAL ENGINEERS		<b>PROJECT #</b> 113321	<b>TEST HOLE NO.</b> 6
<b>PROJECT:</b> City of Winnipeg		<b>LOGGED BY:</b> RB	
<b>LOCATION:</b> Inlet, Crest of Creek Bank, 1.5 m North and 8.0 m East of Fence		<b>VIEWED BY:</b> AOD	
<b>CONTRACTOR:</b> Paddock Drilling Ltd.		<b>DRILL DATE:</b> May 5, 2011	
<b>METHOD:</b> Mobile S-61, 125 mm Solid Stem Auger		<b>DRILL DEPTH (m):</b> 10.7

DEPTH (m)	ELEVATION (m)	SOIL SYMBOL	SOIL DESCRIPTION	COMMENTS
0.00	231.80	SS	0 - 0.15 m TOPSOIL	
0.50	231.30	[Diagonal hatching symbol]	0.15 - 0.8 m SILT (Fill) - clayey - trace sand, trace gravel, trace organics - Dark brown and black - stiff, moist, intermediate plasticity

1.00	230.80			
1.50	230.30			
2.00	229.80	[Horizontal hatching symbol]	0.8 - 3.4 m SILT - clayey - trace sand, trace gravel - grey - firm to stiff, moist, intermediate plasticity - sand seam at 2.0 m (< 3 mm thick) - firm below 2.5 m

2.50	229.30			
3.00	228.80			
3.50	228.30			
4.00	227.80			
4.50	227.30	[Cross-hatching symbol]	3.4 - 8.5 m CLAY - silty - mottled brown and grey - firm to stiff, moist, high plasticity  - trace gravel, trace silt inclusions (< 3 mm dia.),  - grey, soft below 5.5 m

7.50	224.30			
8.00	223.80	[Vertical hatching symbol]	8.5 - 10.7 m SILT (Till) - trace clay, some sand, some gravel - light grey - loose, wet, low plasticity

8.50	223.30			
9.00	222.80			
9.50	222.30	[Vertical hatching symbol]	10.7 m END OF TEST HOLE AT 10.7 m IN SILT TILL Notes: 1. Seepage below 8.5 m in silt till layer. 2. Squeezing below 8.5 m in silt till layer. 3. Test hole backfilled with auger cuttings.

Below the silty clay is a silt till deposit. It is known to contain a heterogeneous mixture of sand, gravel, cobble and boulder-size materials in a silt and clay matrix. The cobble/boulder sized materials were not recovered from the test holes. The till is loose in consistency having moisture contents in excess of 12 percent. It is visually described as loose to wet. Seepage at the surface of the till was noted in Test Hole 6 and “squeezing” of the test hole in Test Hole 5.

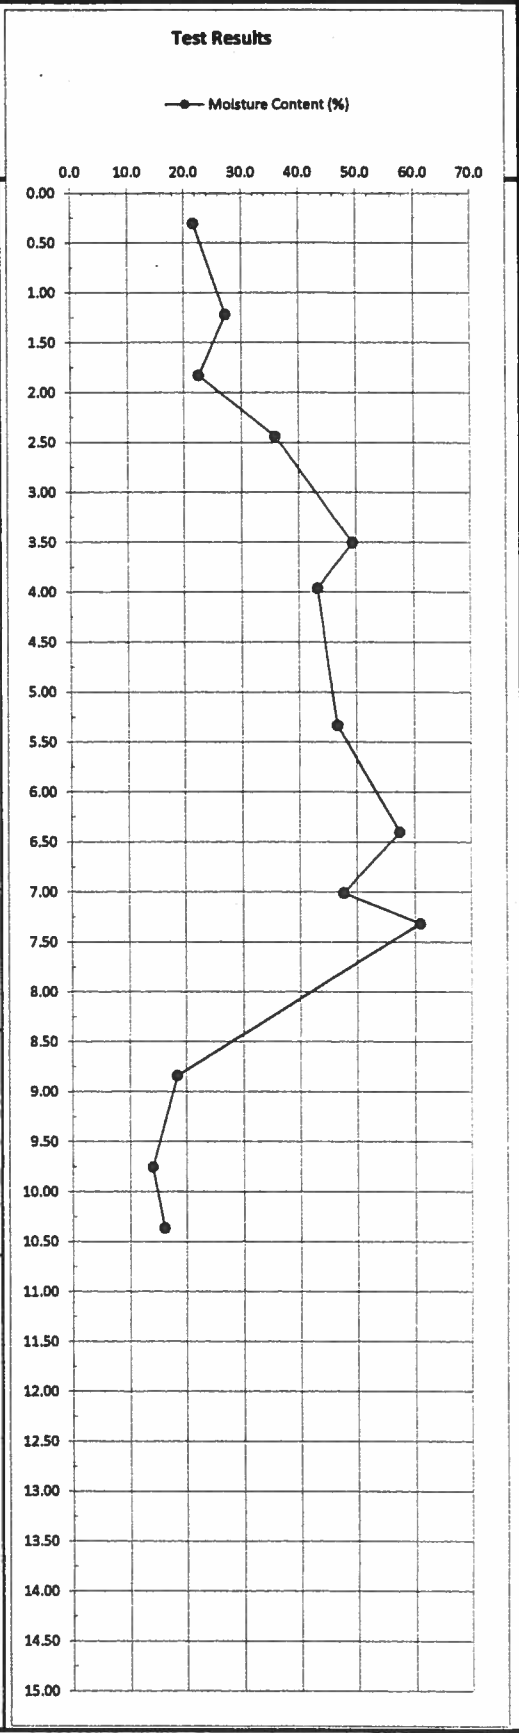
Figure No.: 7

<b>DYREGROV ROBINSON INC.</b> CONSULTING GEOTECHNICAL ENGINEERS	<b>PROJECT #</b> 113321	<b>TEST HOLE NO.</b> 7
<b>PROJECT:</b> City of Winnipeg		<b>LOGGED BY:</b> RB
<b>LOCATION:</b> Westbound Portage Ave. Boulevard, 3.4 m north of curb, 3.5 m East of Culvert		<b>REVIEWED BY:</b> AOD
<b>CONTRACTOR:</b> Paddock Drilling Ltd.		<b>DRILL DATE:</b> May 5, 2011
<b>METHOD:</b> Mobile S-61, 125 mm Solid Stem Auger		<b>DRILL DEPTH (m):</b> 3.4

DEPTH (m)	ELEVATION (m)	SOIL SYMBOL	SOIL DESCRIPTION	COMMENTS
0.00	232.10	/ / / / / / / / / / / / / /	0 - 3.4 m SILT (Fill) - sandy, some gravel - trace organics - dark brown to black - stiff, moist, low Plasticity  - cobbles/boulders below 0.6 m	
0.25	231.85			
0.50	231.60			
0.75	231.35			
1.00	231.10			
1.25	230.85			
1.50	230.60			
1.75	230.35			
2.00	230.10			
2.25	229.85			
2.50	229.60			
2.75	229.35			
3.00	229.10			
3.25	228.85		3.4 m	END OF TEST HOLE AT REFUSAL at 3.4 m IN SILT FILL Notes: 1. Test hole backfilled with auger cuttings.
3.50	228.60			
3.75	228.35			
4.00	228.10			
4.25	227.85			
4.50	227.60			
4.75	227.35			
5.00	227.10			
5.25	226.85			
5.50	226.60			
5.75	226.35			
6.00	226.10			
6.25	225.85			
6.50	225.60			
6.75	225.35			
7.00	225.10			
7.25	224.85			
7.50	224.60

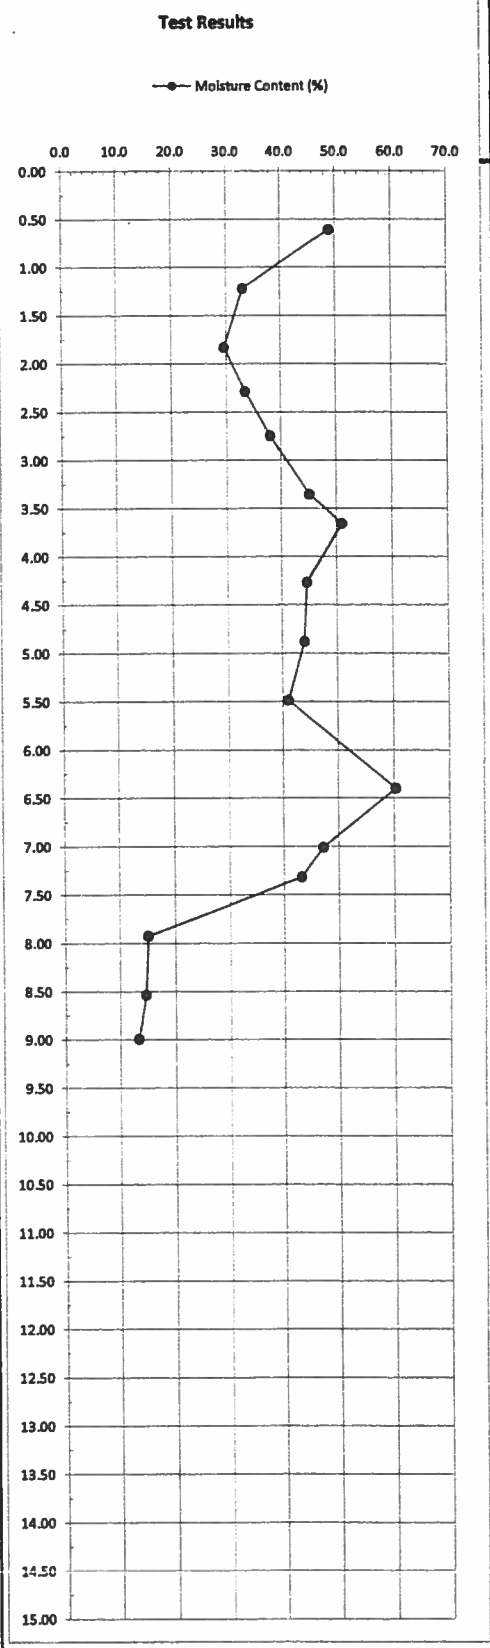
Figure No.: 14

1.00	229.60	[Symbol]	1.1 - 2.3 m SILT - clayey - trace sand - brown - soft to firm, moist, low plasticity	[Symbol]	
1.50	229.10				
2.00	228.60	[Symbol]	2.3 - 7.6 m CLAY - silty - trace sand, trace gravel - trace silt inclusions (< 3 mm dia.) - mottled brown and grey - firm to stiff, moist, high plasticity	[Symbol]	Qu = 32.3 kPa TV = 87.0 kPa PP = 83.4 kPa γbulk = 17.3 kN/m <sup>3</sup>

7.50	223.10	- some silt till inclusions (<25 mm dia.) below 7.0 m			
8.00	222.60	[Symbol]	7.6 - 9.1 m SILT (Till) - trace clay, some sand, some gravel - light grey - loose, wet, low plasticity	[Symbol]

Standpipe piezometers installed in Test Holes 5 and 13 had water elevations of 226.9 and 229.2 metres, respectively, 12 and 11 days after installation.

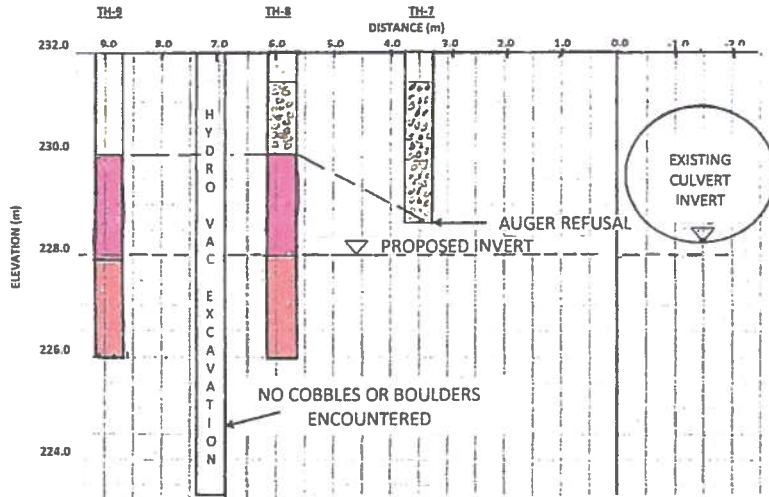
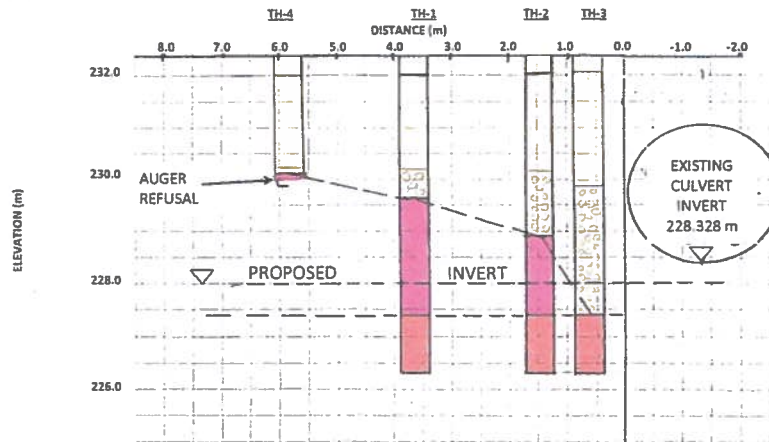
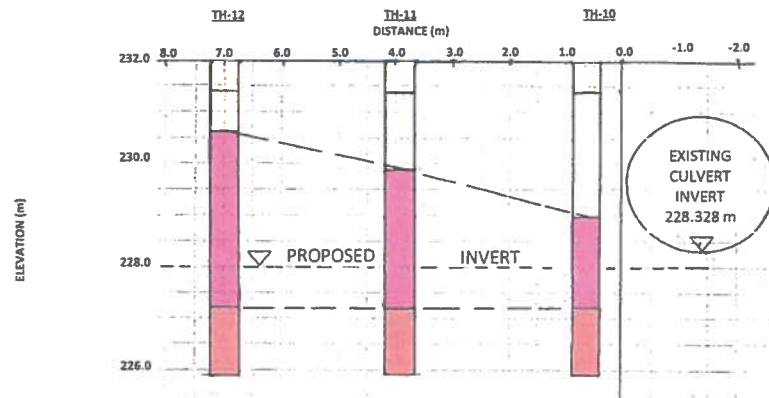
FIGURE 15

The soil profile identified at the north, median and south test hole locations for the culvert alignment are illustrated on Figure 15. The soil profile includes variable thicknesses of fill, silt and clay.

The fill is a medium plastic clayey silt which contains some sand, some gravel with traces of organics and at some locations cobbles/boulders were also encountered. The fill is generally identified as firm to stiff in consistency and is of intermediate plasticity. It ranges in thickness from 1.3 metres at Test Hole 12 to 5.0 metres at Test Hole 3. It is deepest in the test holes which are closest to the existing culvert. Cobbles/boulders were noted below a depth of 2.1 metres in Test Holes 1 to 4 driven through the median section and below 0.6 metres in Test Holes 7 and 8 in the north section. No cobbles/boulders were noted in the south section, Test Holes 10, 11 and 12. The size of the cobbles/boulders could not be identified due to the small diameter test holes (125 mm) which were drilled.

Beneath the fill is a sandy or clayey silt which is firm to stiff in consistency. It varies from low to intermediate plasticity as indicated by the classification tests on samples from Test Holes 1, 8, 9 and 11. The Liquidity Indices were similar in Test Holes 1 and 8, being 0.82 and 0.95 and in Test Holes 9 and 11, 0.38 and 0.53 range. Beneath the sandy silt was a firm to stiff highly plastic silty clay at elevation 228.00 metres on the north section (Test Holes 8 and 9) and the south section (Test Holes 10, 11 and 12) and at the median section, the silty clay was a metre lower at elevation 227.00 metres (Test Holes 1 and 2).

**NORTH SOIL PROFILE**

**MEDIAN SOIL PROFILE**

**SOUTH SOIL PROFILE**

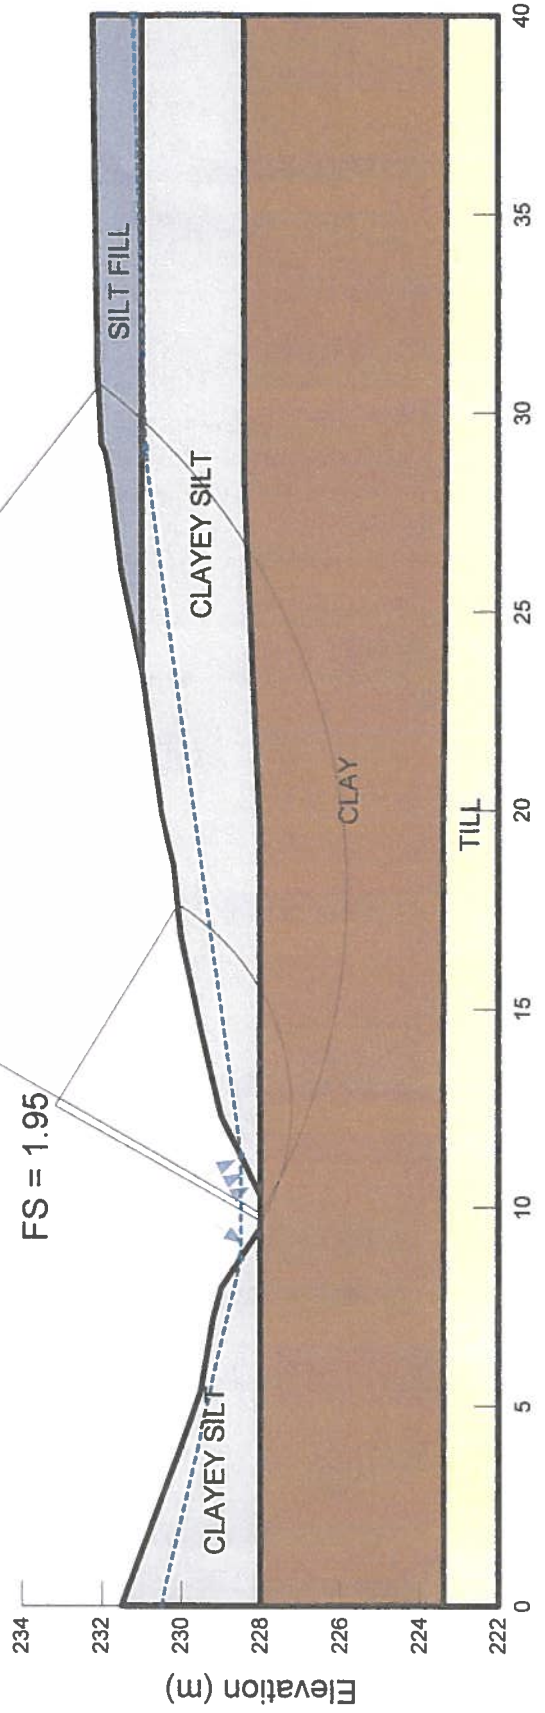
**FIGURE 18**

**Groundwater Conditions: 1 m below Ground Surface**

FS = 1.79

FS = 1.95

The proposed construction at the inlet and outlet have to consider the stability of the Creek banks during construction and in the long term. In this regard, slope stability analyses have been conducted for the east bank both upstream and downstream of the new culvert crossing. The locations of slope profiles which were used for stability analyses are noted and a "large tree" identified which is referenced in the following discussion. The west banks of the Creek will not be affected by the proposed construction.

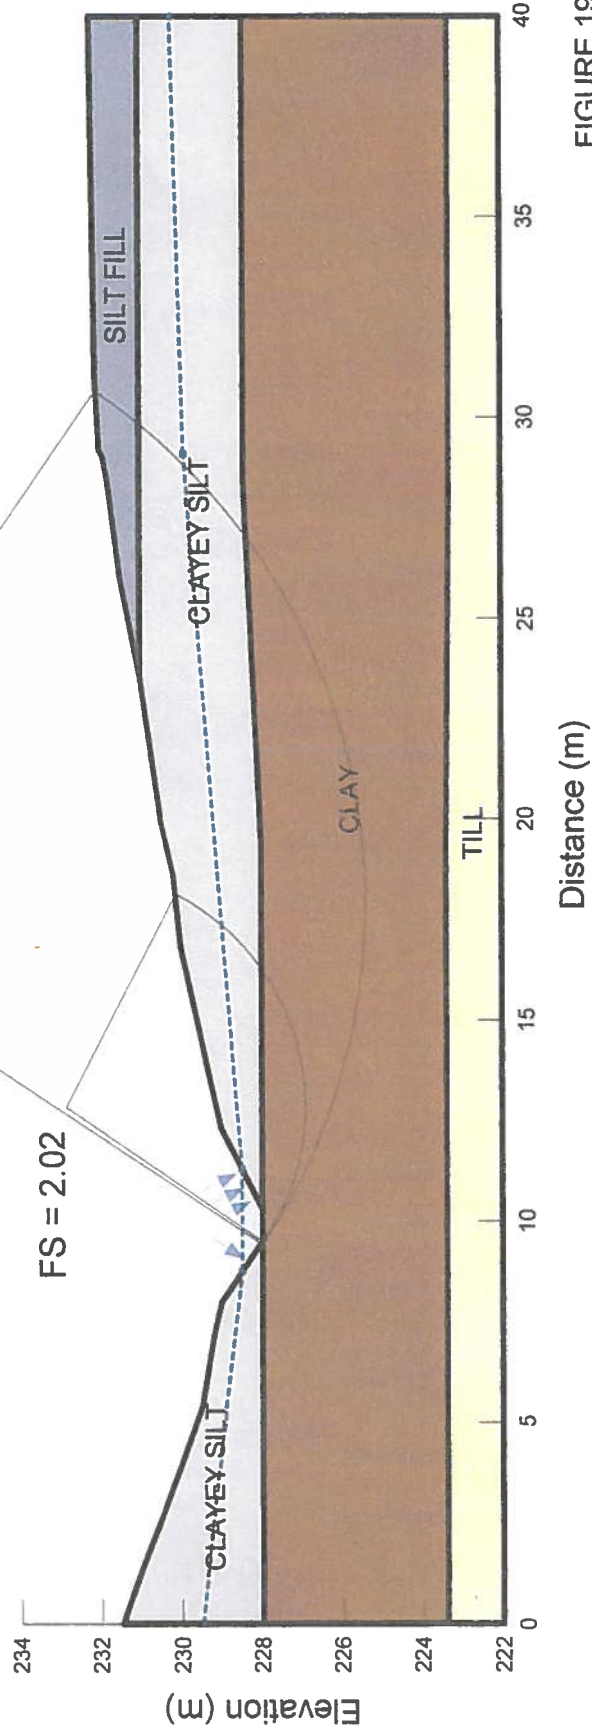
FIGURE 19

Groundwater Conditions: 2 m below Ground Surface

FS = 1.90

FS = 2.02

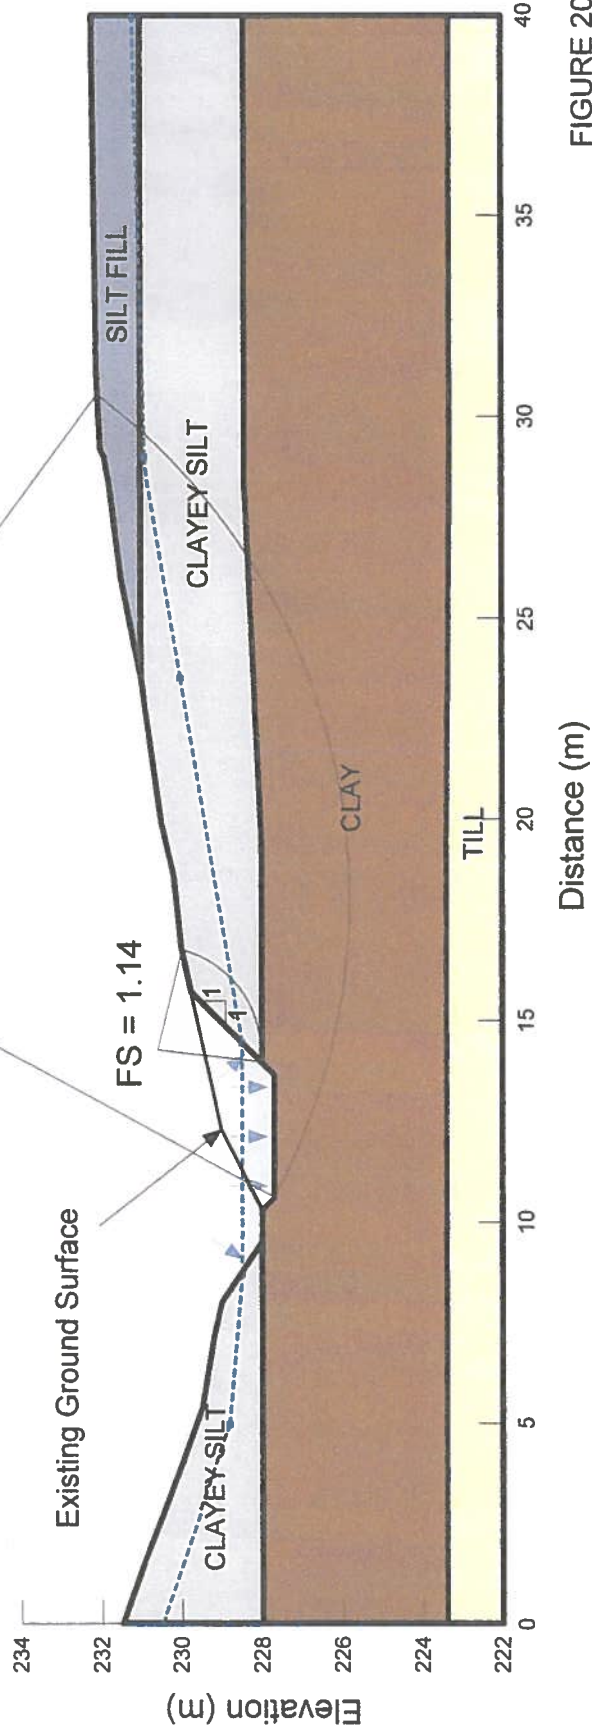
FIGURE 20

Groundwater Conditions: 1 m below Ground Surface

FS = 1.49

FS = 1.14

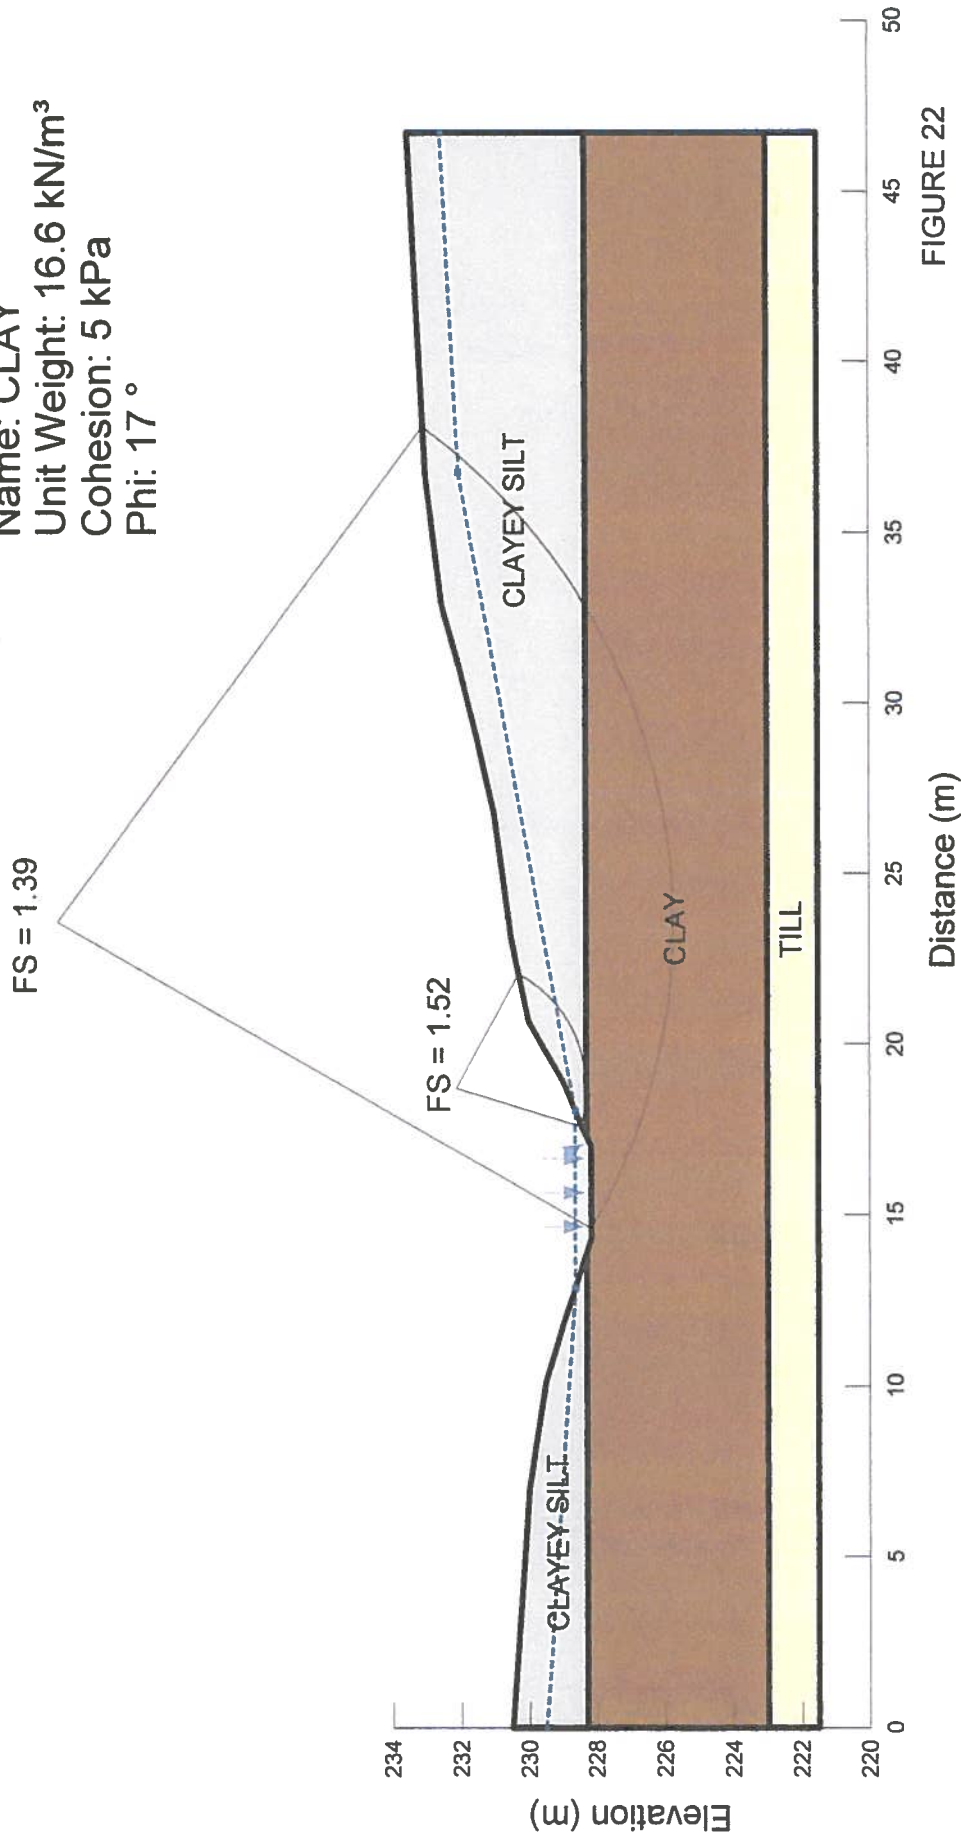
FIGURE 22

**Project:** Portage Avenue at Truro Creek Rehabilitation  
**Client:** City of Winnipeg  
**Description:** Slope Stability Analysis  
**Location:** Outlet - South of Portage Avenue  
 - 1.2 m South of East Head Wall  
**Slope Geometry:** Existing Geometry  
**Creek Water Level:** 0.5 m  
**Groundwater Conditions:** 1 m Below Ground Surface

**Name:** TILL  
**Unit Weight:** 22 kN/m<sup>3</sup>  
**Cohesion:** 0 kPa  
**Phi:** 30 °

**Name:** CLAYEY SILT  
**Unit Weight:** 18 kN/m<sup>3</sup>  
**Cohesion:** 3 kPa  
**Phi:** 19 °

**Name:** CLAY  
**Unit Weight:** 16.6 kN/m<sup>3</sup>  
**Cohesion:** 5 kPa  
**Phi:** 17 °

At the 6.6 metre section, where the new outlet could be located, the overall slope gradient is in the order of 5 horizontal to 1 vertical with a relatively flatter lower slope compared to other sections. The global Factor of Safety of the existing slope with high groundwater conditions is at least 1.47, Figure 25. The site conditions are such that local excavations at the lower slope would be expected to be minimal and would have no consequential impact on the global stability and only minor impact on the lower slope stability during construction.

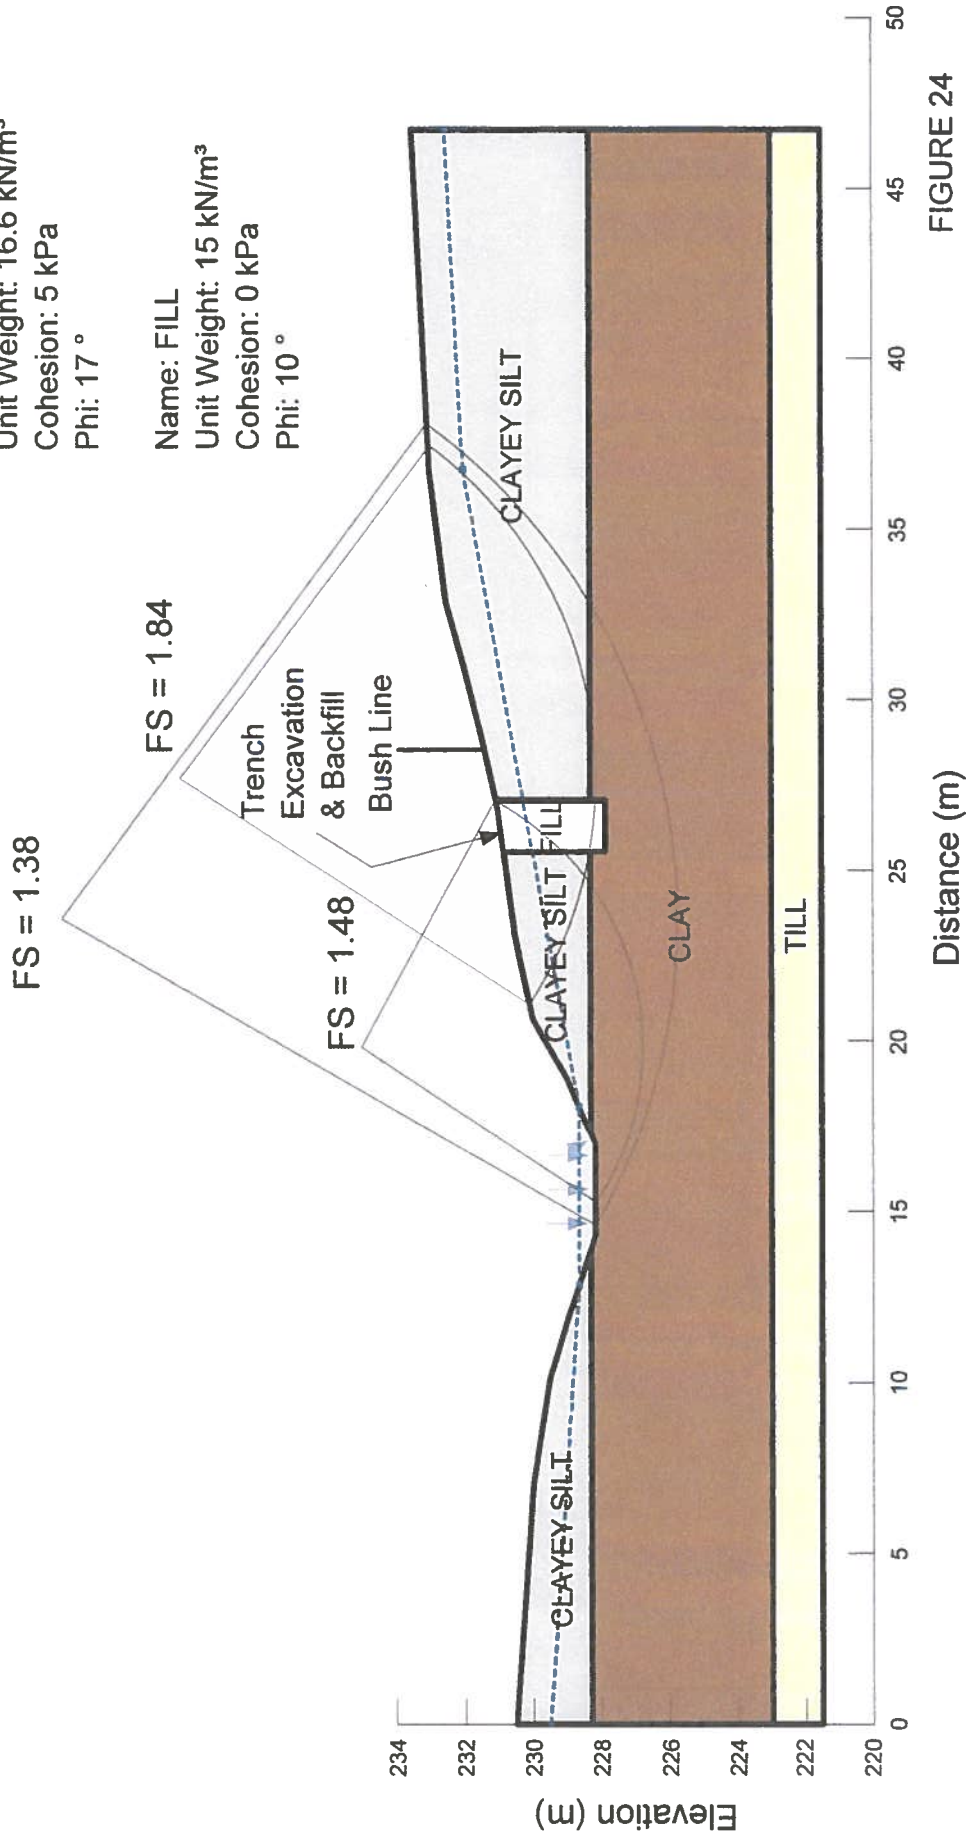
**FIGURE 24**

**Groundwater Conditions: 1 m Below Ground Surface**

**Name: CLAY**  
Unit Weight: 16.6 kN/m<sup>3</sup>  
Cohesion: 5 kPa  
Phi: 17 °

**Name: FILL**  
Unit Weight: 15 kN/m<sup>3</sup>  
Cohesion: 0 kPa  
Phi: 10 °

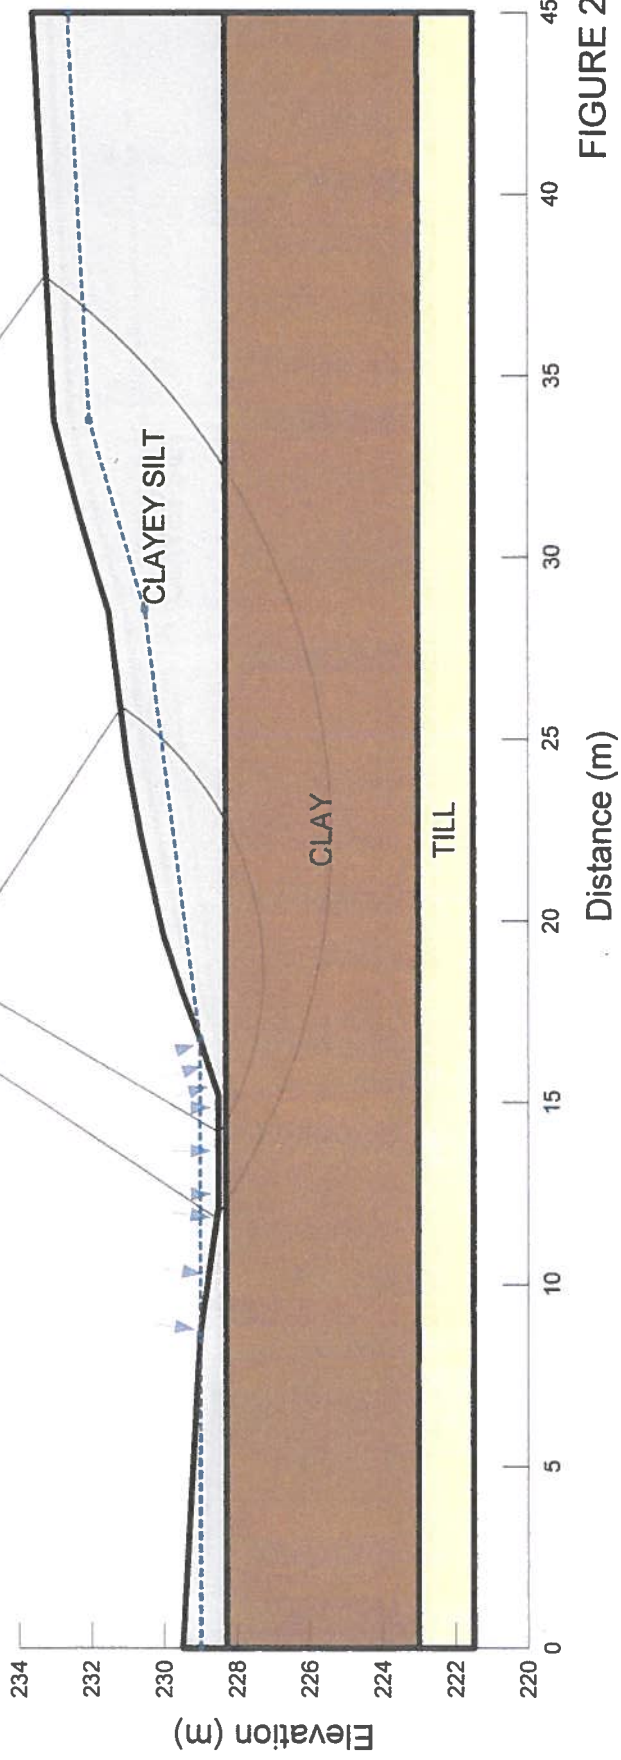
**FIGURE 25**

**Groundwater Conditions: 1 m Below Ground Surface**

**FS = 1.47**

**FS = 1.76**

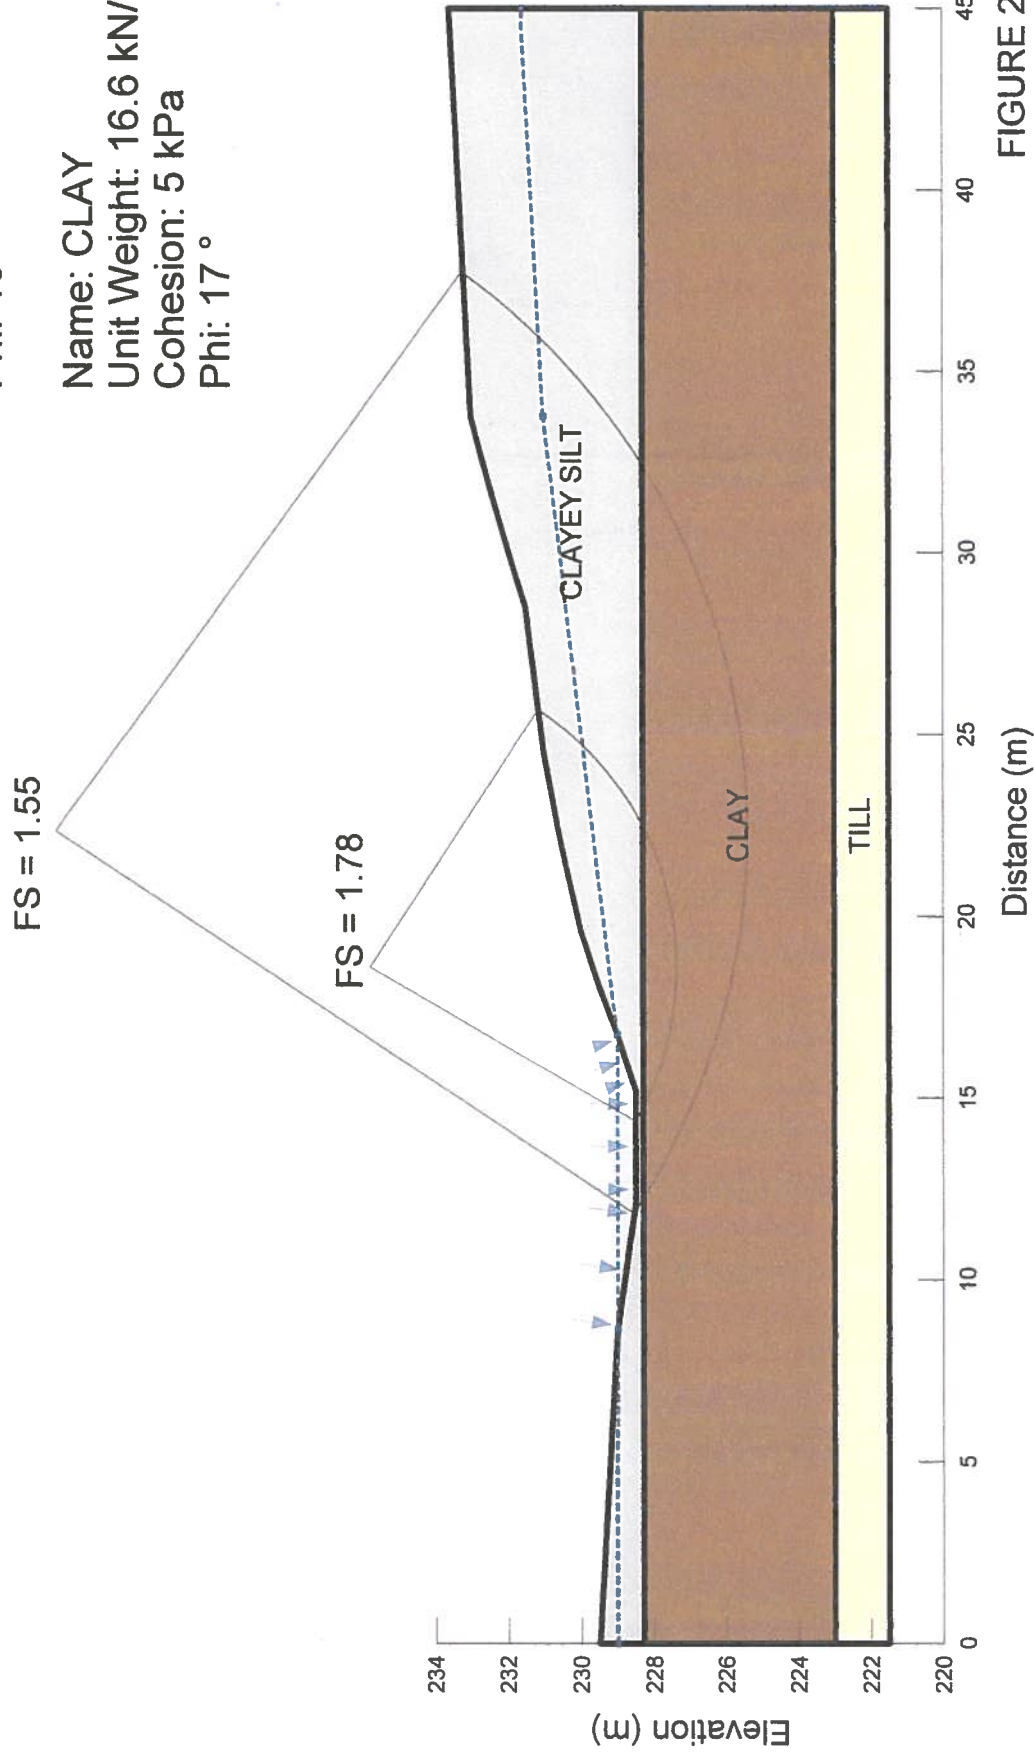
**FIGURE 26**

**Groundwater Conditions: 2 m Below Ground Surface**

**Name: CLAYEY SILT**  
**Unit Weight: 18 kN/m<sup>3</sup>**  
**Cohesion: 3 kPa**  
**Phi: 19°**

**Name: CLAY**  
**Unit Weight: 16.6 kN/m<sup>3</sup>**  
**Cohesion: 5 kPa**  
**Phi: 17°**

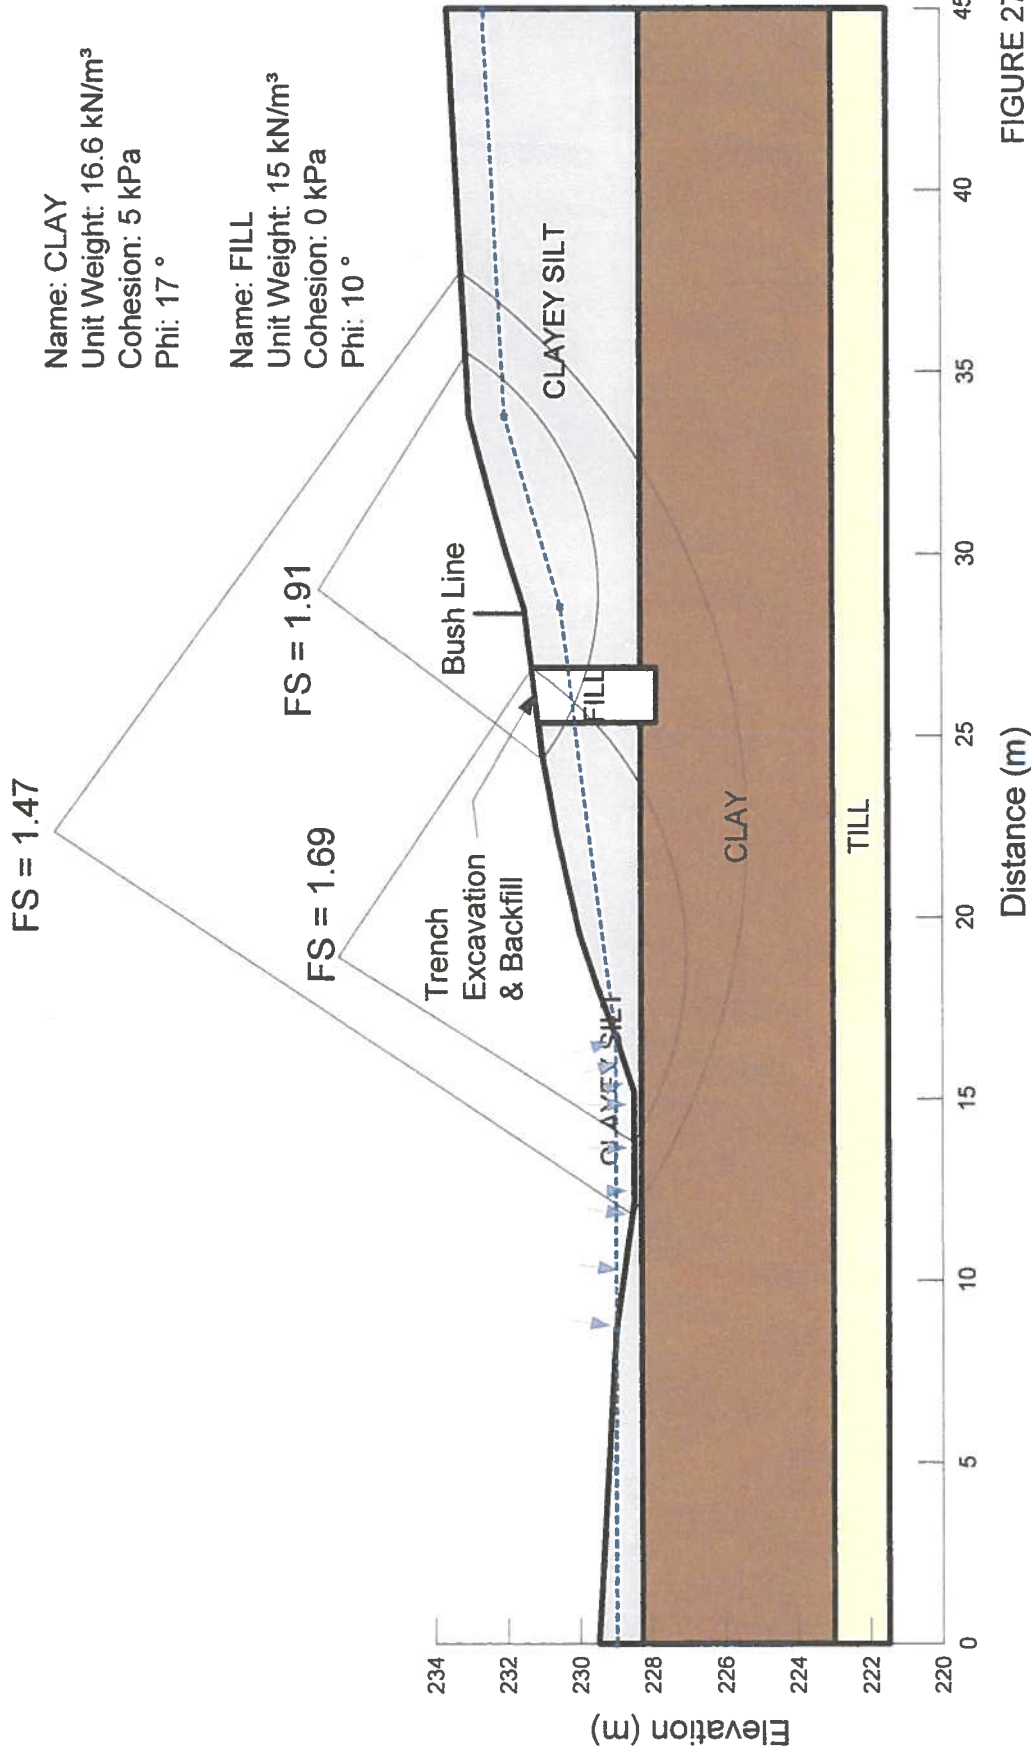
**FIGURE 27**

**Groundwater Conditions: 1 m Below Ground Surface**

Name: CLAY  
Unit Weight: 16.6 kN/m<sup>3</sup>  
Cohesion: 5 kPa  
Phi: 17 °

Name: FILL  
Unit Weight: 15 kN/m<sup>3</sup>  
Cohesion: 0 kPa  
Phi: 10 °
