**GEOTECHNICAL INVESTIGATION**  
**PORTAGE AVENUE AT TRURO CREEK REHABILITATION**

**Prepared for**  
**CITY OF WINNIPEG**  
**PUBLIC WORKS DEPARTMENT**  
**ENGINEERING DIVISION**

**August 2011**

**Project No. 113321**

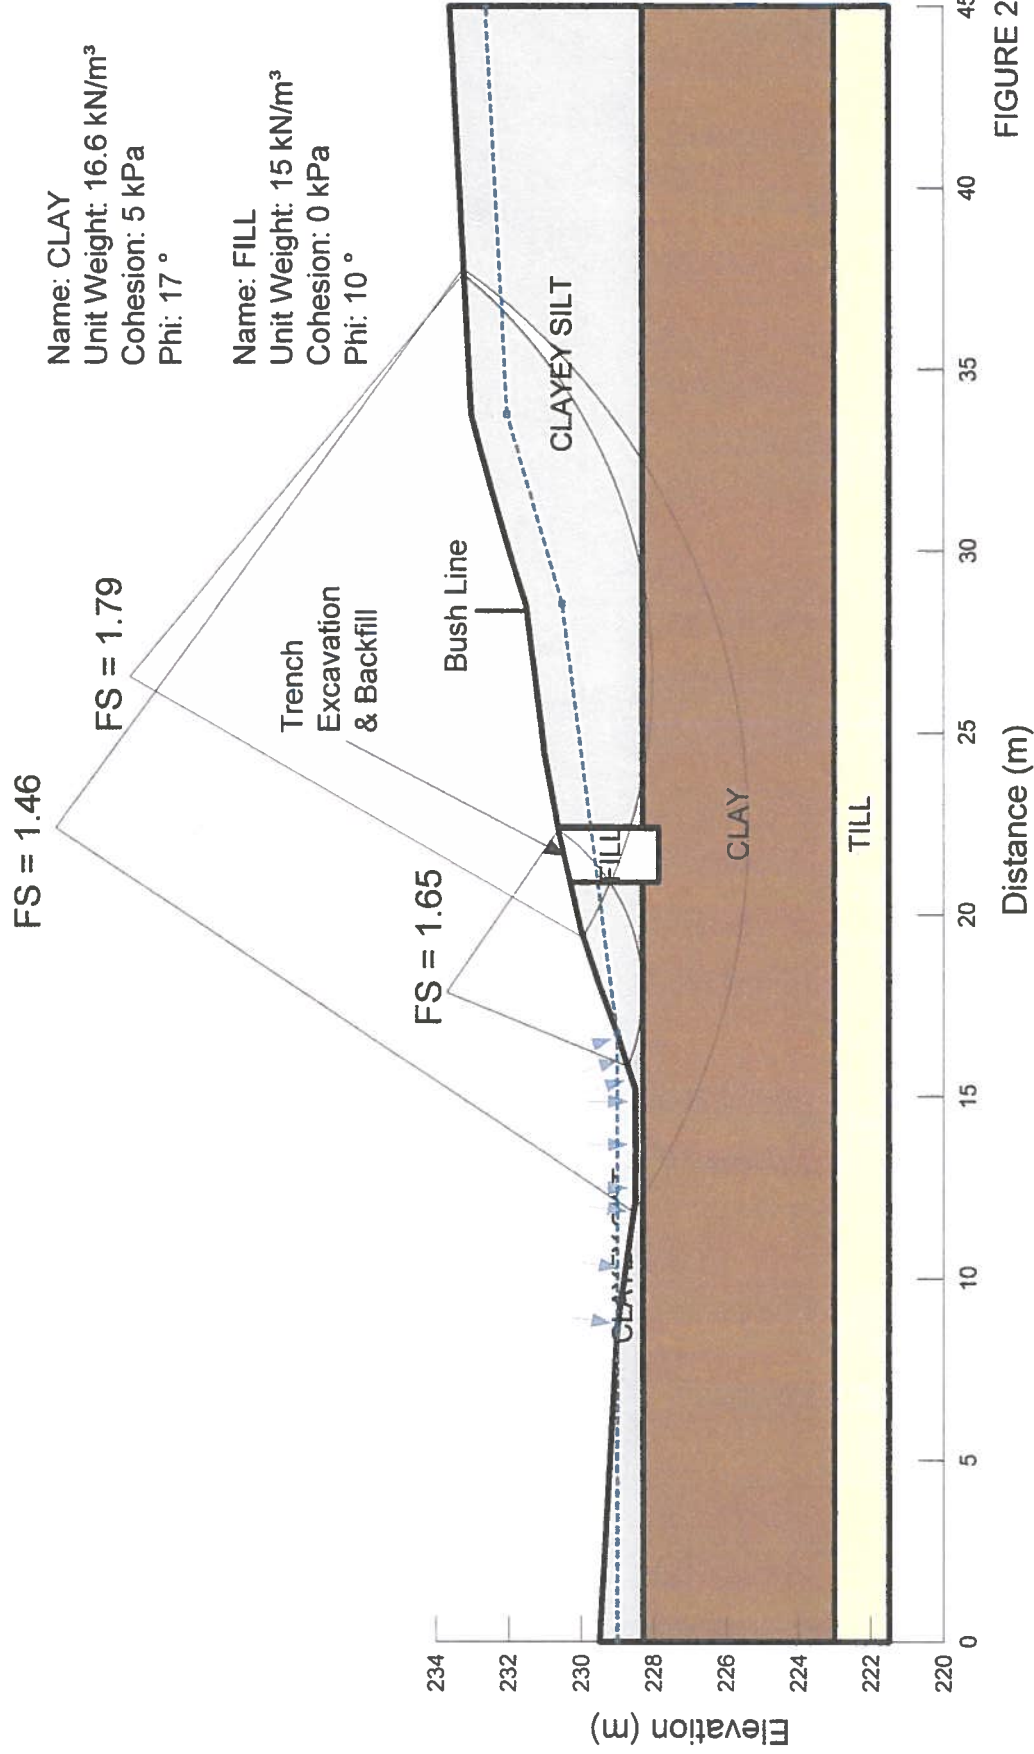
FIGURE 28

Groundwater Conditions: 1 m Below Ground Surface

Name: CLAY  
Unit Weight: 16.6 kN/m<sup>3</sup>  
Cohesion: 5 kPa  
Phi: 17 °

Name: FILL  
Unit Weight: 15 kN/m<sup>3</sup>  
Cohesion: 0 kPa  
Phi: 10 °
