Test Report

Report No.: 001-10A  
Report Date: 1.07.10  
Customer Ref.: P.O. #532097

**New Flyer Industries Xcelsior, front and rear bumper  
installation certification.**

**Romeo RIM Inc. front bumper part number A20170001AXA  
and rear bumper part number A20180001AXA.**

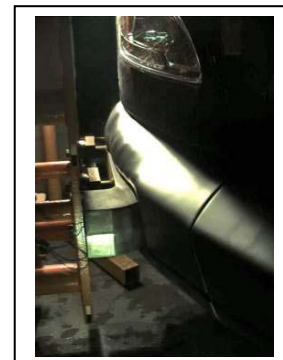
**Front bumper corner impact #1 – Impact speed of 5.4**

**5.9”      12991 lbs.    7.3      5.4 mph**  
Max. Stroke   Peak Load      Peak “G”    Impact speed

**Front bumper corner impact #2 – Impact speed of 5.6**

**6.0”      18240 lbs.    6.8      5.6 mph**  
Max. Stroke   Peak Load      Peak “G”    Impact speed

No visible body damage.

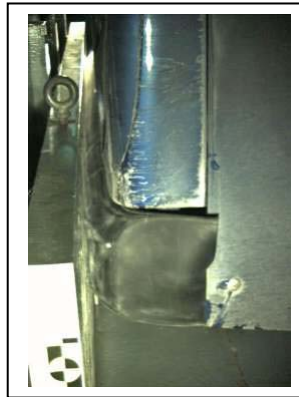
**Rear bumper barrier impact – Impact speed of 2.5mph**

<b>1.9”</b>	<b>73161 lbs.</b>	<b>2.5</b>	<b>2.5 mph</b>
Max. Stroke	Peak Load	Peak “G”	Impact speed

No visible body damage.

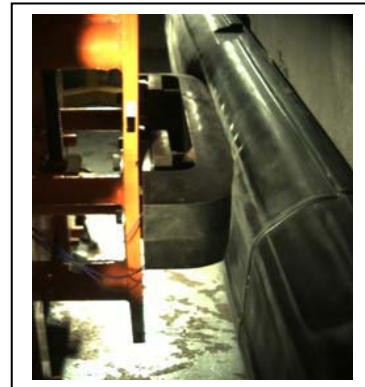
**Rear bumper center impact #2 – Impact speed of 4.2mph**

<b>2.9”</b>	<b>15281 lbs.</b>	<b>5.4</b>	<b>4.2 mph</b>
Max. Stroke	Peak Load	Peak “G”	Impact speed

No visible body damage.

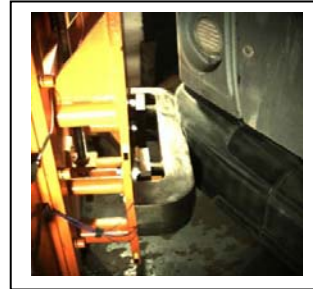
**Rear bumper corner impact #1 – Impact speed of 4.0mph**

<b>3.8"</b>	<b>10776 lbs.</b>	<b>4.1</b>	<b>4.0 mph</b>
Max. Stroke	Peak Load	Peak "G"	Impact speed

No visible body damage.

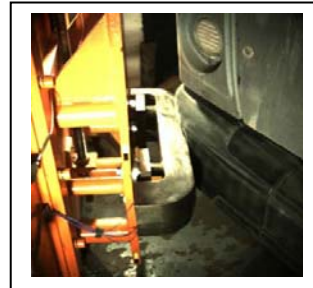
**Rear bumper corner impact #2 – Impact speed of 4.2mph**

<b>3.8"</b>	<b>12743 lbs.</b>	<b>5.1</b>	<b>4.2 mph</b>
Max. Stroke	Peak Load	Peak "G"	Impact speed

No visible body damage.

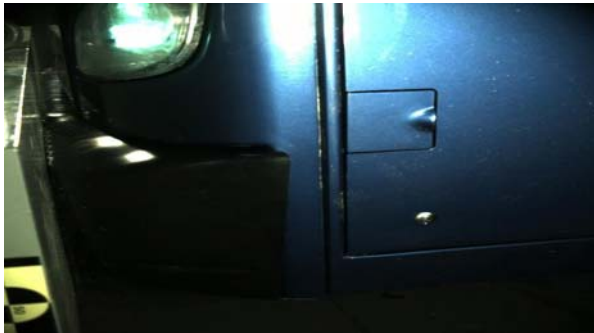
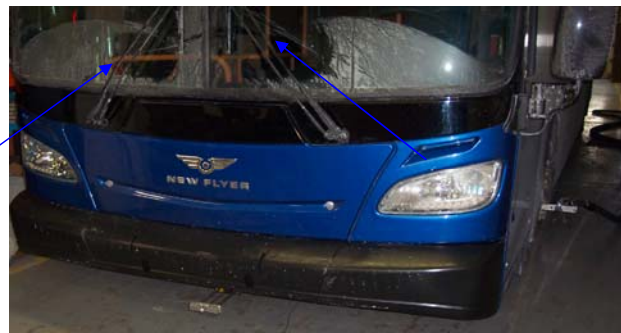
Notes/Pic's

Impact speed was adjusted to 5.2 mph to accommodate for alternate configuration weight of 31,000 pound curb weight  
Two cracks in the windshield were noted which were caused by pre-existing stone chip propagation

Two cracks propagated from existing stone chips. One on each side of the front windshield. No visible body damage.

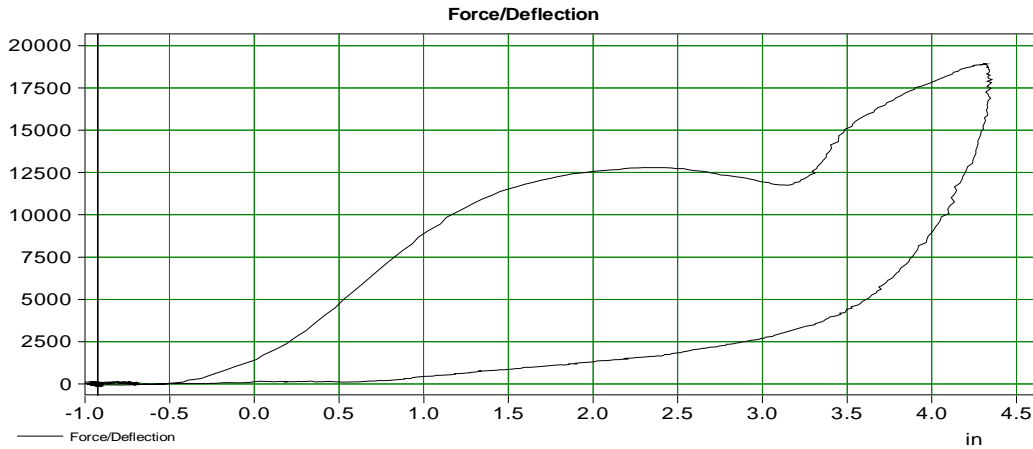
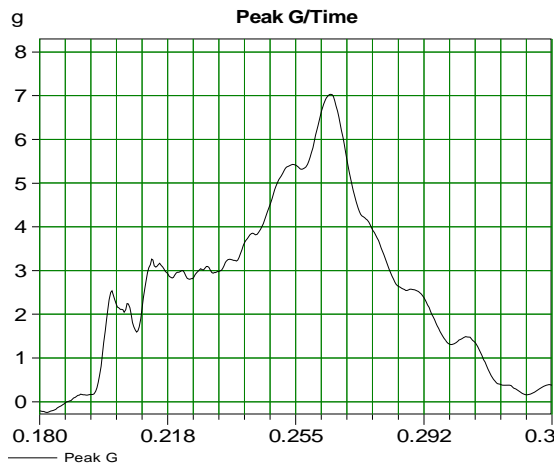
Report file number	001-10A	Date of test	12.17.09
Customer	New Flyer Industries	<b>Data</b>	
Test type	Front bumper center impact #1	Impact speed	6.5 mph
Vehicle weight (as tested)	28,350 lbs.	Load	18979 lbs.
Component description	SWEPT-BPR-FRT-101IN-NF-XCEL	System deflection	4.3"
Customer part number	340289 Rev. A	Deceleration	7.0 "g"
RRI part number	A20170001AXA	Internal data file # 17 12 2009 14 27.DDF

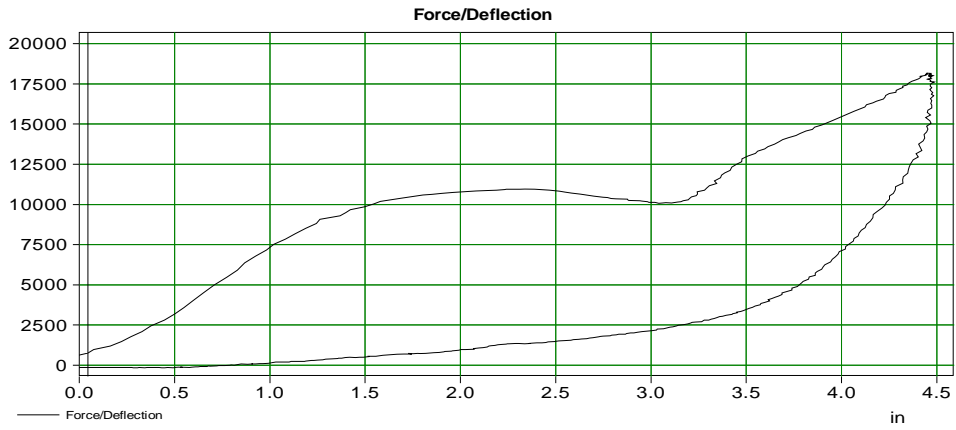
Report file number	001-10A	Date of test	12.17.09
Customer	New Flyer Industries	<b>Data</b>	
Test type	Front bumper center impact #2	Impact speed	6.4 mph
Vehicle weight (as tested)	28,350 lbs.	Load	18172 lbs.
Component description	SWEPT-BPR-FRT-101IN-NF-XCEL	System deflection	4.5"
Customer part number	340289 Rev. A	Deceleration	7.1 "g"
RRI part number	A20170001AXA	Internal data file # 17 12 2009 14 48 .DDF

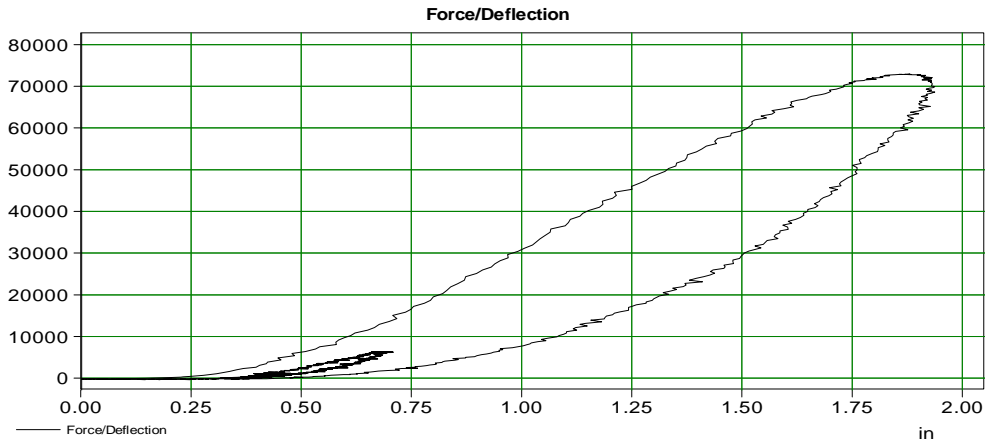
Report file number	001-10A	Date of test	12.18.09
Customer	New Flyer Industries	<b>Data</b>	
Test type	Rear bumper barrier impact	Impact speed	2.5 mph
Vehicle weight (as tested)	28,350 lbs.	Load	73161 lbs.
Component description	SWEPT-BPR-RR-101IN-NF-XCEL	System deflection	1.9"
Customer part number	345569 Rev. A	Deceleration	2.4 "g"
RRI part number	A20180001AXA	Internal data file # 18 12 2009 13 10 .DDF

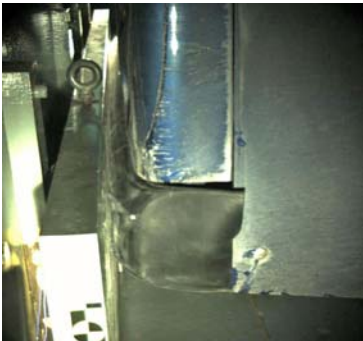
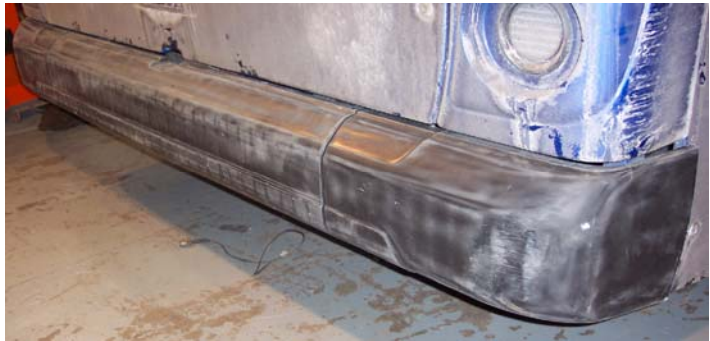
Notes/Pic's

Impact speed was adjusted to 2.5 mph to accommodate for alternate configuration weight of 31,000 pound curb weight

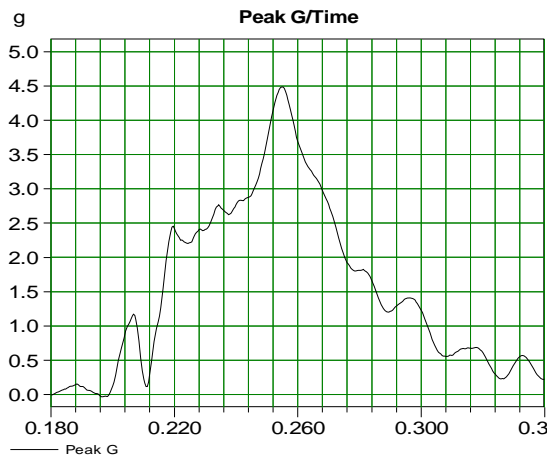
Report file number	001-10A	Date of test	12.17.09
Customer	New Flyer Industries	<b>Data</b>	
Test type	Rear bumper center impact #1	Impact speed	4.0 mph
Vehicle weight (as tested)	28,350 lbs.	Load	11710 lbs.
Component description	SWEPT-BPR-RR-101IN-NF-XCEL	System deflection	2.6"
Customer part number	345569 Rev. A	Deceleration	4.5 "g"
RRI part number	A20180001AXA	Internal data file # 18 12 2009 11 06 .DDF

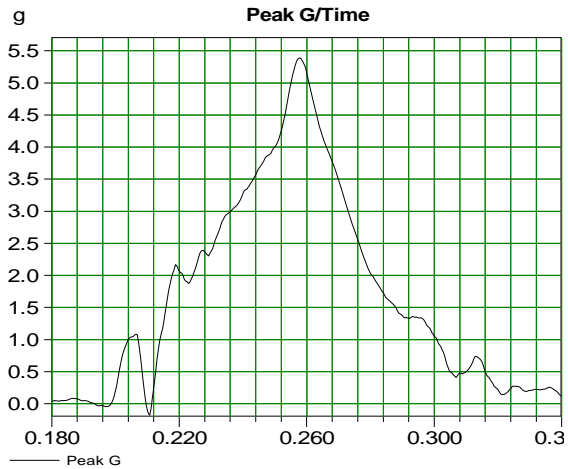
Report file number	001-10A	Date of test	12.17.09
Customer	New Flyer Industries	<b>Data</b>	
Test type	Rear bumper center impact #2	Impact speed	4.2 mph
Vehicle weight (as tested)	28,350 lbs.	Load	15281 lbs.
Component description	SWEPT-BPR-RR-101IN-NF-XCEL	System deflection	2.9"
Customer part number	345569 Rev. A	Deceleration	5.4 "g"
RRI part number	A20180001AXA	Internal data file # 18 12 2009 11 14 .DDF

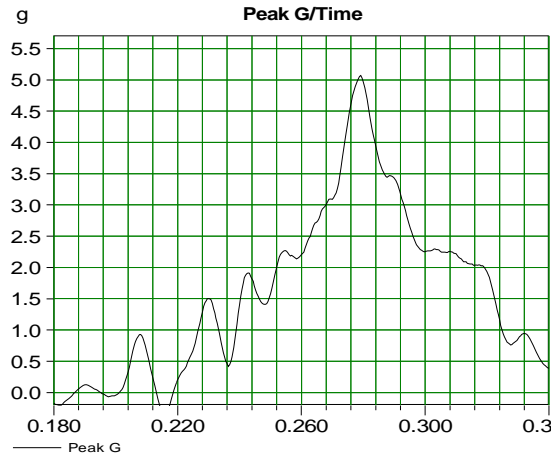
<b>Report file number</b>	001-10A	<b>Date of test</b>	12.18.09
<b>Customer</b>	New Flyer Industries	<b>Data</b>	
<b>Test type</b>	Rear bumper corner impact 2	<b>Impact speed</b>	4.2 mph
<b>Vehicle weight (as tested)</b>	28,350 lbs.	<b>Load</b>	12743 lbs.
<b>Component description</b>	SWEPT-BPR-RR-101IN-NF-XCEL	<b>System deflection</b>	3.8"
<b>Customer part number</b>	345569 Rev. A	<b>Deceleration</b>	5.1 "g"
<b>RRI part number</b>	A20180001AXA	Internal data file # 18 12 2009 09 45 .DDF
