Morrison Hershfield
Salter Street Rehabilitation
Sub-Surface Investigation

0035-045-00

April 6, 2017
Final Report

**RE: Salter Street Rehabilitation
Sub-Surface Investigation Report**

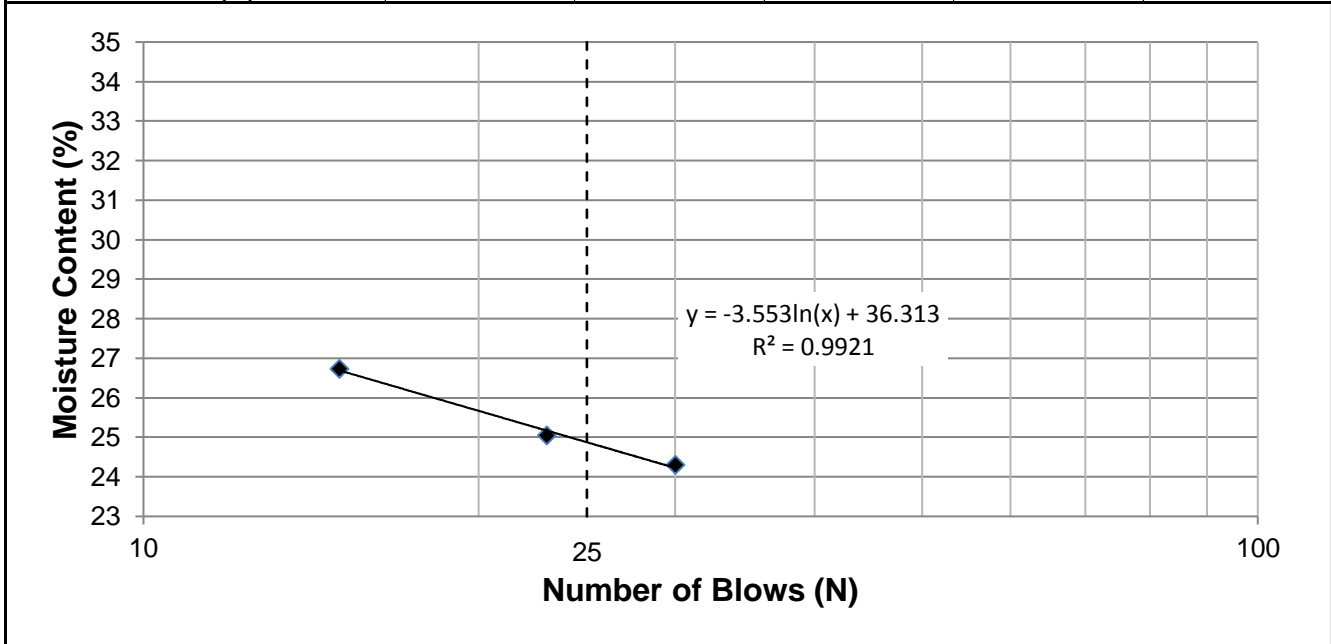
Liquid Limit

Trial #	1	2	3	4	5
Number of Blows (N)	15	23	30		
Mass Wet Soil + Tare (g)	27.984	28.329	27.798		
Mass Dry Soil + Tare (g)	25.101	25.496	25.129		
Mass Tare (g)	14.319	14.184	14.148		
Mass Water (g)	2.883	2.833	2.669		
Mass Dry Soil (g)	10.782	11.312	10.981		
Moisture Content (%)	26.739	25.044	24.306

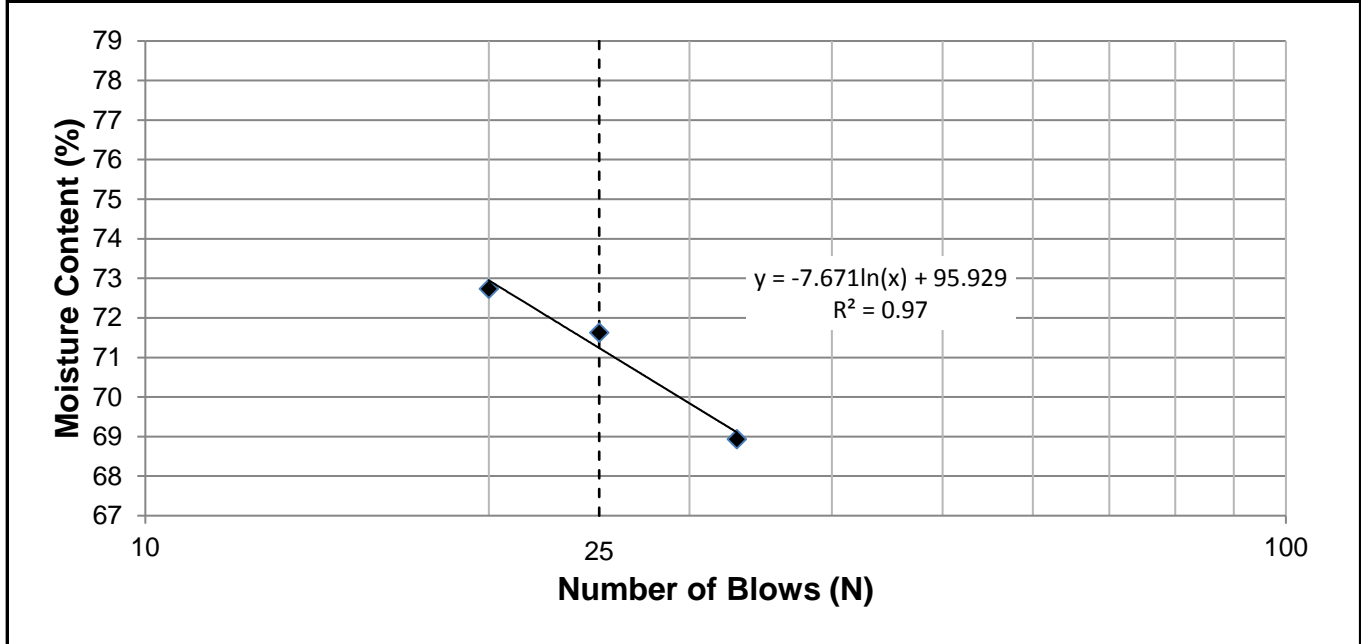
Liquid Limit

Trial #	1	2	3	4	5
Number of Blows (N)	20	25	33		
Mass Wet Soil + Tare (g)	23.495	24.402	25.304		
Mass Dry Soil + Tare (g)	19.571	20.153	20.604		
Mass Tare (g)	14.176	14.221	13.786		
Mass Water (g)	3.924	4.249	4.700		
Mass Dry Soil (g)	5.395	5.932	6.818		
Moisture Content (%)	72.734	71.628	68.935

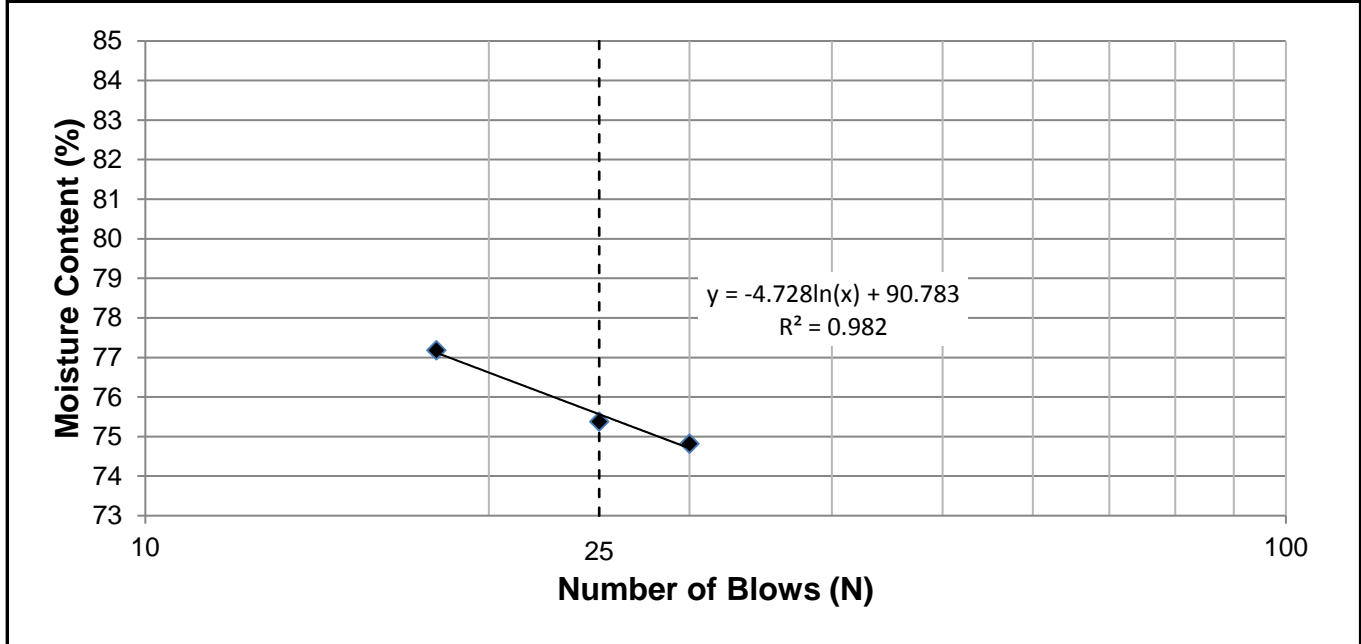
Liquid Limit

Trial #	1	2	3	4	5
Number of Blows (N)	18	25	30		
Mass Wet Soil + Tare (g)	23.964	25.590	24.698		
Mass Dry Soil + Tare (g)	19.593	20.680	20.231		
Mass Tare (g)	13.930	14.166	14.261		
Mass Water (g)	4.371	4.910	4.467		
Mass Dry Soil (g)	5.663	6.514	5.970		
Moisture Content (%)	77.185	75.376	74.824

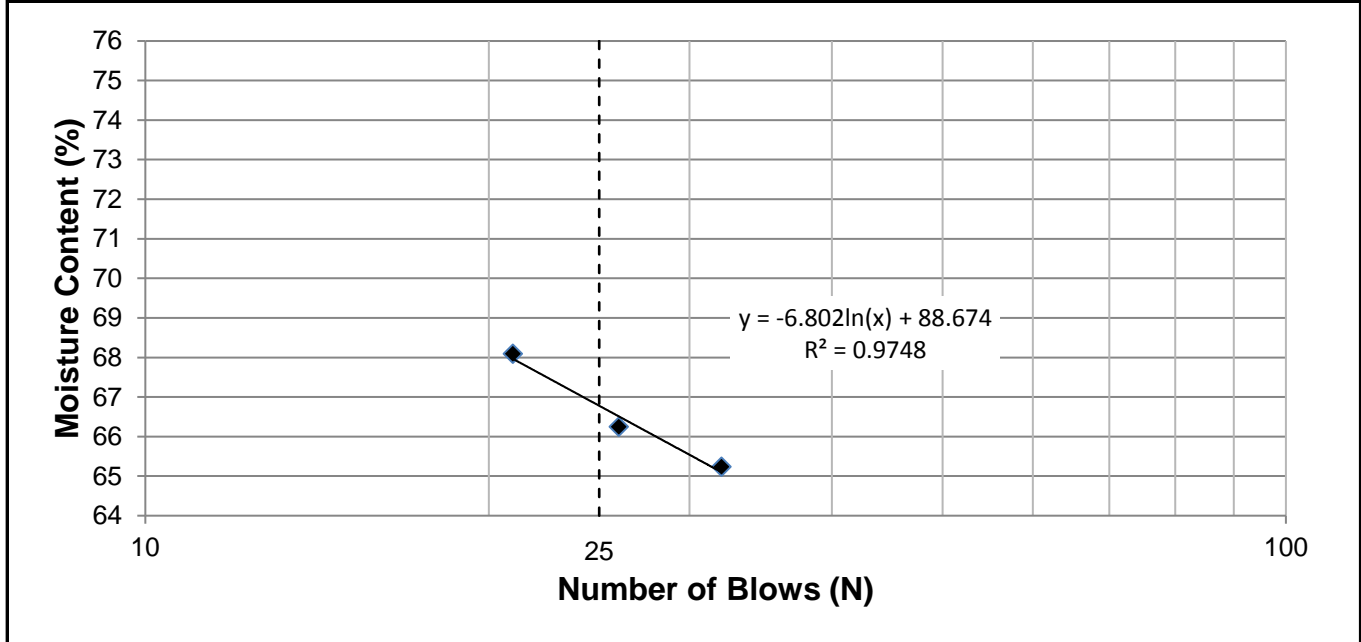
Liquid Limit

Trial #	1	2	3	4	5
Number of Blows (N)	21	26	32		
Mass Wet Soil + Tare (g)	26.058	26.253	24.836		
Mass Dry Soil + Tare (g)	21.247	21.521	20.629		
Mass Tare (g)	14.182	14.378	14.180		
Mass Water (g)	4.811	4.732	4.207		
Mass Dry Soil (g)	7.065	7.143	6.449		
Moisture Content (%)	68.096	66.247	65.235

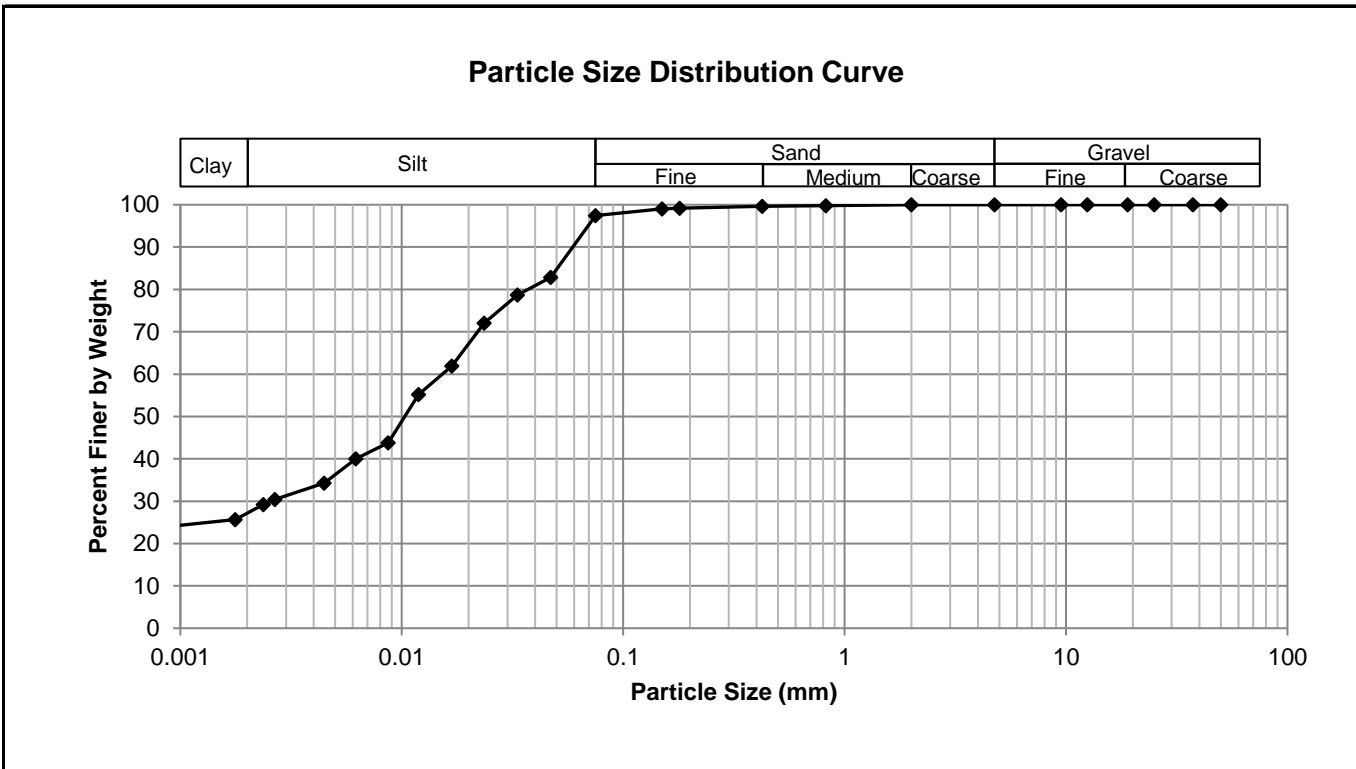
Test Hole TH17-03
Sample # G54
Depth (m) 0.9 - 1.2
Sample Date 13-Mar-17
Test Date 20-Mar-17
Technician SX

Gravel	0.0%
Sand	2.6%
Silt	70.4%
Clay	27.0%

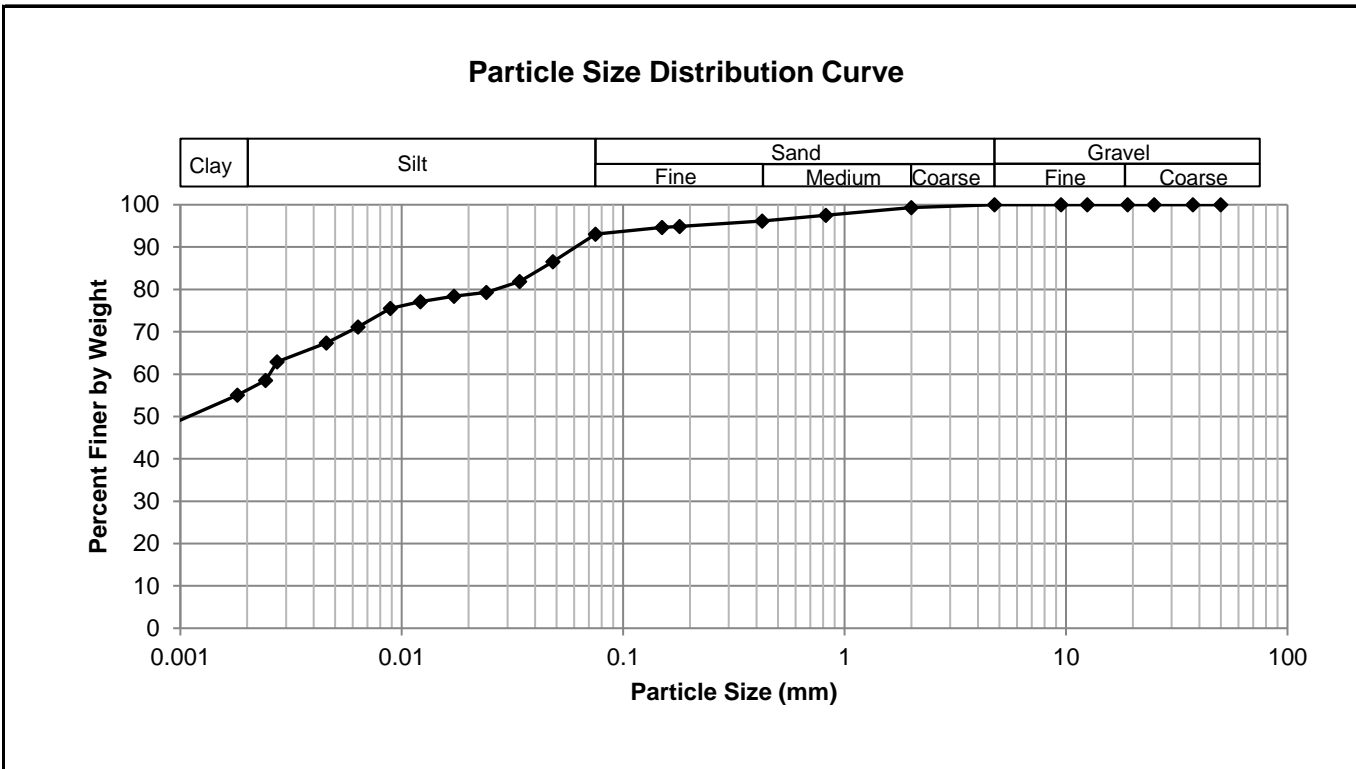
Test Hole TH17-05
Sample # G44
Depth (m) 0.2 - 0.3
Sample Date 13-Mar-17
Test Date 21-Mar-17
Technician SX

Gravel	0.0%
Sand	7.0%
Silt	36.9%
Clay	56.1%

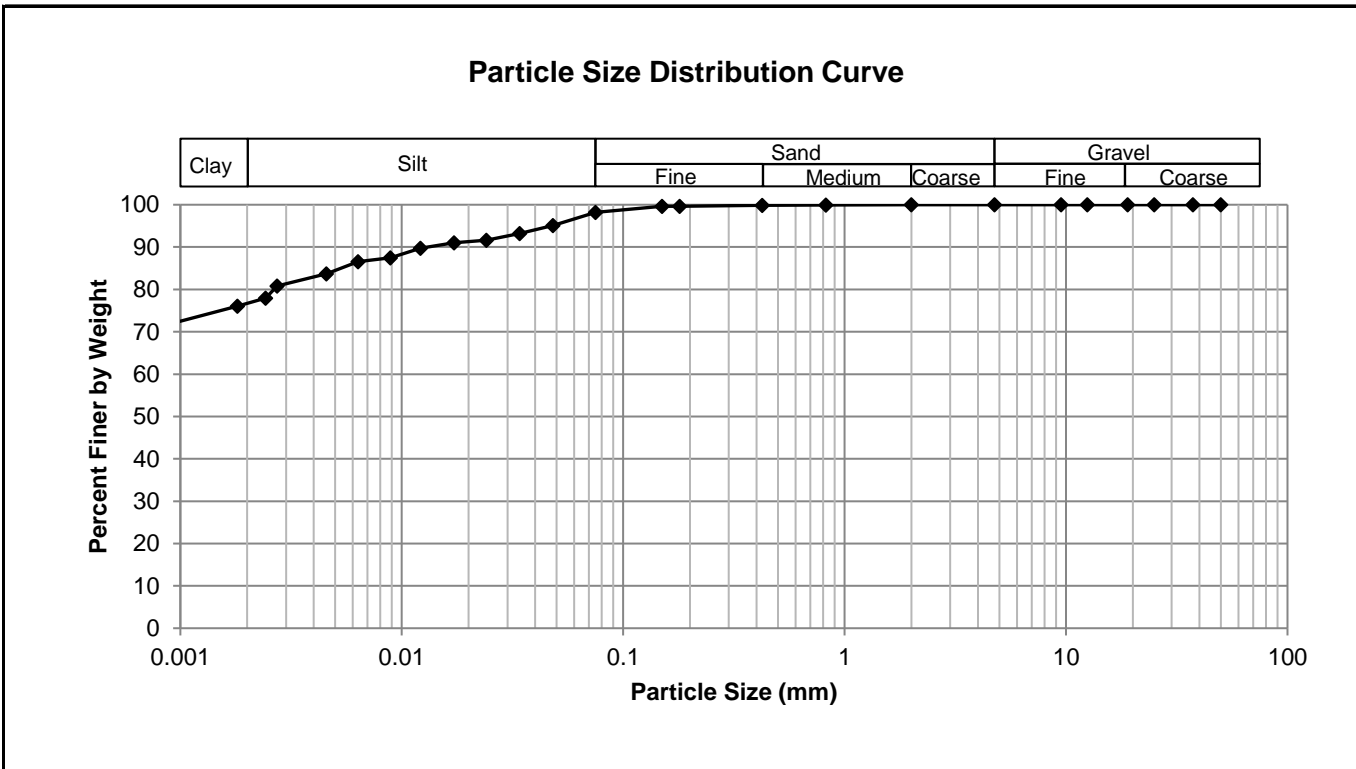
Test Hole TH17-05
Sample # G46
Depth (m) 0.7 - 0.9
Sample Date 13-Mar-17
Test Date 21-Mar-17
Technician SX

Gravel	0.0%
Sand	1.8%
Silt	21.5%
Clay	76.6%

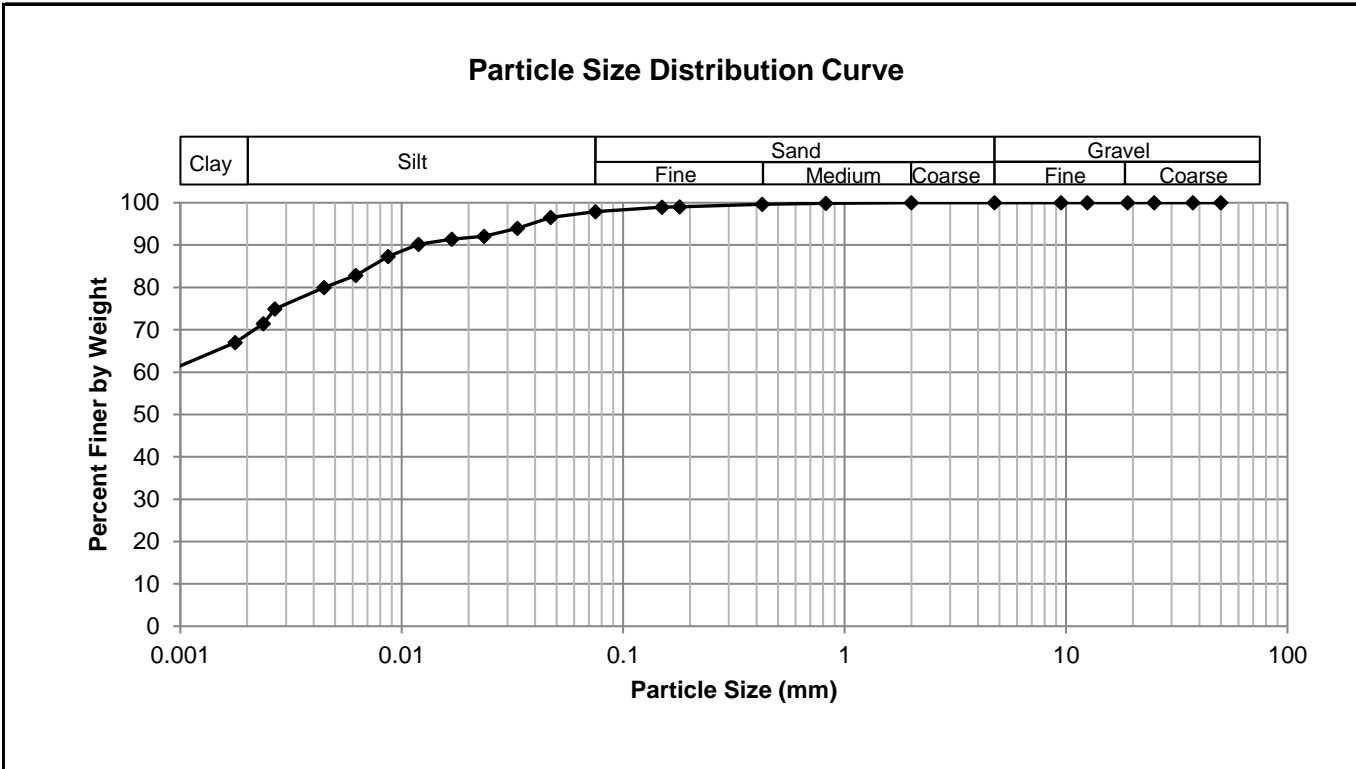
Test Hole TH17-07
Sample # G40
Depth (m) 0.9 - 1.2
Sample Date 13-Mar-17
Test Date 20-Mar-17
Technician SX

Gravel	0.0%
Sand	2.1%
Silt	29.2%
Clay	68.7%

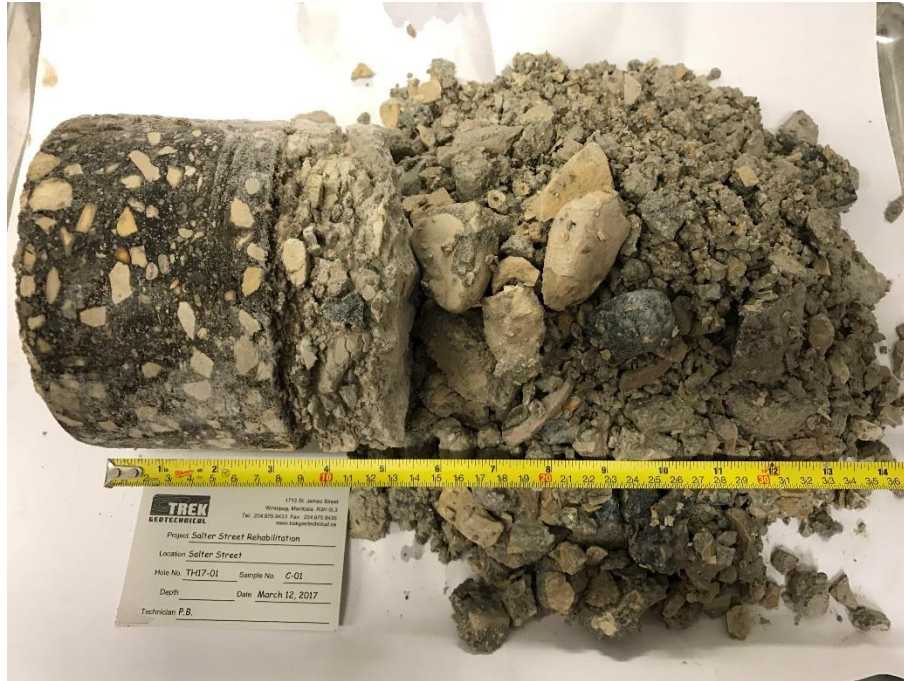
231.3			ASPHALT (90 mm THICK)															
			CONCRETE (215 mm THICK)															
231.1																		
231.0			CLAY (FILL) - some silt, trace sand, trace gravel (<15 mm dia), light to dark brown, frozen, moist and soft when thawed, high plasticity		G01													
	-0.5		CLAY - silty - dark green - frozen, moist and firm to stiff when thawed - high plasticity		G02													
	-1.0				G03													
	-1.5				G04													
	-2.0				G05													
	-2.5		-trace fine sand, trace silt inclusions (<50 mm), light to dark brown below 1.52 m		G06

Photo 1: Pavement Core Sample at Test Hole TH17-01

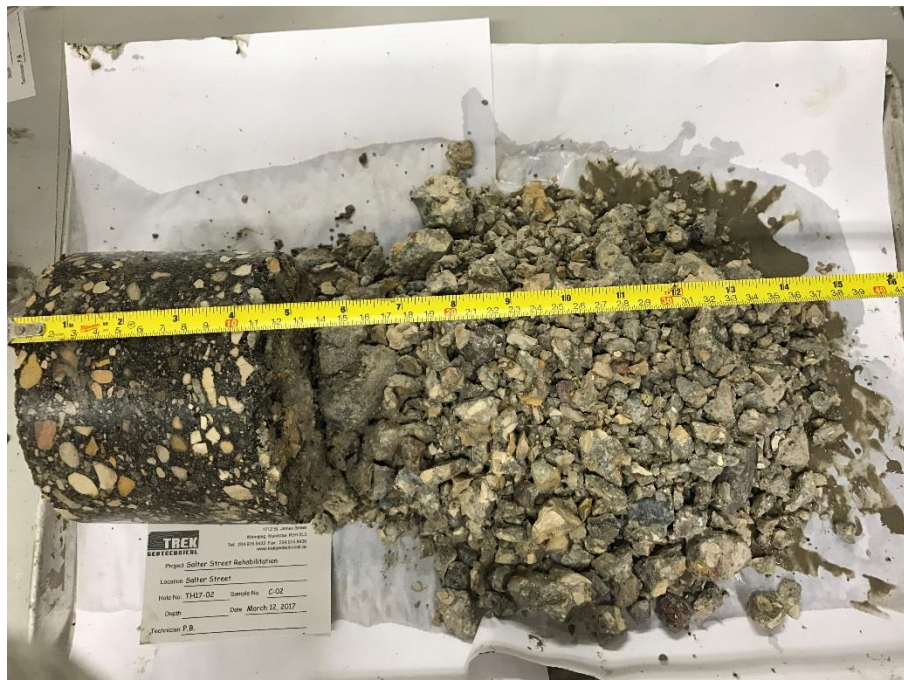
230.9			ASPHALT (115 mm THICK)																
230.8			CONCRETE (135 mm THICK)																
230.7			SAND AND GRAVEL (<20 mm dia) - some clay, trace silt, light brown, frozen, moist and soft when thawed		G08	●													
	-0.5		CLAY - silty, trace organics to 0.67 m - dark green to black - frozen, moist and firm when thawed - high plasticity		G09		●

Photo 2: Pavement Core Sample at Test Hole TH17-02

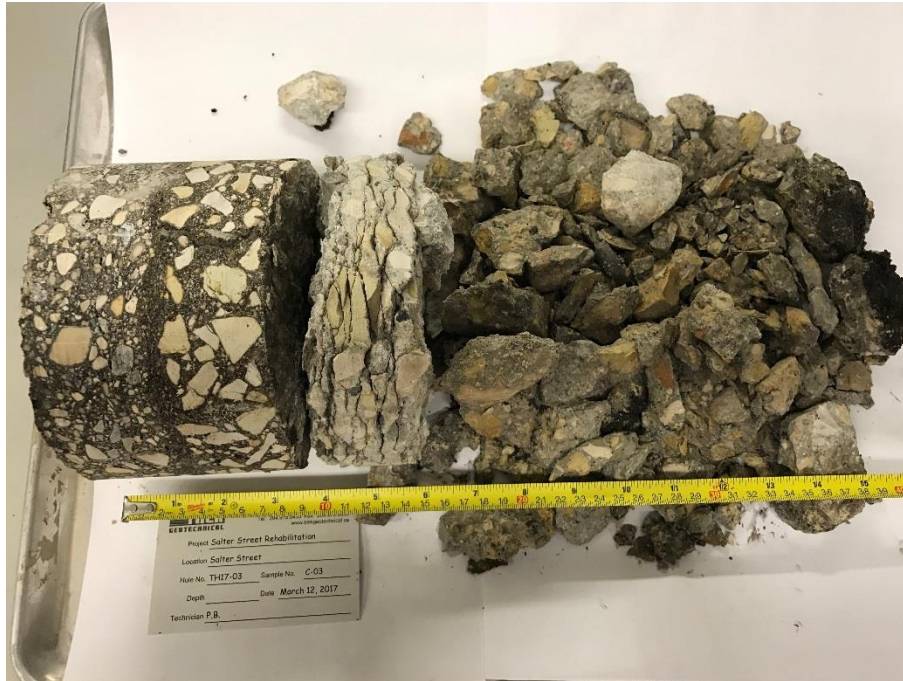
230.8			ASPHALT (95 mm THICK)														
230.7			CONCRETE (180 mm THICK)														
230.6			CLAY (FILL) - some silt, trace sand, trace gravel (<20 mm dia), light to dark brown, frozen, moist and soft when thawed, high plasticity		G51

Photo 3: Pavement Core Sample at Test Hole TH17-03

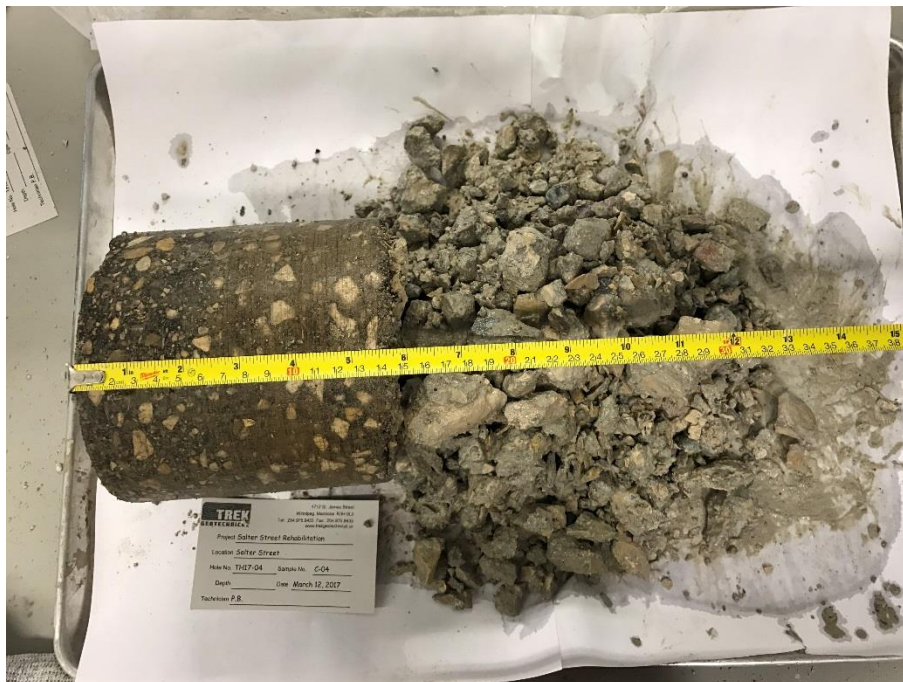
230.6			ASPHALT (140 mm THICK)														
230.5			CONCRETE (110 mm THICK)														
230.4			SAND AND GRAVEL - some clay, trace silt, light brown, frozen, moist and soft when thawed		G16		●										
	-0.5		CLAY - silty - dark green - frozen, moist and firm to stiff when thawed - high plasticity		G17			●									●
					G18			●									●
	-1.0				G19			●									●
	-1.5				G20			●

Photo 4: Pavement Core Sample at Test Hole TH17-04

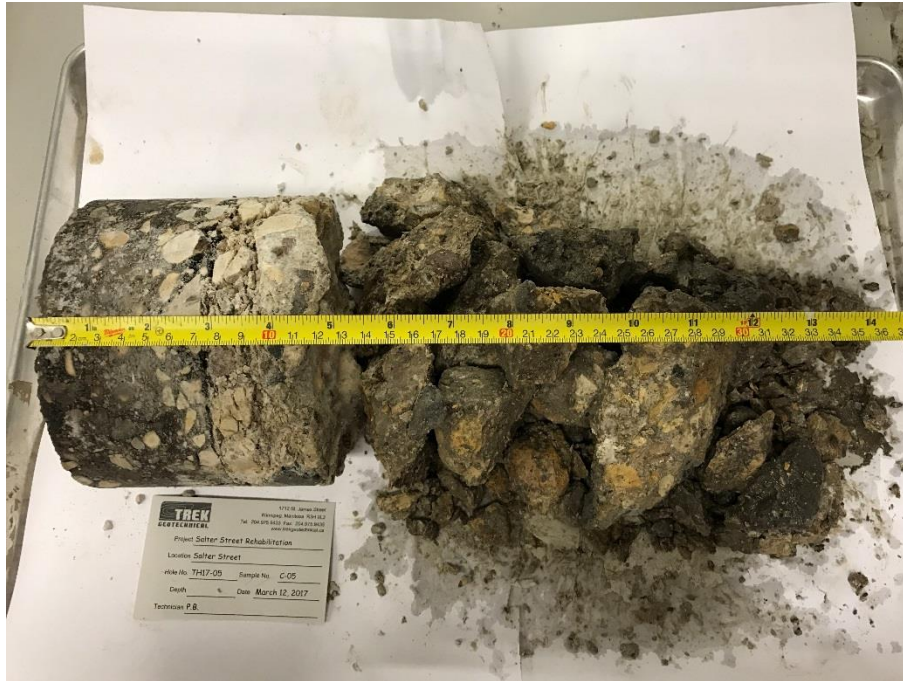
Photo 5: Pavement Core Sample at Test Hole TH17-05

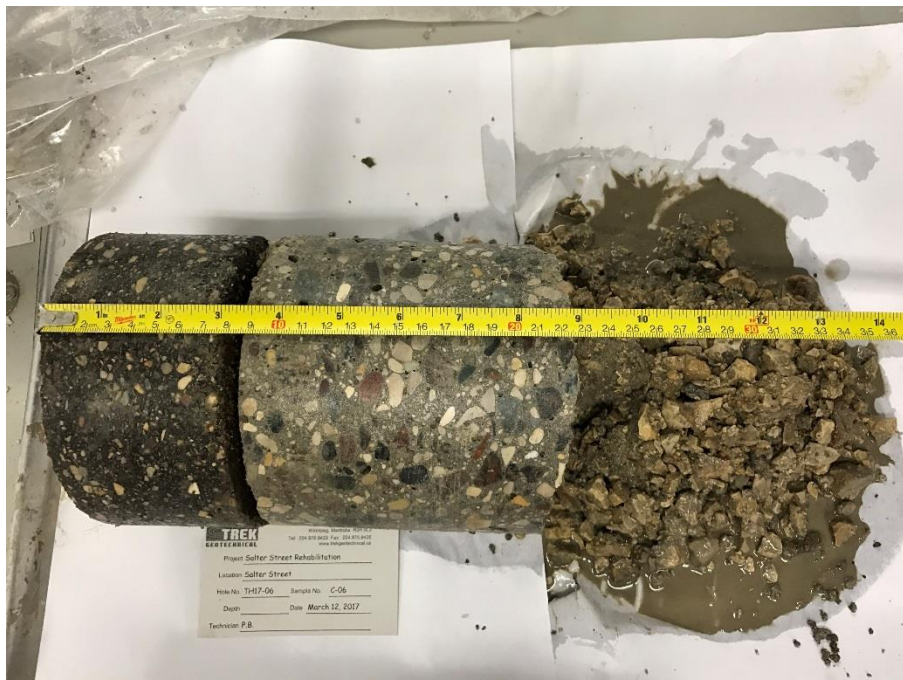
230.7			ASPHALT (75 mm THICK)														
230.6			CONCRETE (150 mm THICK)														
230.5			CLAY (FILL) - trace silt, trace sand, light to dark brown, moist and soft when thawed, high plasticity	<input checked="" type="checkbox"/>	G23			●									
	-0.5		CLAY - silty - dark green - frozen, moist and firm to stiff when thawed - high plasticity	<input checked="" type="checkbox"/>	G24			●						■			
				<input checked="" type="checkbox"/>	G25			●						■			
	-1.0			<input checked="" type="checkbox"/>	G26			●						■			
				<input checked="" type="checkbox"/>	G27			●						■			
	-1.5			<input checked="" type="checkbox"/>													
	-2.0			<input checked="" type="checkbox"/>

Photo 6: Pavement Core Sample at Test Hole TH17-06

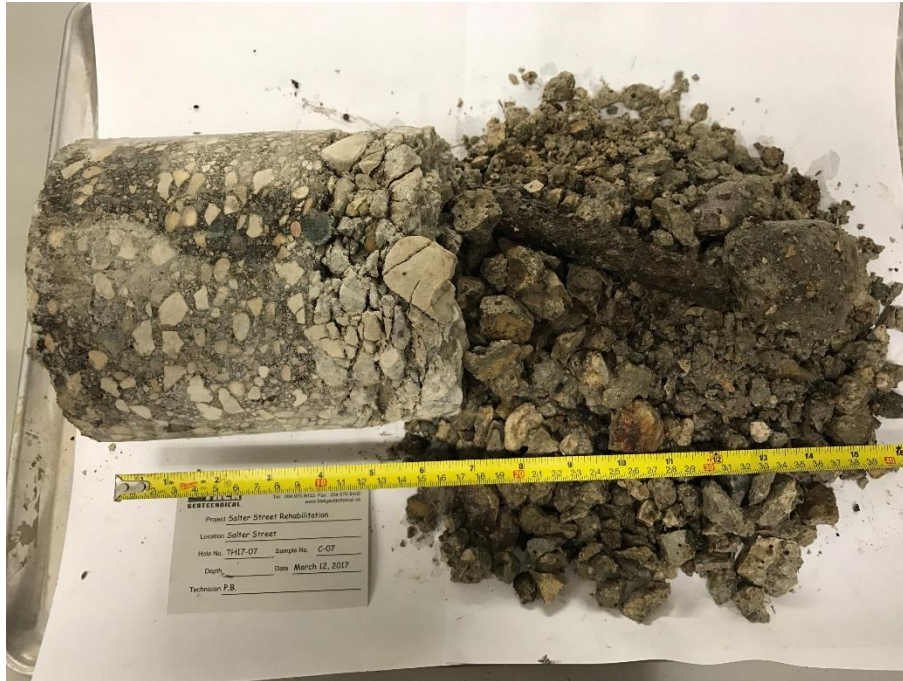
Photo 7: Pavement Core Sample at Test Hole TH17-07

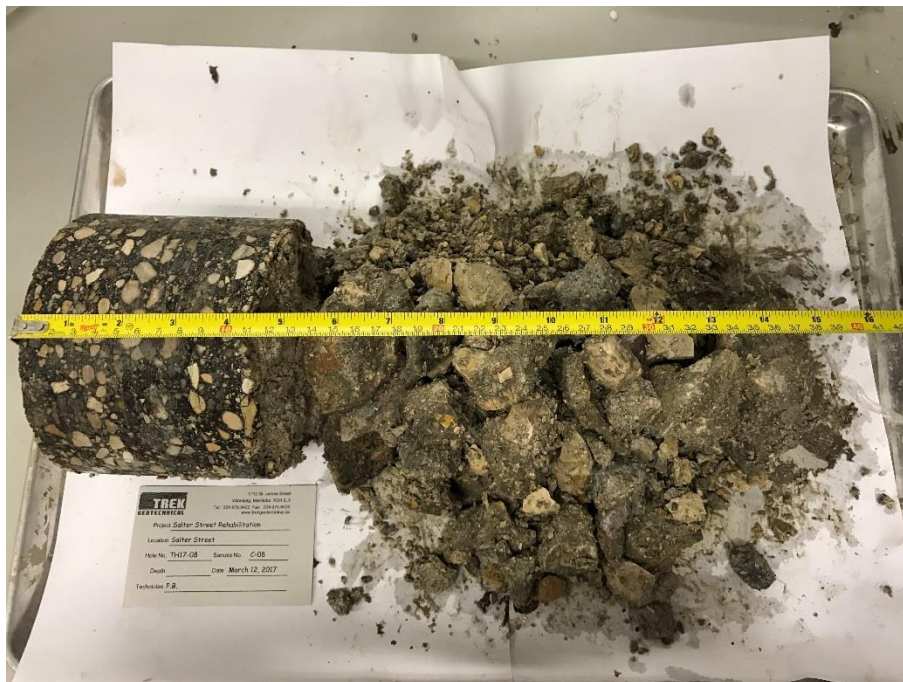
Photo 8: Pavement Core Sample at Test Hole TH17-08
