Project  
St. John's Library Renovation

Drawing  
Details

Reviewed By  
PS  
Drawing No.  
A-601

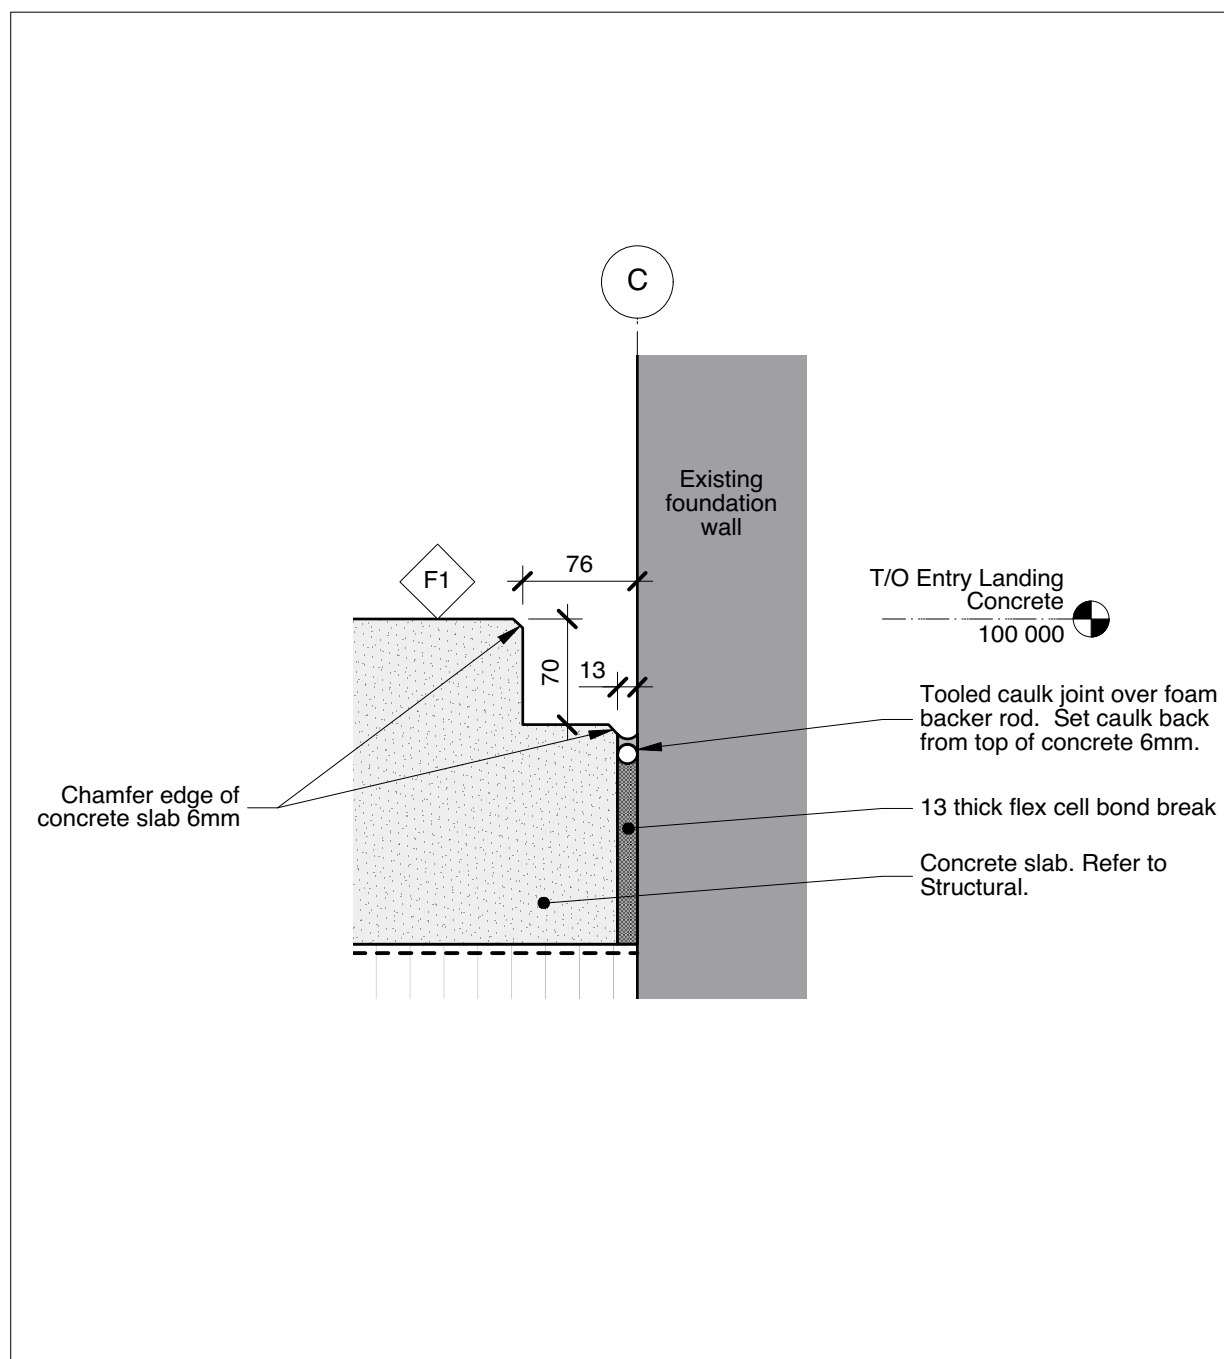
11 A-601 1:5  
Typical Section Detail - Concrete Floor Juncture to Existing Exterior Foundation Wall

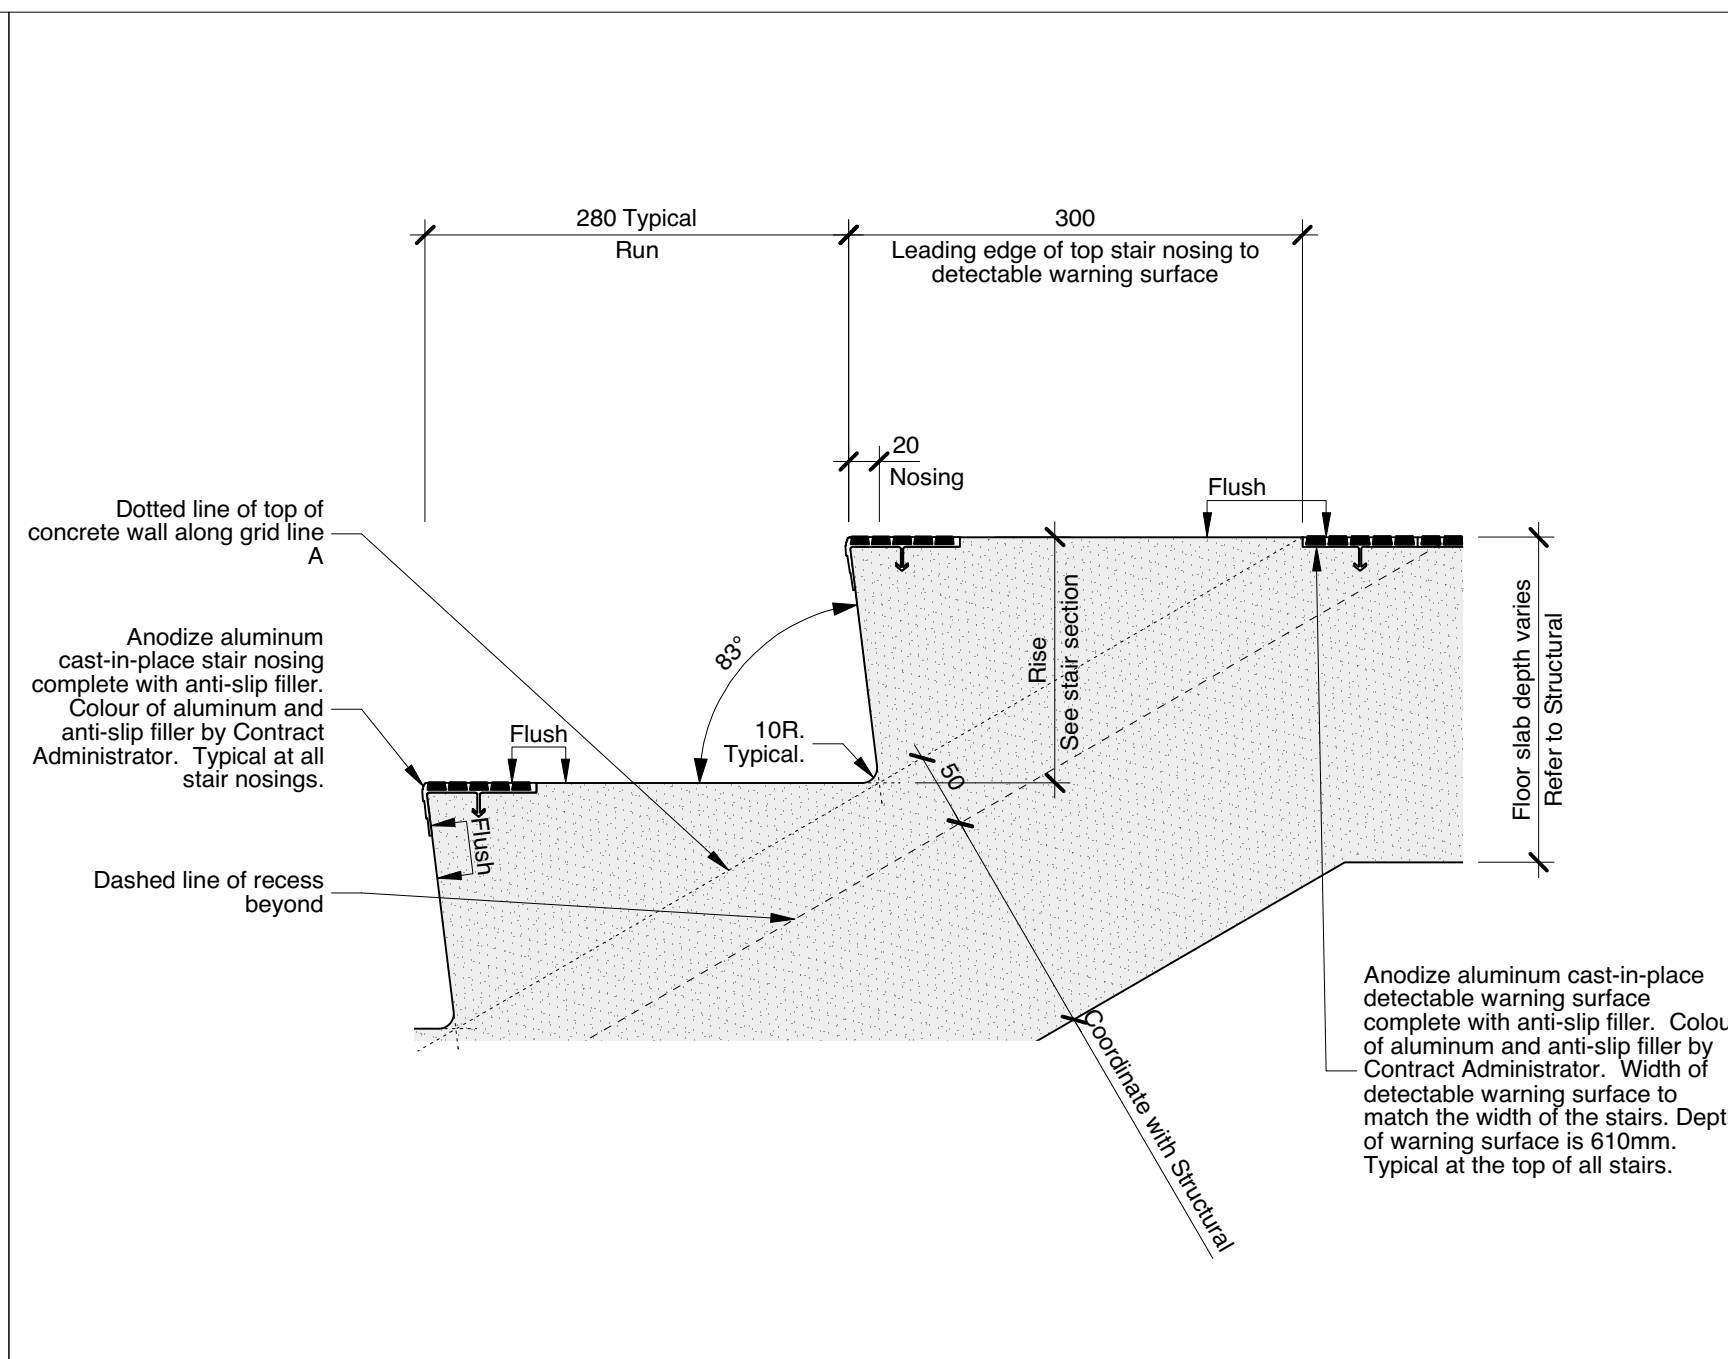
9 A-601 1:20  
Section Detail - Typical Stair Tread

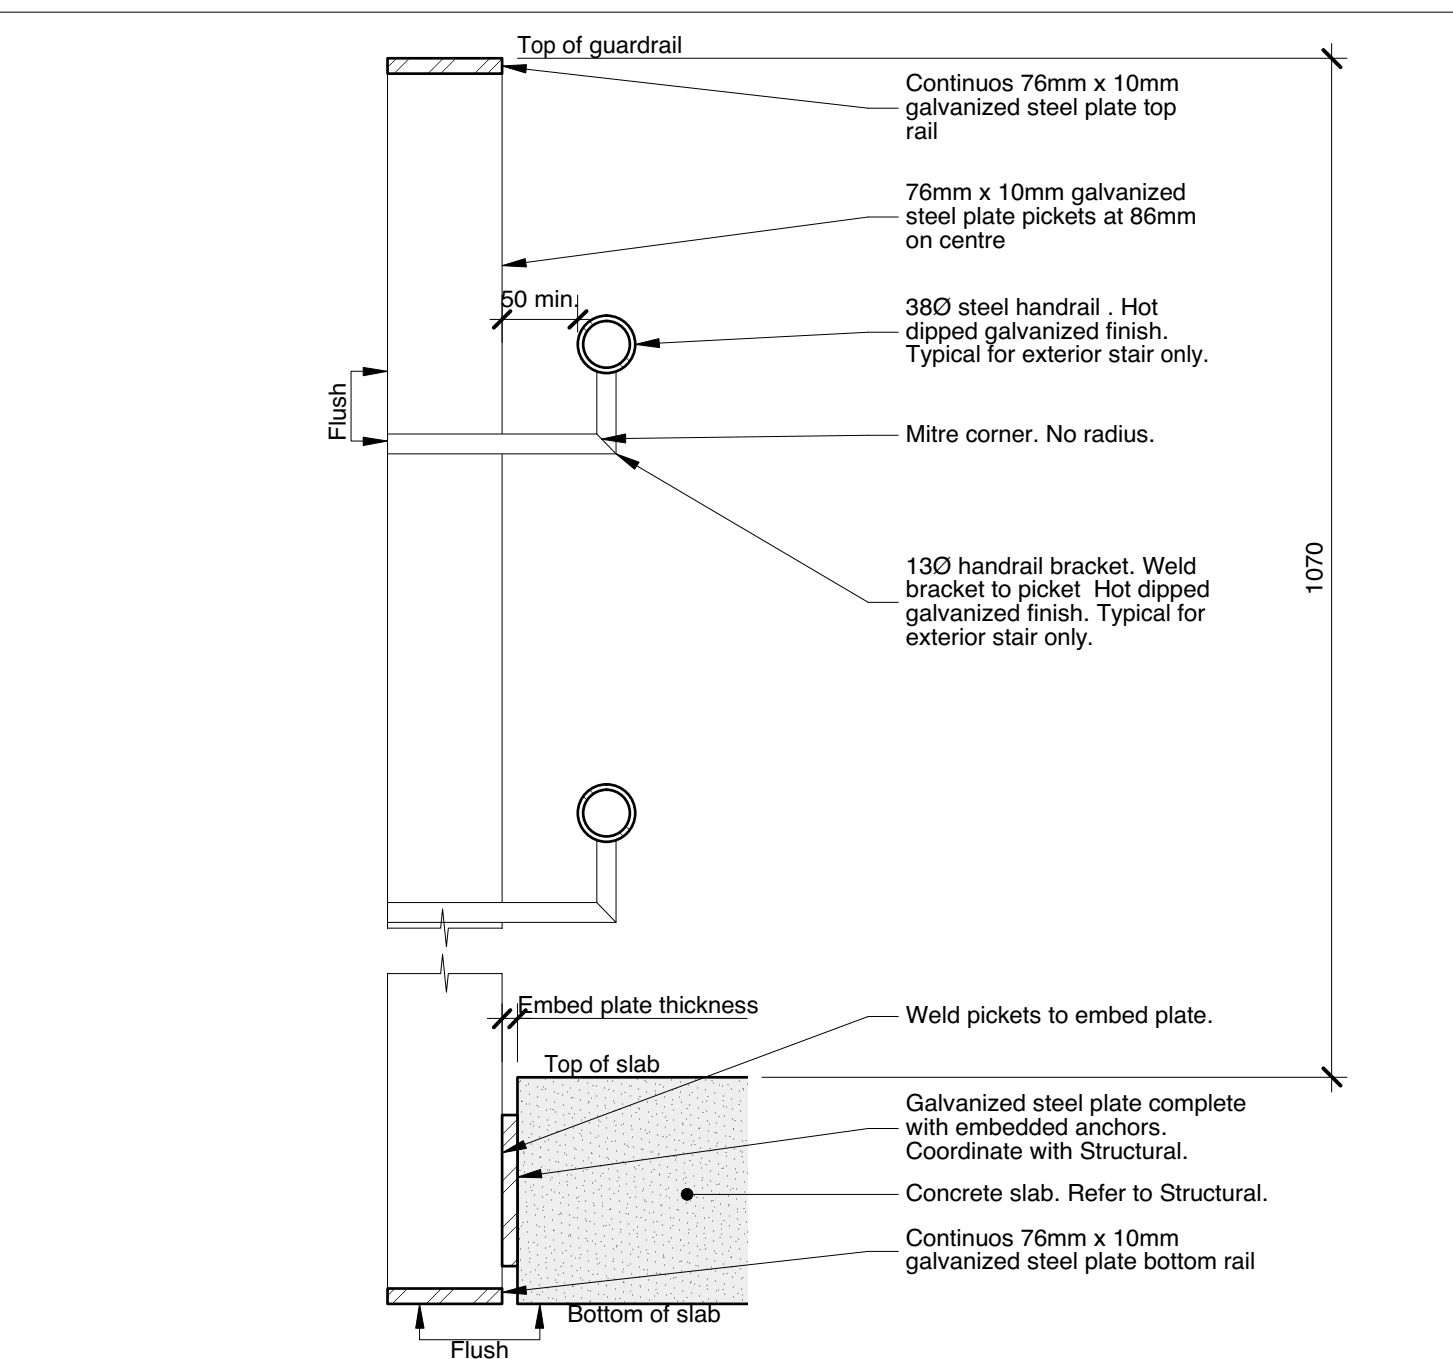
6 A-601 1:5  
Section Detail - Exit Stair Guardrail/ Handrail

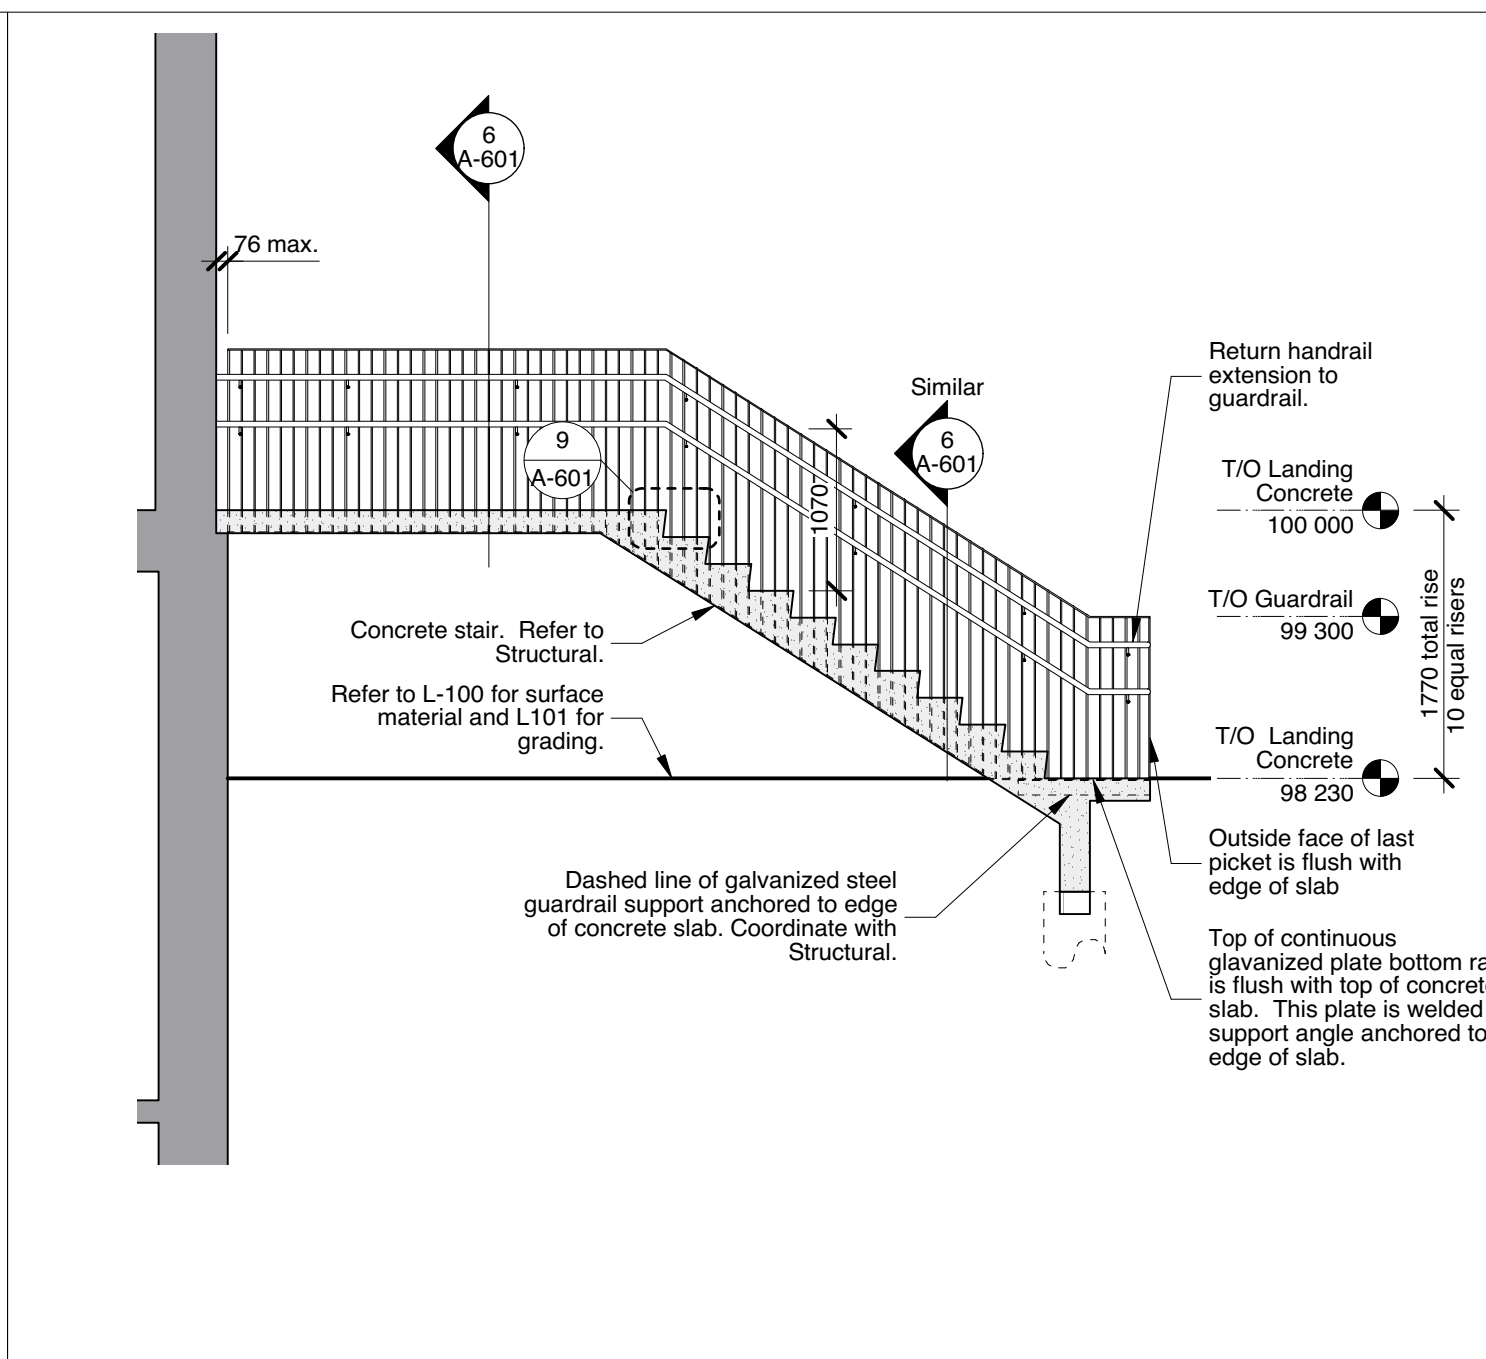
3 A-601 1:50  
Stair Section - Exterior Exit Stair from Main Floor

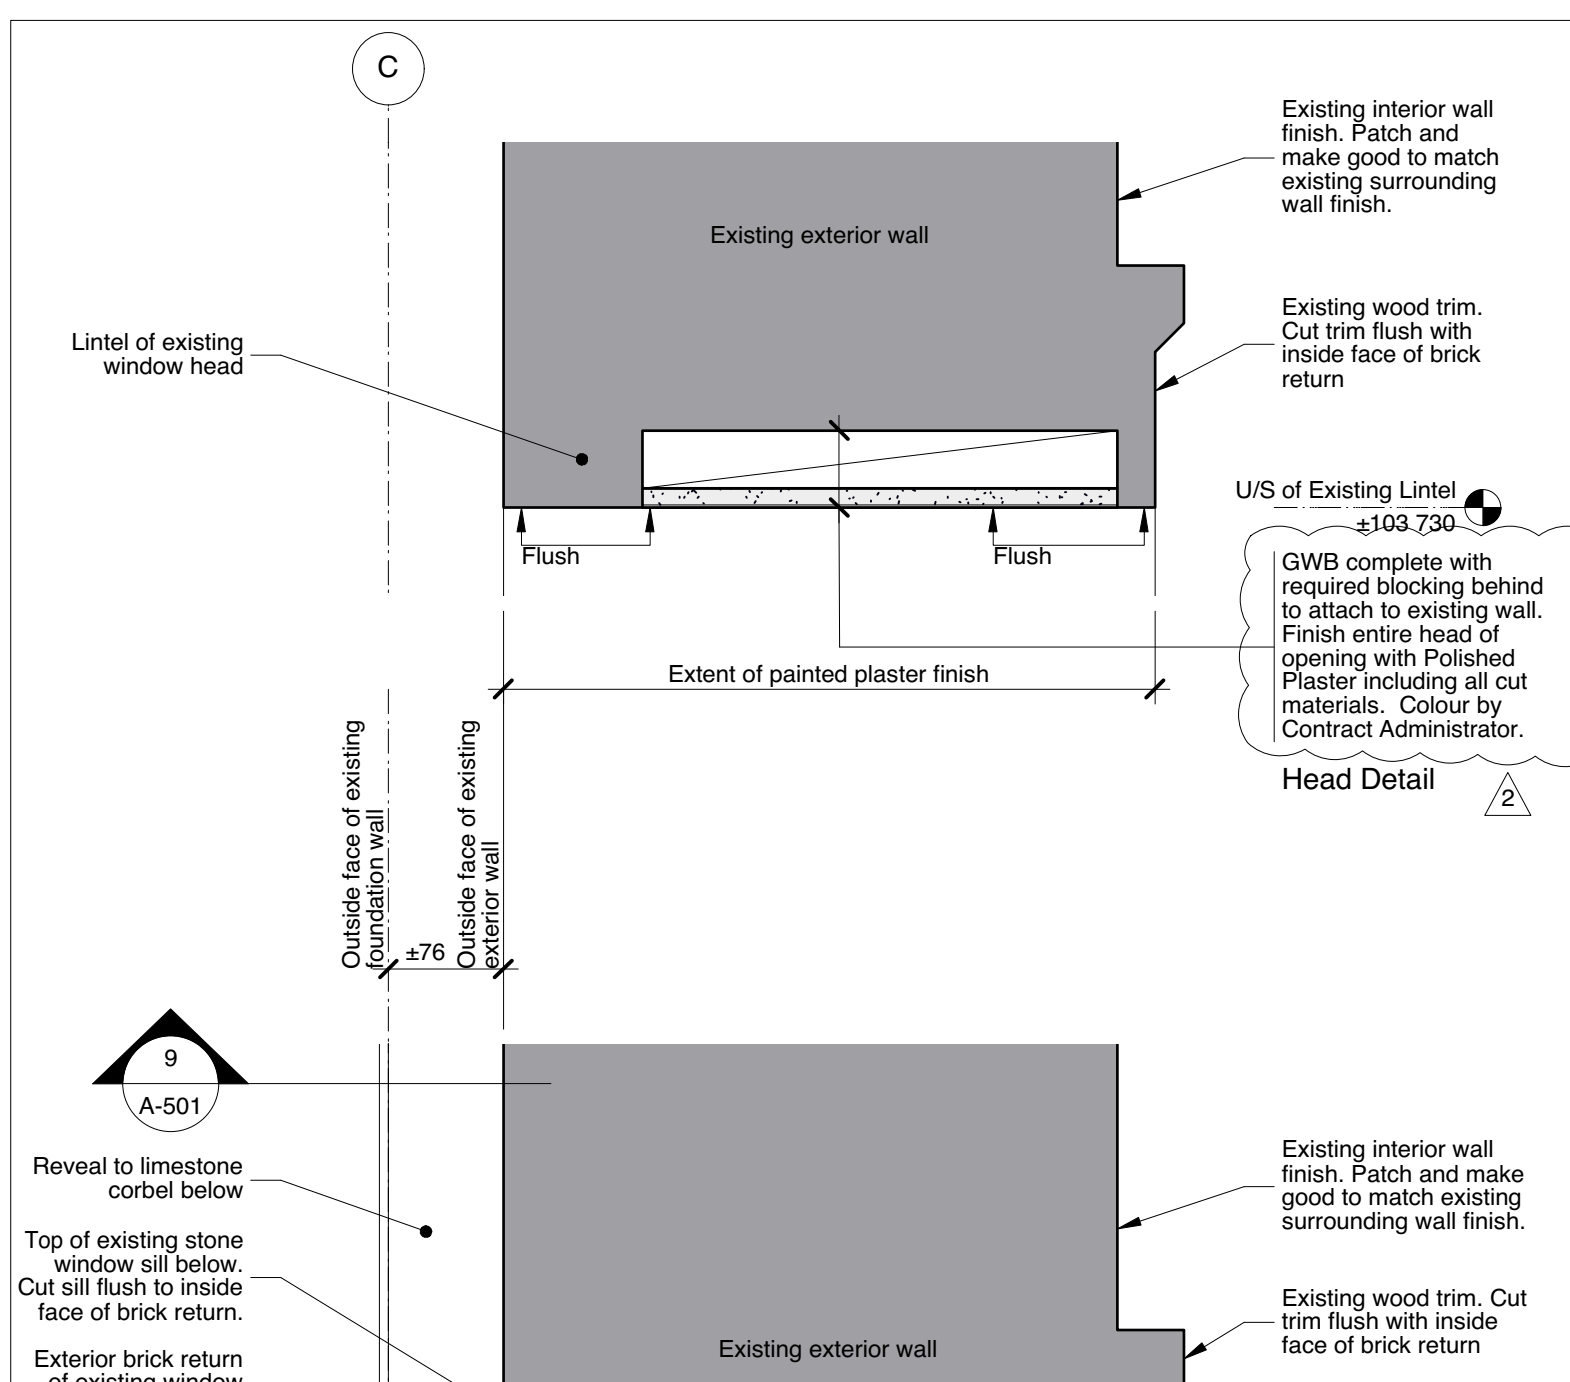
10 A-601 1:5  
Detail - Link Between Main Level Reading Room and Existing Stacks Through Existing Window Opening

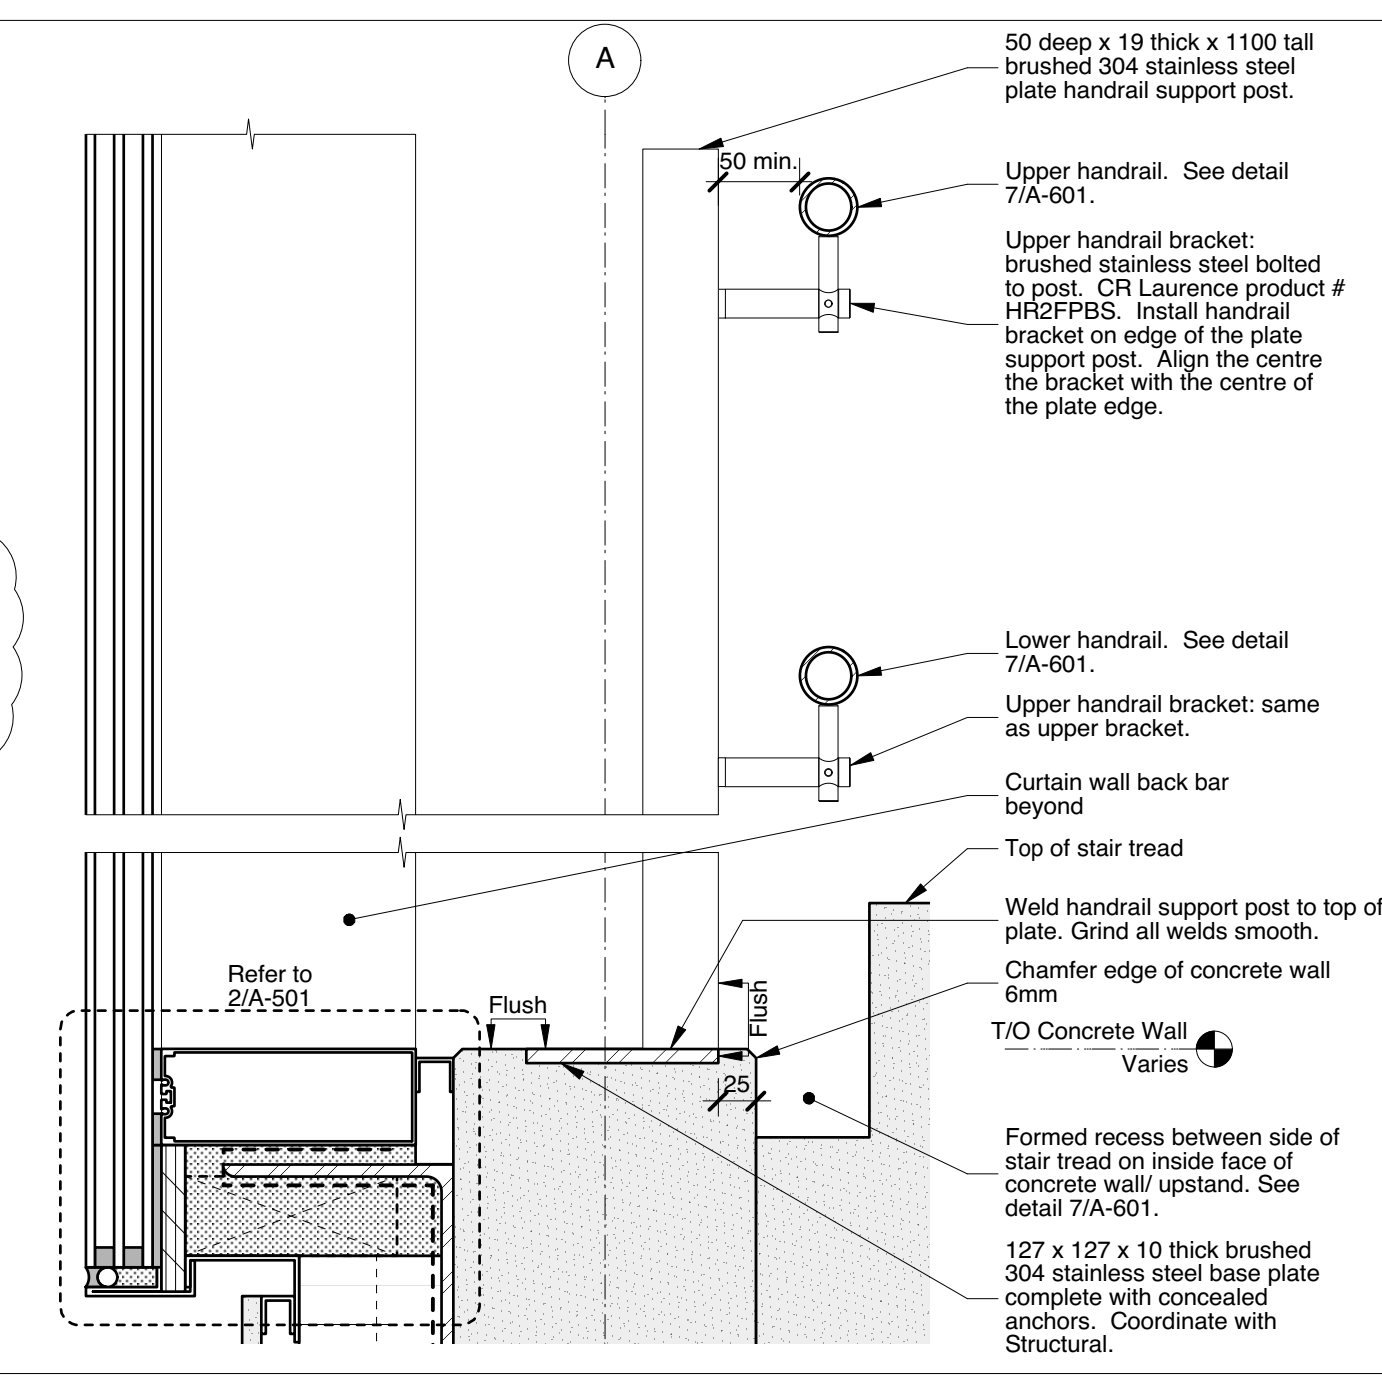
8 A-601 1:5  
Section Detail - Handrail Parallel to Curtain Wall on Grid A

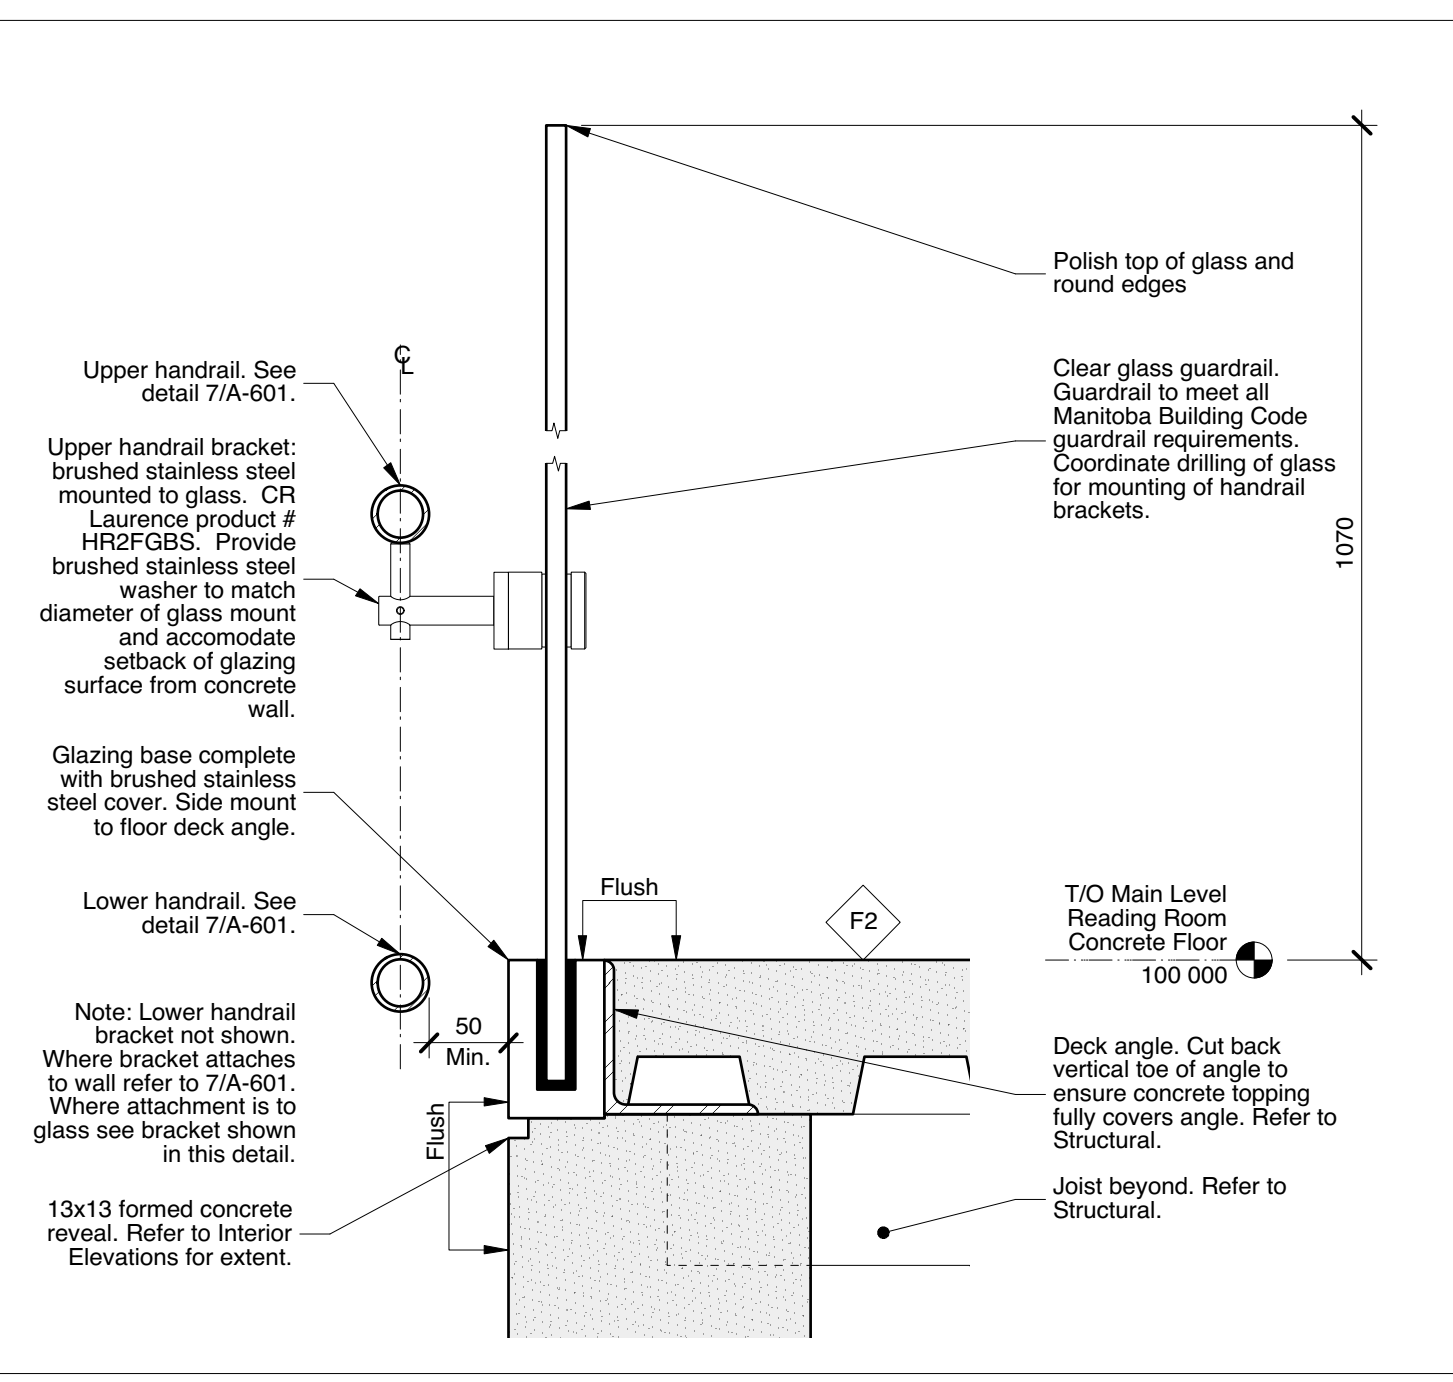
5 A-601 1:5  
Section Detail - Guardrail at Head of Main Level Reading Room Stairs

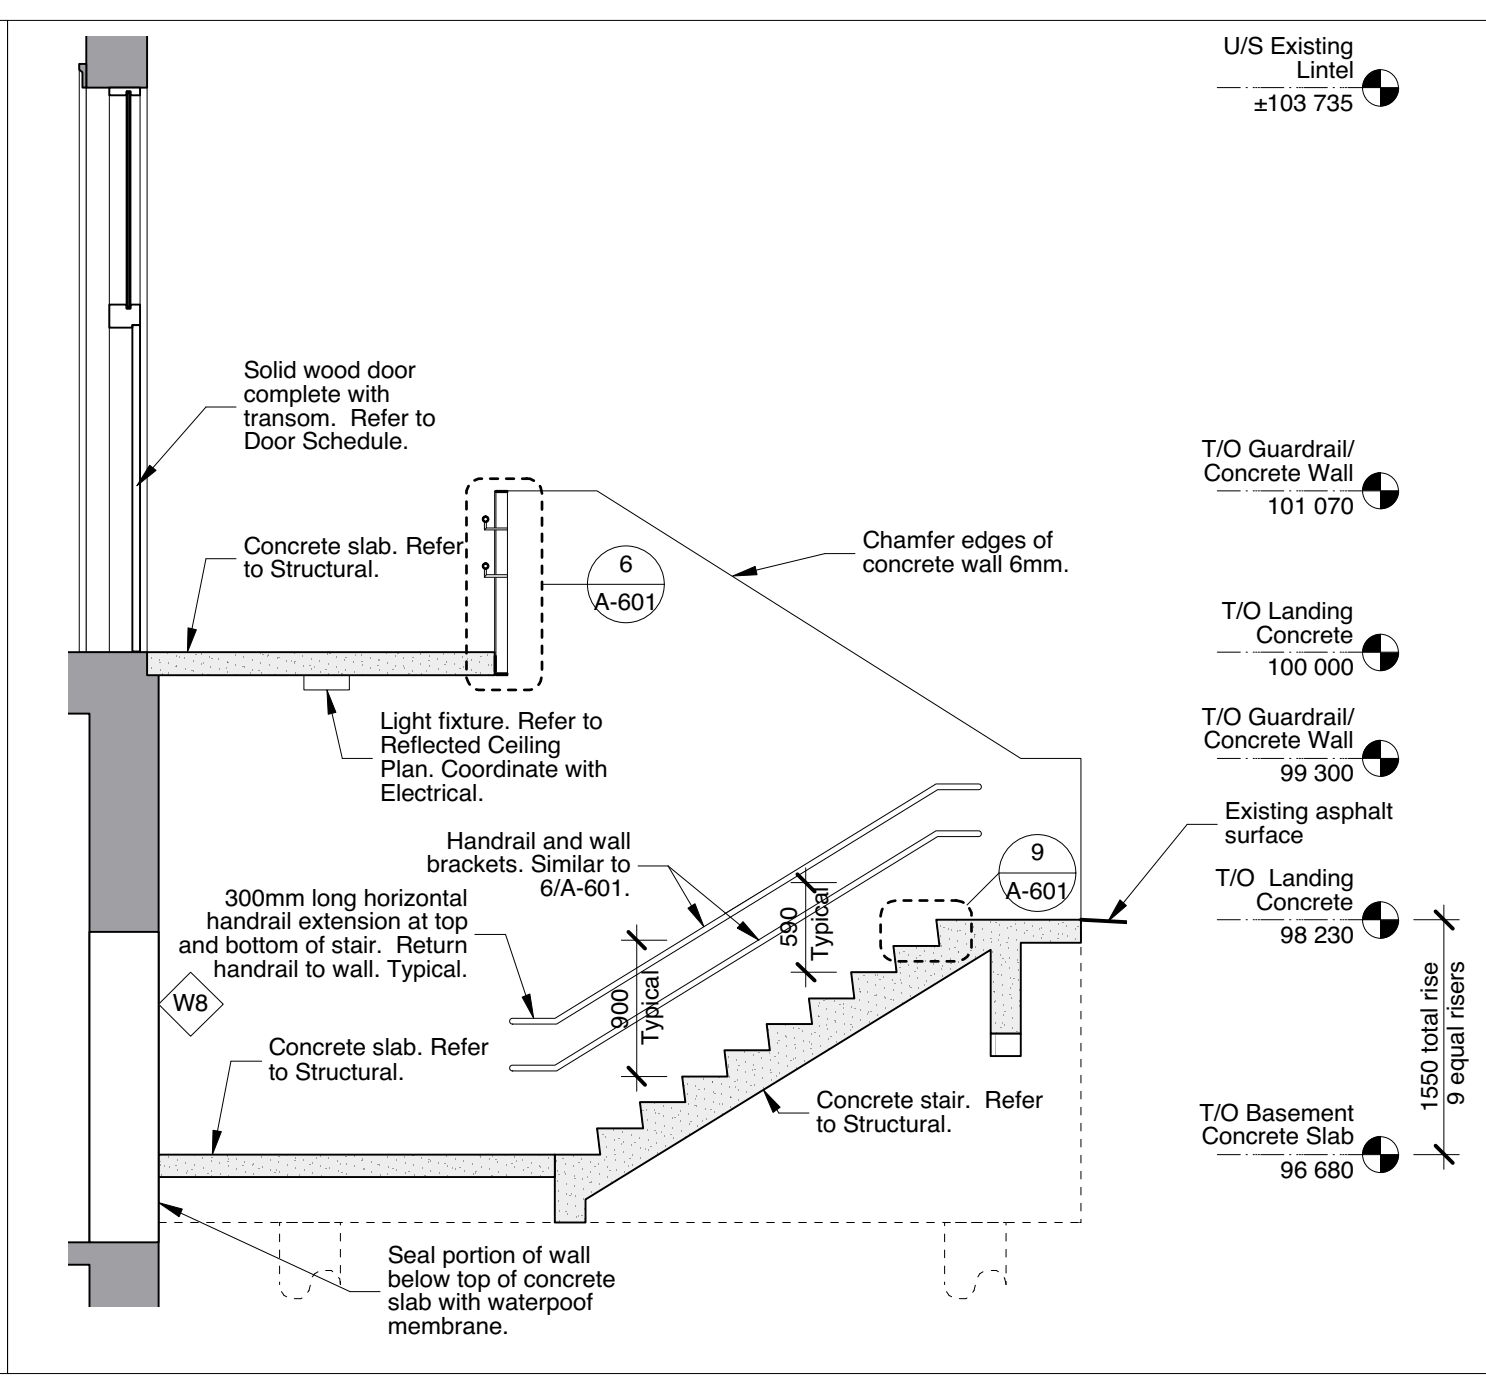
2 A-601 1:50  
Stair Section - Exterior Exit Stair from Basement

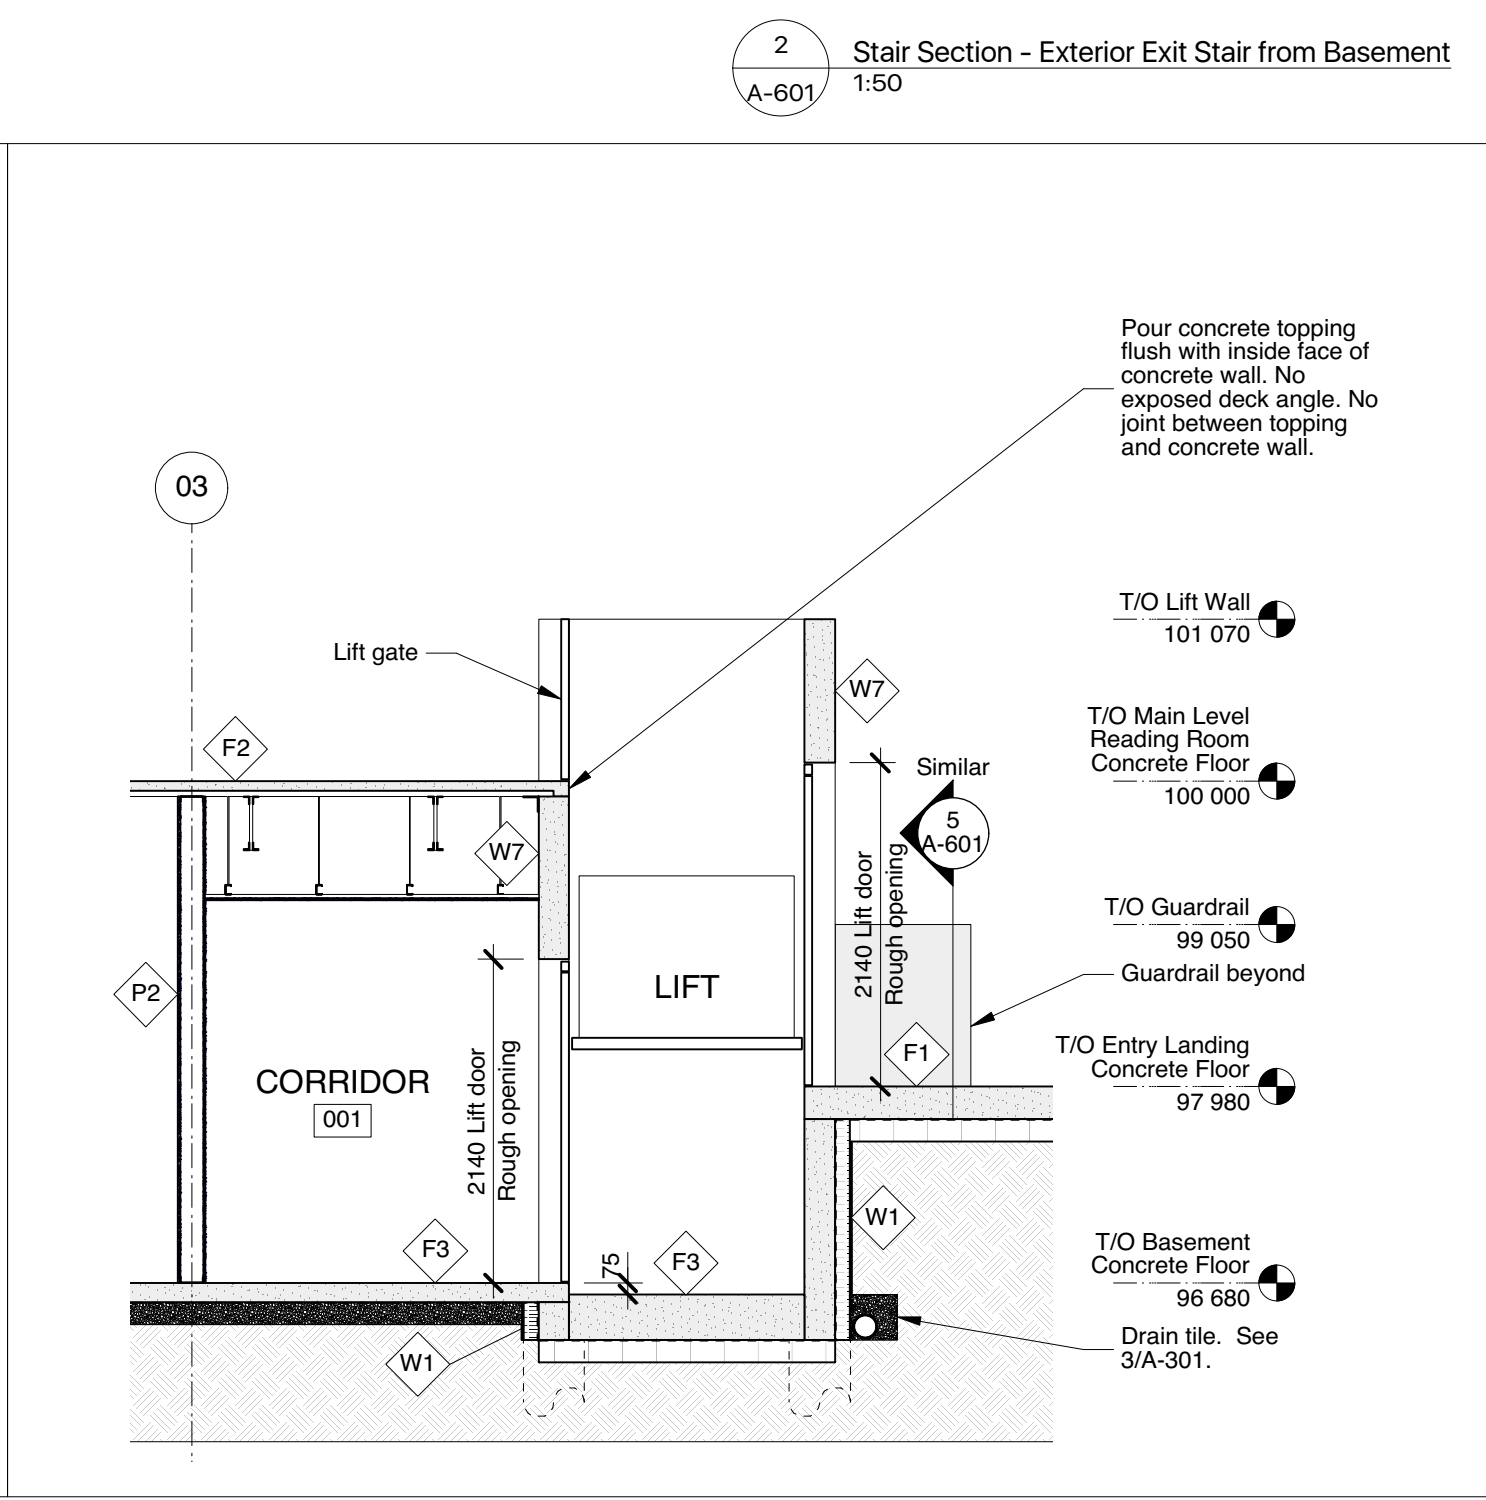
1 A-601 1:50  
Lift Section - East West Section Through Lift
