FERMOR AVENUE BRIDGE OVER SEINE RIVER
BRIDGE RE-HABILITATION, PEDESTRIAN-CYCLIST UNDERPASS STRUCTURE AND ROADWORKS FROM ST. ANNE'S ROAD TO ARCHIBALD STREET

CITY DRAWING NUMBER: B-118-2017-CS-018
SHEET 018 OF 100
CONSULTANT DRAWING NUMBER: CS-018

ABUTMENT MODIFICATIONS 2 OF 5
NEW BEARING SEAT ELEVATIONS

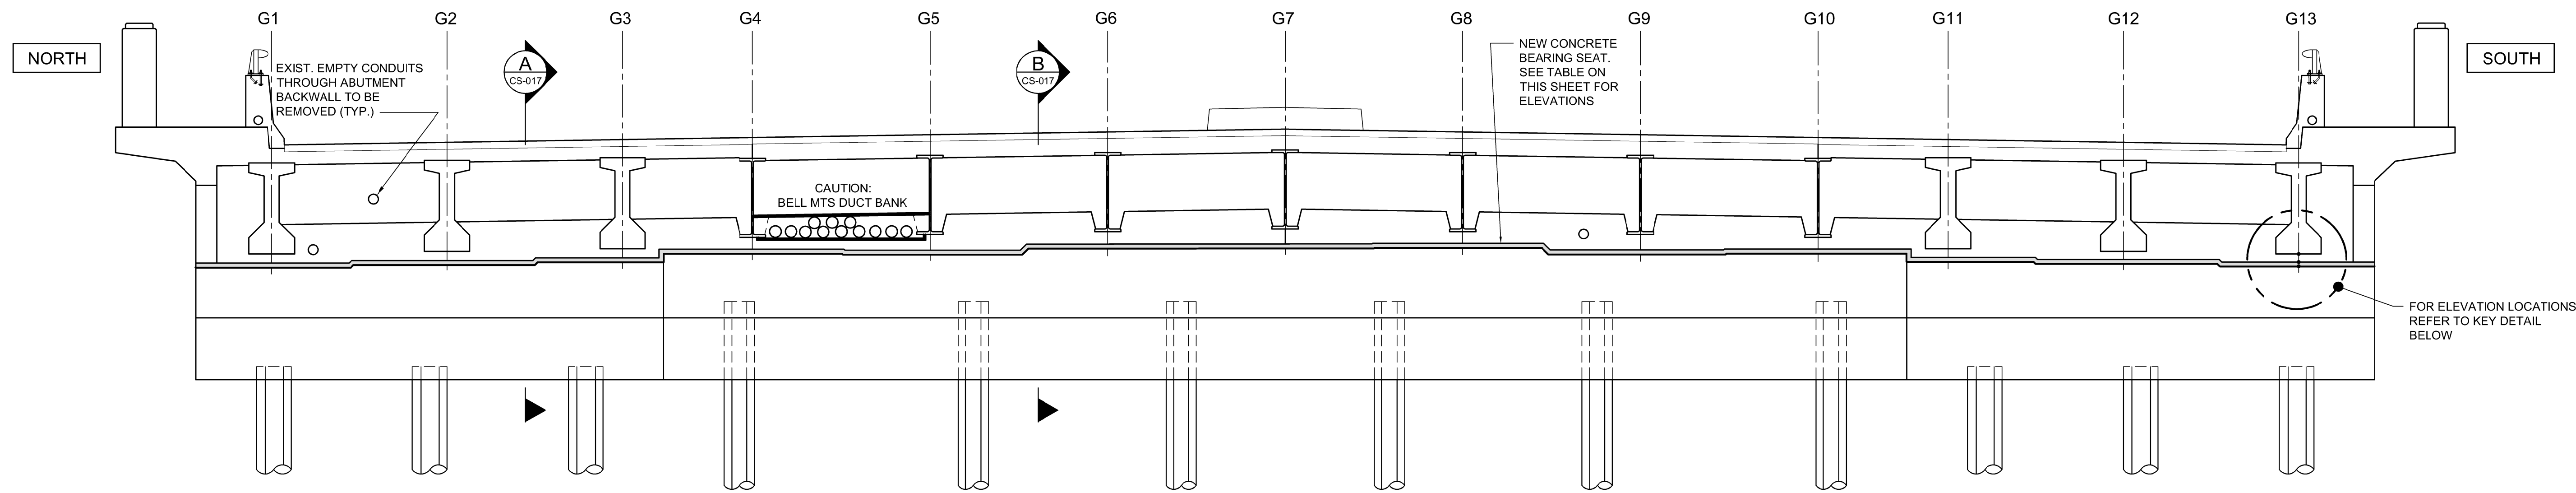
EAST ABUTMENT FRONT ELEVATION
1:40
NOTE: EXISTING SUPERSTRUCTURE SHOWN

EAST ABUTMENT				
ELEVATION LOCATION	EL. 'A' EXISTING U/S OF GIRDER ELEVATIONS (SITE SURVEY)	EL. 'B' EXISTING ELEVATION OF ABUTMENT CAP AT GIRDER CL (SITE SURVEY)	EL. 'C' PROPOSED U/S OF GIRDER ELEVATION	EL. 'D' FINAL ELEVATION OF BEARING SEAT AT ABUTMENT CL
G1	231.259	231.104	231.254	231.125
G2	231.267	231.108	231.273	231.144
G3	231.296	231.143	231.300	231.171
G4	231.447	231.248	231.448	231.351
G5	231.468	231.241	231.475	231.378
G6	231.511	231.309	231.509	231.412
G7	231.531	231.307	231.531	231.434
G8	231.507	231.312	231.509	231.412
G9	231.481	231.240	231.475	231.378
G10	231.449	231.245	231.448	231.351
G11	231.303	231.145	231.300	231.171
G12	231.279	231.122	231.273	231.144
G13	231.249	231.085	231.254	231.125

- NOTES:**
- THE EXISTING U/S GIRDER ELEVATIONS DO NOT APPEAR TO AGREE WITH THE THEORETICAL U/S GIRDER ELEVATIONS FROM THE 1954, 1969 AND 1984 DRAWINGS.
 - THE DESIGN PHILOSOPHY WAS TO MAINTAIN THE UNDERSIDE GIRDER ELEVATIONS AFTER REHABILITATION TO LIMIT STRESSES IN THE STRUCTURE OTHERWISE CAUSED BY DIFFERENTIAL GIRDER MOVEMENTS.
 - THE ELEVATIONS IN THE TABLE WERE SURVEYED BY DILLON CONSULTING LIMITED IN OCTOBER, 2017. THE CONTRACTOR SHALL VERIFY THE EXISTING UNDERSIDE GIRDER ELEVATIONS PRIOR TO JACKING THE SUPERSTRUCTURE AND REVIEW THE RESULTS WITH THE CONTRACT ADMINISTRATOR.
 - EXISTING OR PROPOSED BEARINGS ARE NOT SHOWN FOR CLARITY. SEE SHEETS CS-022 & CS-023 FOR BEARING DETAILS.

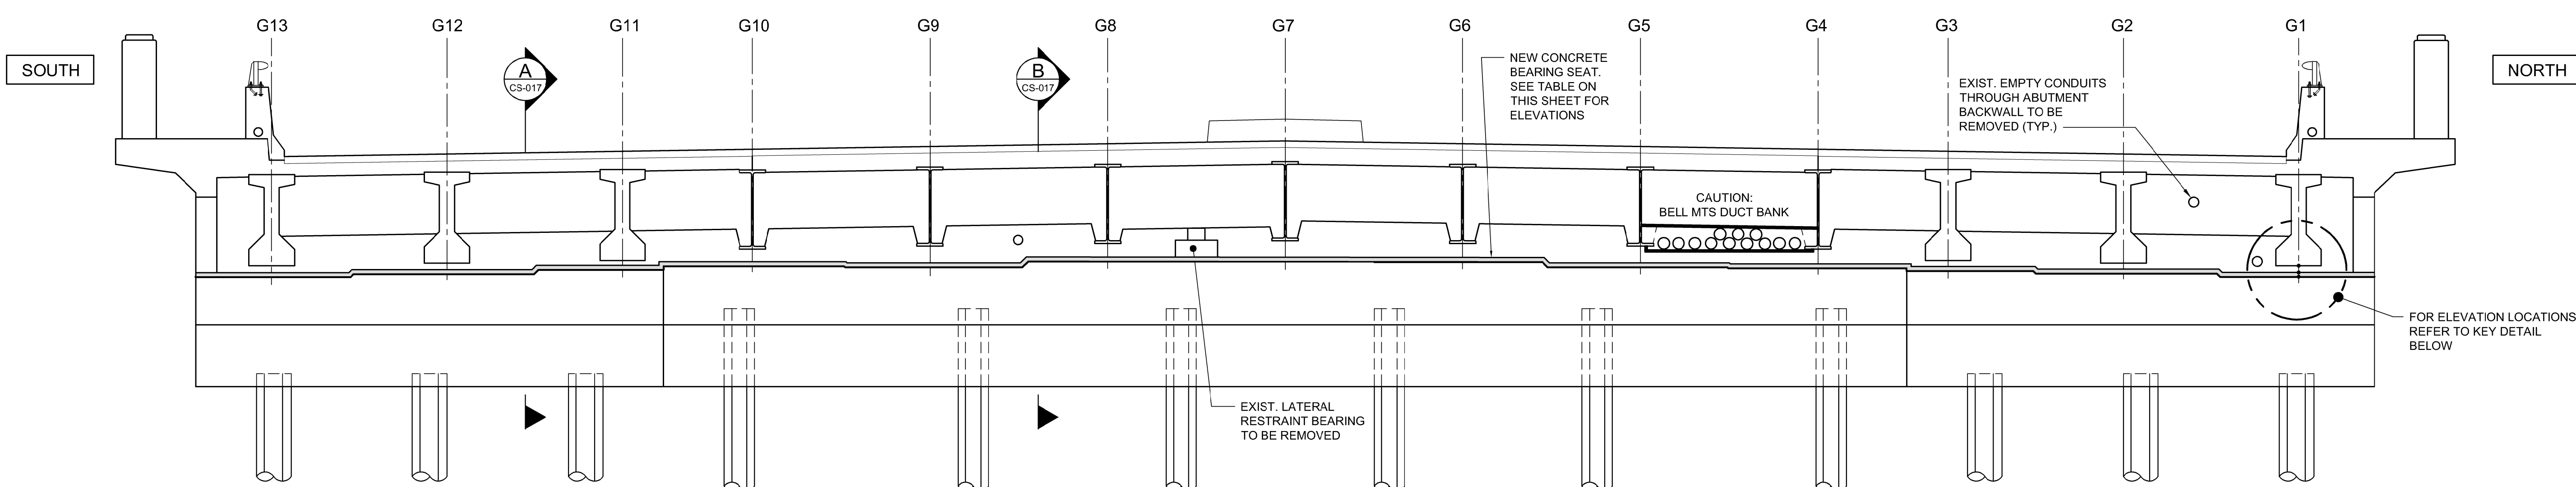
WEST ABUTMENT FRONT ELEVATION
1:40
NOTE: EXISTING SUPERSTRUCTURE SHOWN

WEST ABUTMENT				
ELEVATION LOCATION	EL. 'A' EXISTING U/S OF GIRDER ELEVATIONS (SITE SURVEY)	EL. 'B' EXISTING ELEVATION OF ABUTMENT CAP AT GIRDER CL (SITE SURVEY)	EL. 'C' PROPOSED U/S OF GIRDER ELEVATION	EL. 'D' FINAL ELEVATION OF BEARING SEAT AT ABUTMENT CL
G1	231.235	231.069	231.232	231.103
G2	231.253	231.096	231.254	231.125
G3	231.286	231.127	231.295	231.166
G4	231.383	231.168	231.387	231.290
G5	231.410	231.159	231.412	231.315
G6	231.446	231.230	231.450	231.353
G7	231.478	231.242	231.478	231.381
G8	231.454	231.244	231.450	231.353
G9	231.414	231.172	231.412	231.315
G10	231.390	231.188	231.387	231.290
G11	231.303	231.139	231.295	231.166
G12	231.255	231.087	231.254	231.125
G13	231.228	231.069	231.232	231.103

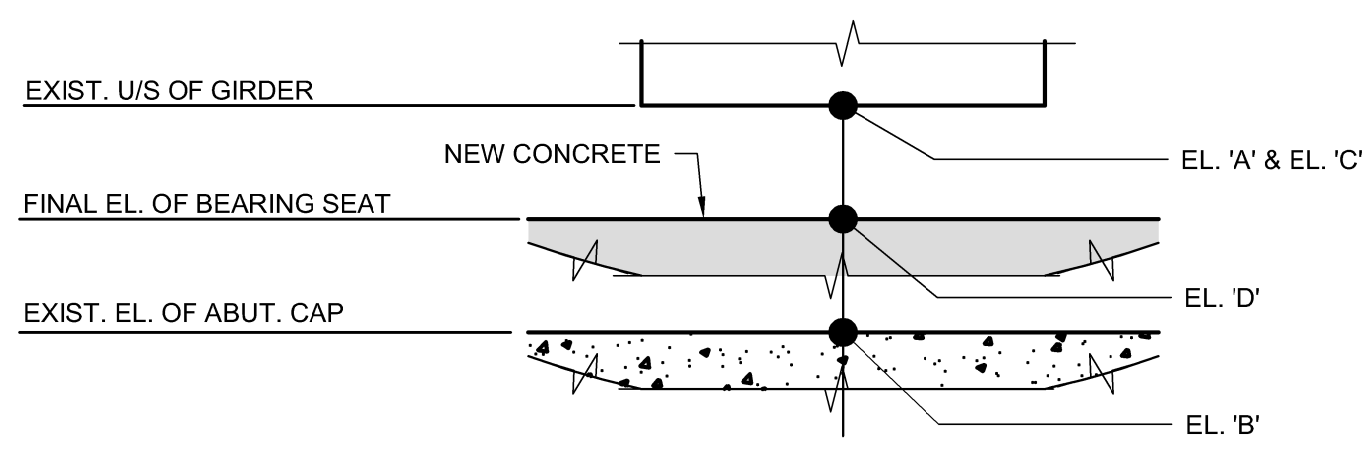
KEY DETAIL
NOTE: REFER TO TABLES SHOWN THIS SHEET FOR ELEVATIONS
