# APPENDIX 'B' PAVEMENT CORE REPORT

## Pavement Core Location Plan Pembina Highway Northbound, Ducharme Avenue to Cloutier Drive

## TABLE 1 PEMBINA HIGHWAY FROM CLOUTIER DRIVE TO DUCHARME AVENUE CORING INVESTIGATION

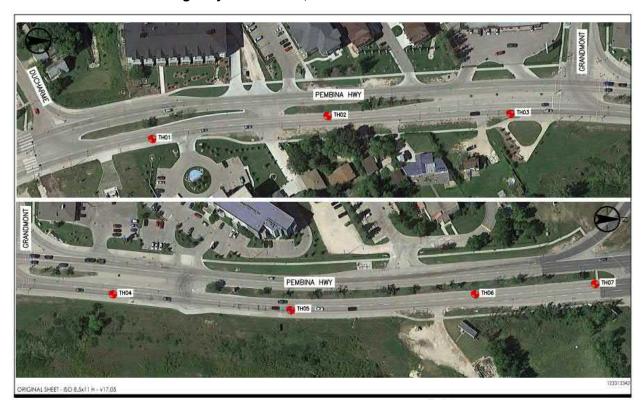
Image obtained from Stantec Consulting Ltd. Geotechnical Report (Image source: Google Earth)
