Project
WINNIPEG TRANSIT
 2018 STRUCTURAL AND ROOFING REPAIRS

1520 MAIN STREET
 WINNIPEG, MANITOBA

Sheet Title
 TYPICAL SECTIONS & DETAILS

File	2018-0145	Date	2018-06-04
Design	IM	Drawn	DNM
Revision	0	Sheet No.	S5.1

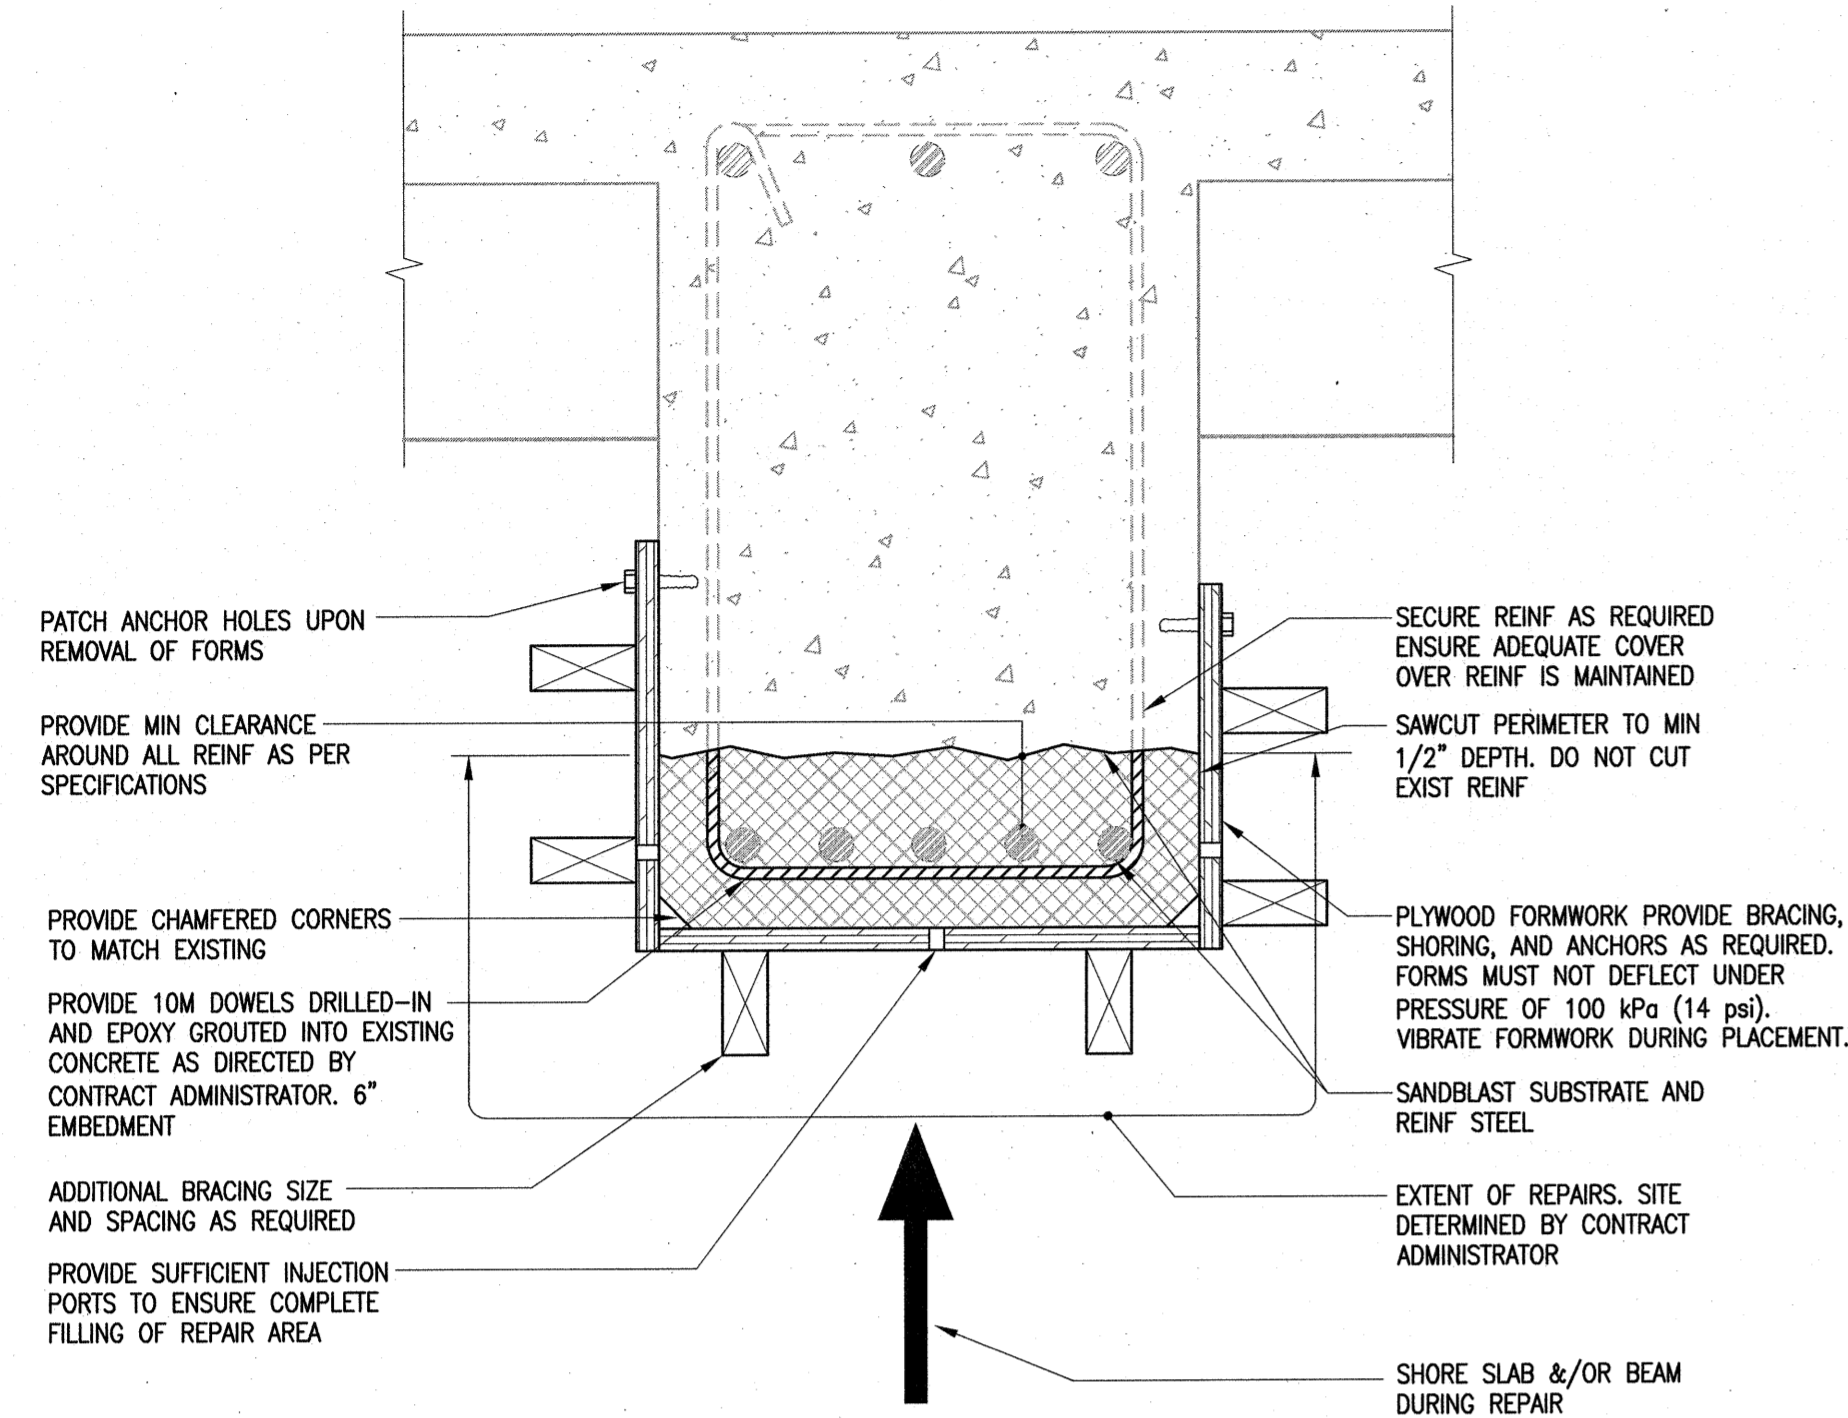
1 TYPICAL BEAM PRESSURE GROUTING REPAIR
 * S5.1 N.T.S.

INSTALL TEMPORARY BEAM SHORING. SHORING REQUIREMENTS AND SETUP TO BE COORDINATED WITH CONTRACT ADMINISTRATOR

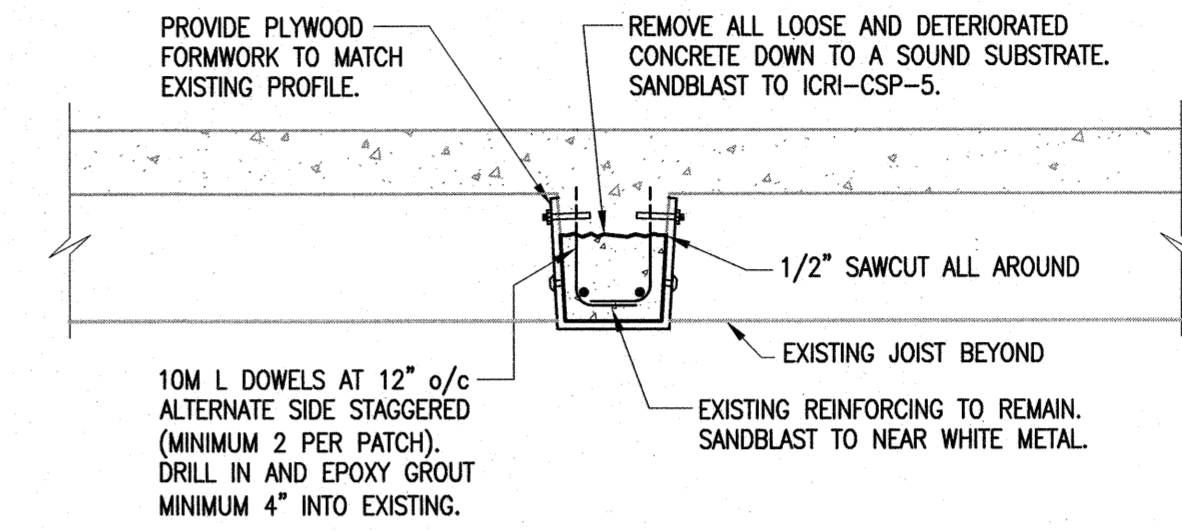
3 JOIST PRESSURE GROUTING REPAIR
 S2.1 S5.1 N.T.S. (UNIT PRICE PER LINEAL FOOT)
