Pavement Investigation

City of Winnipeg Street Investigation

WX19433

CITY OF WINNIPEG STREET CORING
REHABILITATION OF GRANT AVENUE
FROM KENASTON BOULEVARD TO MONTROSE STREET
WINNIPEG, MANITOBA

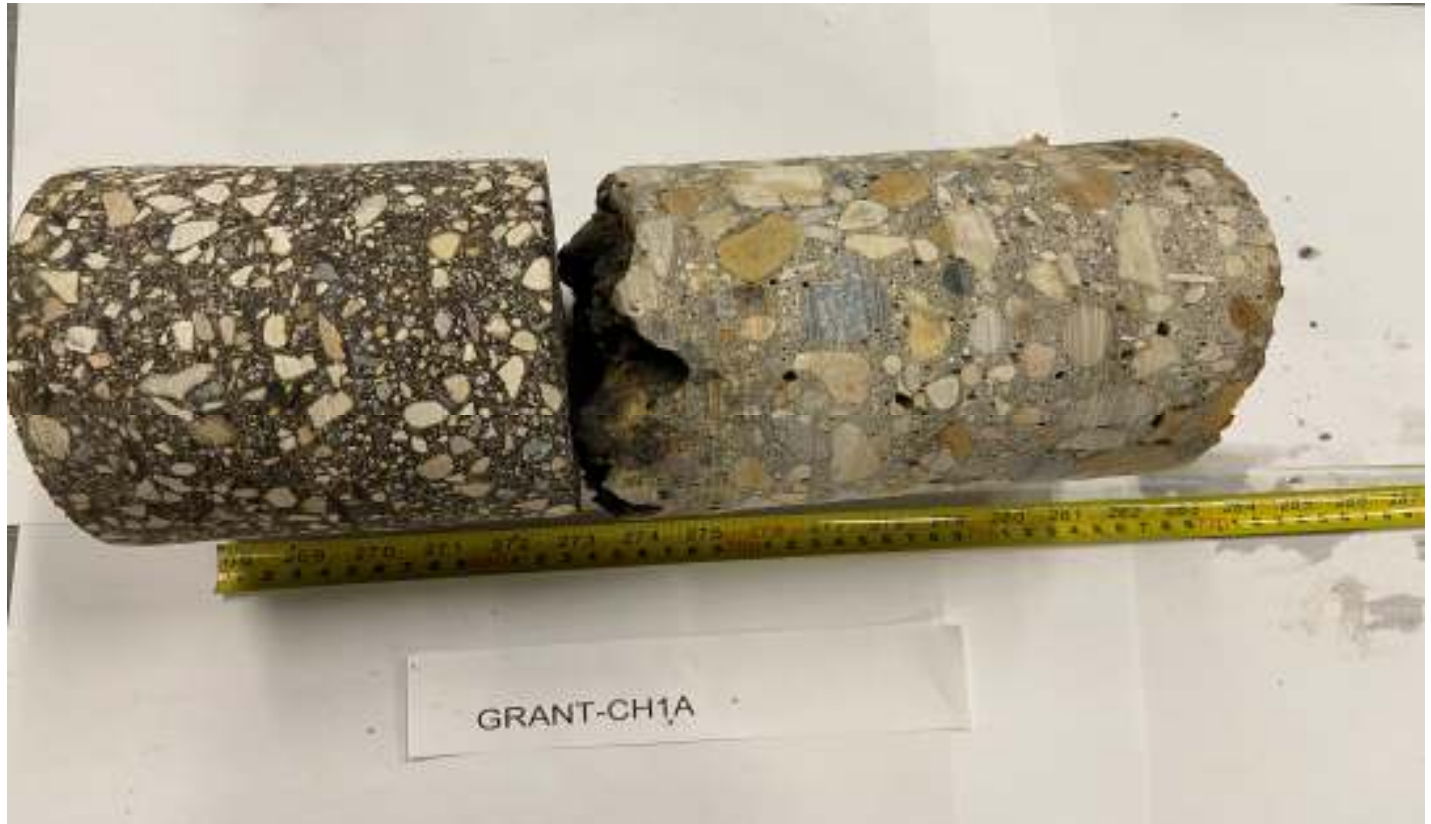
Asphalt		Concrete		
Thickness (mm)	Density (kg/m ³)	Thickness (mm)	Density (kg/m ³)	Compressive Strength (MPa)
138	2370	200.0	2357	50.0
Underlying Structure:		Clay Fill – gravelly, silty, high plastic, moist, stiff, brown

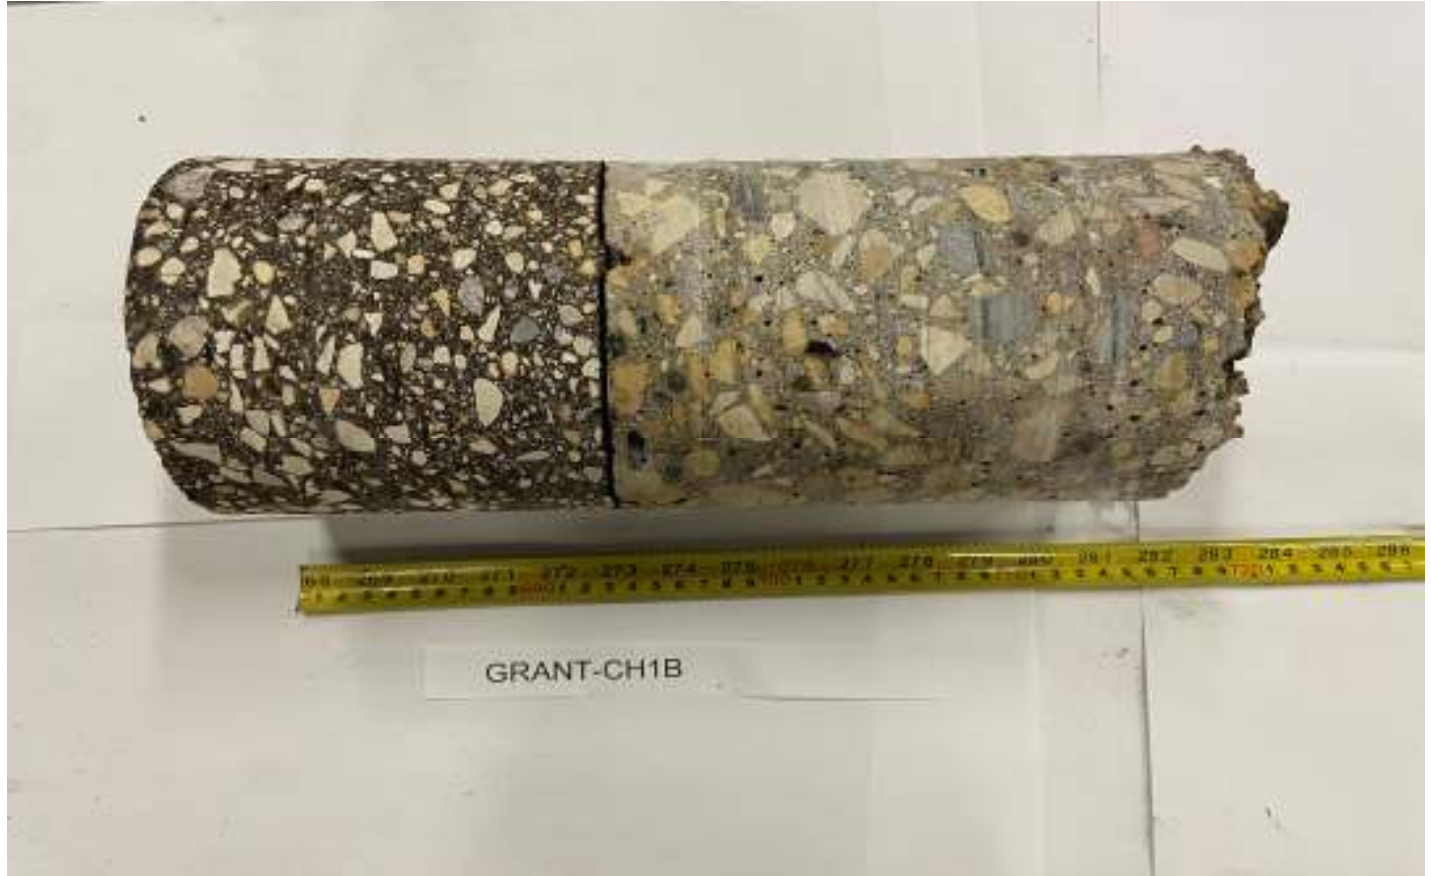
Asphalt		Concrete		
Thickness (mm)	Density (kg/m ³)	Thickness (mm)	Density (kg/m ³)	Compressive Strength (MPa)
138	2363	200.0	2278	49.6
Underlying Structure:		Clay Fill – gravelly, silty, high plastic, moist, stiff, brown

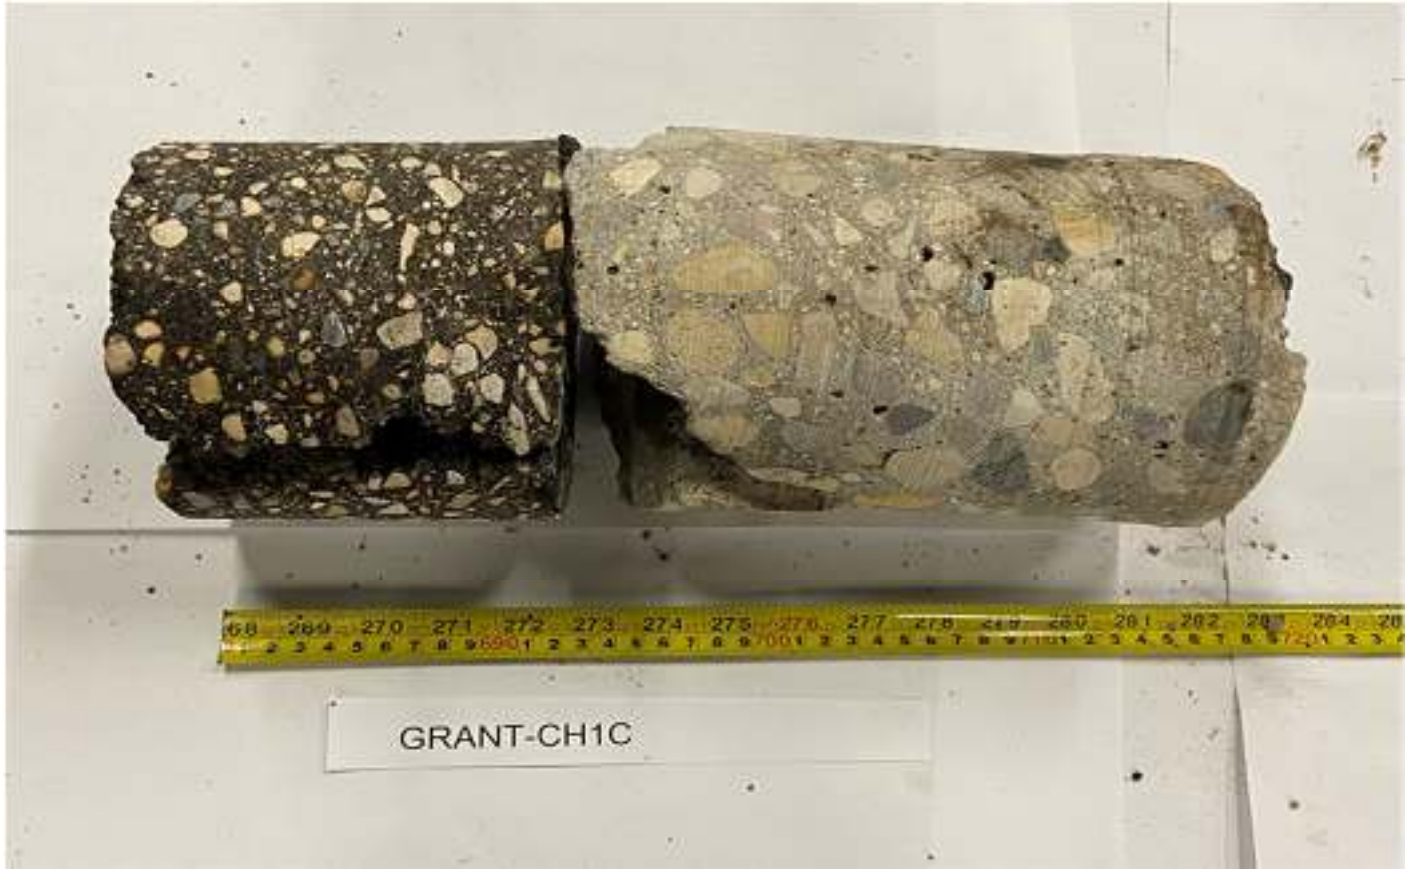
Asphalt		Concrete		
Thickness (mm)	Density (kg/m ³)	Thickness (mm)	Density (kg/m ³)	Compressive Strength (MPa)
138	N/A	200.0	N/A	N/A
Underlying Structure:		Clay Fill – gravelly, silty, high plastic, moist, stiff, brown

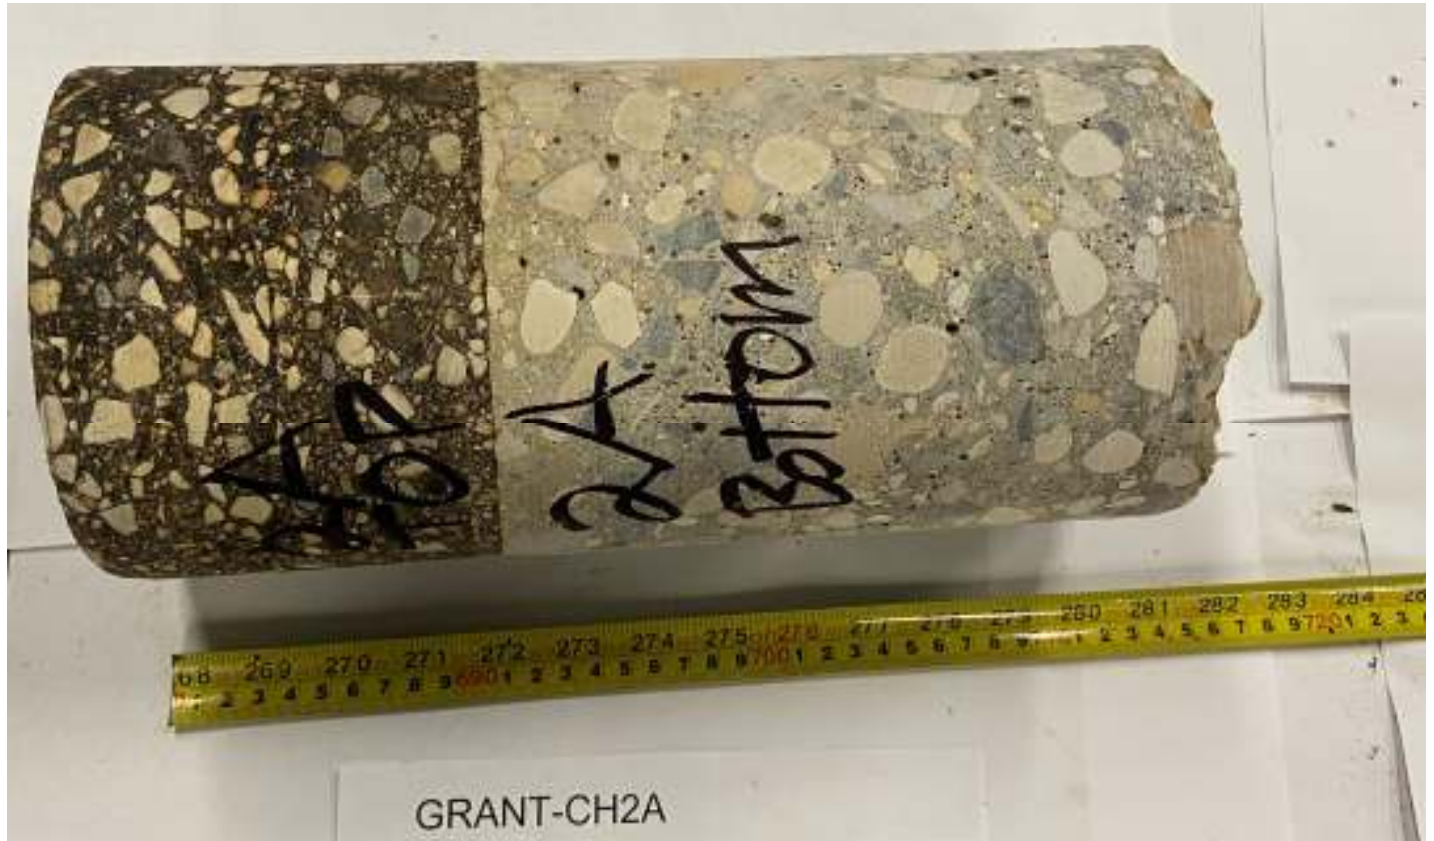
Asphalt		Concrete		
Thickness (mm)	Density (kg/m ³)	Thickness (mm)	Density (kg/m ³)	Compressive Strength (MPa)
112	2387	209	2367	49.7
Underlying Structure:		Gravel Fill – poorly graded, medium grained, moist, compact to dense (inferred), brown (20mm Limestone)

CORE PHOTOGRAPHS PAVEMENT CORE SAMPLE GRANT-CH2A WINNIPEG, MANITOBA			
Wood Environment and Infrastructure Solutions	MID-SLAB			
Drawn: JW	Scale: N/A	Date: 7 September 2021	Project No.: WX19433	Figure: A5

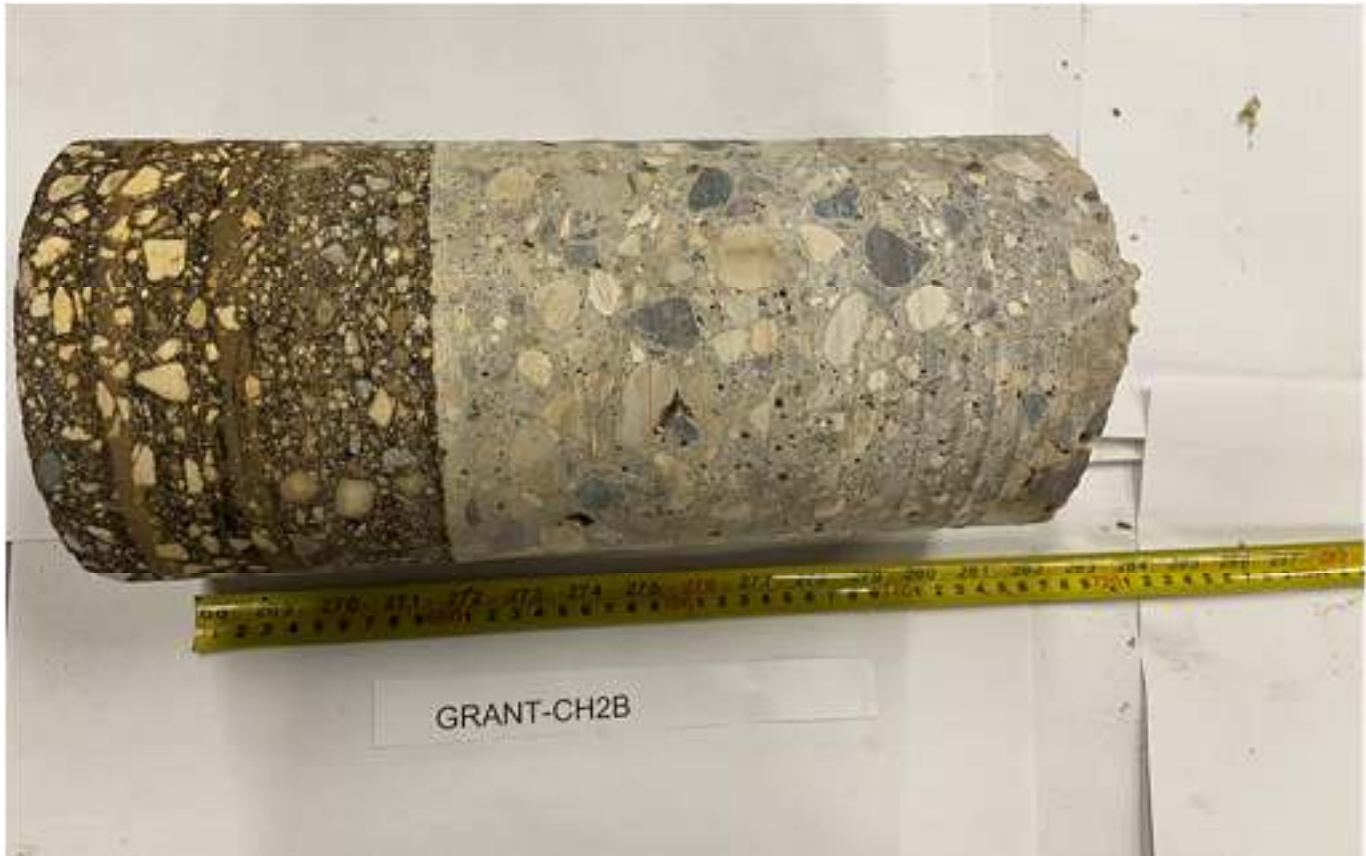
Asphalt		Concrete		
Thickness (mm)	Density (kg/m ³)	Thickness (mm)	Density (kg/m ³)	Compressive Strength (MPa)
112	2366	222	2381	52.0
Underlying Structure:		Gravel Fill – poorly graded, medium grained, moist, compact to dense (inferred), brown (20mm Limestone)

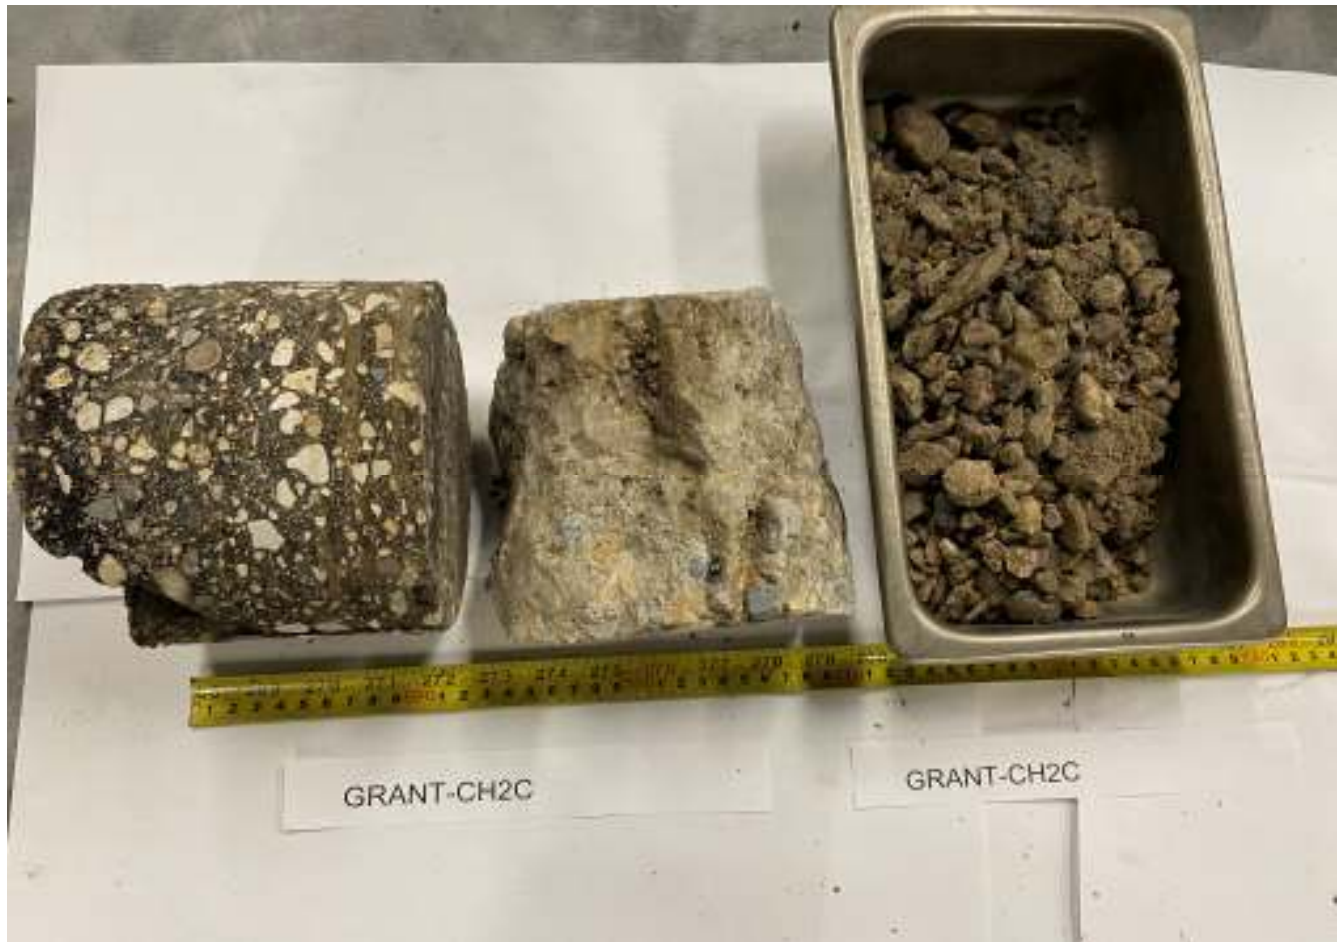
Asphalt		Concrete		
Thickness (mm)	Density (kg/m ³)	Thickness (mm)	Density (kg/m ³)	Compressive Strength (MPa)
121	N/A	200	N/A	N/A
Underlying Structure:		Gravel Fill – poorly graded, medium grained, moist, compact to dense (inferred), brown (20mm Limestone)

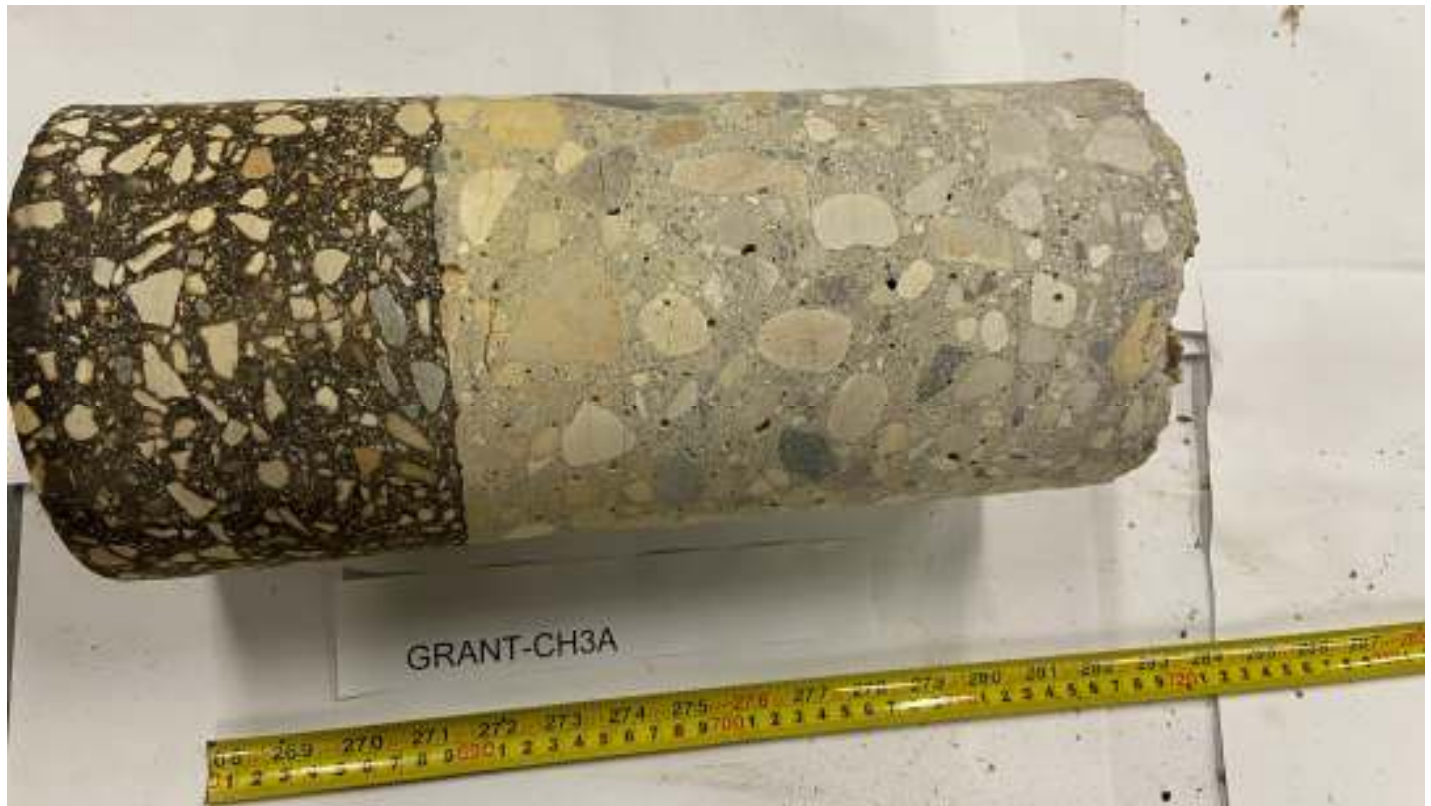
Asphalt		Concrete		
Thickness (mm)	Density (kg/m ³)	Thickness (mm)	Density (kg/m ³)	Compressive Strength (MPa)
110	2394	226	2404	56.3
Underlying Structure:		Gravel Fill – poorly graded, medium grained, moist, compact to dense (inferred), brown (20mm Limestone)

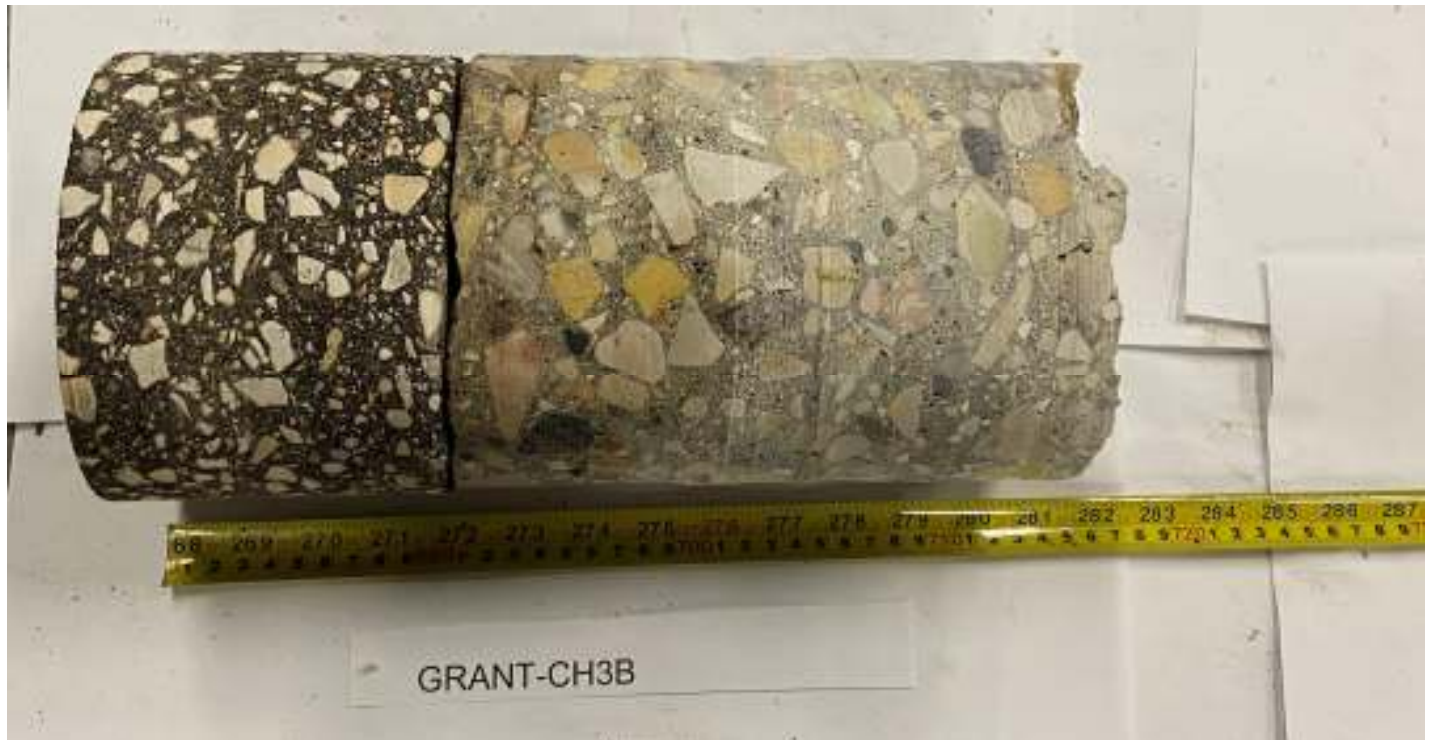
Asphalt		Concrete		
Thickness (mm)	Density (kg/m ³)	Thickness (mm)	Density (kg/m ³)	Compressive Strength (MPa)
110	2389	215	2421	49.3
Underlying Structure:		Gravel Fill – poorly graded, medium grained, moist, compact to dense (inferred), brown (20mm Limestone)

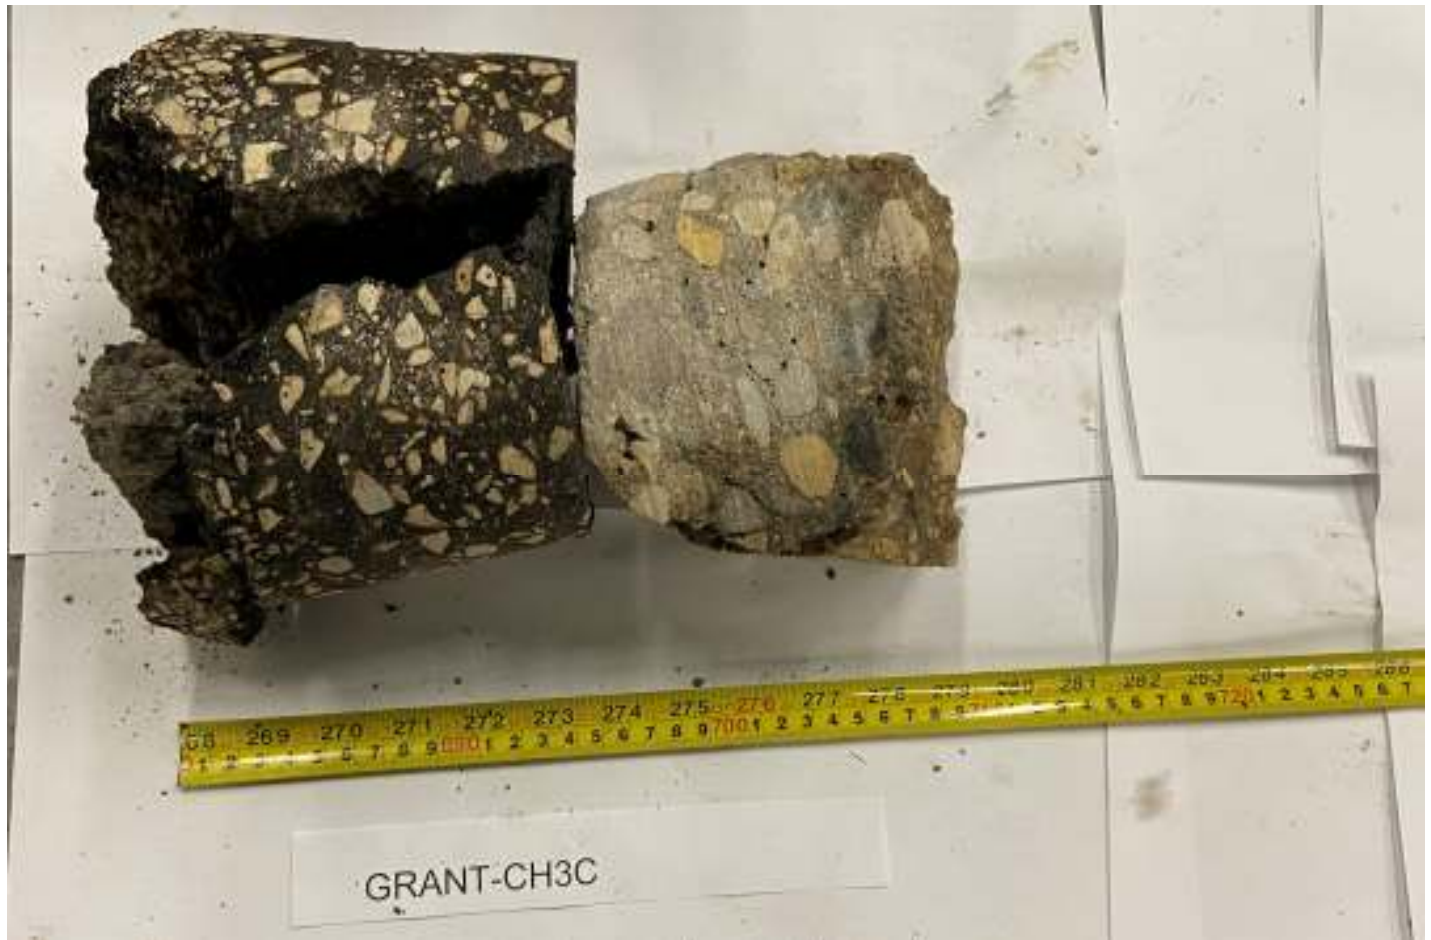
Asphalt		Concrete		
Thickness (mm)	Density (kg/m ³)	Thickness (mm)	Density (kg/m ³)	Compressive Strength (MPa)
150	N/A	198	N/A	N/A
Underlying Structure:		Gravel Fill – poorly graded, medium grained, moist, compact to dense (inferred), brown (20mm Limestone)

CORE PHOTOGRAPHS PAVEMENT CORE SAMPLE GRANT-CH3C WINNIPEG, MANITOBA		
Wood Environment and Infrastructure Solutions		JOINT		
Drawn: JW	Scale: N/A	Date: 7 September 2021	Project No.: WX19433	Figure: A10

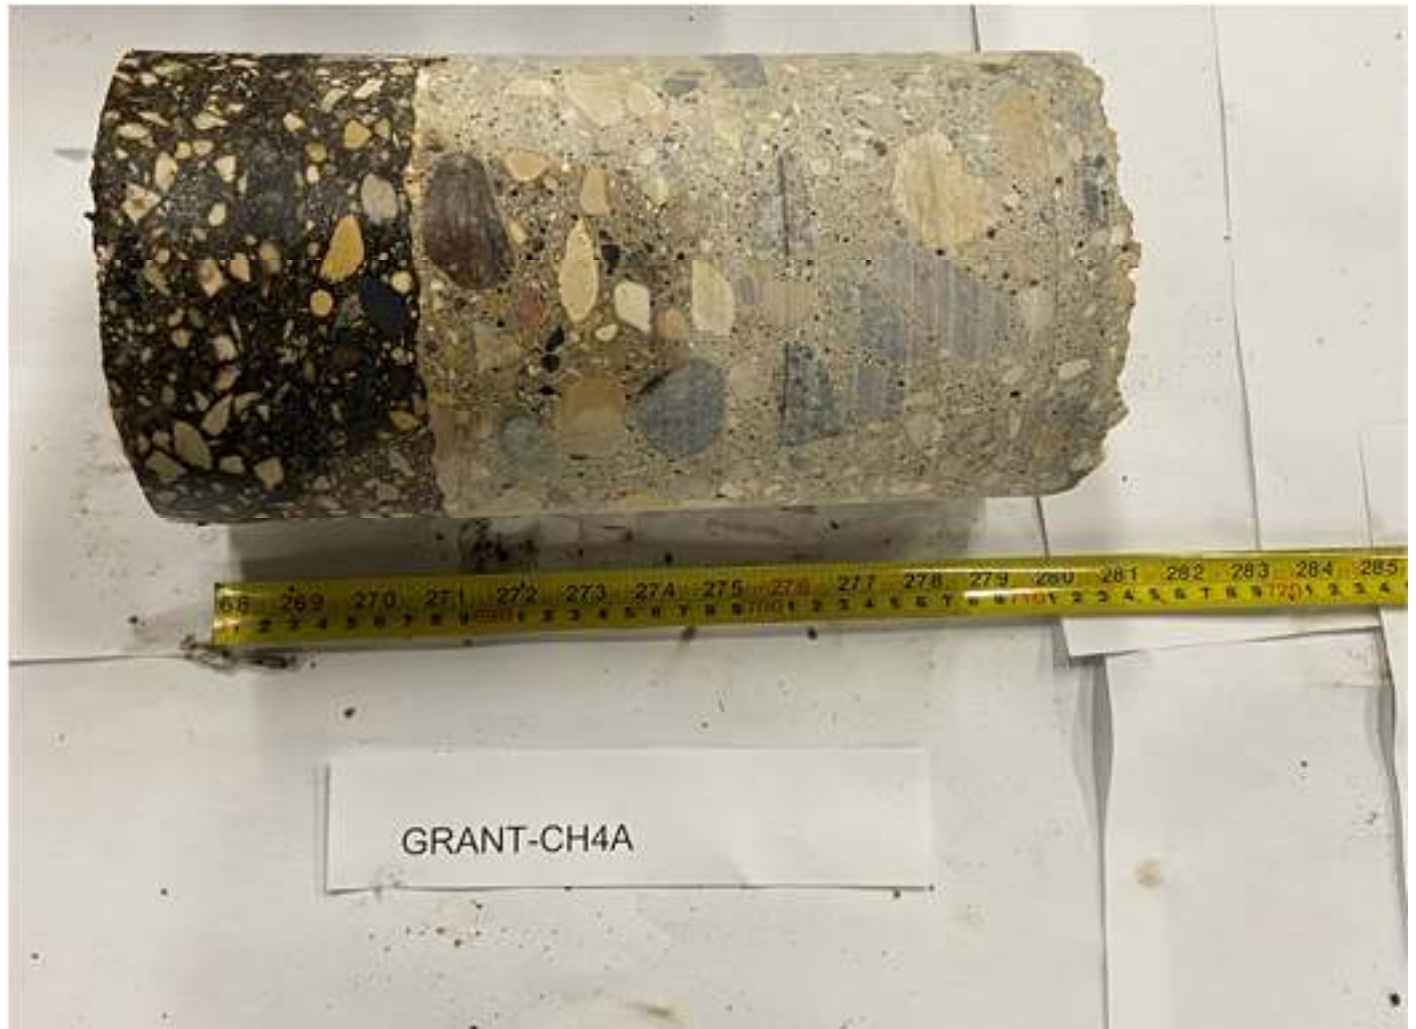
Asphalt		Concrete		
Thickness (mm)	Density (kg/m ³)	Thickness (mm)	Density (kg/m ³)	Compressive Strength (MPa)
112	2364	215	2337	45.8
Underlying Structure:		Gravel Fill – poorly graded, medium grained, moist, compact to dense (inferred), brown (20mm Limestone)

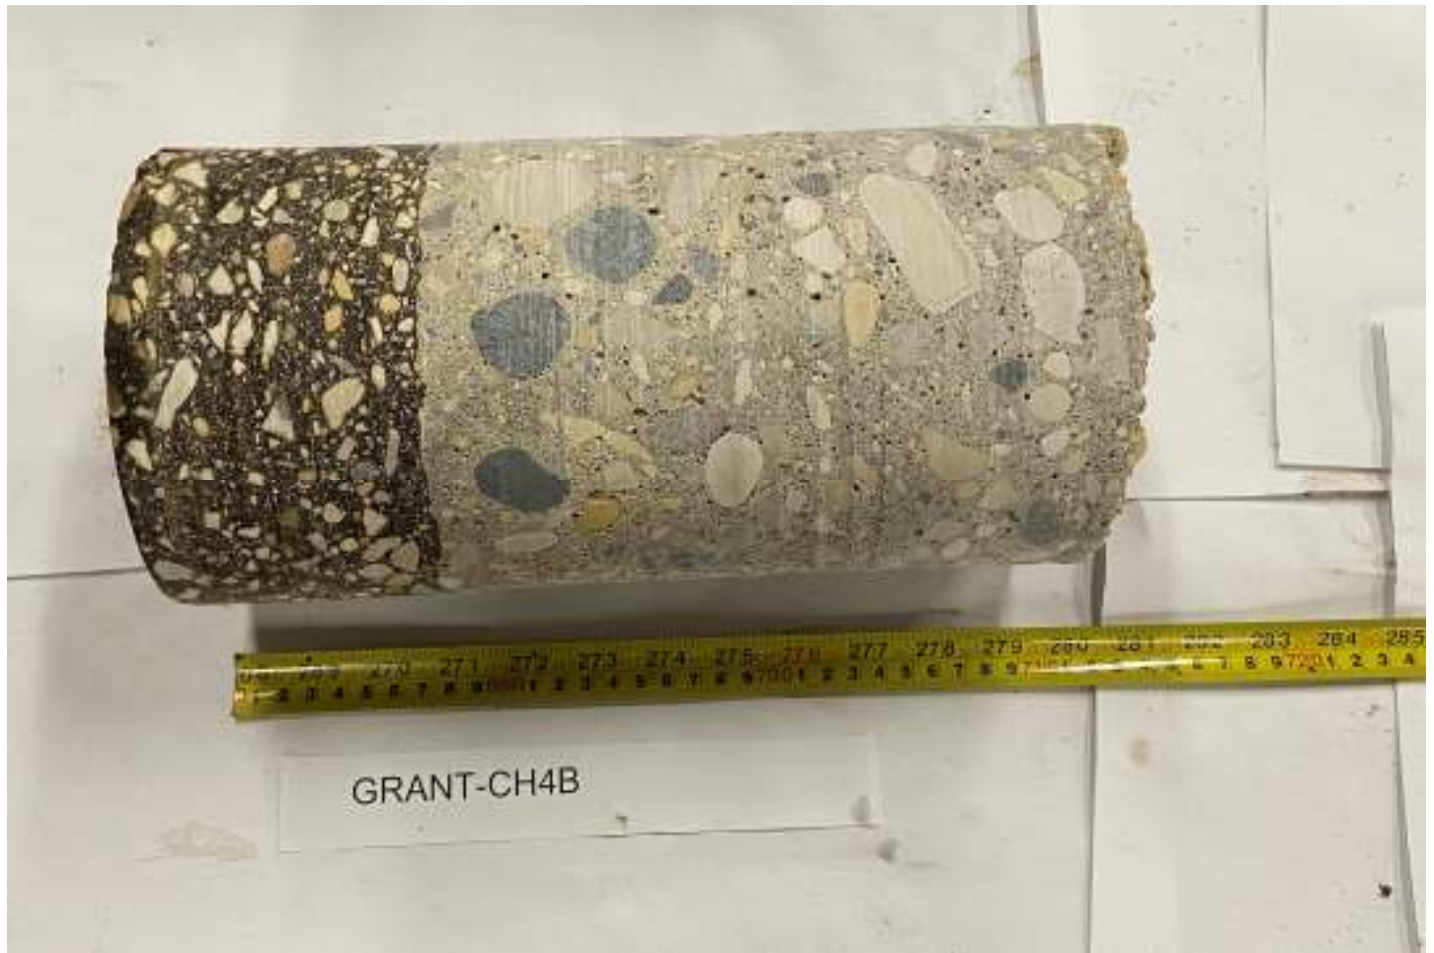
Asphalt		Concrete		
Thickness (mm)	Density (kg/m ³)	Thickness (mm)	Density (kg/m ³)	Compressive Strength (MPa)
90	2365	222	2318	33.2
Underlying Structure:		Gravel Fill – poorly graded, medium grained, moist, compact to dense (inferred), brown (20mm Limestone)

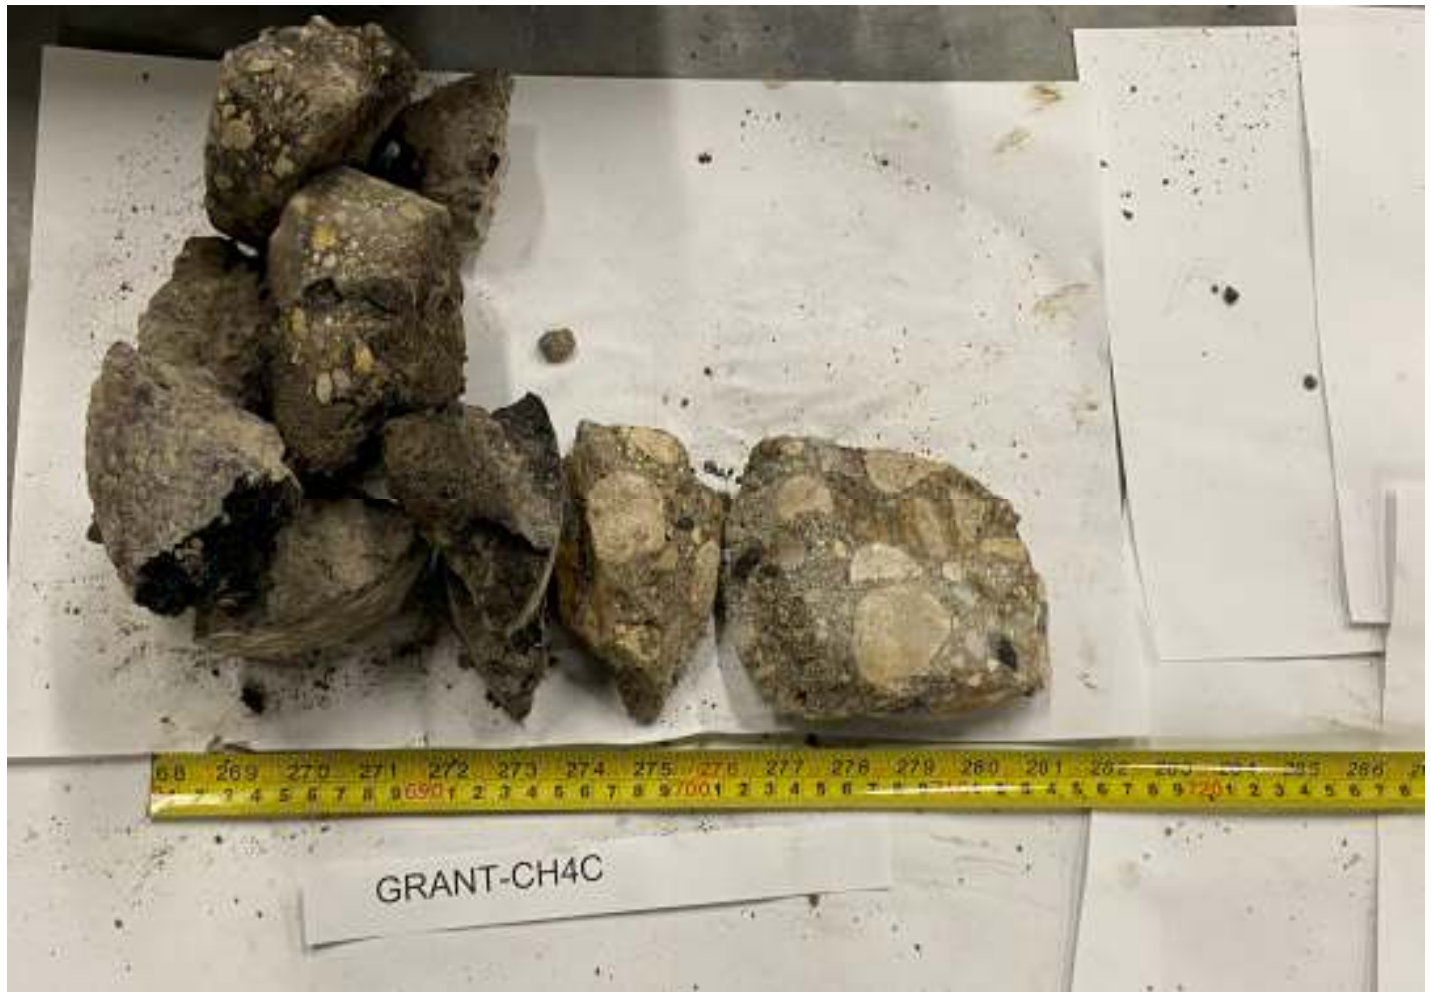
Asphalt		Concrete		
Thickness (mm)	Density (kg/m ³)	Thickness (mm)	Density (kg/m ³)	Compressive Strength (MPa)
110	N/A	230	N/A	N/A
Underlying Structure:		Gravel Fill – poorly graded, medium grained, moist, compact to dense (inferred), brown (20mm Limestone)

CORE PHOTOGRAPHS PAVEMENT CORE SAMPLE GRANT-CH4C WINNIPEG, MANITOBA			
Wood Environment and Infrastructure Solutions	JOINT			
Drawn: JW	Scale: N/A	Date: 7 September 2021	Project No.: WX19433	Figure: A13

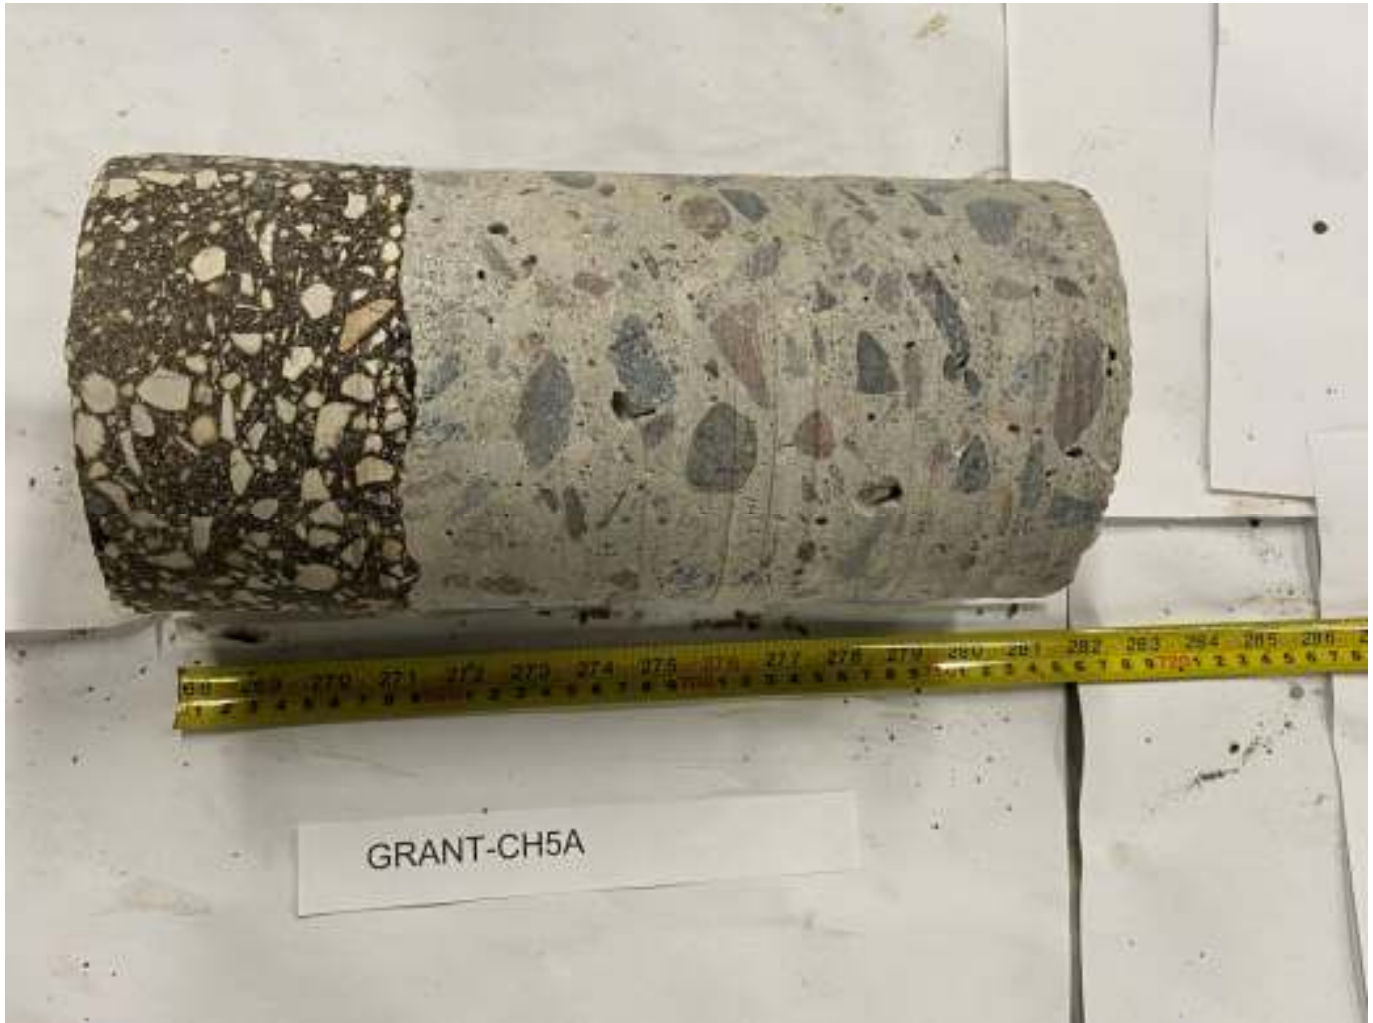
Asphalt		Concrete		
Thickness (mm)	Density (kg/m ³)	Thickness (mm)	Density (kg/m ³)	Compressive Strength (MPa)
91	2362	221	2312	41.7
Underlying Structure:		Gravel Fill – poorly graded, medium grained, moist, compact to dense (inferred), brown (20mm Limestone)

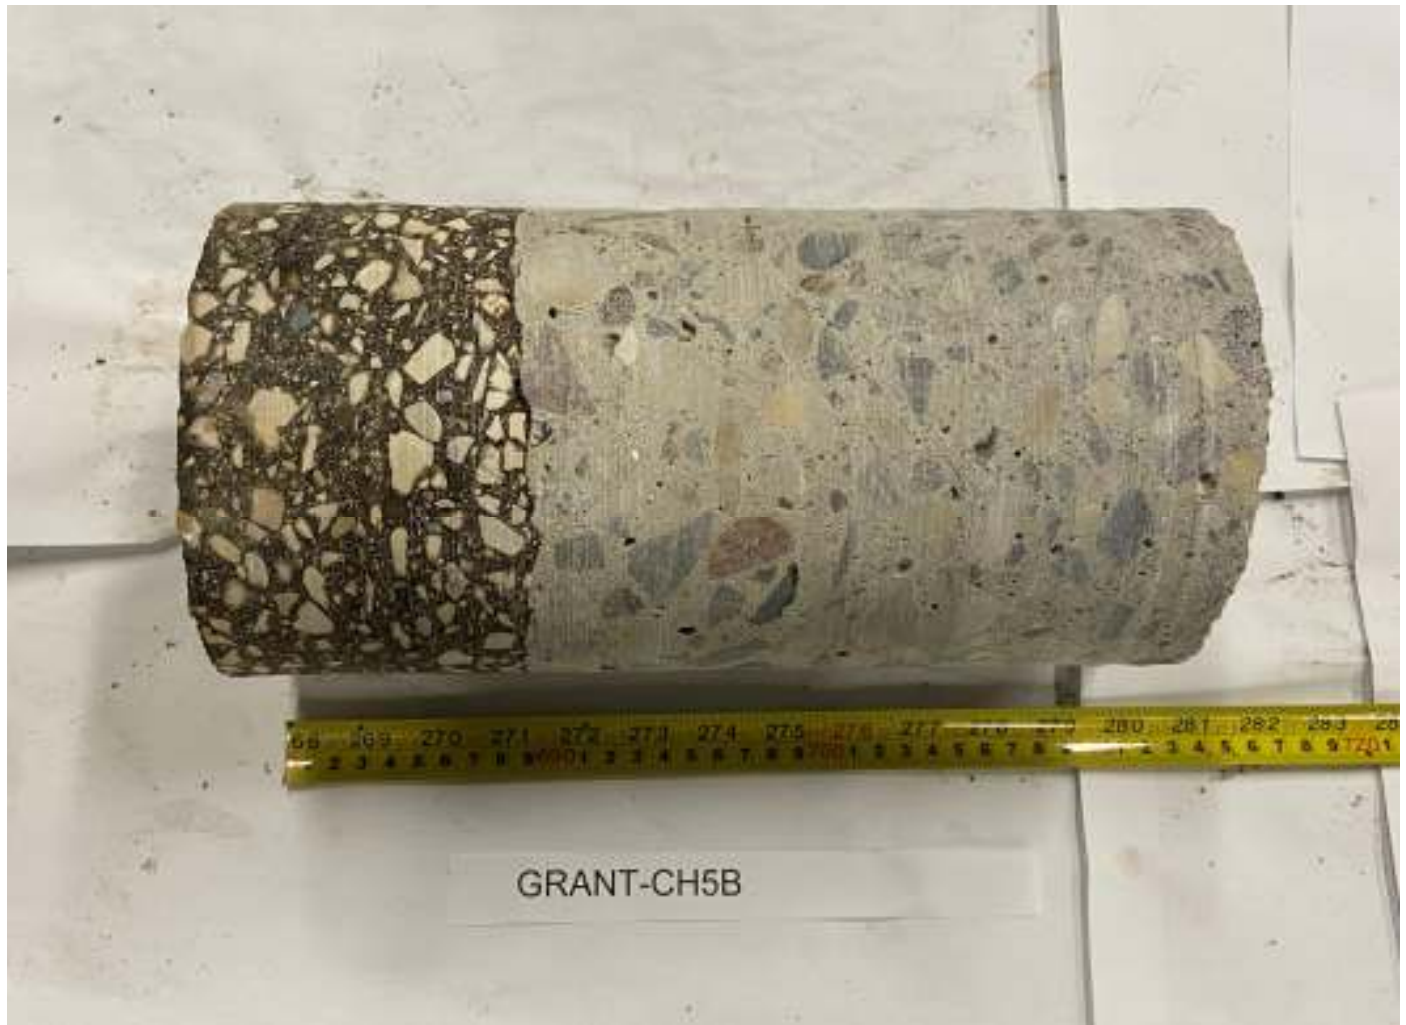
Asphalt		Concrete		
Thickness (mm)	Density (kg/m ³)	Thickness (mm)	Density (kg/m ³)	Compressive Strength (MPa)
93	2350	210	2317	35.2
Underlying Structure:		Gravel Fill – poorly graded, medium grained, moist, compact to dense (inferred), brown (20mm Limestone)

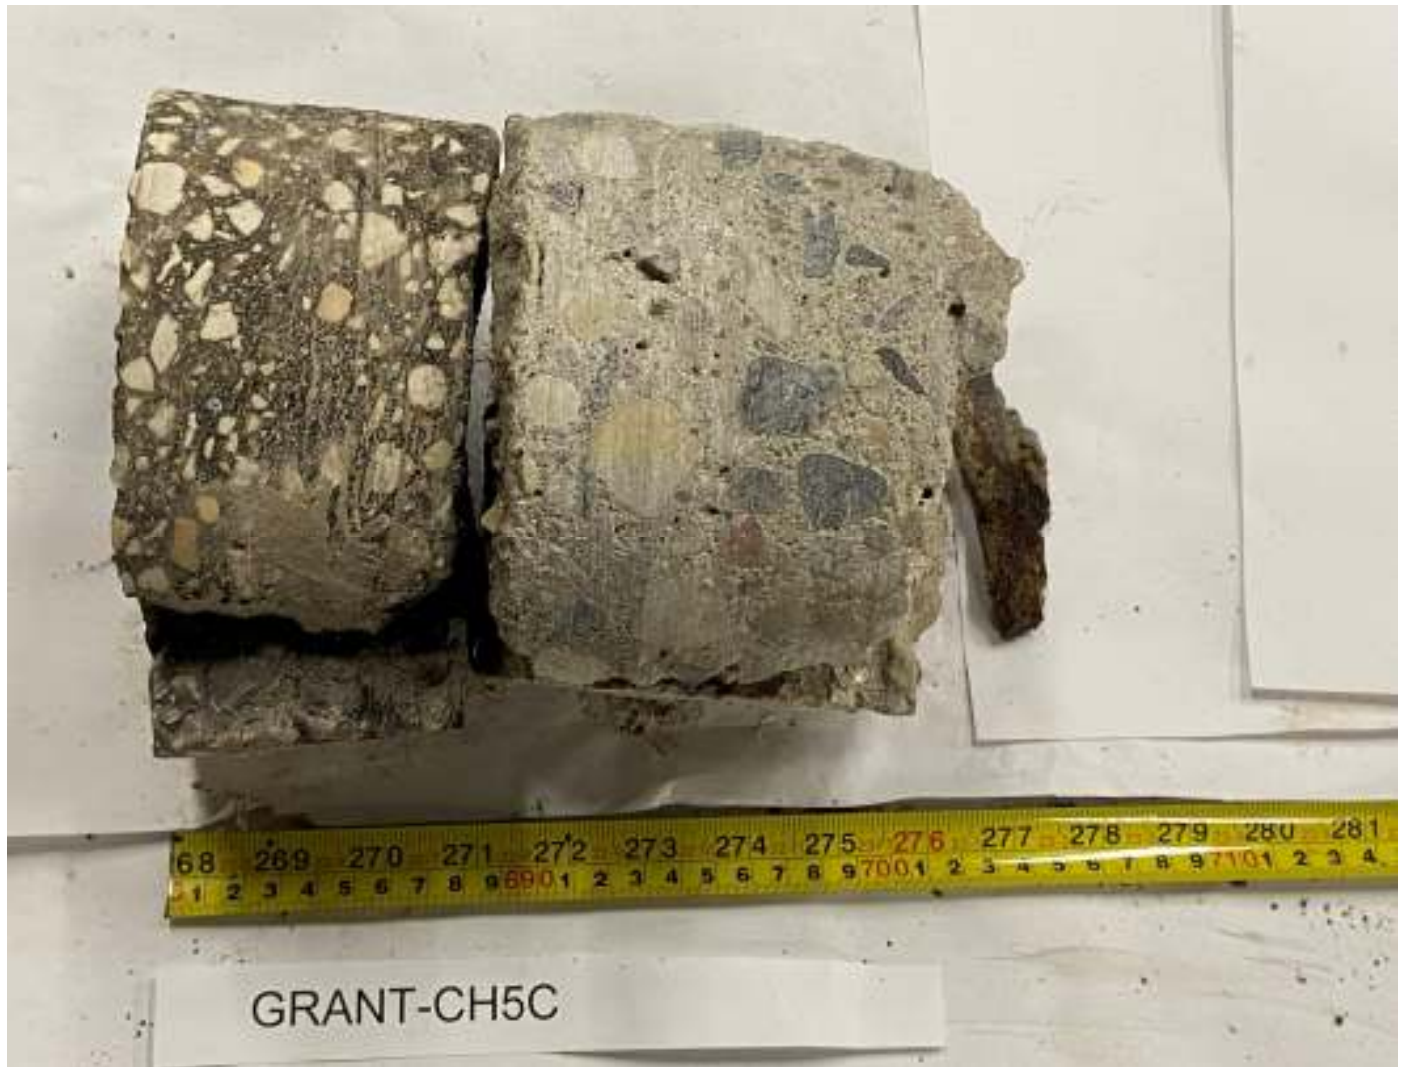
Asphalt		Concrete		
Thickness (mm)	Density (kg/m ³)	Thickness (mm)	Density (kg/m ³)	Compressive Strength (MPa)
85	N/A	230	N/A	N/A
Underlying Structure:		Gravel Fill – poorly graded, medium grained, moist, compact to dense (inferred), brown (20mm Limestone)

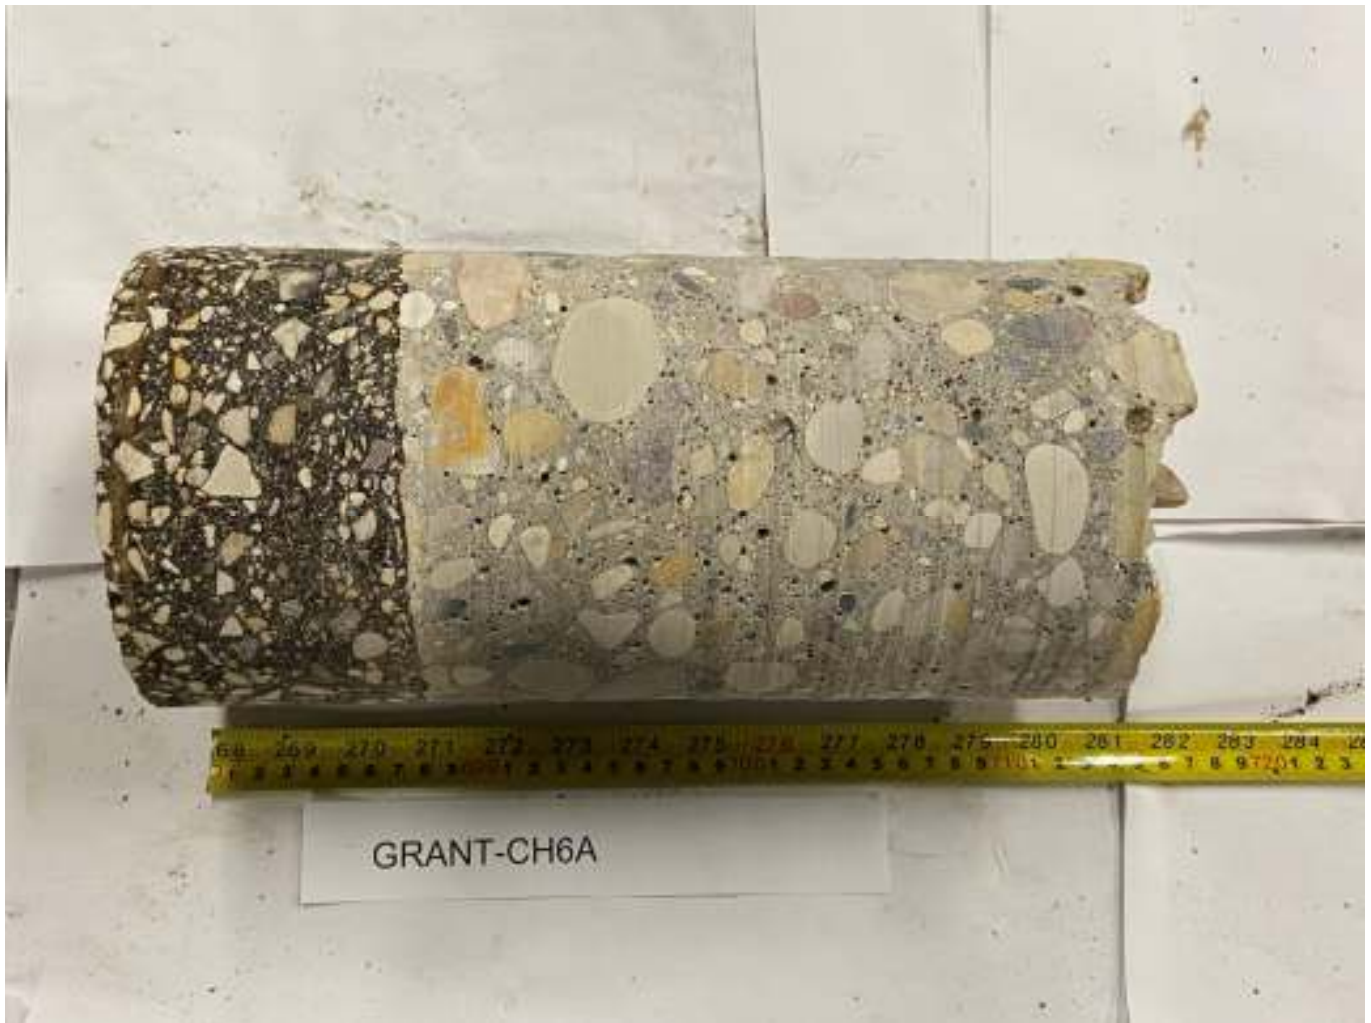
Asphalt		Concrete		
Thickness (mm)	Density (kg/m ³)	Thickness (mm)	Density (kg/m ³)	Compressive Strength (MPa)
90	2389	257	2332	44.0
Underlying Structure:		Gravel Fill – poorly graded, medium grained, moist, compact to dense (inferred), brown (20mm Limestone)
