Pavement Investigation

City of Winnipeg Street Investigation

WX19433

CITY OF WINNIPEG STREET CORING
REHABILITATION OF GRANT AVENUE
FROM KENASTON BOULEVARD TO MONTROSE STREET
WINNIPEG, MANITOBA

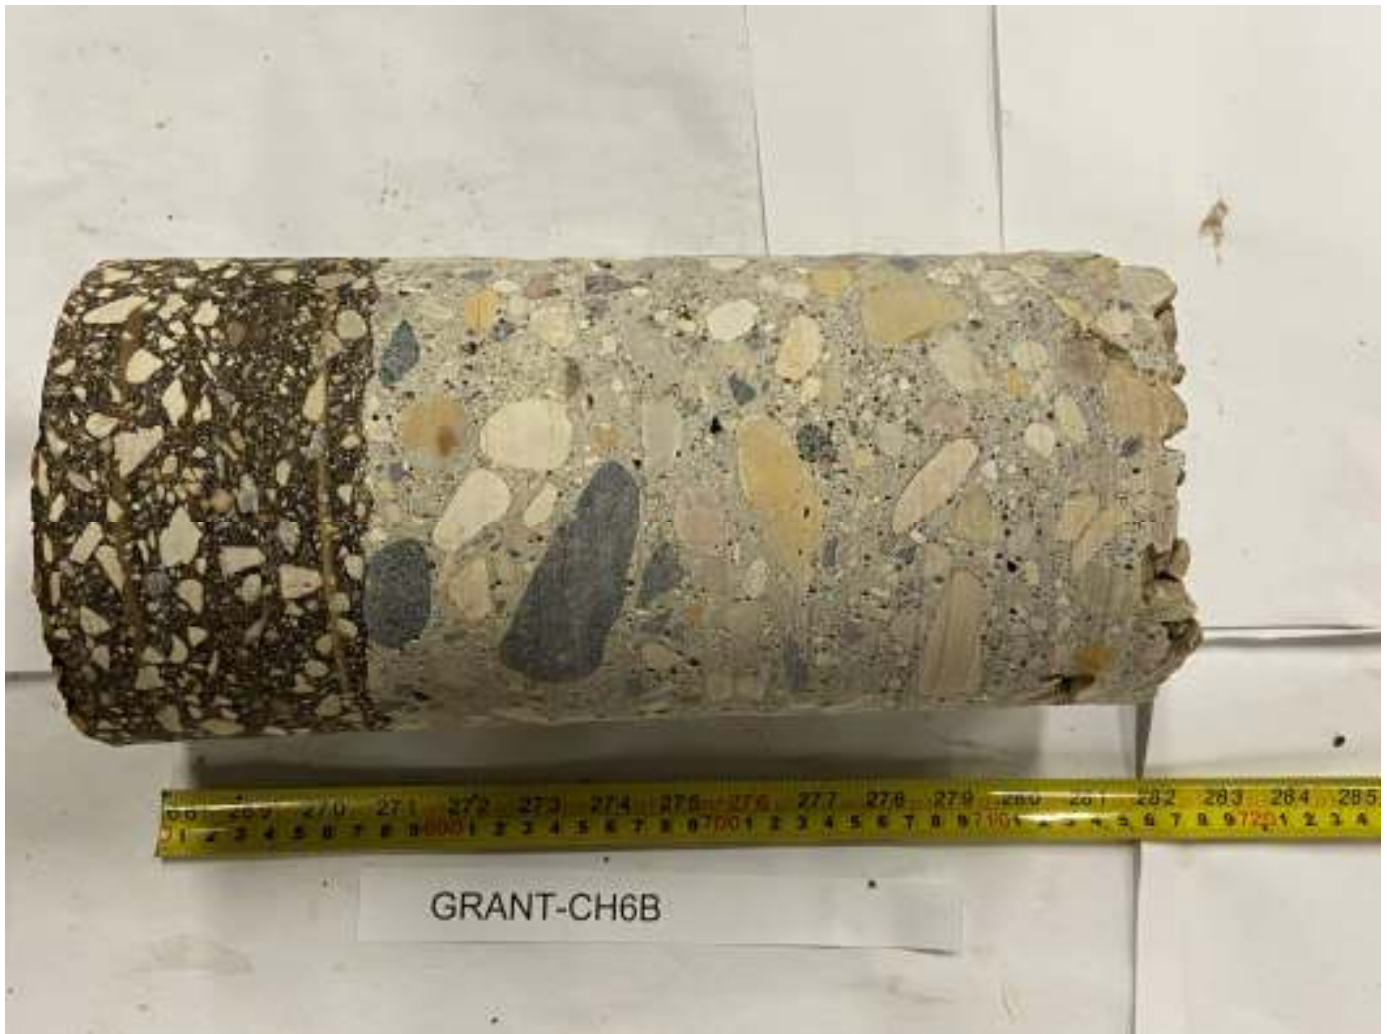
Asphalt		Concrete		
Thickness (mm)	Density (kg/m ³)	Thickness (mm)	Density (kg/m ³)	Compressive Strength (MPa)
86	2388	236	2337	40.8
Underlying Structure:		Gravel Fill – poorly graded, medium grained, moist, compact to dense (inferred), brown (20mm Limestone)

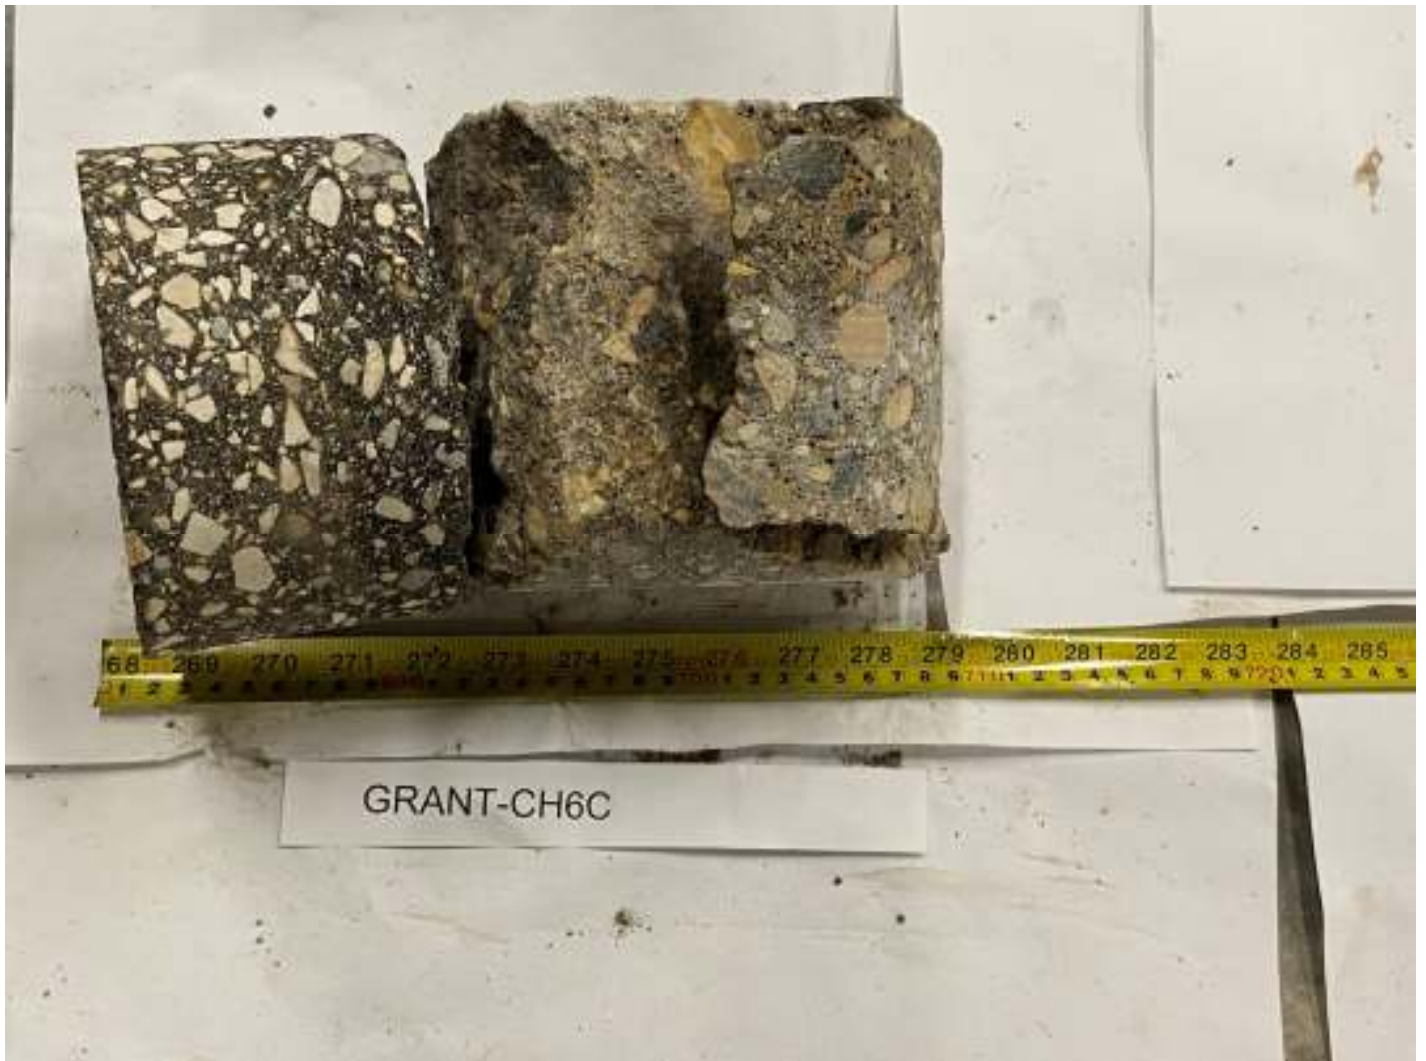
Asphalt		Concrete		
Thickness (mm)	Density (kg/m ³)	Thickness (mm)	Density (kg/m ³)	Compressive Strength (MPa)
95	N/A	210	N/A	N/A
Underlying Structure:		Gravel Fill – poorly graded, medium grained, moist, compact to dense (inferred), brown (20mm Limestone)

CORE PHOTOGRAPHS PAVEMENT CORE SAMPLE GRANT-CH6C WINNIPEG, MANITOBA			
	JOINT			
Wood Environment and Infrastructure Solutions	Drawn: JW	Scale: N/A	Date: 7 September 2021	Project No.: WX19433
				Figure: A19

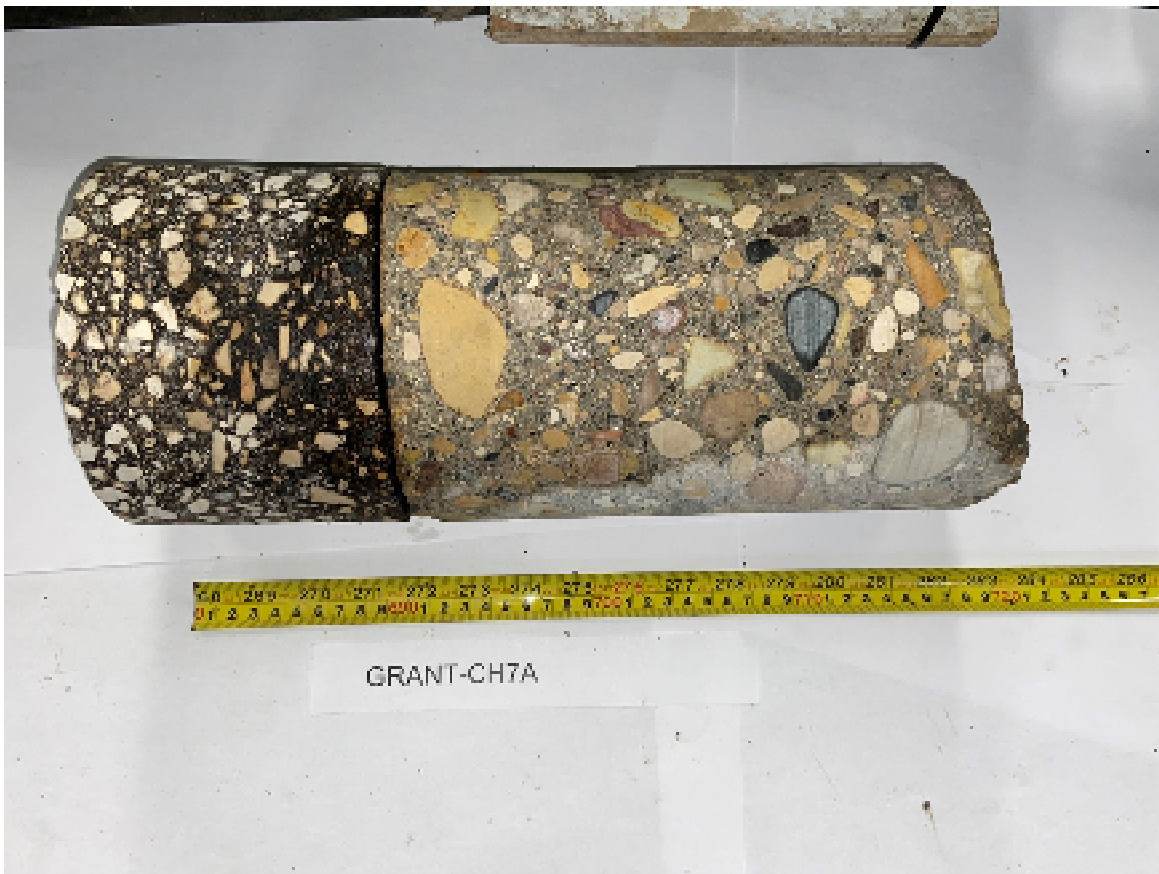
Asphalt		Concrete		
Thickness (mm)	Density (kg/m ³)	Thickness (mm)	Density (kg/m ³)	Compressive Strength (MPa)
111	2367	254	2227	32.1
Underlying Structure:		Clay – Silty, High Plastic, Moist, Stiff, Brown

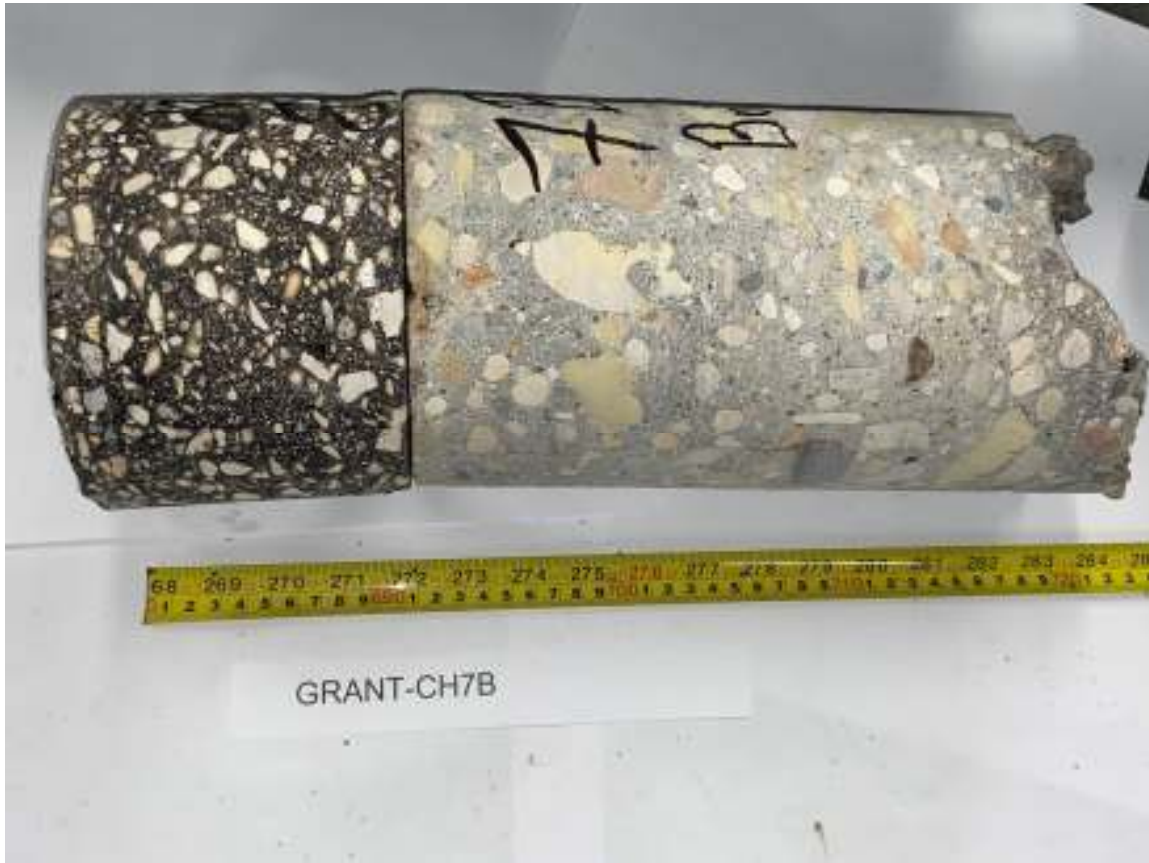
Asphalt		Concrete		
Thickness (mm)	Density (kg/m ³)	Thickness (mm)	Density (kg/m ³)	Compressive Strength (MPa)
113	2386	263	2316	34.2
Underlying Structure:		Clay – Silty, High Plastic, Moist, Stiff, Brown

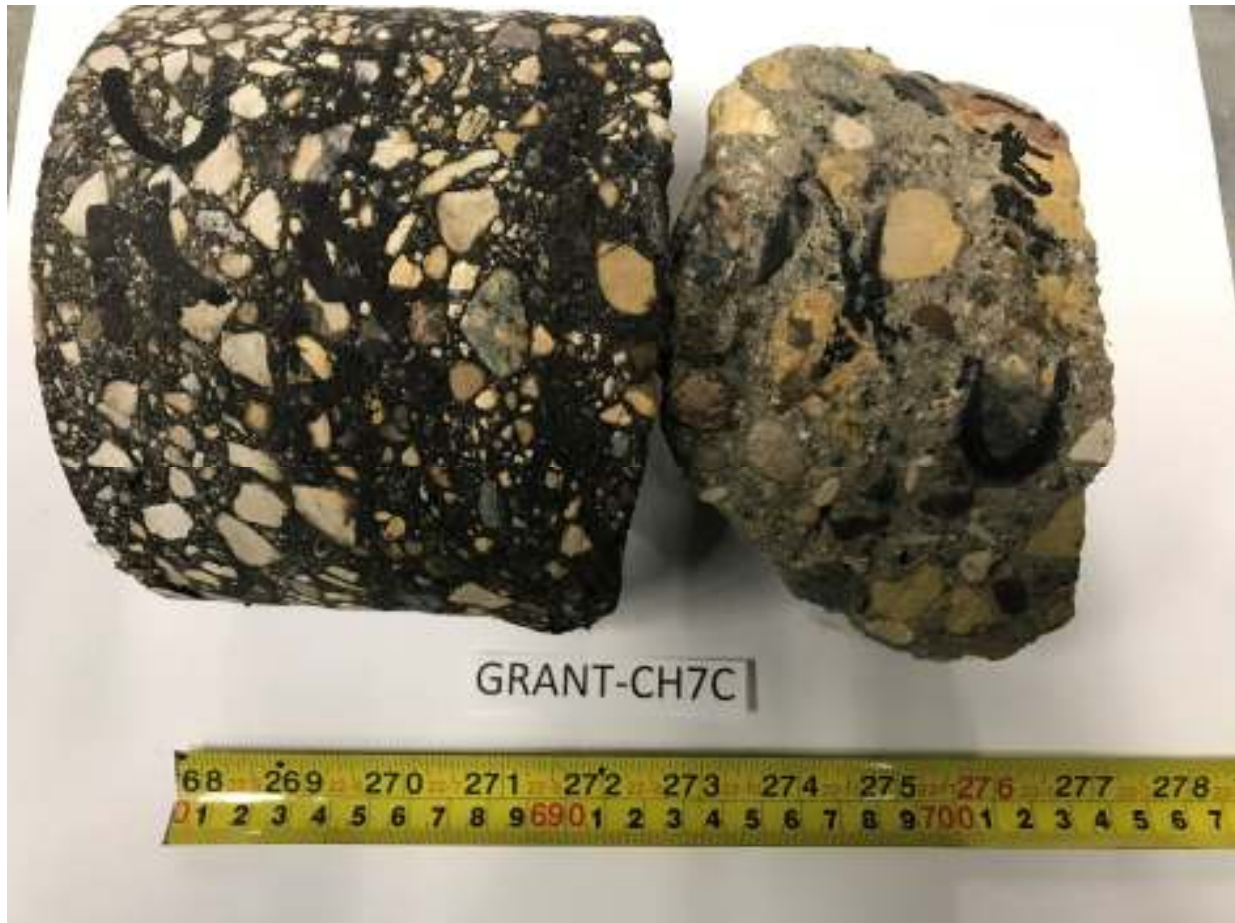
Asphalt		Concrete		
Thickness (mm)	Density (kg/m ³)	Thickness (mm)	Density (kg/m ³)	Compressive Strength (MPa)
112	N/A	250	N/A	N/A
Underlying Structure:		Clay – Silty, High Plastic, Moist, Stiff, Brown

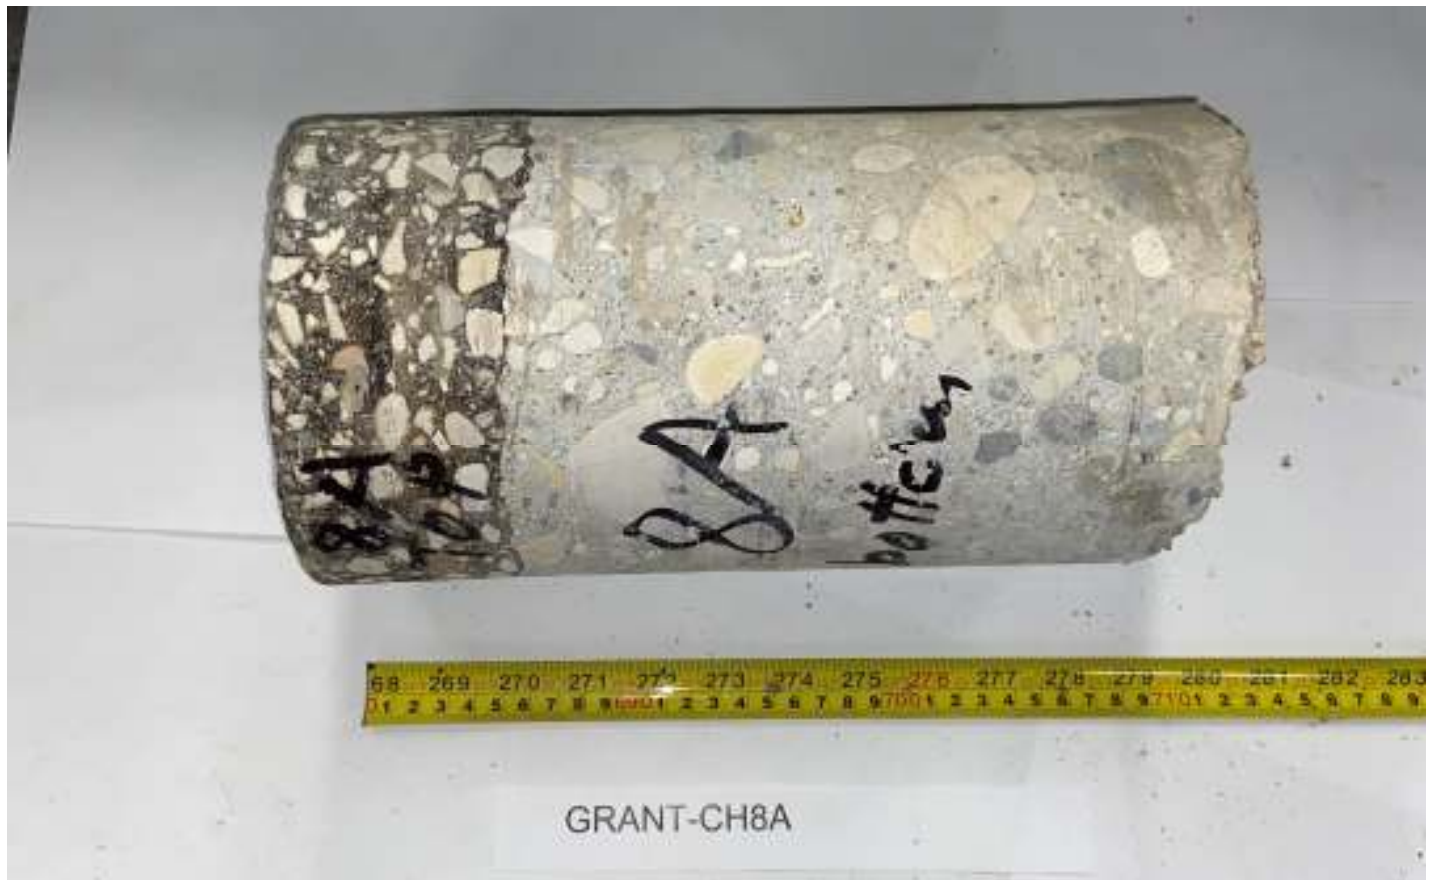
Asphalt		Concrete		
Thickness (mm)	Density (kg/m ³)	Thickness (mm)	Density (kg/m ³)	Compressive Strength (MPa)
71	2401	205	2368	39.7
Underlying Structure:		Gravel Fill – poorly graded, medium grained, moist, compact to dense (inferred), brown (20mm Limestone)

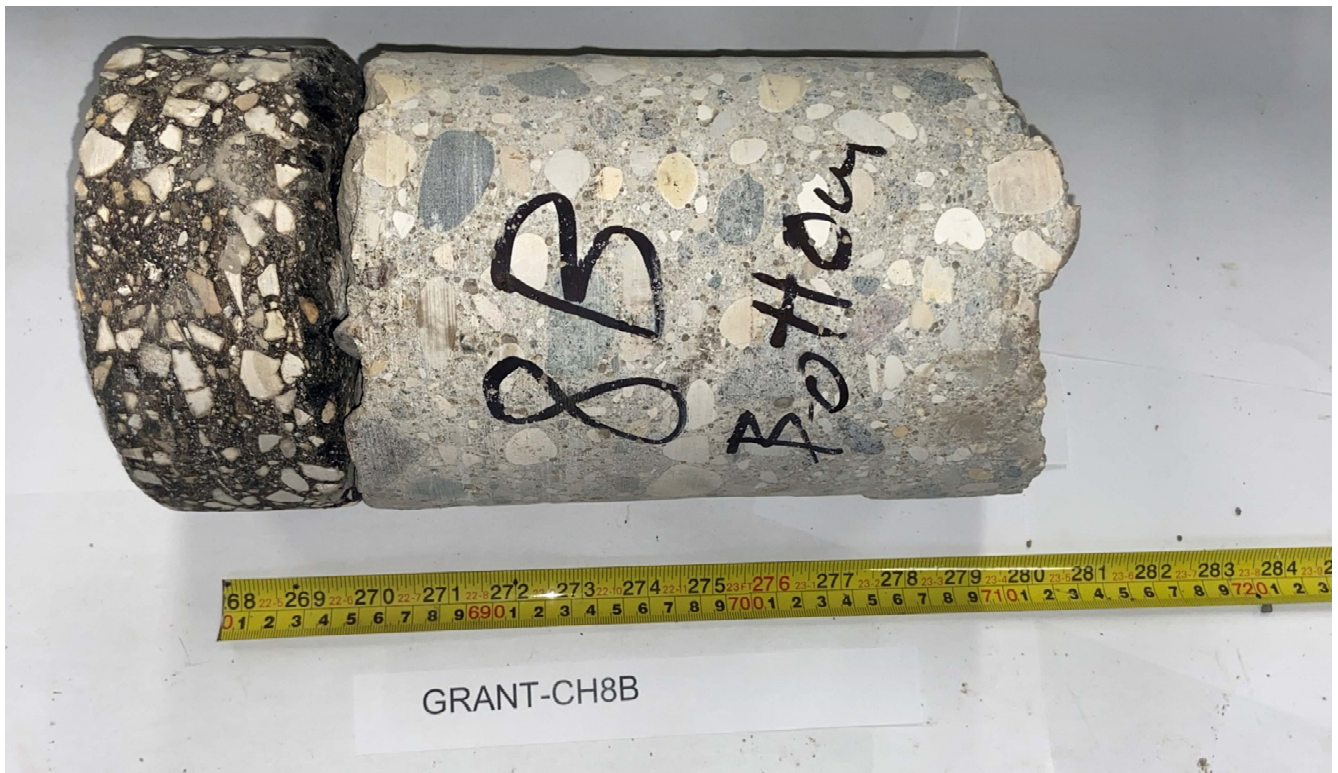
Asphalt		Concrete		
Thickness (mm)	Density (kg/m ³)	Thickness (mm)	Density (kg/m ³)	Compressive Strength (MPa)
66	2419	200	2356	47.4
Underlying Structure:		Gravel Fill – poorly graded, medium grained, moist, compact to dense (inferred), brown (20mm Limestone)

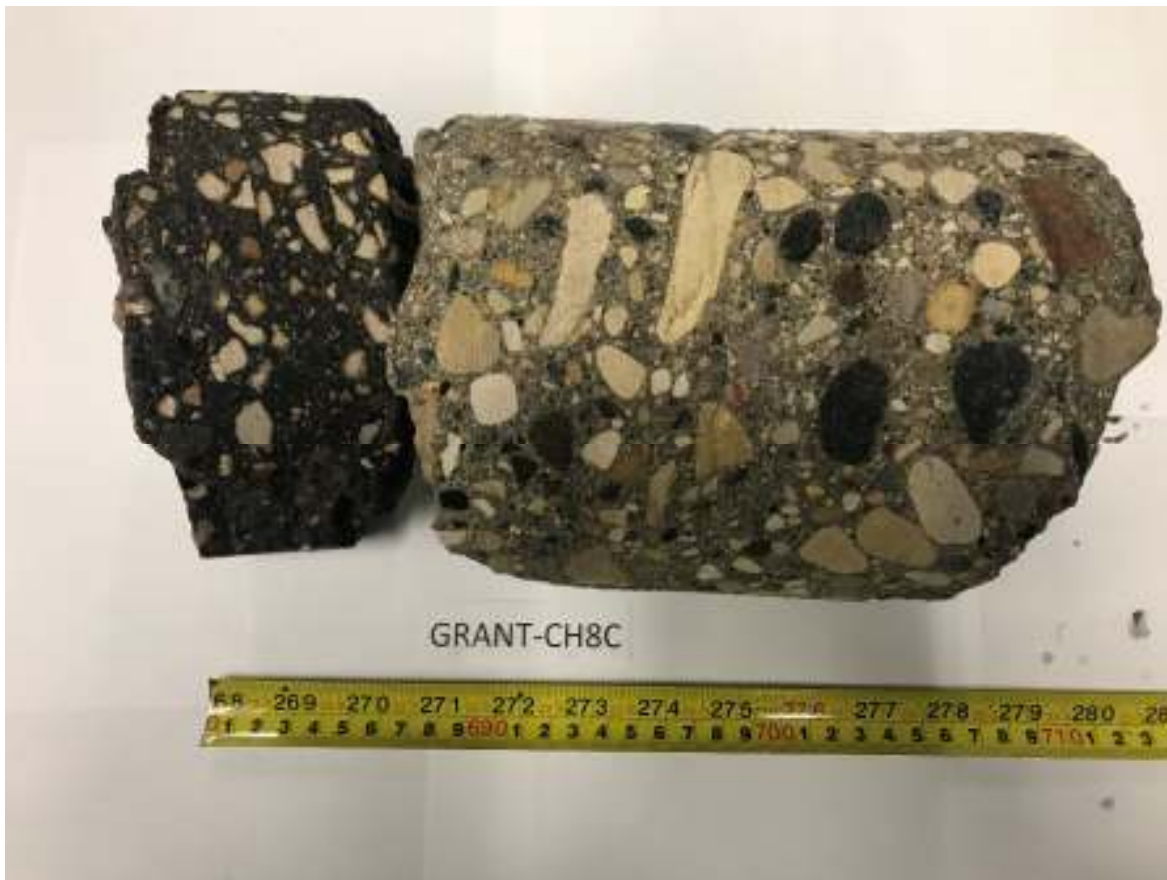
Asphalt		Concrete		
Thickness (mm)	Density (kg/m ³)	Thickness (mm)	Density (kg/m ³)	Compressive Strength (MPa)
70	N/A	200	N/A	N/A
Underlying Structure:		Clay – Silty, High Plastic, Moist, Stiff, Brown

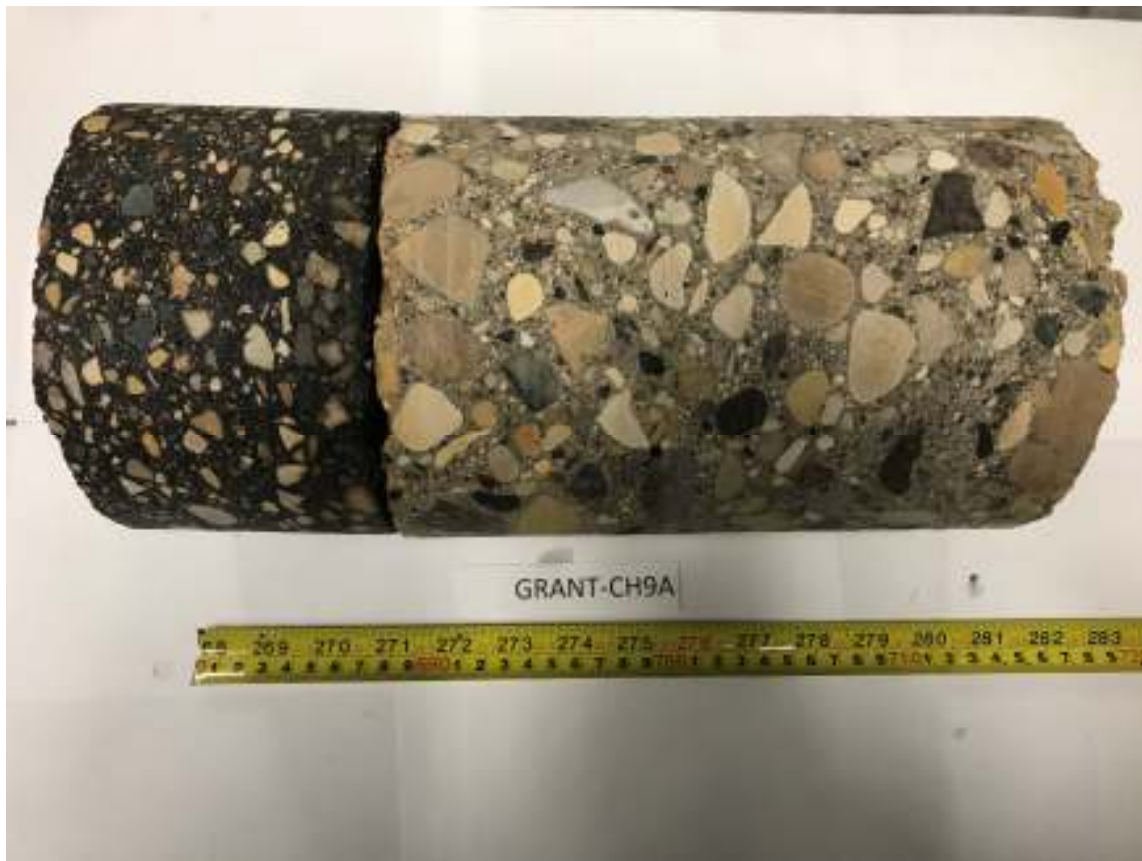
Asphalt		Concrete		
Thickness (mm)	Density (kg/m ³)	Thickness (mm)	Density (kg/m ³)	Compressive Strength (MPa)
96	2342	226	2425	47.1
Underlying Structure:		Gravel Fill – poorly graded, medium grained, moist, compact to dense (inferred), brown (20mm Limestone)

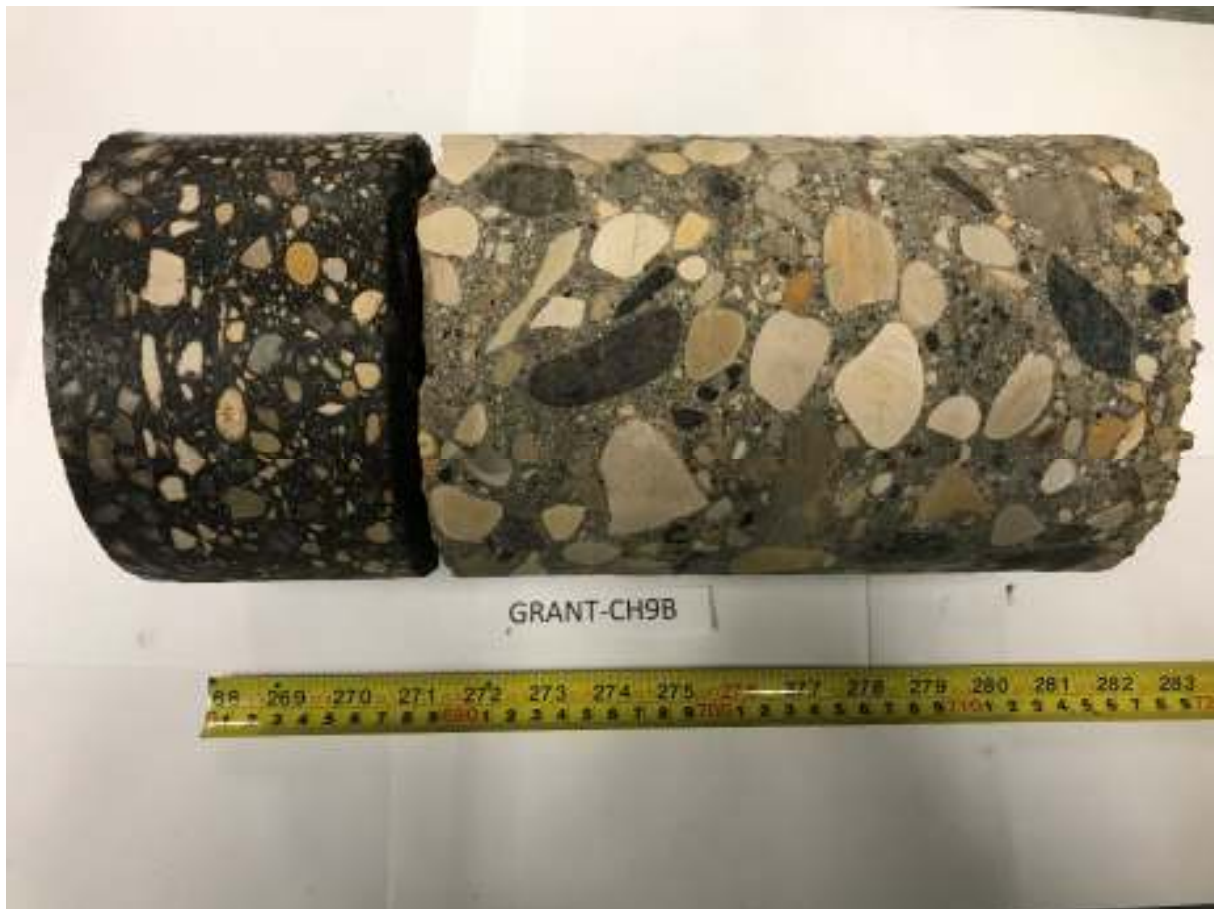
Asphalt		Concrete		
Thickness (mm)	Density (kg/m ³)	Thickness (mm)	Density (kg/m ³)	Compressive Strength (MPa)
93	2349	222	2405	41.5
Underlying Structure:		Gravel Fill – poorly graded, medium grained, moist, compact to dense (inferred), brown (20mm Limestone)

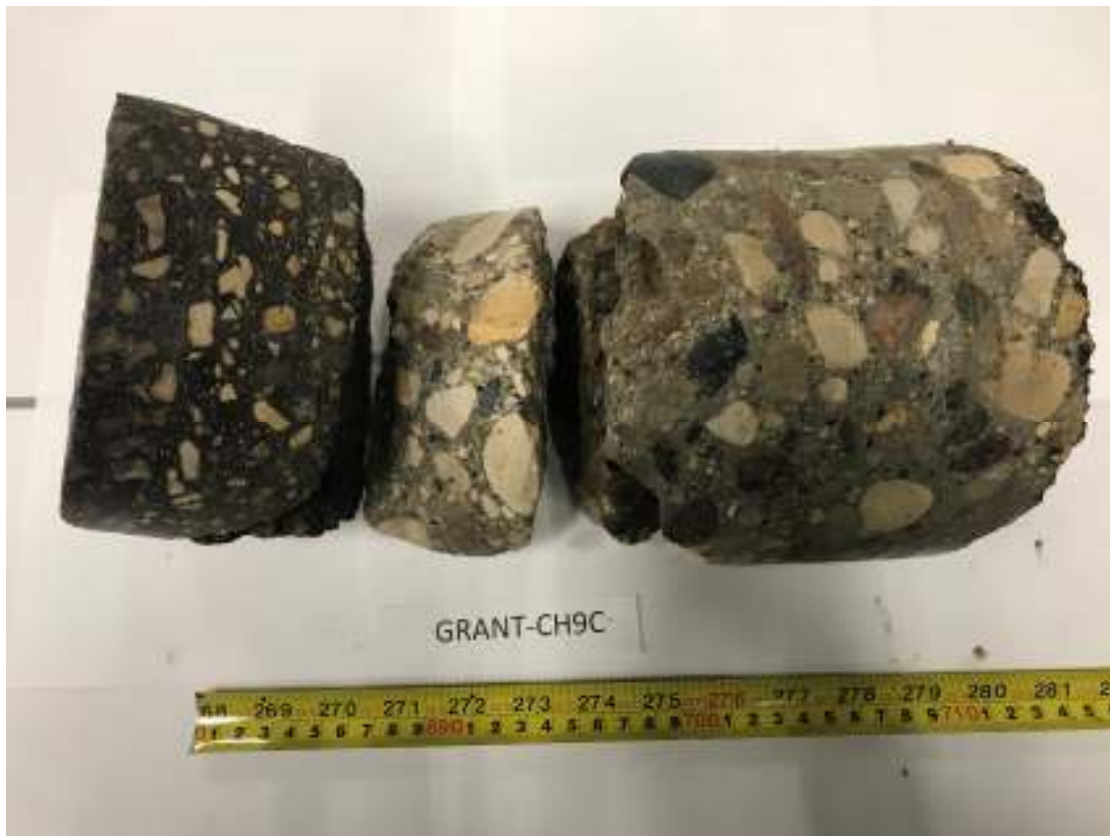
Asphalt		Concrete		
Thickness (mm)	Density (kg/m ³)	Thickness (mm)	Density (kg/m ³)	Compressive Strength (MPa)
87	N/A	225	N/A	N/A
Underlying Structure:		Gravel Fill – poorly graded, medium grained, moist, compact to dense (inferred), brown (20mm Limestone)

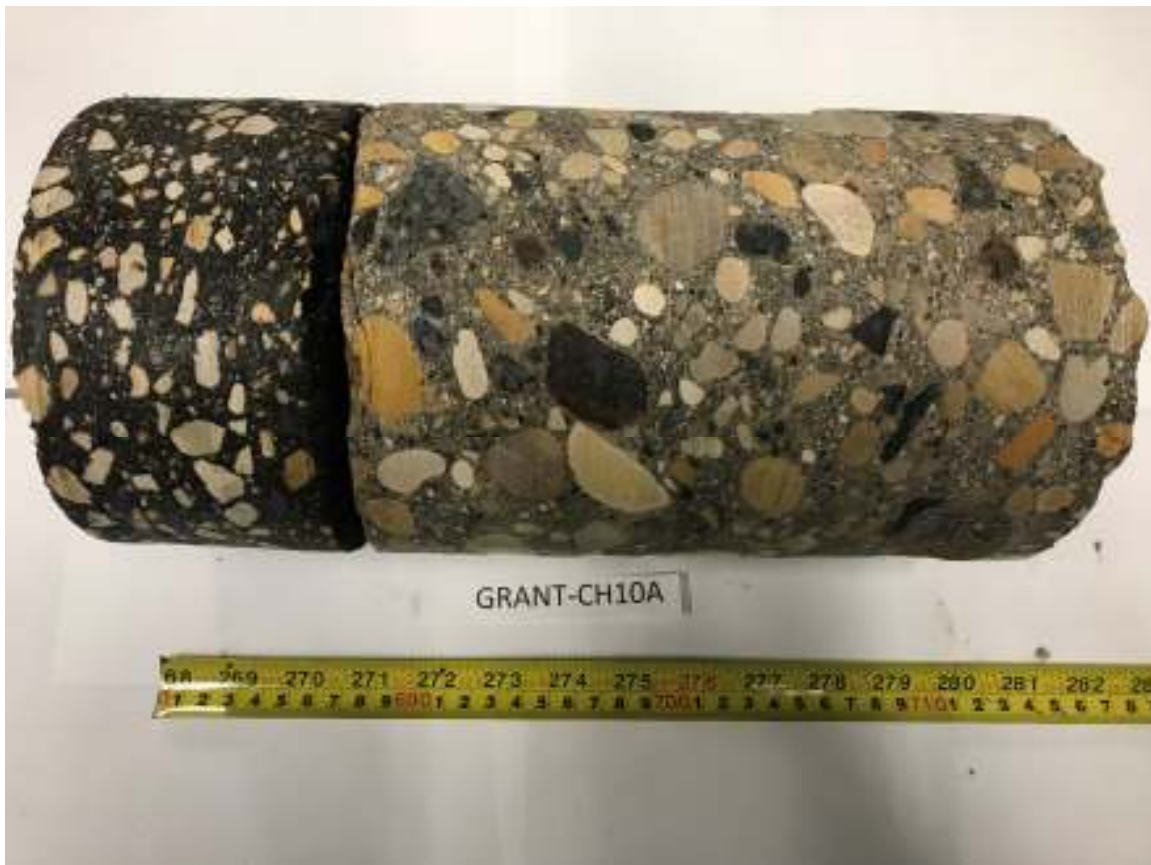
Asphalt		Concrete		
Thickness (mm)	Density (kg/m ³)	Thickness (mm)	Density (kg/m ³)	Compressive Strength (MPa)
83	2392	217	2390	40.2
Underlying Structure:		Clay Fill – Gravelly, Silty, High Plastic, Moist, Stiff, Brown

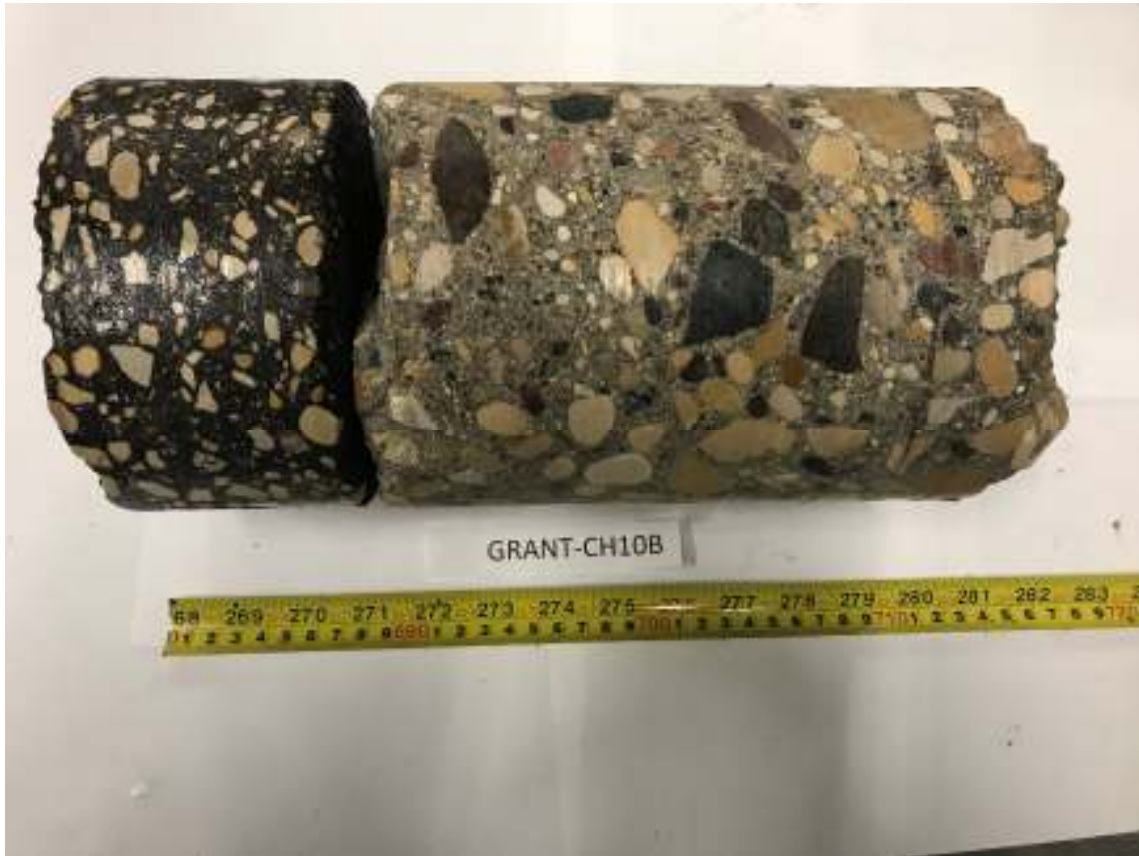
Asphalt		Concrete		
Thickness (mm)	Density (kg/m ³)	Thickness (mm)	Density (kg/m ³)	Compressive Strength (MPa)
80	2401	211	2386	39.5
Underlying Structure:		Clay – Silty, High Plastic, Moist, Stiff, Brown

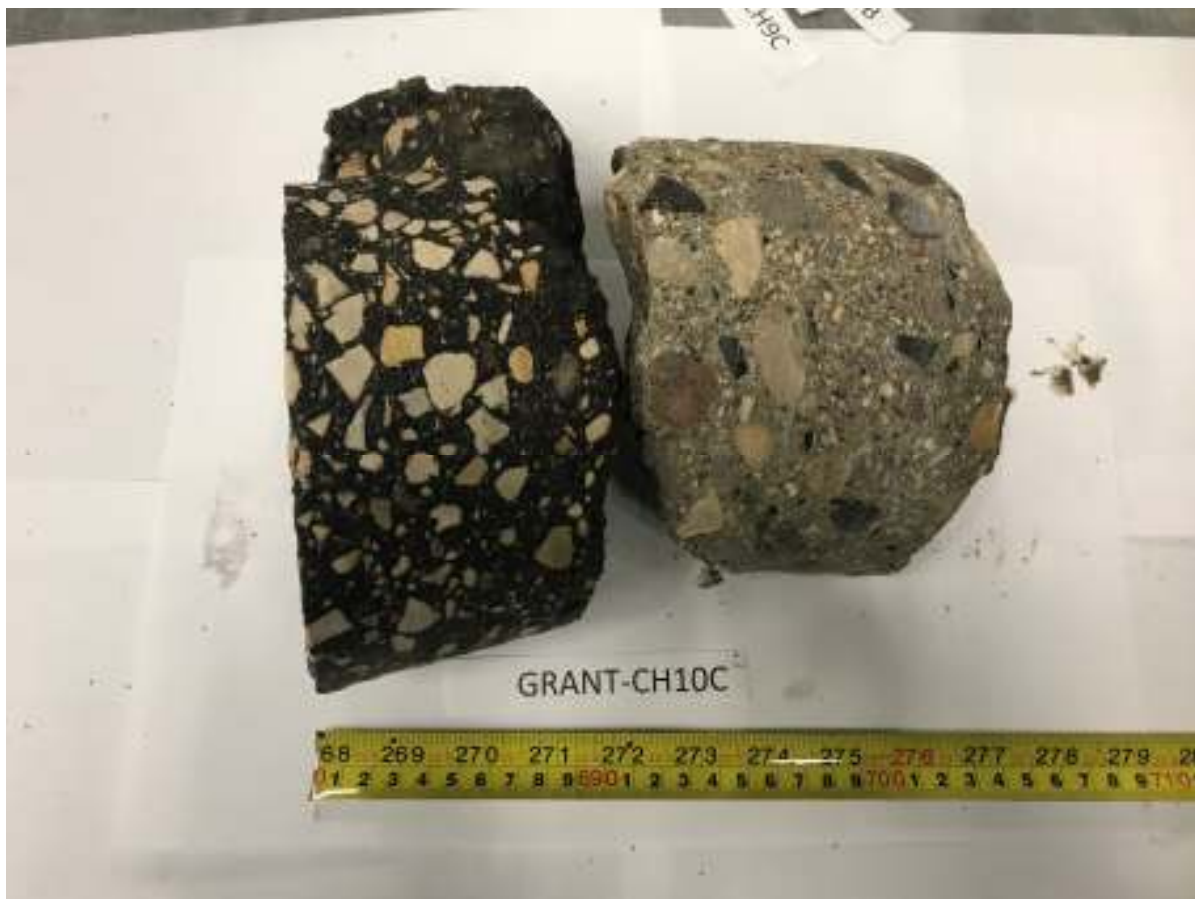
Asphalt		Concrete		
Thickness (mm)	Density (kg/m ³)	Thickness (mm)	Density (kg/m ³)	Compressive Strength (MPa)
80	N/A	200	N/A	N/A
Underlying Structure:		Clay Fill – Gravelly, Silty, High Plastic, Moist, Stiff, Brown

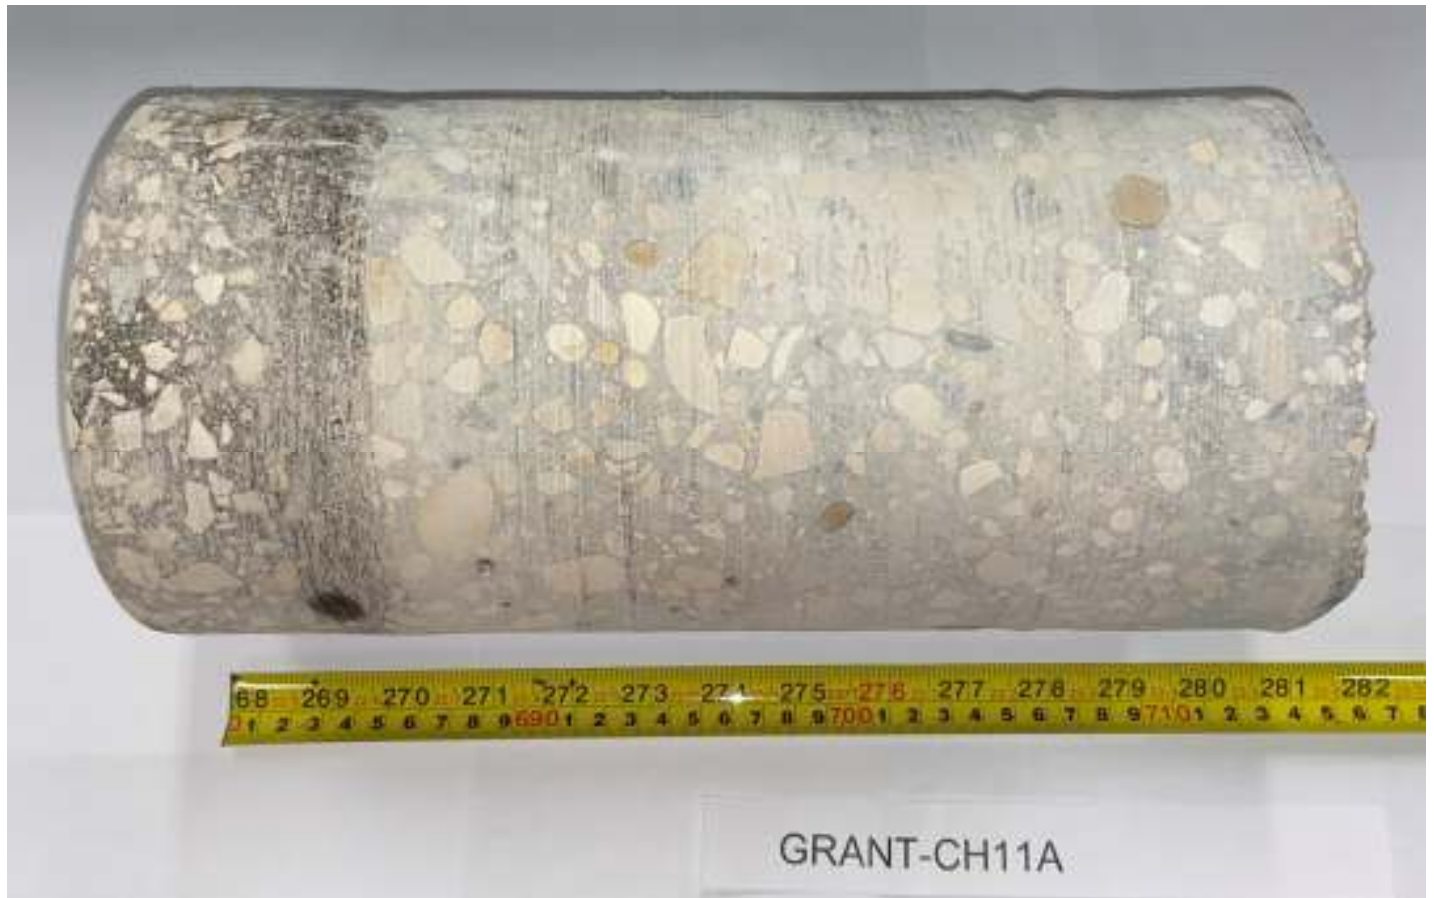
Asphalt		Concrete		
Thickness (mm)	Density (kg/m ³)	Thickness (mm)	Density (kg/m ³)	Compressive Strength (MPa)
73	2348	244	2284	50.5
Underlying Structure:		Gravel Fill – poorly graded, medium grained, moist, compact to dense (inferred), brown (20mm Limestone)
