THE CITY OF WINNIPEG WATER AND WASTE DEPARTMENT

NORTH END SEWAGE TREATMENT PLANT UV TRANSFORMER REPAIR EXISTING PHOTOGRAPHS

1-0101U-E0021 001 00 A1

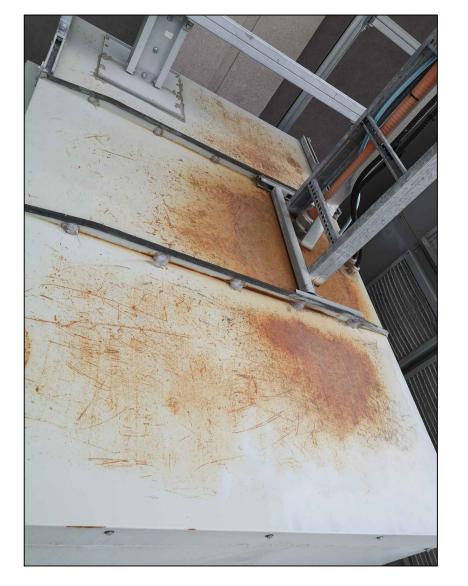
**LST-4 EXISTING ROOF** 123

CONSTRUCTION NOTES:	
1	REMOVE AND REPLACE ALL ROOF PANELS REGARDLESS OF EXISTING CONDITION.
2	REMOVE AND RE-INSTALL ALL CABLES TO ALLOW FOR THE TRANSFORMER ROOF REPLACEMENT. RE-ENTRY OF ALL AUXILIARY CABLES FROM THE BACK SIDE OF THE TRANSFORMER.

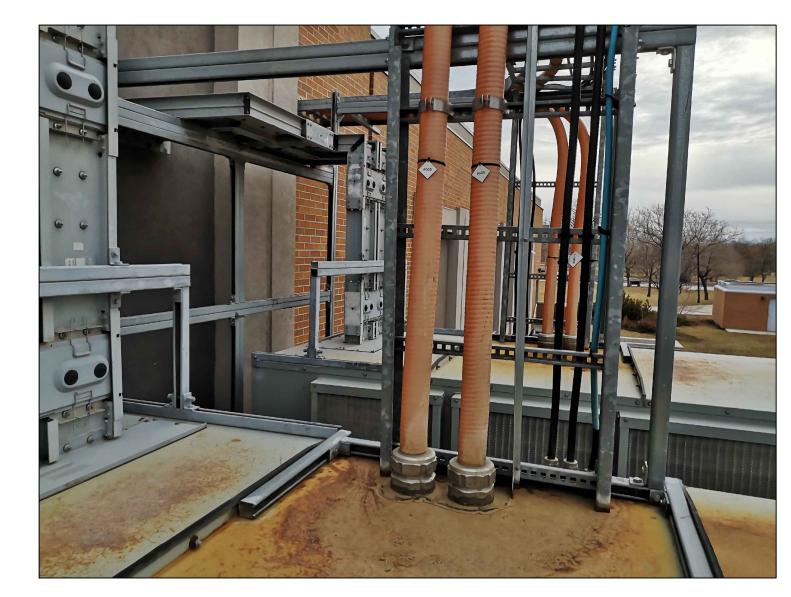
UVT-3 (FOREGROUND) AND UVT-2 (BACKGROUND) EXISTING ROOF 1 2 3

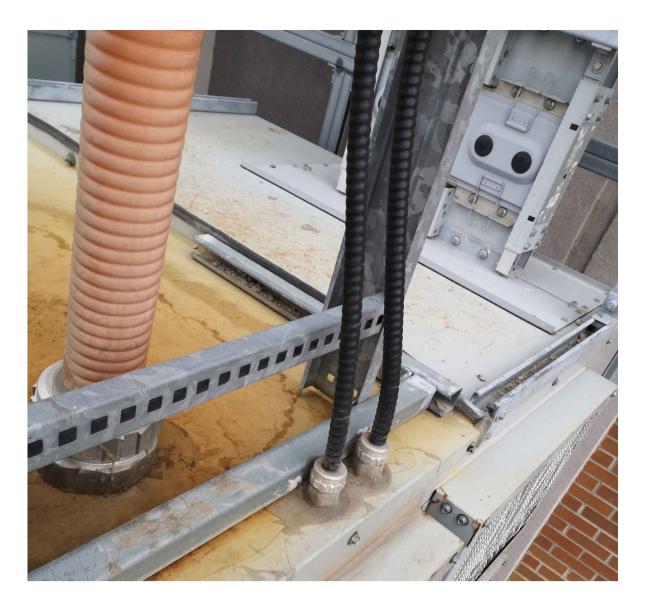
**UVT-2 EXISTING ROOF** 123

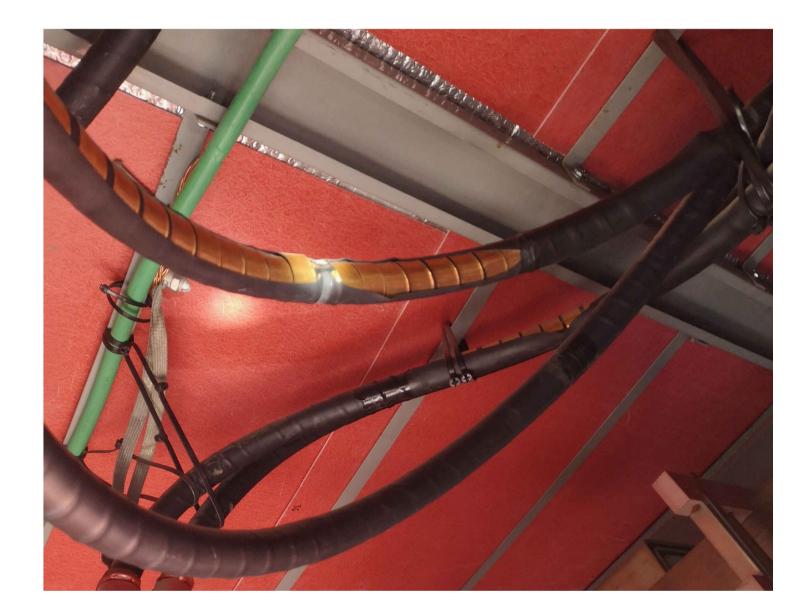
**UVT-2 PRIMARY CABLE** 4 5 6

REMOVE ALL CABLE TRAY AND BUSDUCT SUPPORT CHANNELS AND REPLACE WITH SUPPORTS INDEPENDENT OF THE TRANSFORMER ENCLOSURE.

CAREFULLY DISCONNECT AND REMOVE THE PRIMARY CABLES (AND OTHER CABLES) TO ALLOW FOR THE ROOF REPLACEMENT.

RE-INSTALL THE PRIMARY CABLES (AND OTHER CABLES) AND REPLACE ALL THE CABLE GLANDS.

REPAIR DAMAGED CONDUCTORS. UTILIZE COMPONENTS FROM CSA APPROVED MEDIUM VOLTAGE SPLICE KIT TO IMPLEMENT THE REPAIR.

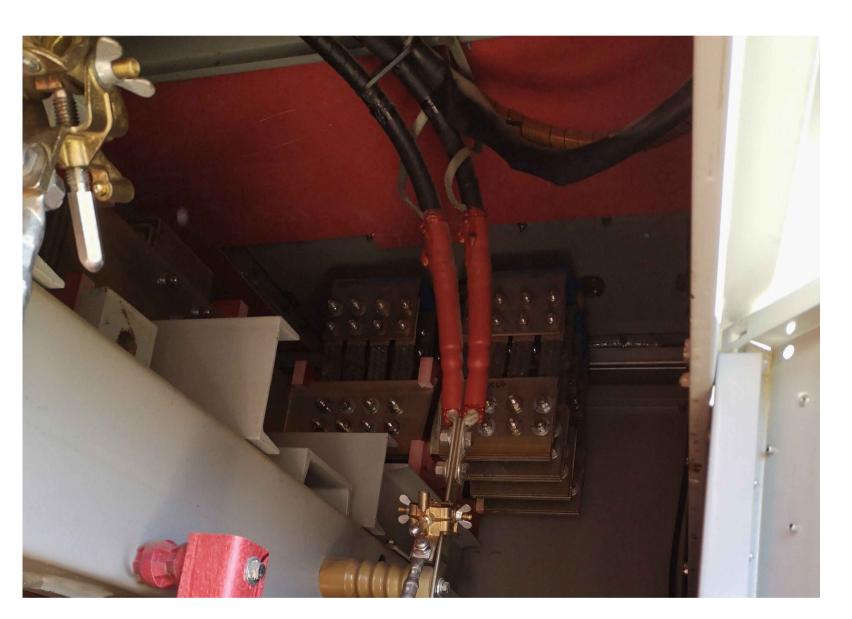
**UVT-2 BUSDUCT CONNECTION** 4 5 7

DISCONNECT AND RECONNECT THE SECONDARY BUSDUCT CONNECTIONS AS REQUIRED FOR THE ROOF REPLACEMENT.

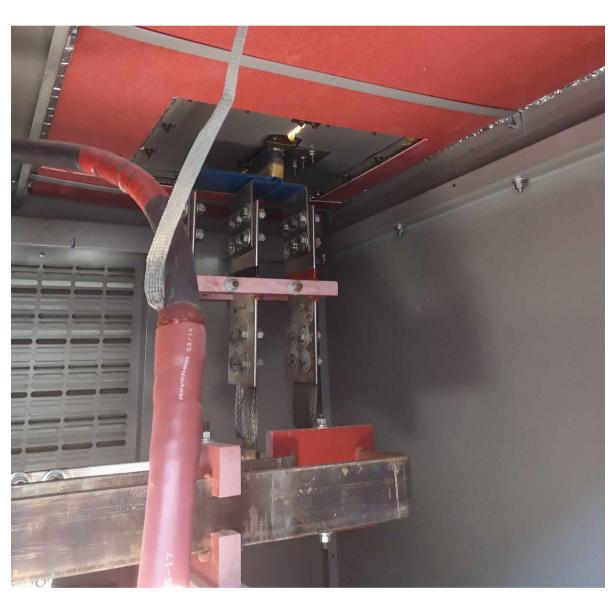
457

LST-4 SECONDARY BUSDUCT CONNECTION
