# City of Winnipeg 2014:

## 500mm (20in) Northeast Interceptor Siphon

Condition Assessment Report, Standard Analysis

**PICA Project: Winnipeg 8007**

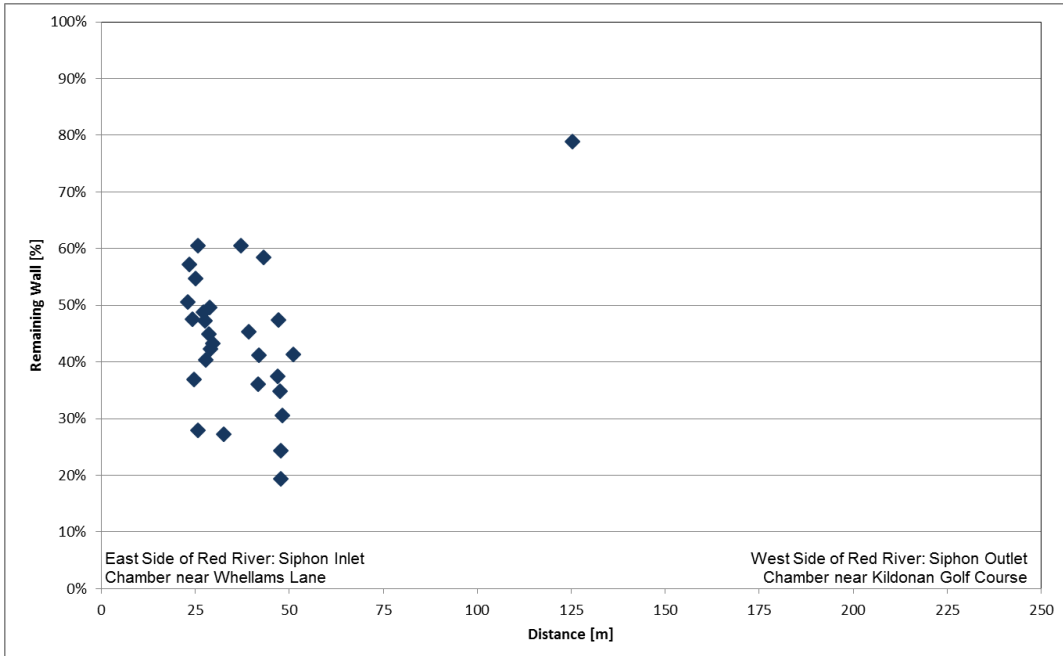
Figures 1 and 2 illustrate the distribution of localized wall loss along the 500mm (20in) Northeast Interceptor inspection with respect to remaining wall and circumferential location respectively. Note that there may be some (partially) overlapping data points due to defect proximity.

Figure 1: Distribution of wall loss with respect to remaining wall (%NWT) in pitting regions along the 500mm (20in) Northeast Interceptor Siphon.

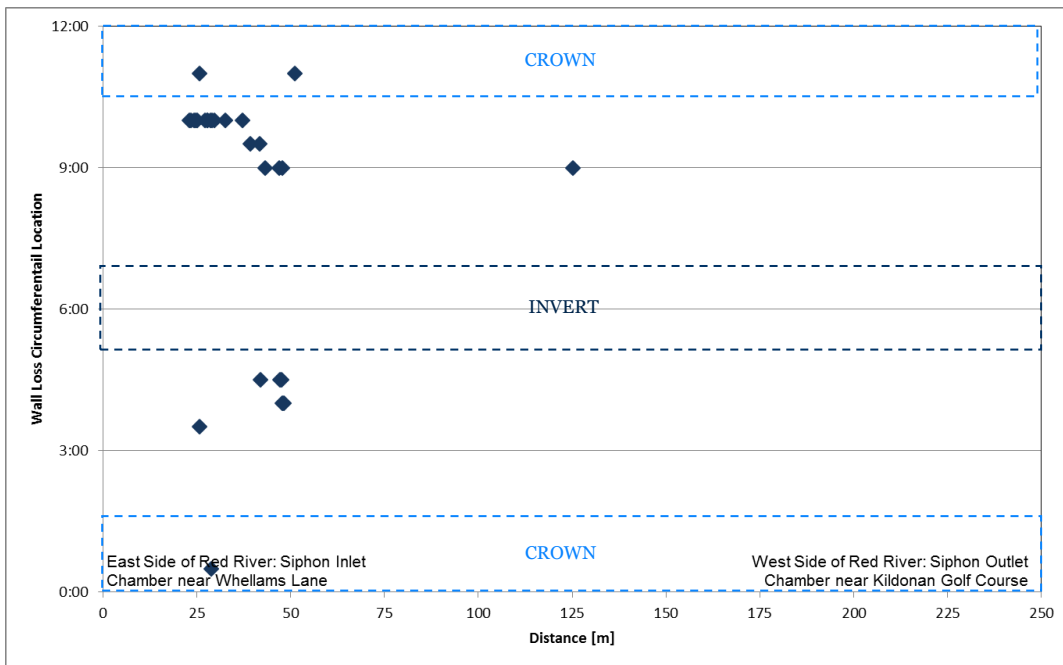
Figure 2: Circumferential distribution of the pitting regions along the 500mm (20in) Northeast Interceptor.

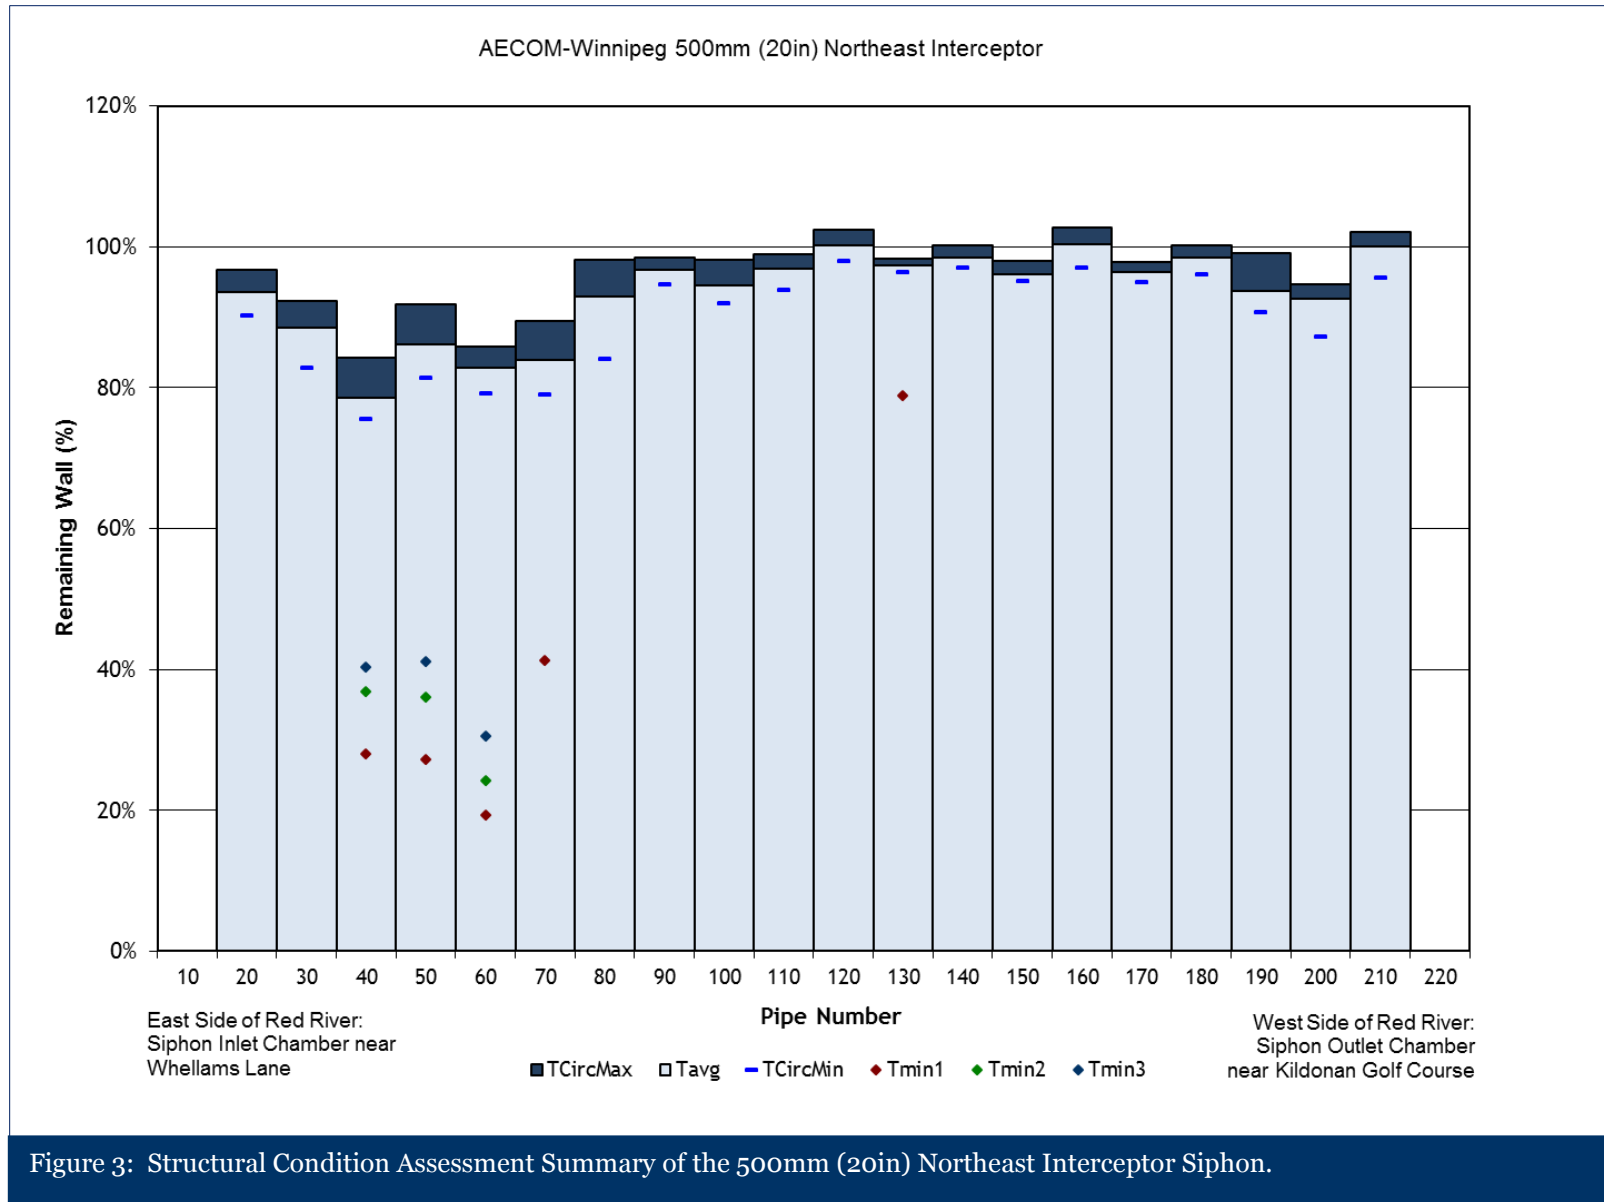
Figure 3: Structural Condition Assessment Summary of the 500mm (20in) Northeast Interceptor Siphon.

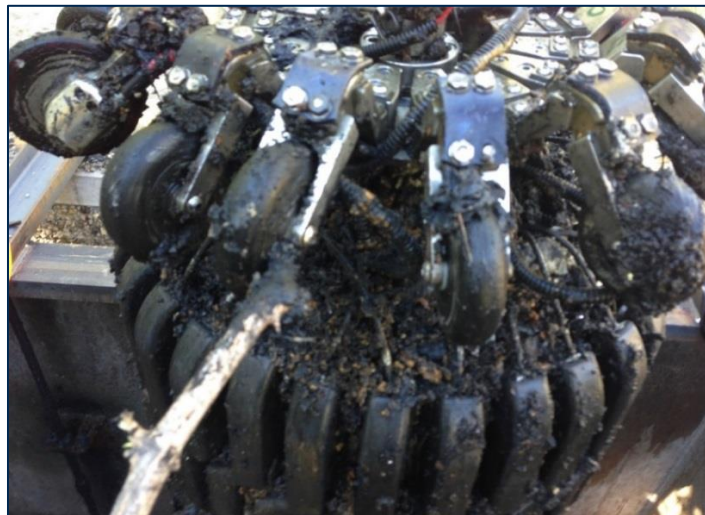
It is unusual for the on-board odometer to be off by more than 0.3% given the redundant configuration of the odometer wheels. Photos taken of the Chimera tool shortly after the inspection showed considerable debris accumulation (rags, hair, solids, etc.) by the tool. In addition, the inspection data exhibited substantial travel related noise believed to be due to internal debris. It is therefore possible that the on-board odometers were intermittently locking up due to grit, rags and other debris. The revised (longer) length of 229.9m was based on the wireline odometer, which is not impacted by build-up in the siphon.

Figure 5: Debris accumulation on 20-inch Chimera tool.

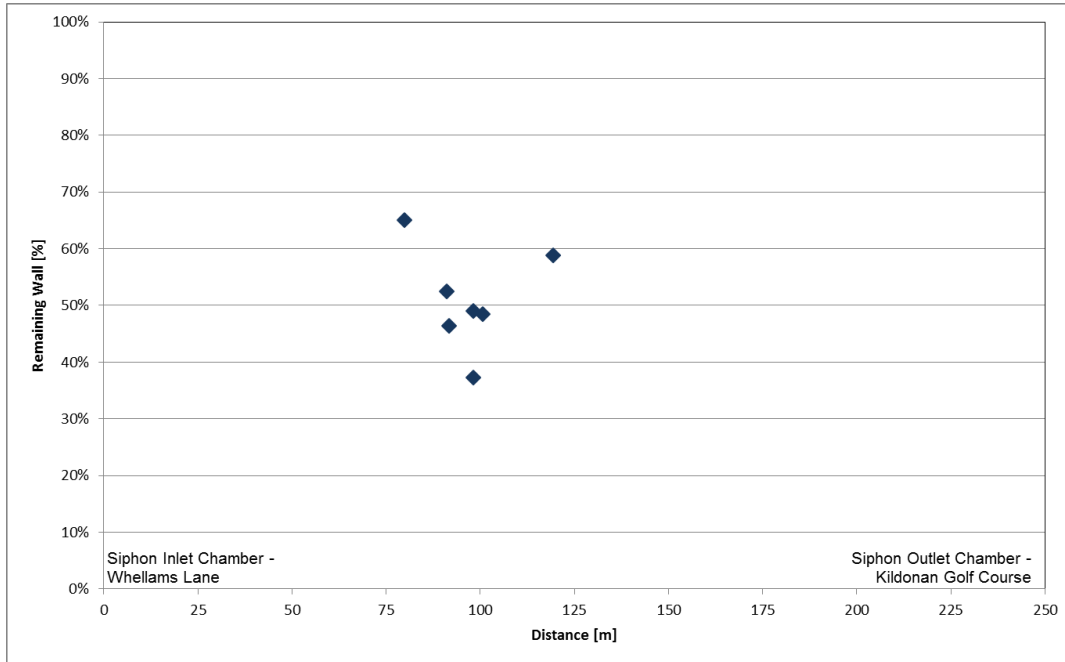
Figures 1 and 2 illustrate the distribution of localized wall loss along the 800mm (32in) Northeast Interceptor Siphon inspection with respect to remaining wall and circumferential location respectively. Note that there may be some (partially) overlapping data points due to defect proximity.

Figure 1: Distribution of wall loss with respect to remaining wall (%NWT) in pitting regions along the 800mm (32in) Northeast Interceptor Siphon.

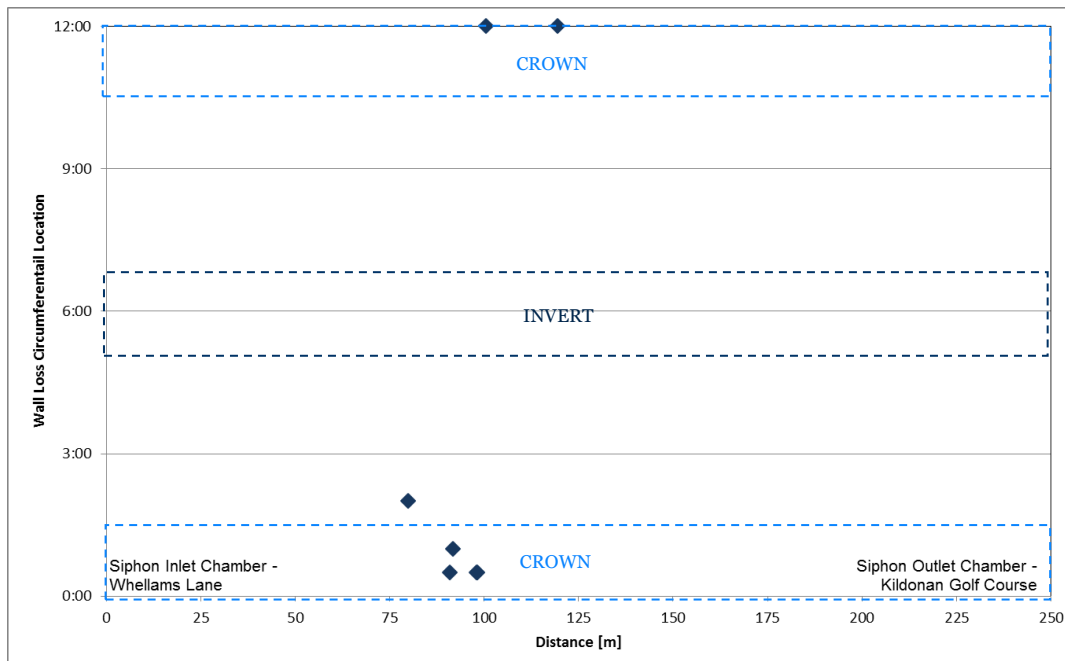
Figure 2: Circumferential distribution of the pitting regions along the 800mm (32in) Northeast Interceptor Siphon.

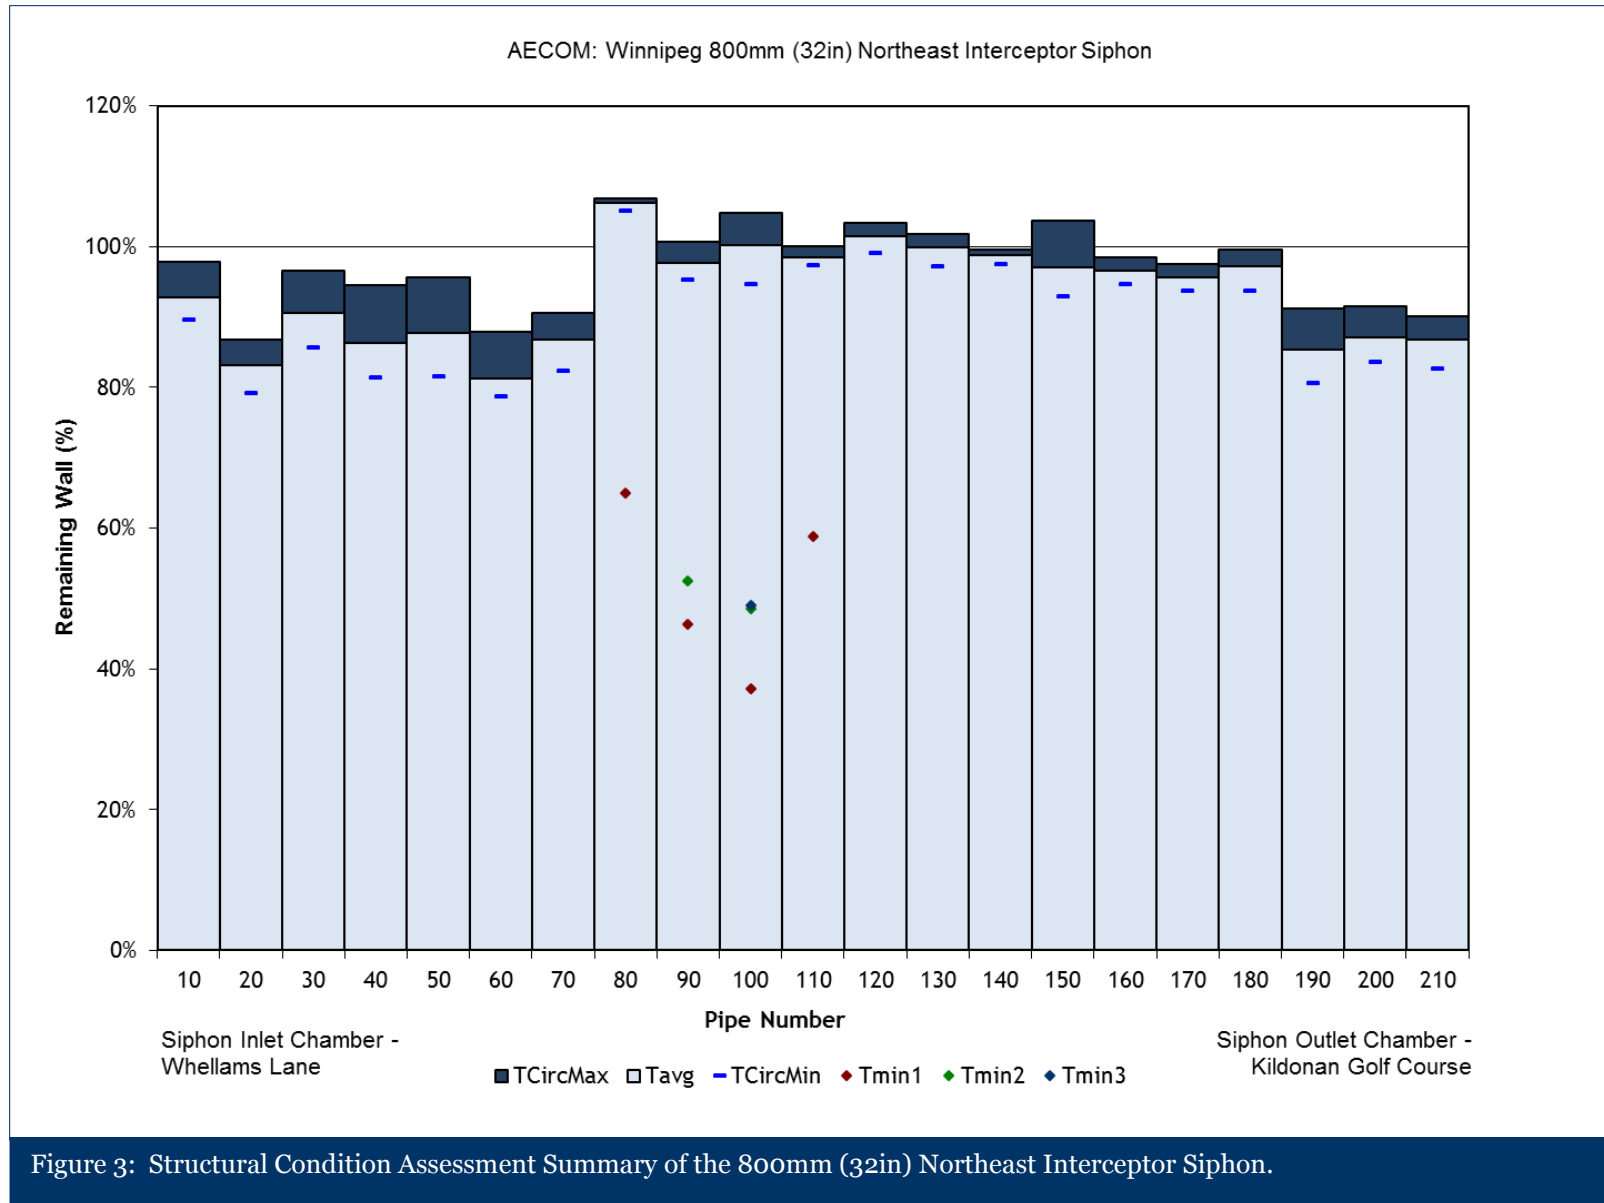
Figure 3: Structural Condition Assessment Summary of the 800mm (32in) Northeast Interceptor Siphon.

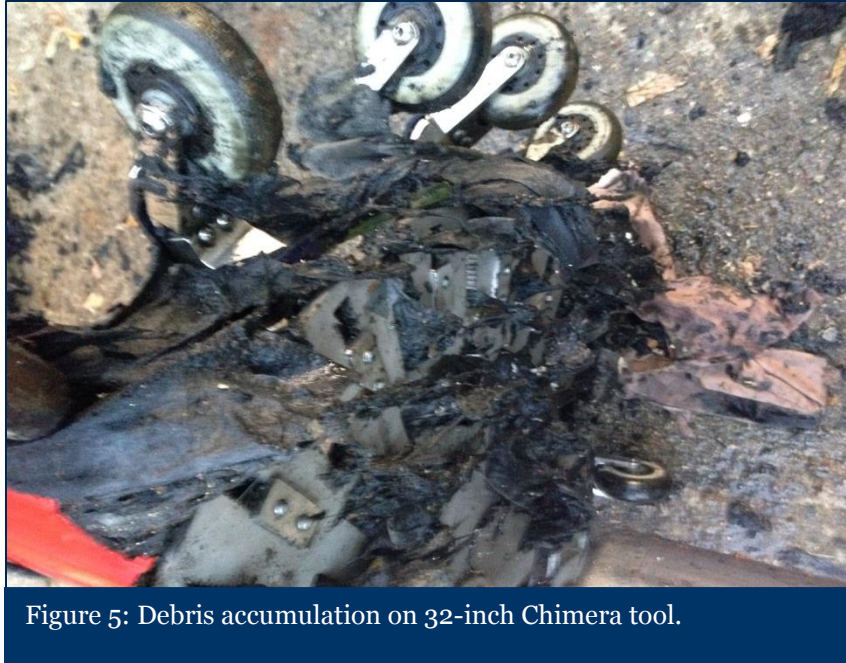
The observed noise is likely related to the amount of debris in the line, which may be product remnants as well as accumulated tuberculation deposits. It is also possible that there is a greater amount of debris along the invert of the pipe, thus impacting the sensors closest to the bottom of the pipe.

Figure 5: Debris accumulation on 32-inch Chimera tool.
