APPENDIX E – SOILS INVESTIGATION REPORT AND TEST HOLE LOGS

To	Marvin McDonald	Page	1
CC	Barry Biswanger		
Subject	Midtown Feedermain Bridge - Geotechnical Investigation		
From	Omer Eissa, Faris Khalil		
Date	November 6, 2012	Project Number	60256129 (403.19.2)

This memorandum summarizes the results of the geotechnical field program and provides geotechnical assessment for the observed instability at the south bank of the Midtown Feedermain Bridge crossing the Assiniboine River. The Midtown Feedermain is a 900 mm diameter pipe extending over a single span steel truss bridge supported by two piers located on the North and South banks of the Assiniboine River. It is understood the bridge has reached its service life and the City of Winnipeg is considering rehabilitation of the existing bridge and treatment options to control the impact of the observed slope instabilities at the south bank of the subject structure.

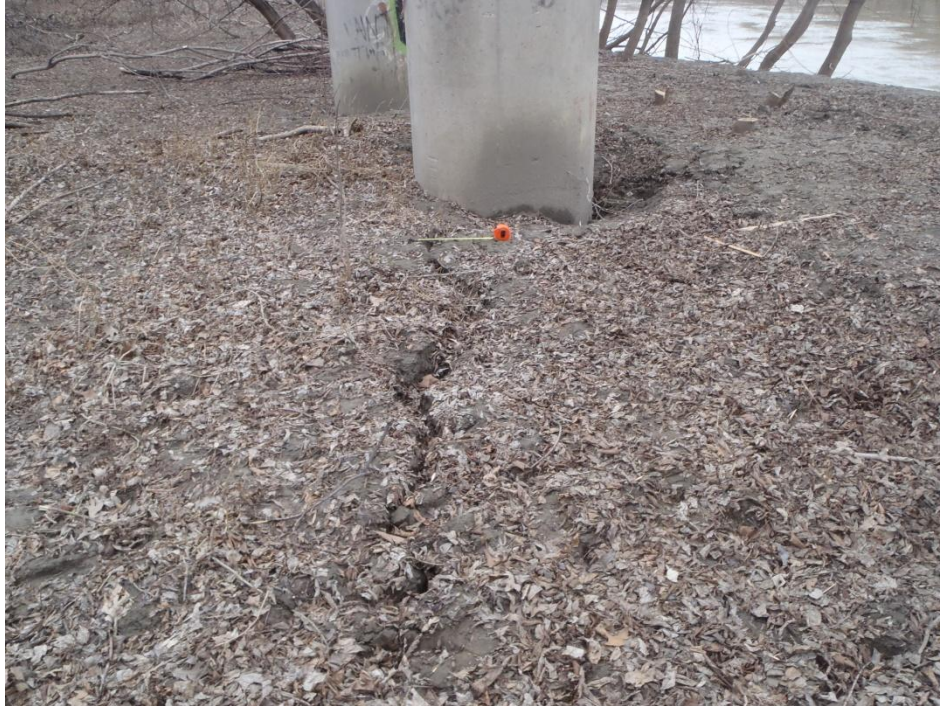
been monitored periodically since July 2010 using slope indicator (SI) readings. The results of the monitoring are presented in the attached Appendix C. With the exception of the tension crack in the vicinity of the south pier on the east side, Photo 01, no major movements have been detected in the SI readings since the aforementioned reassessment report dated February 6th, 2012.

Photo 01: Tension Crack in the Vicinity of the South Pier (looking west).

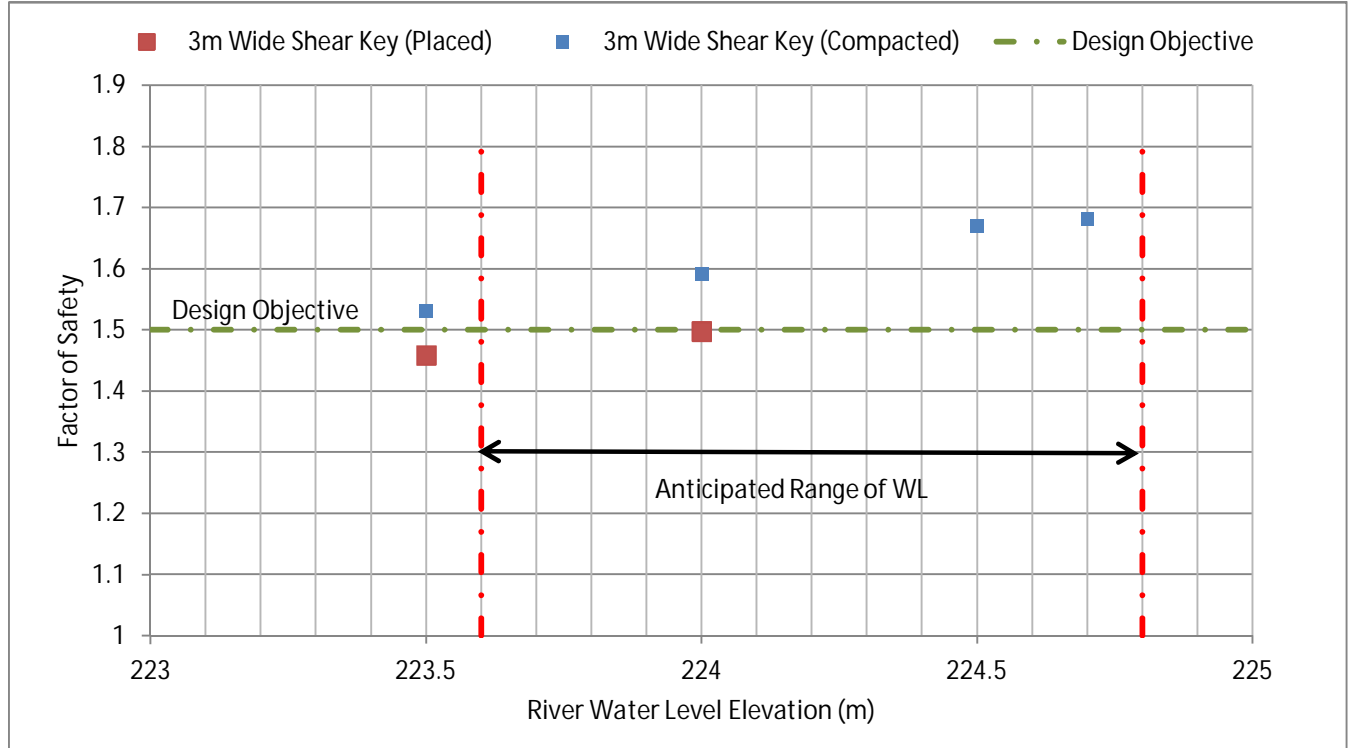
A sensitivity analysis of calculated FS with respect to the river water level was conducted to verify acceptable FS over the range of anticipated river water level. Based on available historical monitoring data, the water level in the Assiniboine River at the bridge location generally ranges from an ice level of approximately 223.6 m to a normal summer level of 224.7. The results of the sensitivity analysis are presented on Figure 02 indicating acceptable FS over the anticipated range of river water level.

Figure 02: Factor of Safety vs. River Water Elevation

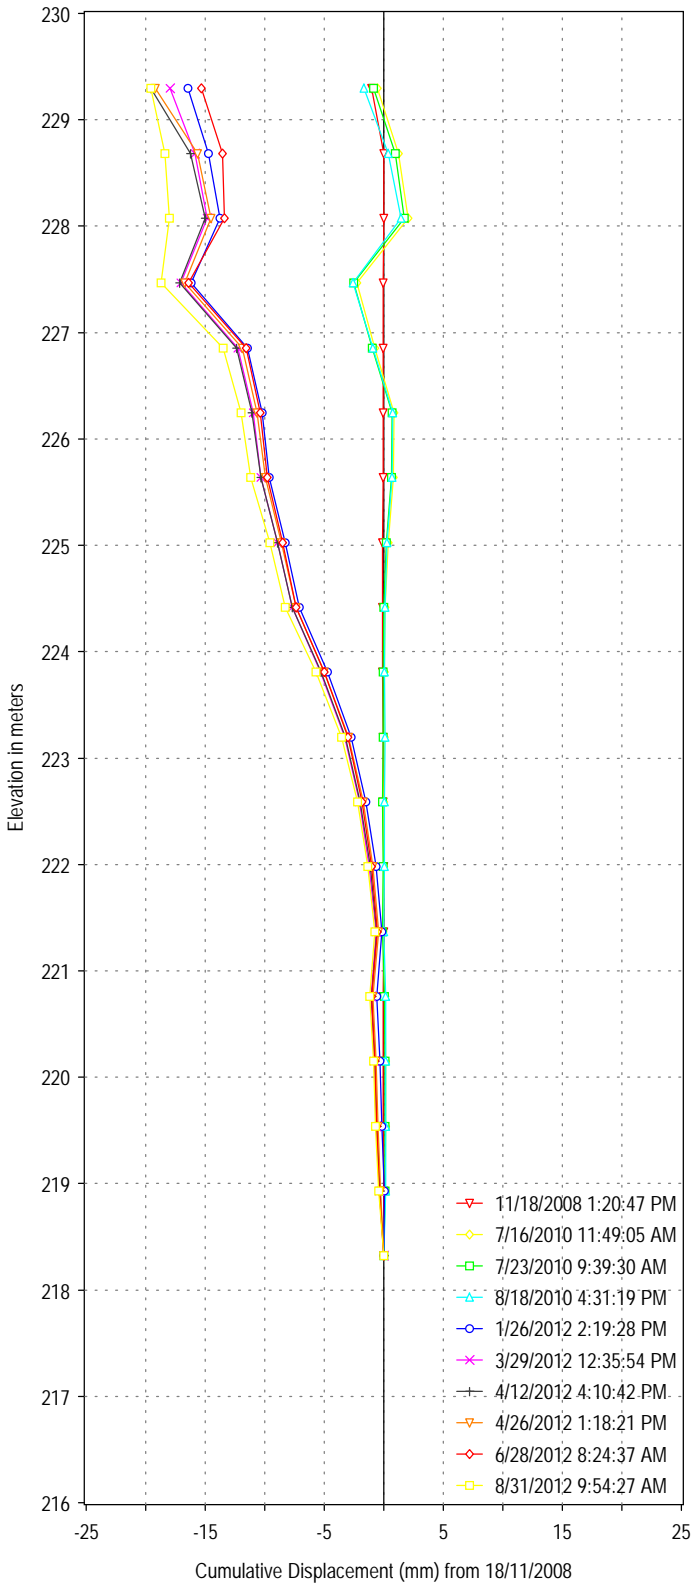
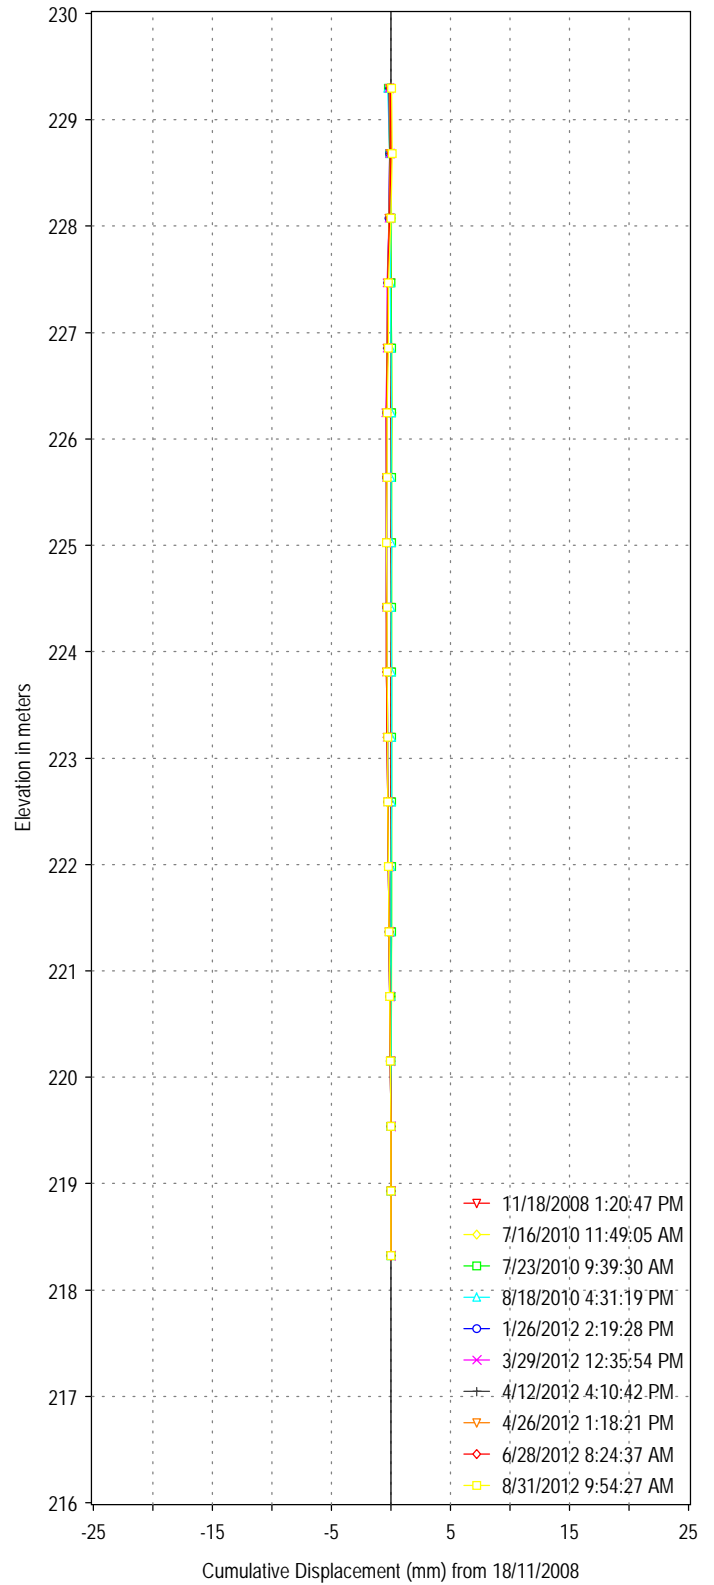
SI02, A-Axis

SI02, B-Axis

Midtown Feedermain South Bank
 SI08-02
 Ground Surface at Elev. 229.1 m
 Cumulative Displacement

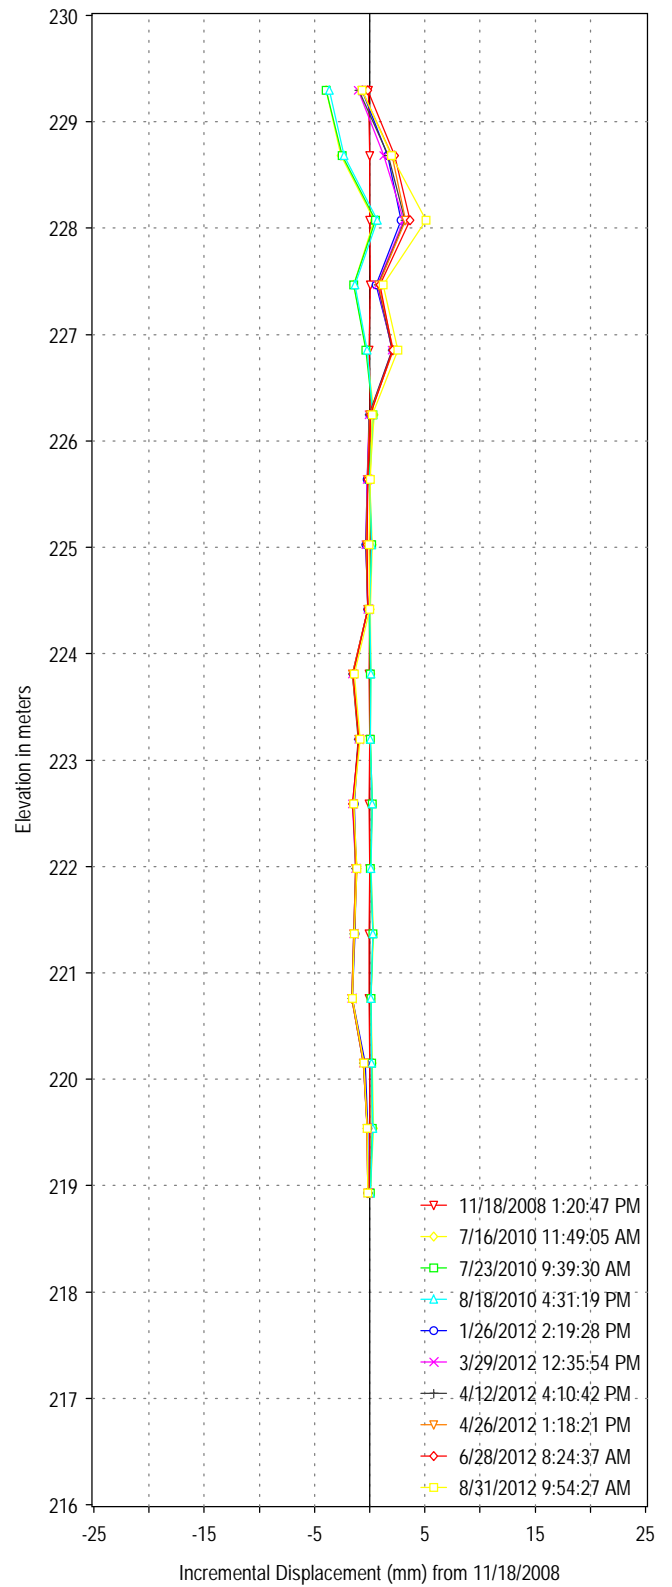
SI02, A-Axis

SI02, B-Axis

Midtown Feedermain South Bank
 SI08-02
 Ground Surface at Elev. 229.1
 Incremental Displacement

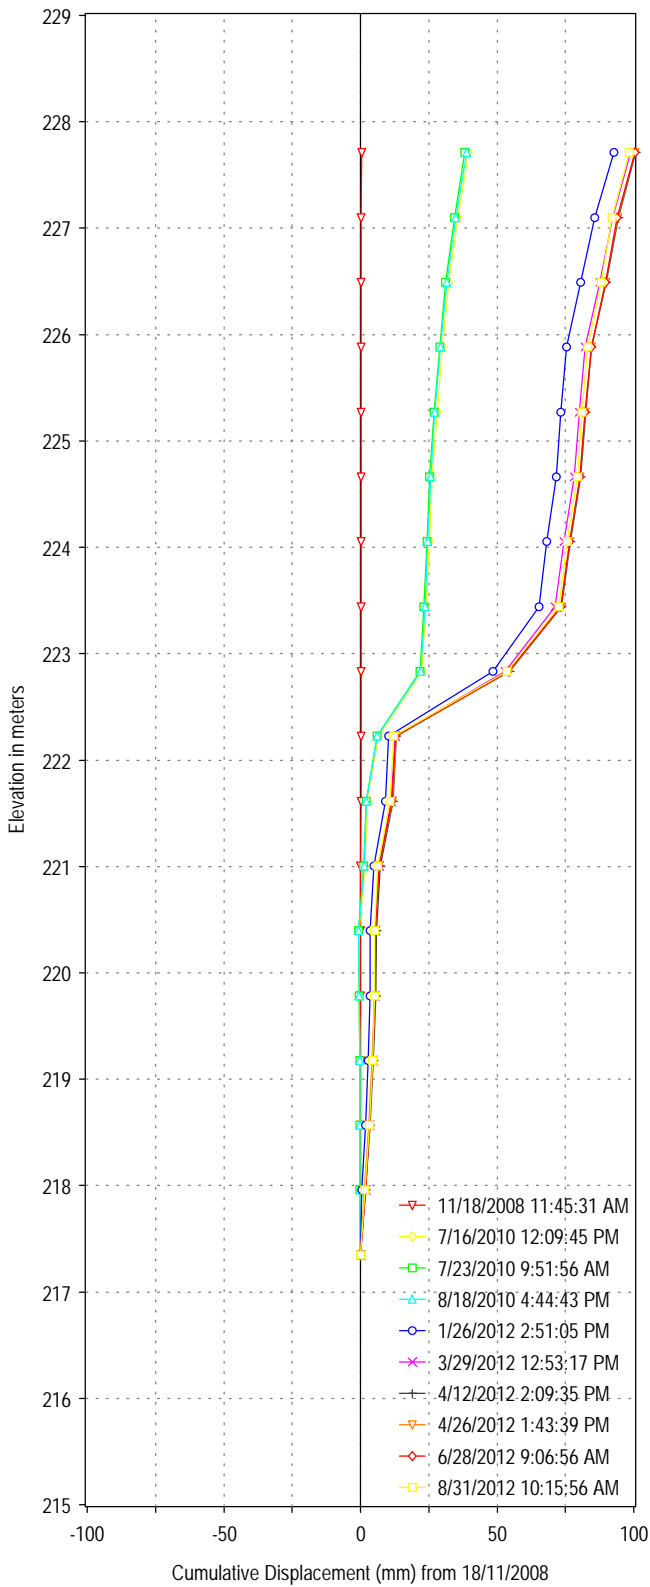
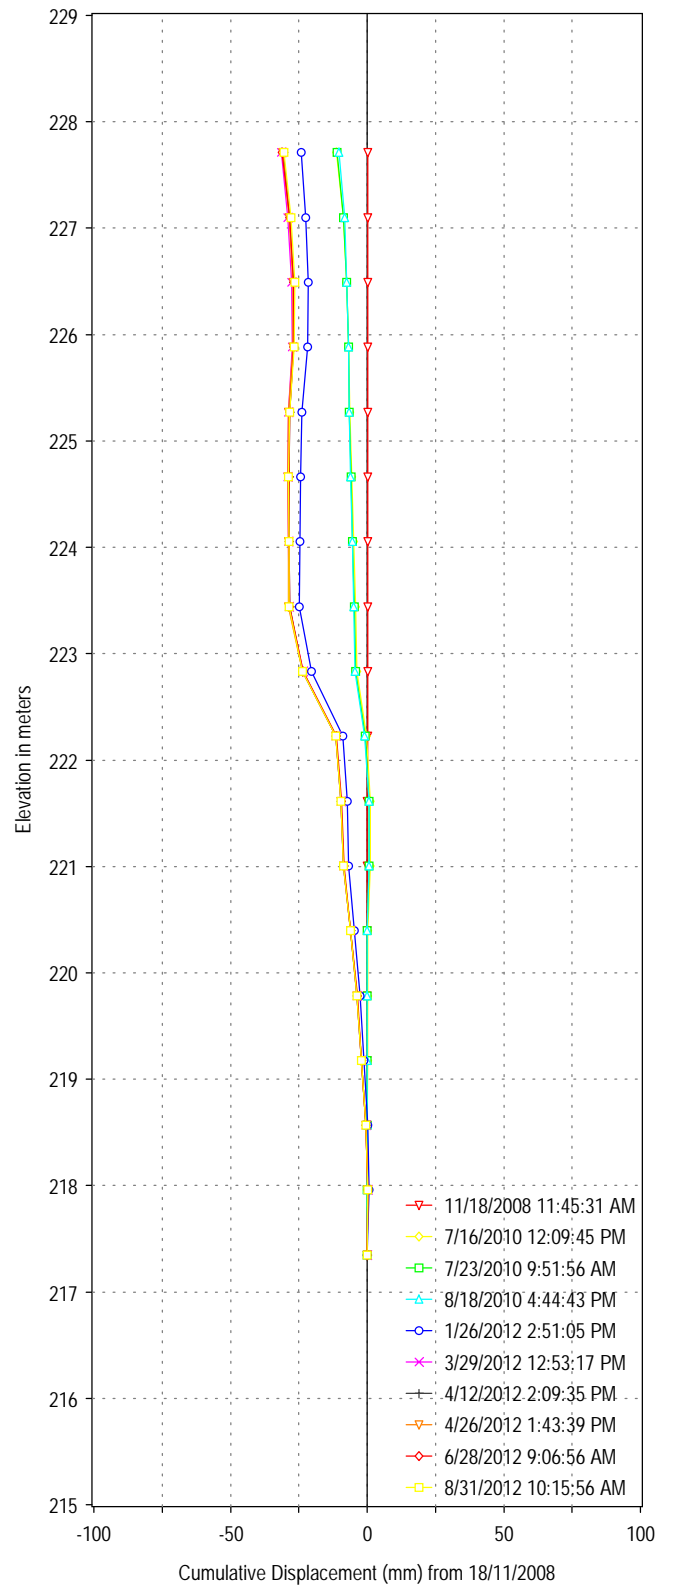
SI03, A-Axis

SI03, B-Axis

Midtown Feedermain South Bank
 SI080-03
 Ground Surface at Elev. 227.4 m
 Cumulative Displacement

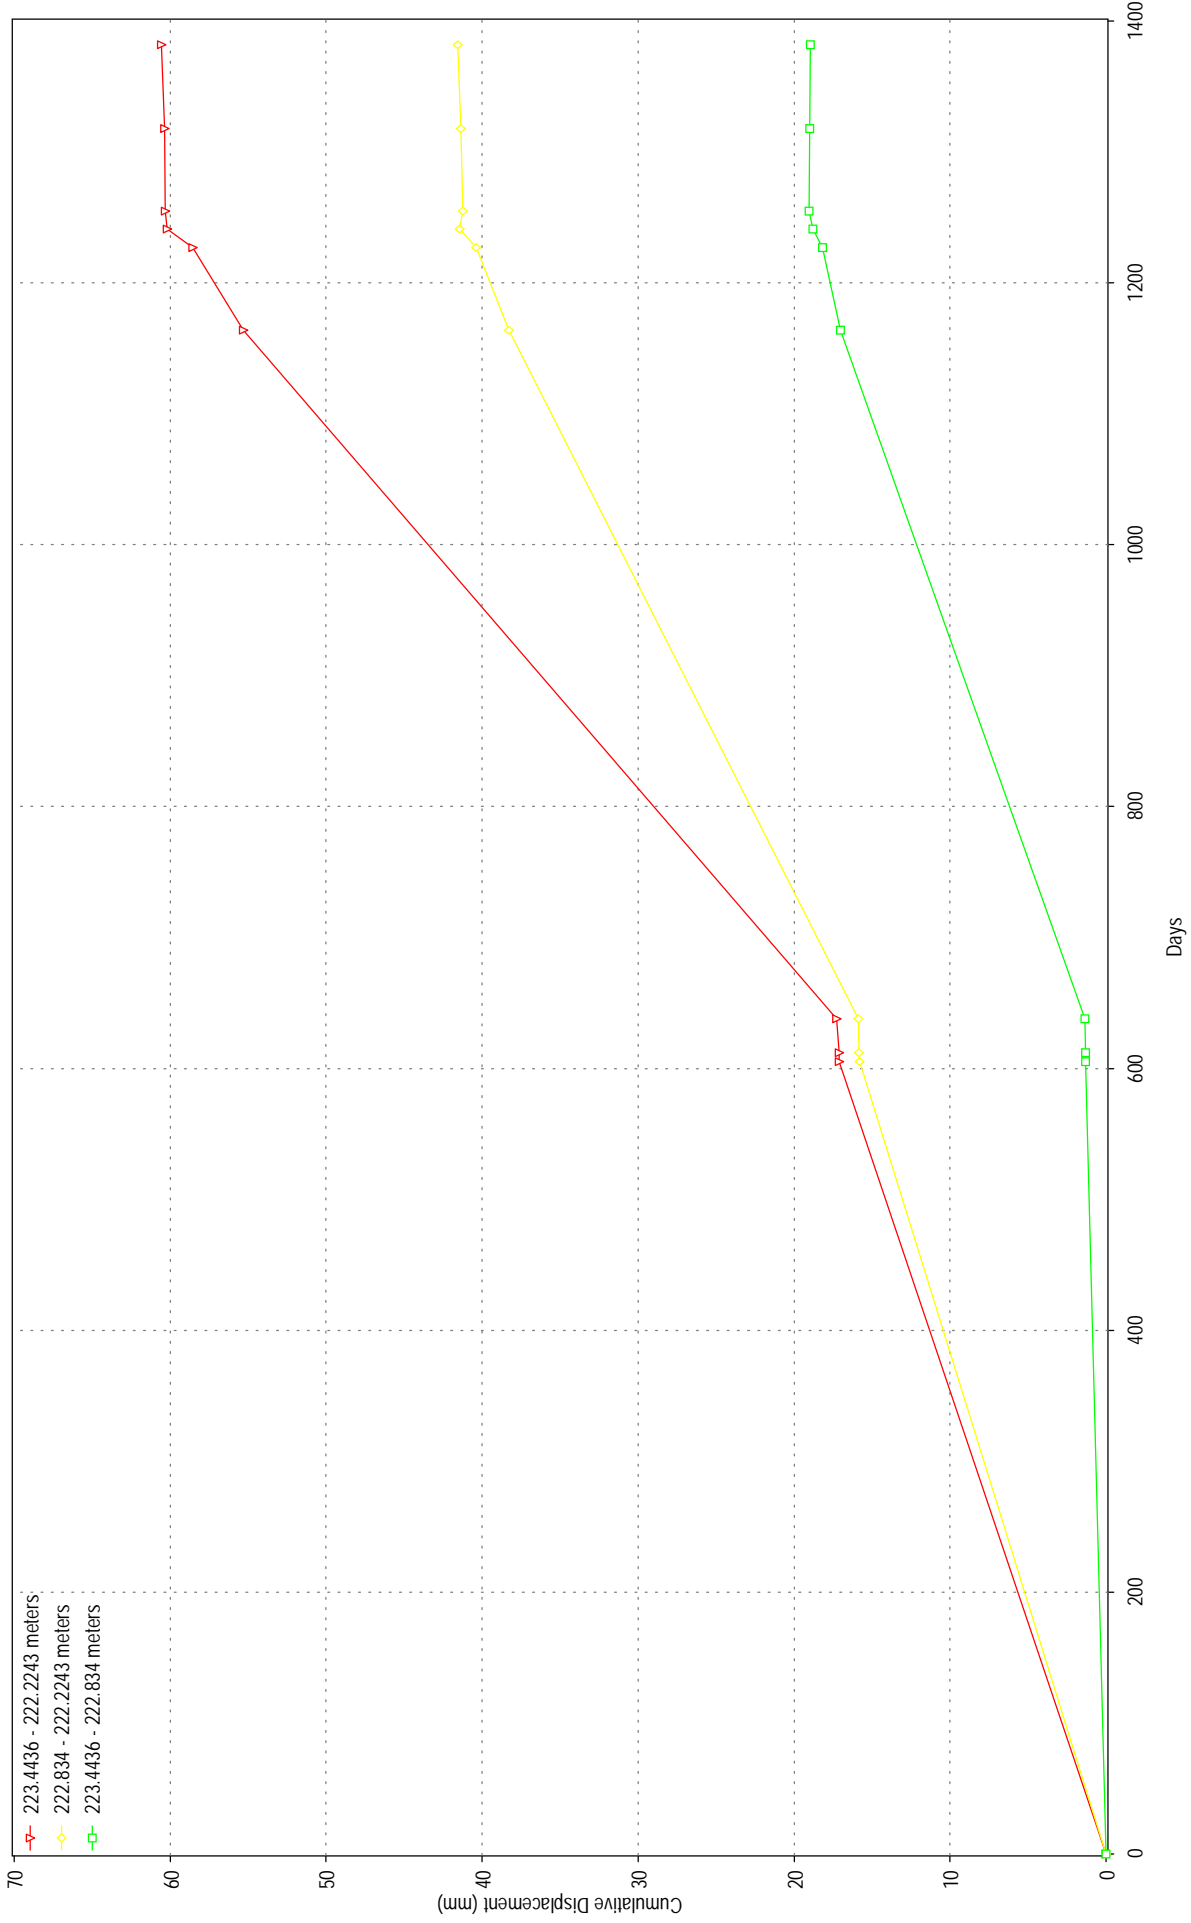
MIDTWN SI03, A-Axis

Midtown Feedermain South Bank
SI08-03
Ground Surface at Elev. 227.4 m
Time vs. Displacement

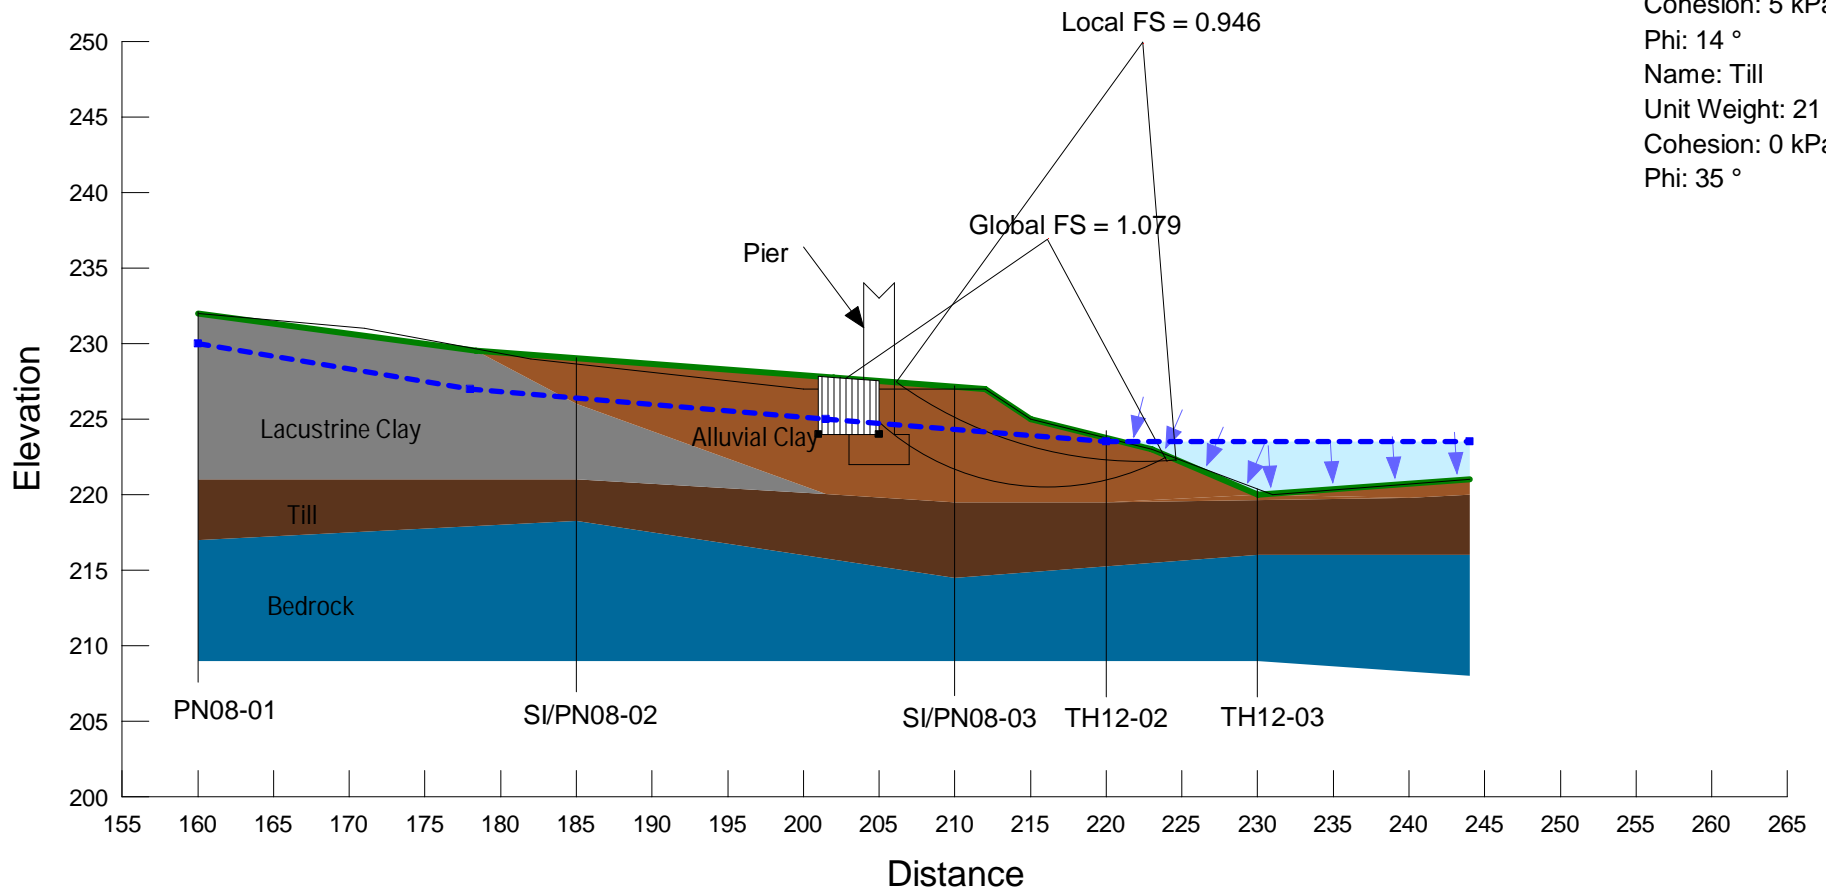
File Name: Midtown Feedermain - #2-South Bank LGW.gsz
 Name: SLOPE/W Midtown Feedermain- Existing Geometry (WL = 223.5 m)
 Method: Morgenstern-Price
 Description: Figure 1: South Bank - Existing Geometry (WL = 223.5 m)

Name: Alluvial Clay
 Unit Weight: 17 kN/m³
 Cohesion: 0 kPa
 Phi: 18 °
 Name: Lacustrine Clay
 Unit Weight: 17 kN/m³
 Cohesion: 5 kPa
 Phi: 14 °
 Name: Till
 Unit Weight: 21 kN/m³
 Cohesion: 0 kPa
 Phi: 35 °

Case	Calculated FS	
	Global Slip Surface	Local Slip Surface
Existing Condition	1.08	0.95
Slope Regrade	1.21	1.08
Slope Regrade + Shear Key	1.67	1.41
Slope Regrade + Shear Key + Riprap	1.68	1.53

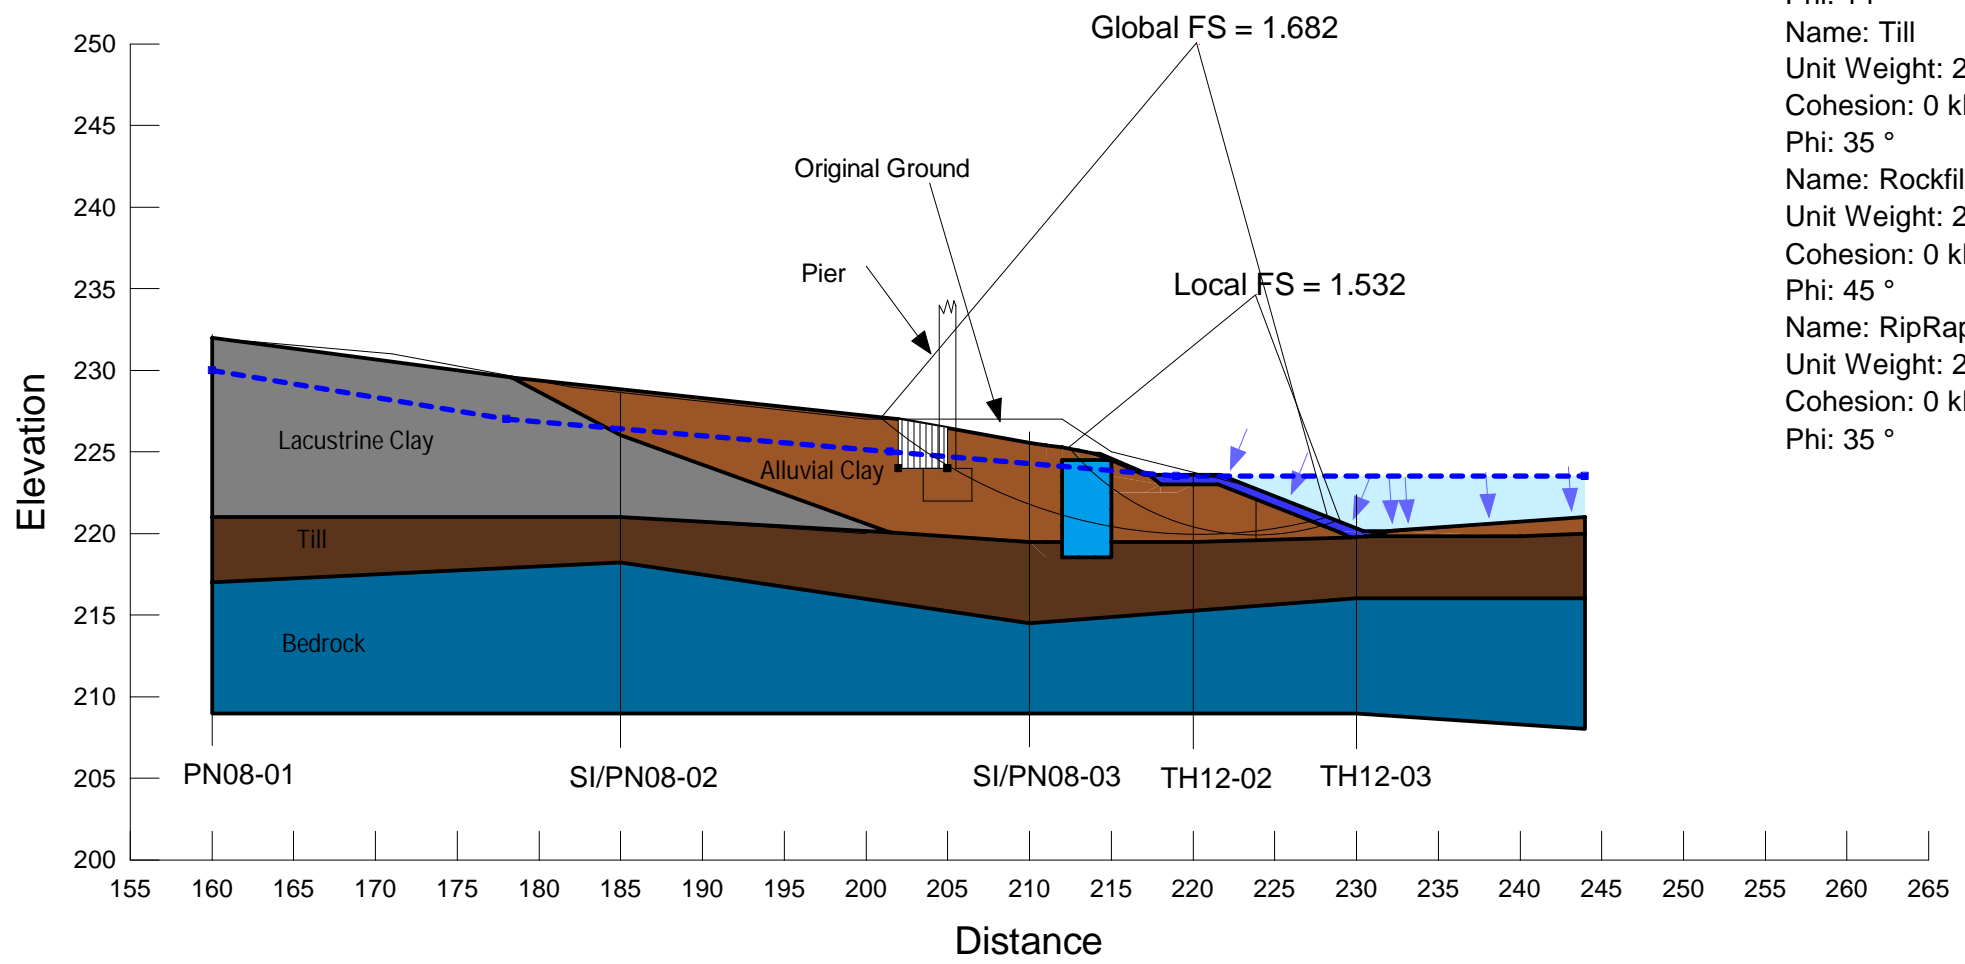
File Name: Midtown Feedermain - Final#23 South Bank (Compacted 3 m-ReG+RC+RP).gsz
 Name: SLOPE/W Midtown FM - Water Level = 223.5 m
 Method: Morgenstern-Price
 Description: Figure 4: South Bank - Regrading + Shear Key(3m) + Rip Rap Blanket

- Name: Alluvial Clay
 Unit Weight: 17 kN/m³
 Cohesion: 0 kPa
 Phi: 18 °
- Name: Lacustrine Clay
 Unit Weight: 17 kN/m³
 Cohesion: 5 kPa
 Phi: 14 °
- Name: Till
 Unit Weight: 21 kN/m³
 Cohesion: 0 kPa
 Phi: 35 °
- Name: Rockfill
 Unit Weight: 21 kN/m³
 Cohesion: 0 kPa
 Phi: 45 °
- Name: RipRap
 Unit Weight: 21 kN/m³
 Cohesion: 0 kPa
 Phi: 35 °
