## **GWWD Grade Crossing Assessment**

# PROFESSIONAL CONSULTING SERVICES FOR REPLACEMENT OF RAILWAY CROSSING PROTECTION CROSSING ASSESSMENT

PROJECT NO.: 18M-00174-00  
DATE: AUGUST 22, 2019

**Subject: Assessment of the At-Grade Railway Crossing of the Greater Winnipeg Water District Railway and Trans-Canada Highway No. 1**

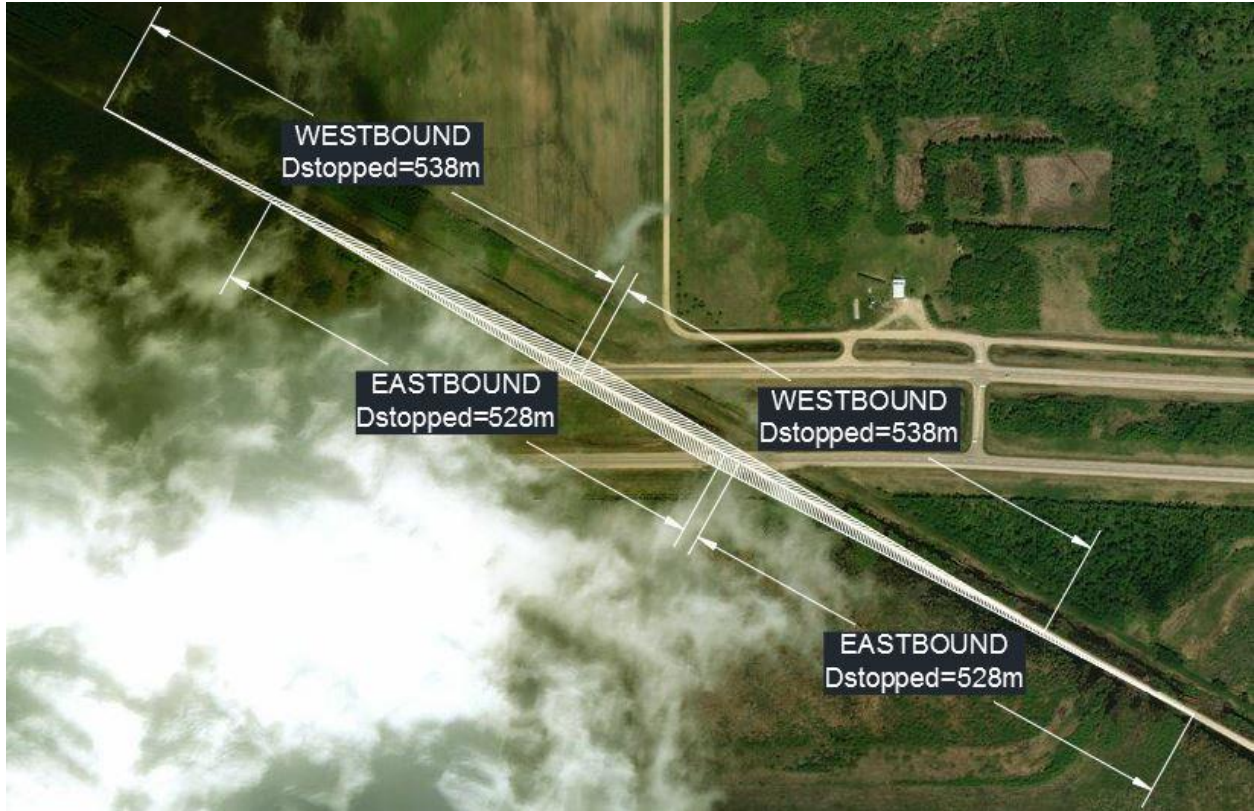
**Figure 1: Aerial Imagery of Sightline Triangles**

The GCR Article 21 outlines the sightline requirements for existing grade crossings. The sightline requirements of GCR Article 21 must be in place by November 27, 2021; however, it is recommended that sightlines be in place as soon as practicable to enhance the safety at the grade crossings. The following section provides a summary of the design parameters involved in determining sightline requirements, lists the required sightlines, and provides an aerial image of the crossing showing the required sightline triangles.

The review of the existing sightlines found that sightlines are in place for both approaches in either direction. It was noted that trees and shrubs are growing in the northeast quadrant of the westbound approach, and southwest quadrant of the eastbound approach. While these trees and shrubs are currently too low to obstruct sightlines, they

should be monitored and removed as necessary. Refer to **Appendix A** for details on the sightline parameter calculations.

SIGHTLINE PARAMETER	REQUIRED	RECOMMENDATION
D <sub>STOPPED</sub> : Westbound Approach Facing North	538 m	Quadrant is clear of obstructions and required sightlines are in place. However, it was observed that there are trees and shrubs that are currently too low to obstruct sightlines, but they should be monitored.
D <sub>STOPPED</sub> : Westbound Approach Facing South	538 m	Quadrant is clear of obstructions and required sightlines are in place.
D <sub>STOPPED</sub> : Eastbound Approach Facing North	528 m	Quadrant is clear of obstructions and required sightlines are in place.
D <sub>STOPPED</sub> : Eastbound Approach Facing South	528 m	Quadrant is clear of obstructions and required sightlines are in place. However, it was observed that there are trees and shrubs that are currently too low to obstruct sightlines, but they should be monitored.

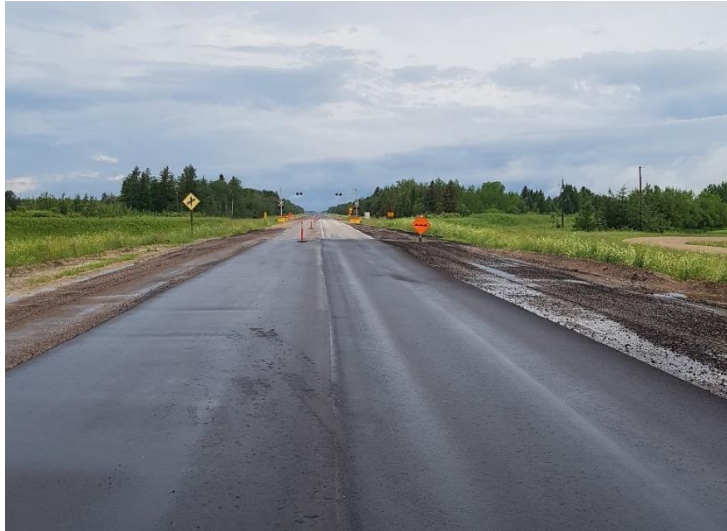
Description: Westbound crossing taken from east approach. Crossing Sign and light units are visible within SSD.

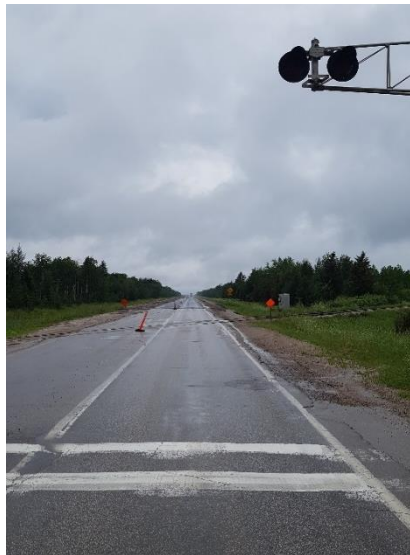
Description: Westbound crossing right lane.

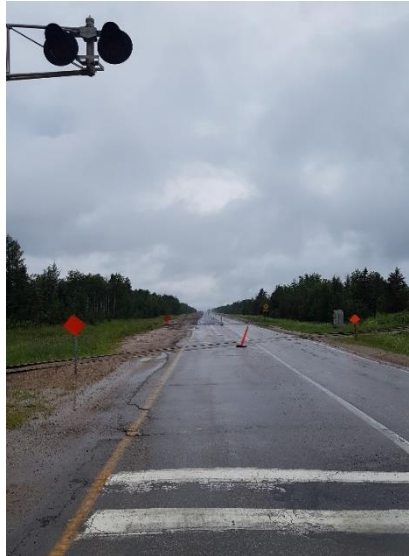
Description: Westbound crossing left lane.

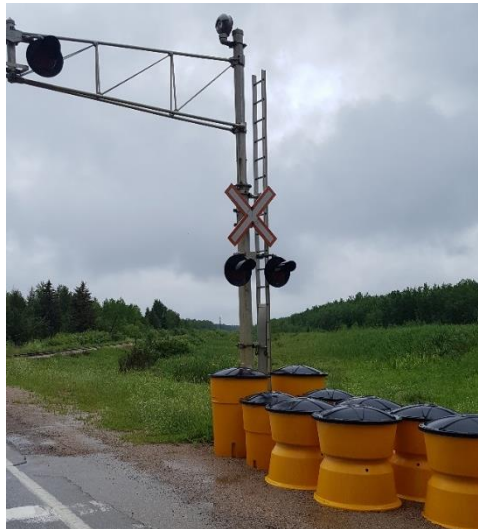
Description: Westbound sightlines to the north. Sightlines are clear; however, as vegetation grows it will eventually obstruct the sightlines.

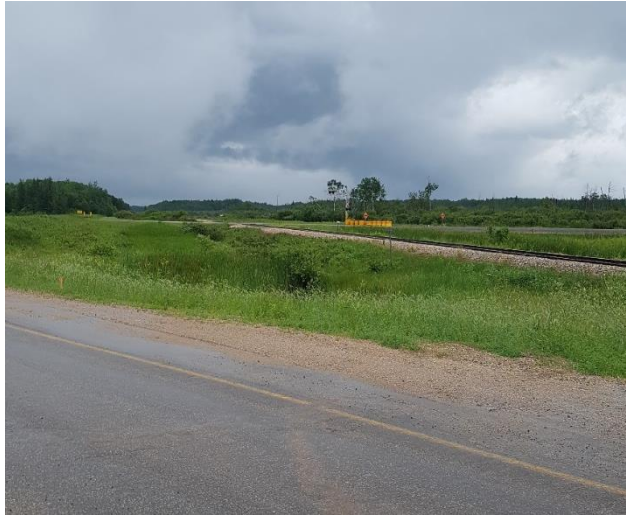
Description: Westbound sightlines to the south. Sightlines are clear.

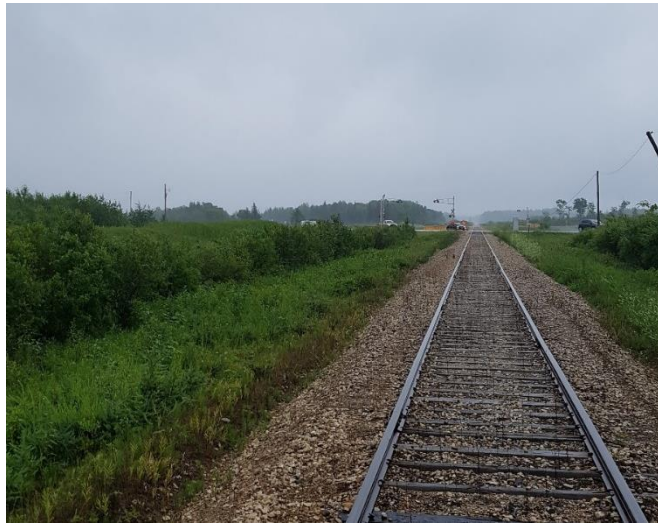
Description: Westbound crossing from the south along the rail track. Note: Vegetation in ditch that will eventually obstruct the sightlines.

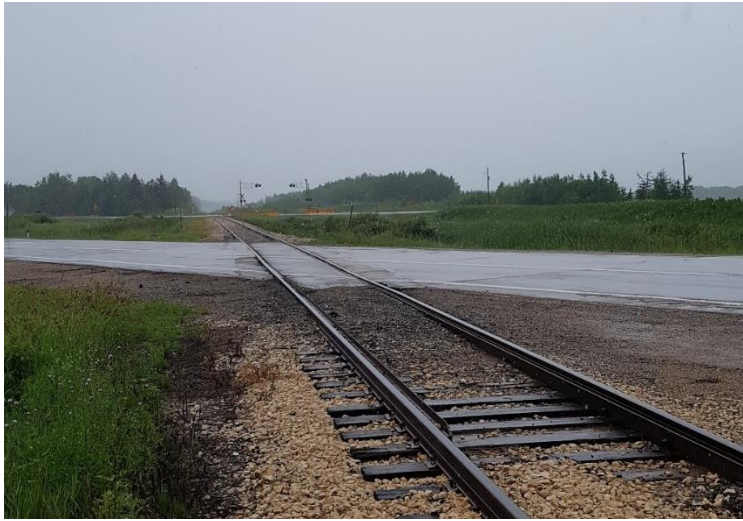
Description: Westbound crossing from the north along the rail track.

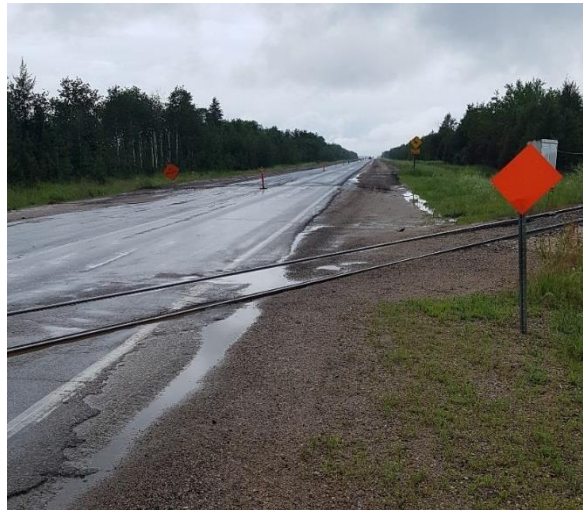
Description: Westbound crossing north, crossing the surface extension. Note: Gravel has been built up between rails, but asphalt crossing surface does not extend into shoulder. There is a hole in the gravel at the edge of the asphalt between the rails.

GCR REFERENCE	GCS REFERENCE	DEFICIENCY	RECOMMENDATIONS
<b>GCR 58 – Immediate Requirements</b>			
Article 58	Article 3.1	The crossing surface is not extended 0.5 m beyond the edge of the shoulder for either of the approaches.	The crossing surface should be extended such that it is at least 0.5 m beyond the edge of the shoulder at both approaches.
Article 58	Article 4.1.2	The north side of the eastbound approach is missing the cantilever, Grade Crossing Sign and front light.	The cantilever with flashing lights and bells (FLB) should be reinstalled prior to the crossing warning system being put back into service.
<b>GCR 60-71 – 2021 Requirements</b>			
Article 60	Article 5.1	The crossing surface is in poor condition on both the eastbound and westbound approaches due to chipping of the asphalt on the field side of the rail.	The asphalt should be repaired or the crossing surface replaced.
Article 63	Article 8.5	An Emergency Notification Sign was not present on either of the approaches.	An Emergency Notification Sign containing information on the location of the grade crossing and the railway company's emergency telephone number must be installed parallel to the road or on each side of the grade crossing, facing the approaching traffic.

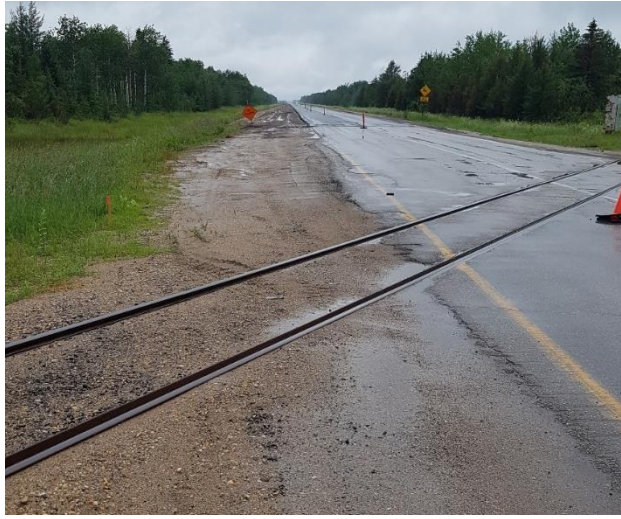
Description: Westbound crossing south, crossing the surface extension. Note: Gravel has been built up between rails, but asphalt crossing surface does not extend into shoulder.

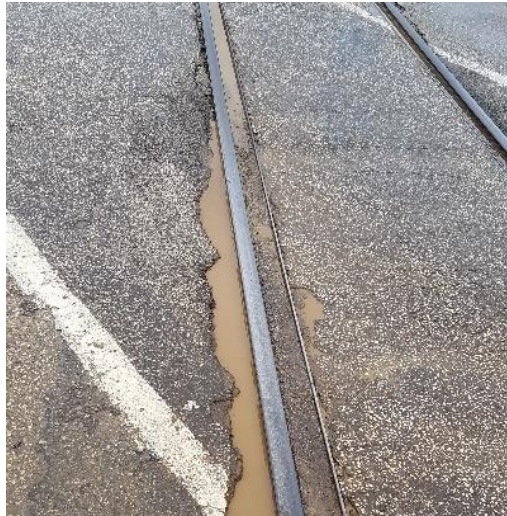
Description: Chipped asphalt on field side of rail at the crossing surface. Worst case was 127 mm wide and 102 mm deep.

GCR REFERENCE	GCS REFERENCE	PARAMETER	EXISTING CONDITIONS	COMPLIANCE (YES/NO)	RECOMMENDATIONS
<b>Crossing Surface and Road Approach: General</b>					
Article 60	Article 5.1	Crossing Surface: Smoothness and Continuity.	Poor: Asphalt is chipped on the field side of the rail at both approaches.	No	Replace crossing surface or repair asphalt.
Article 60	Figure 5-1b	Sidewalk, Path or Trail present?	No	N/A	No Recommendation
Article 60	Figure 5-1b	Separation distance between road crossing surface and sidewalk, path or trail crossing surface.	N/A	N/A	No Recommendation
Article 60	Figure 5-1b	If separation distance is less than 1 m, the crossing surface must be continuous.	N/A	N/A	No Recommendation
<b>Crossing Surface and Road Approach: Westbound Approach</b>					
Article 60	Figure 5-1b	Crossing Surface Extension: Road Approach.	North Side: <0.5 m South Side: <0.5 m	No	Crossing surface must be extended at least 0.5 m beyond shoulder width of approaches.

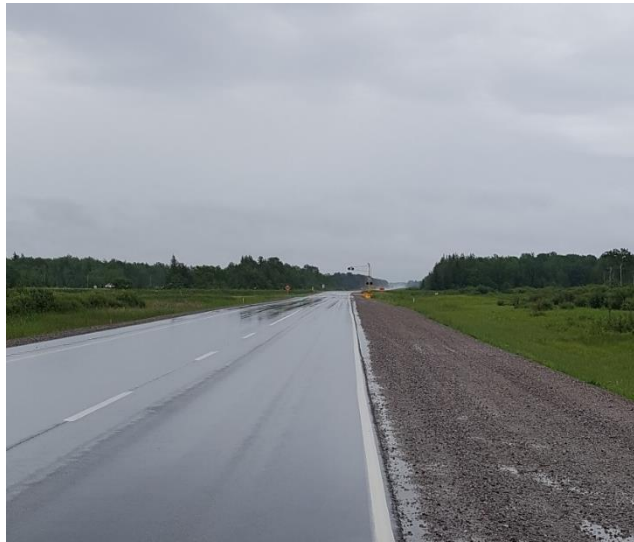
Description: Eastbound crossing taken from west approach. Crossing Sign and light units are visible within SSD.

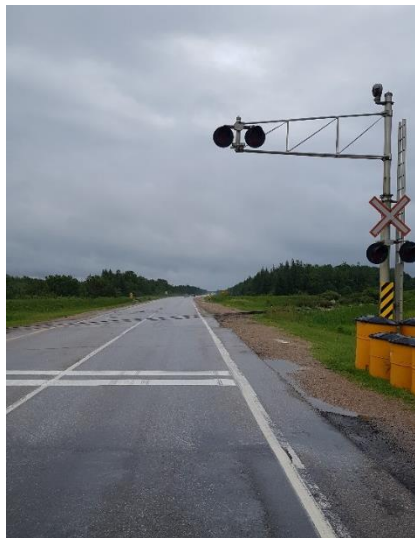
Description: Eastbound crossing right lane.

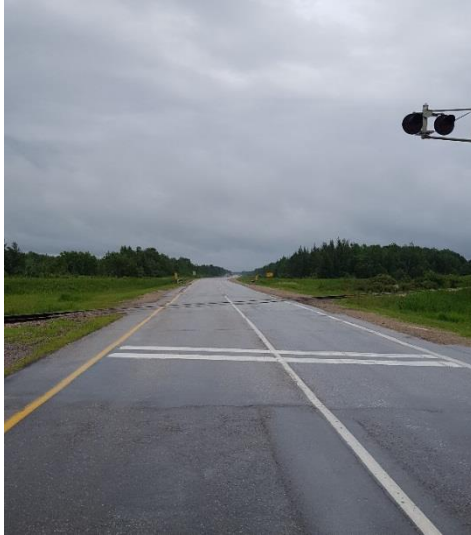
and front lights are missing on the north side of the eastbound lane.
Number of Tracks Sign	Not Applicable.
Reflective Material on Front of Sign	Front of Sign consists of reflective material.

Description: Eastbound crossing left lane. Note: No Crossing Sign or light unit on the left side.

GCR REFERENCE	GCS REFERENCE	PARAMETER	EXISTING CONDITIONS	COMPLIANCE (YES/NO)	RECOMMENDATIONS
Article 67(1)	-----	Prepare to Stop at Railway Crossing Sign is required if at least one set of front light units is not visible within stopping sight distance or if weather conditions repeatedly obscure visibility of the warning system.	Front light units are visible within SSD.	Yes	No Recommendation
Article 67(2)	Article 18.1	Prepare to Stop at Railway Crossing Sign	N/A	N/A	No Recommendation
Article 67(2)	Article 18.2	Advanced Activation Time	N/A	N/A	No Recommendation
Article 68(1)	Article 13.1	Light units must be installed to ensure a crossing user is within the effective distribution pattern within SSD and is able to see at least one set of front light units clearly.	Light unit south of road is clearly visible within SSD. Light unit north of road is not present.	No	Install light units north of road.

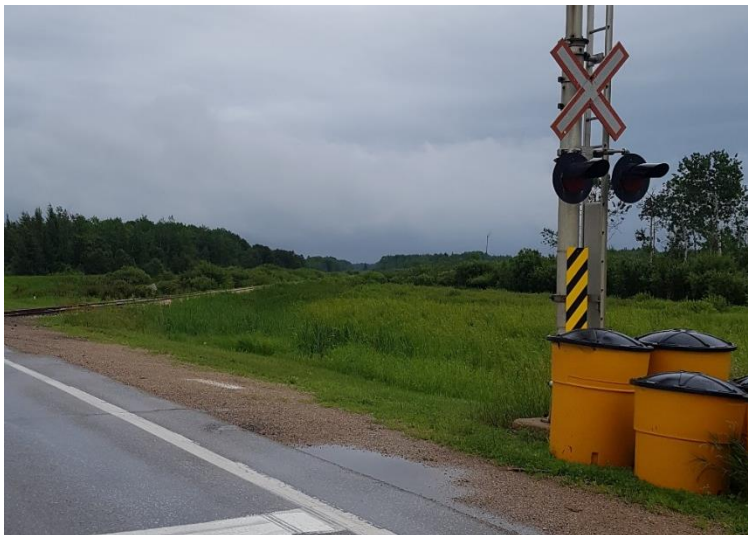
Description: Eastbound sightlines to the south. Sightlines are clear; however, as vegetation grows, it will eventually obstruct the sightlines.

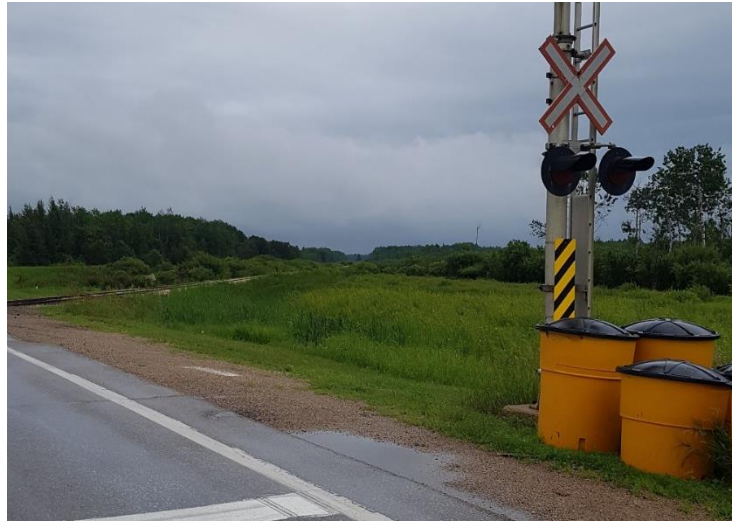
Description: Eastbound Sightlines to the north. Sightlines are clear.

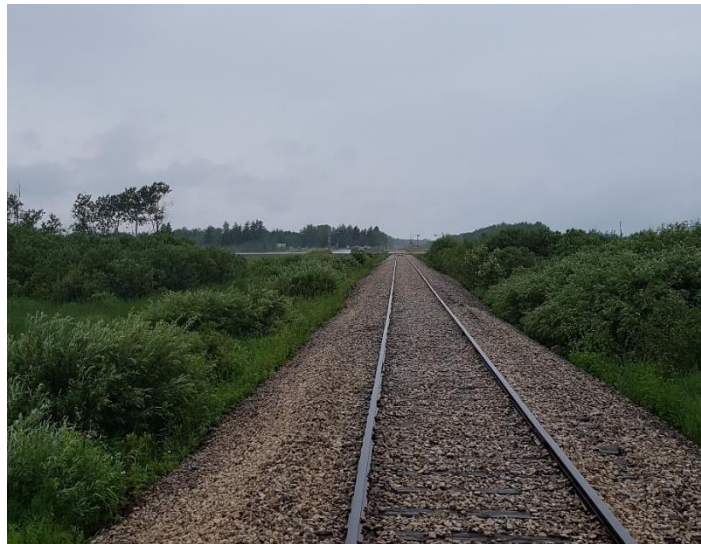
Description: Eastbound crossing from the south along the rail track. Note: Vegetation in ditch that will eventually obstruct the sightlines.

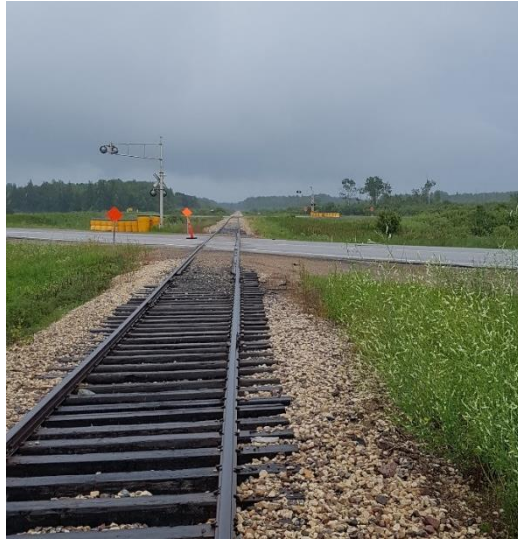
Description: Eastbound crossing from the north along the rail track.

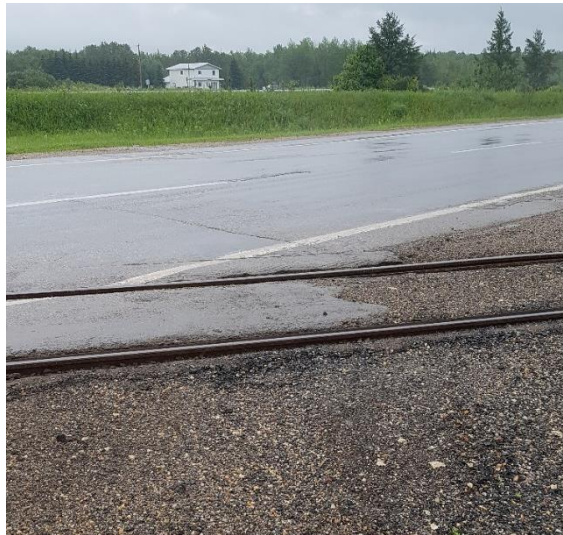
Description: Eastbound crossing south, crossing the surface extension. Note: The surface does not sufficiently extend beyond the roadway.

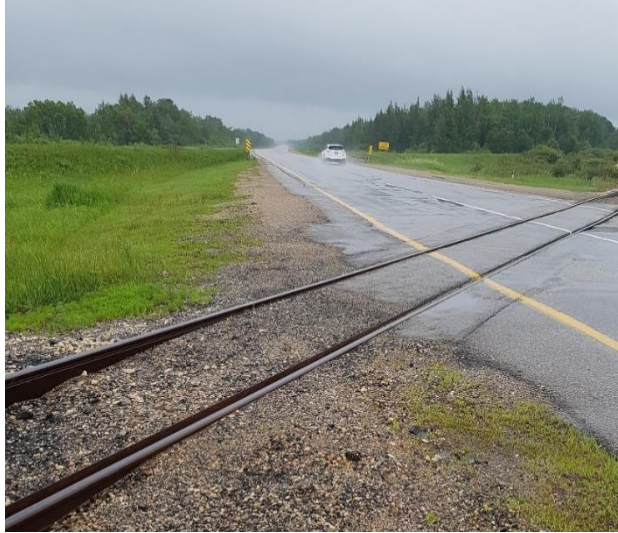
Description: Eastbound crossing north, crossing the surface extension. Note: The surface does not sufficiently extend beyond the roadway.

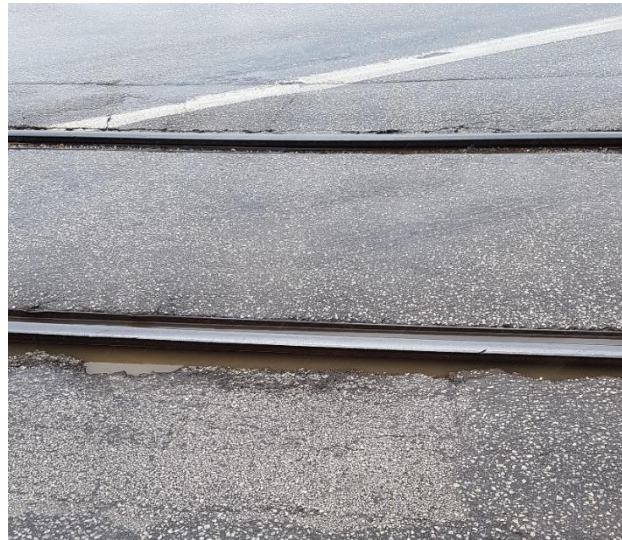
Description: Chipped asphalt on field side of rail at the crossing surface. Worst case was 51 mm wide and 102 mm deep.
