Memorandum

To	Marvin McDonald	Page	1
CC			
Subject	Preliminary Geotechnical Assessment- Fort Garry Interceptor Sewer Crossing at the Red River		
From	Alex Hill		
Date	December 12, 2013	Project Number	60274906 (403.9.2)

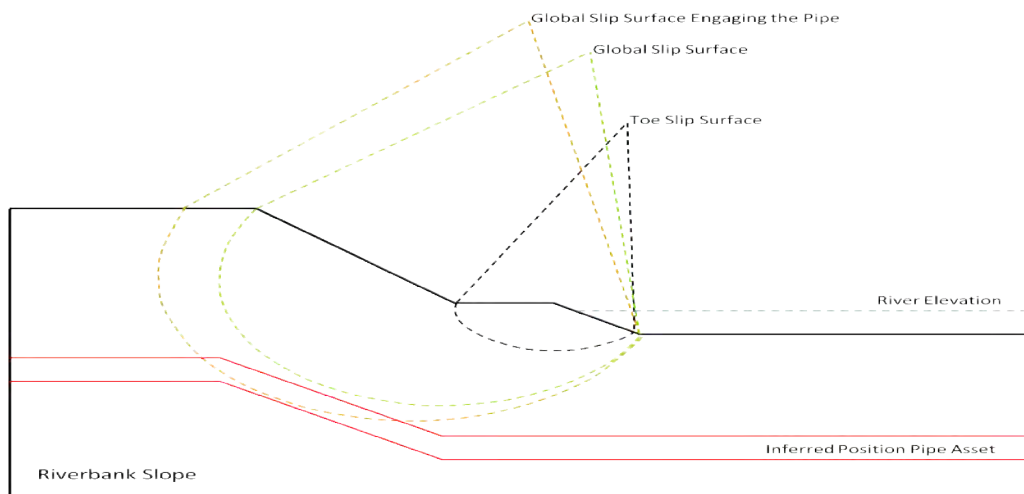
Figure 1: Assessed Slip Surfaces within Analysis

As part of the analysis, the following slip surfaces were considered of interest and are presented graphically in Figure 1 below. A Factor of Safety (FS) was assigned to each of the following:

- **Global Slip Surface (GS):** Defined as a slip surface that largely encompasses the slope soil mass, and has an entry and exit point at or just beyond the slope crest and toe.
- **Global Slip Surface Engaging Pipe (GS+P):** Defined as a slip surface that meets the criteria of a global slip surface and encompasses part of the buried pipe.
- **Toe Slip Surface (TS):** Defined as a slip surface that is localised to the toe of the slope, which has a minimum depth of 0.5 m. At some locations the FS of this slip surface may be lower than the critical or global FS. Instability at the toe of the slope may reduce the FS for the global or critical slip surfaces. Retrogressive failures starting at the toe may also work towards the riverbank.

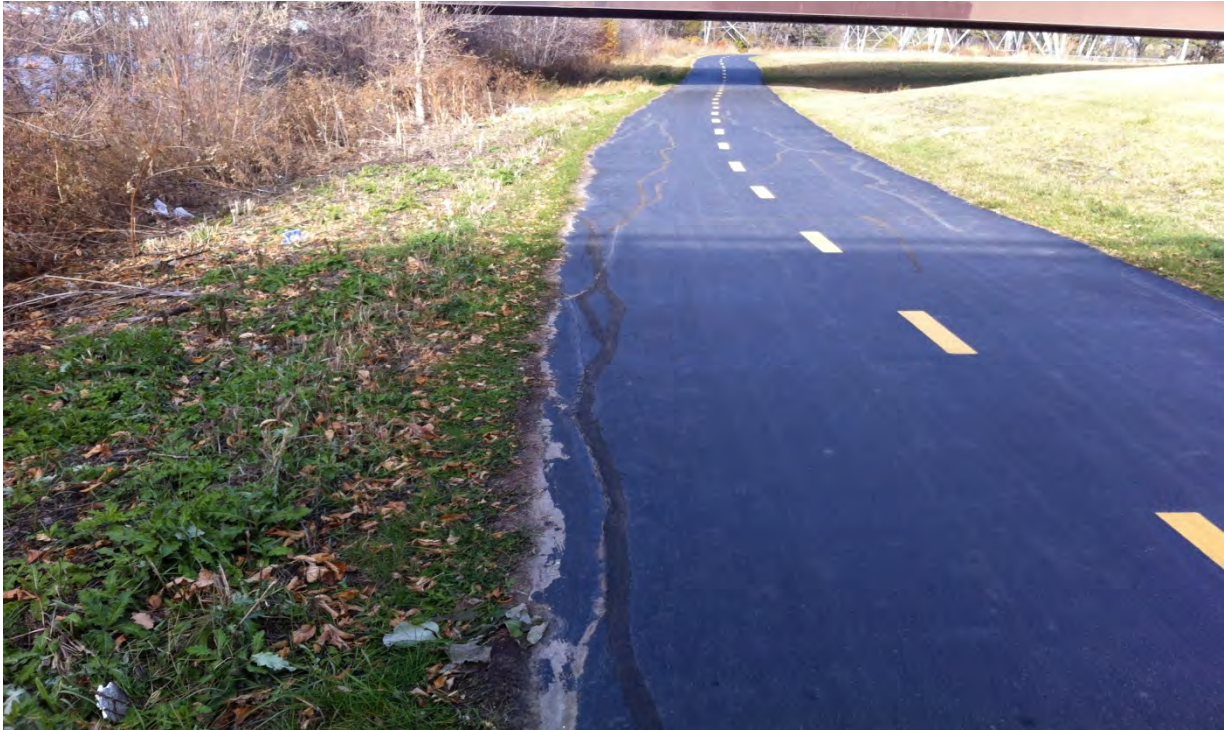
- A tension crack was observed on the asphalt walkway running approximately 10 meters in both directions perpendicular to interceptor alignment. No vertical displacement within the pavement surface was noted. It was further evident that historical movement along the tension crack in the horizontal direction may have occurred, which appeared to have been partially repaired. There may be a number of mechanisms attributable to the identified pavement cracking including sub-base/sub-grade failure, seasonal swelling and shrinkage of sub-grade, and movement within the riverbank slope.

Photo 1: Cracking along the existing asphalt access road, mid-slope facing north.

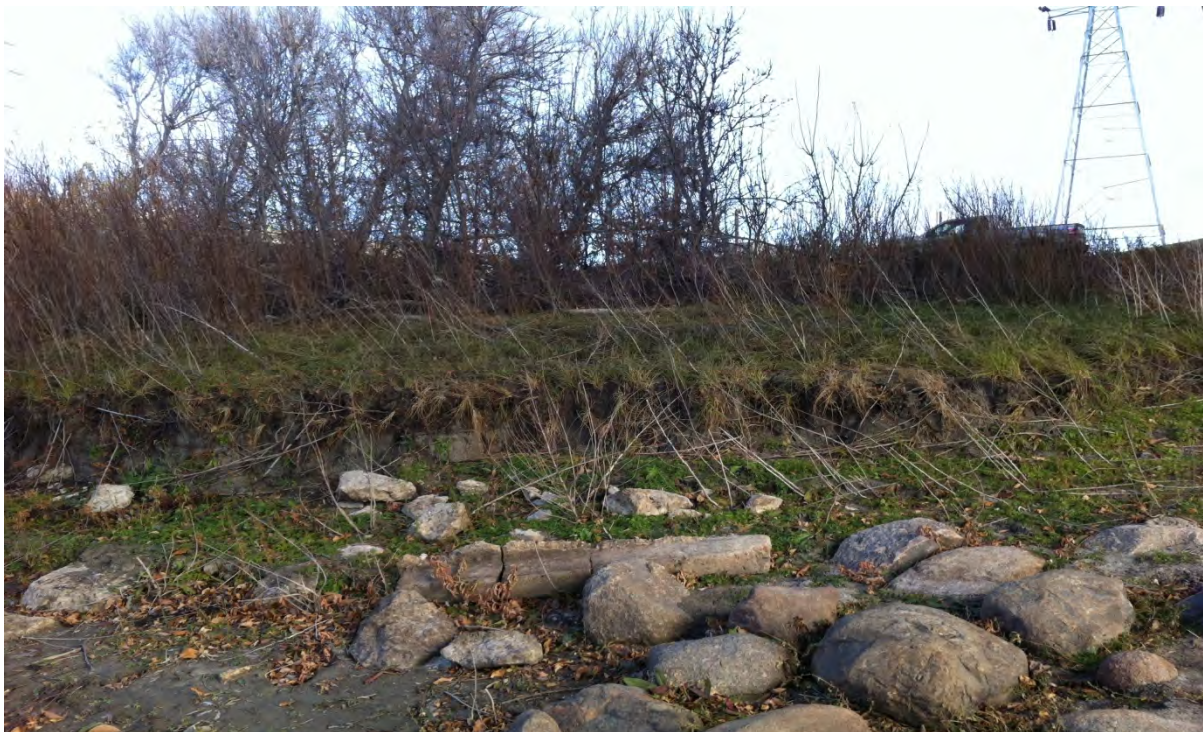
There appeared to be no clear indication of deep-seated rotational or translational movement/failure within the riverbank slope either historically or at present. Based on the erosion of the alluvial soils at the toe of the slope, the most significant driver of any slope instability would likely be the localized softening and weathering of soils due to water erosion, and the further reduction of toe weight due to erosion. A loss of materials at the toe of the slope may, in time, propagate further upslope by a process of retrogressive failure.

Photo 2: Erosion of riverbank toe, facing east.

A rip-rap blanket consisting of quarried limestone is recommended along the lower slope from an elevation of approximately 222.02 m, to an approximate elevation of 225 m, with a corresponding thickness of 1 m. It is anticipated that partial sub-cut into the existing riverbank slope (between NWWL and NSWL) of approximately 0.5 m will be required.

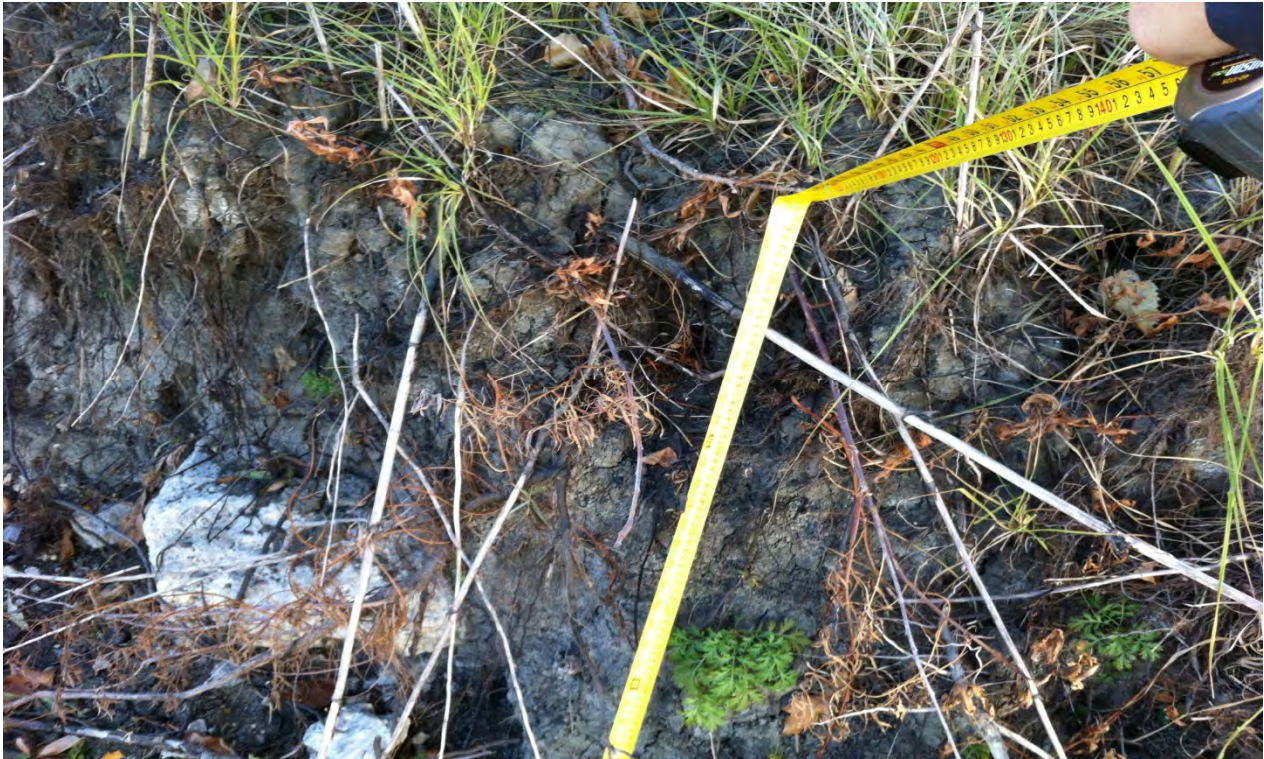
Shallow failures or sloughing of the bank face often follow floods or heavy precipitation which can saturate the bank and reduce the strength of the soil. There is no evidence of deep-seated or rotation failures along the subject riverbank slope, but the rate of bank loss may be accelerated following heavy precipitation or rapid drawdown events. For the most part, the lower portion of the riverbank slope is covered with semi-mature trees and tall shrubs which contribute to reducing erosion to the near-surface soils during heavy rainfall. Little or no vegetation was observed on the over-steepened bank face above the river level, leaving it vulnerable to erosion.

Photo 3: Exposed alluvial soils within eroded riverbank toe (highly weathered and softened), facing east.

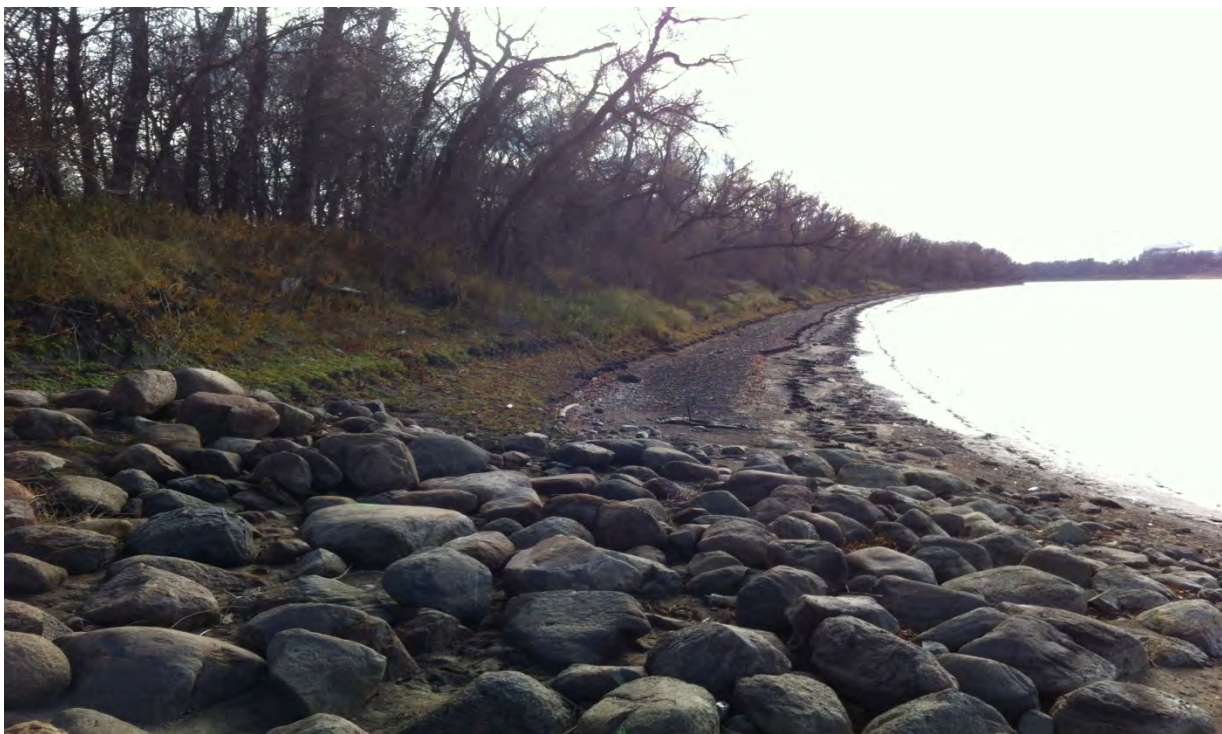
Erosion scour from land drainage sewer outfall at bridge pier of eastbound Fort Garry Bridge was observed approximately 12.0 m south of sewer interceptor pipe alignment. Rip-rap, where present at the toe of the bridge abutment slope, was relatively intact, with erosion being limited to the alluvial materials deposited on the previously placed rip-rap.

Photo 4: Rip-rap blanket placed below eastbound Bishop Grandin Bridge, facing south.

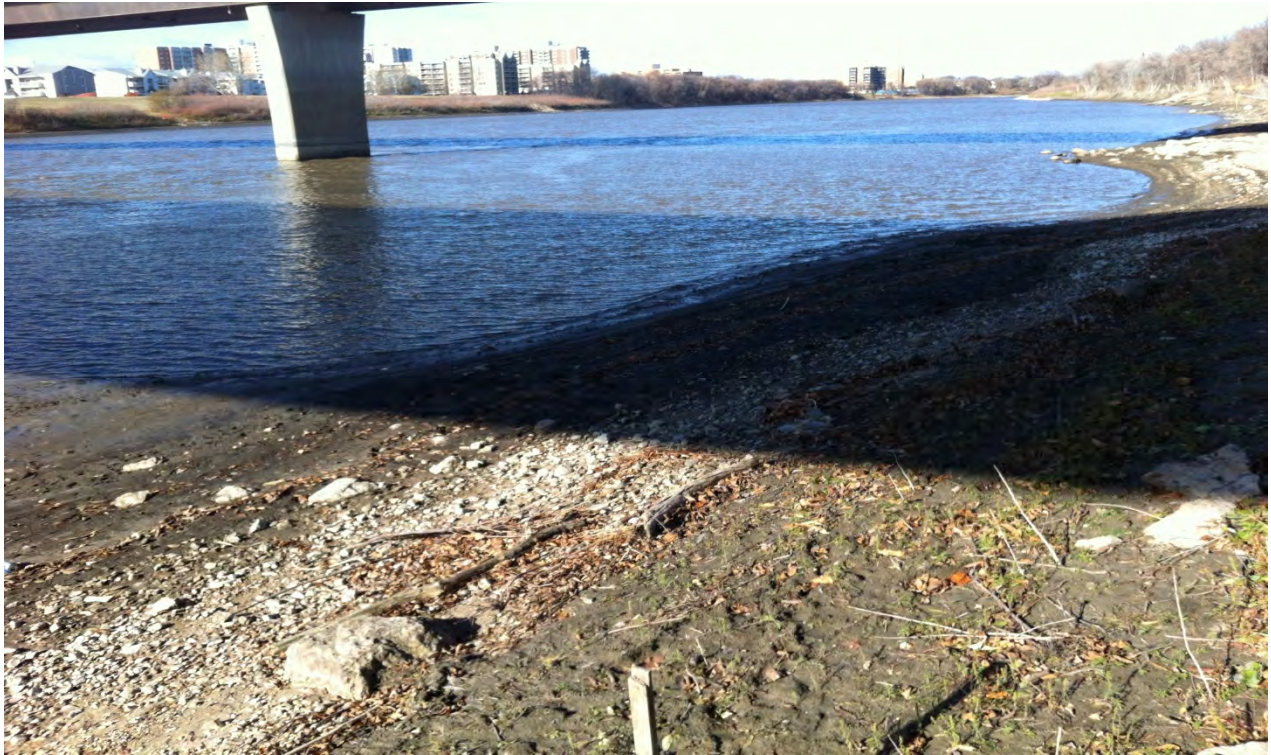
Photo 5: River elevations (November 2013), facing northwest.

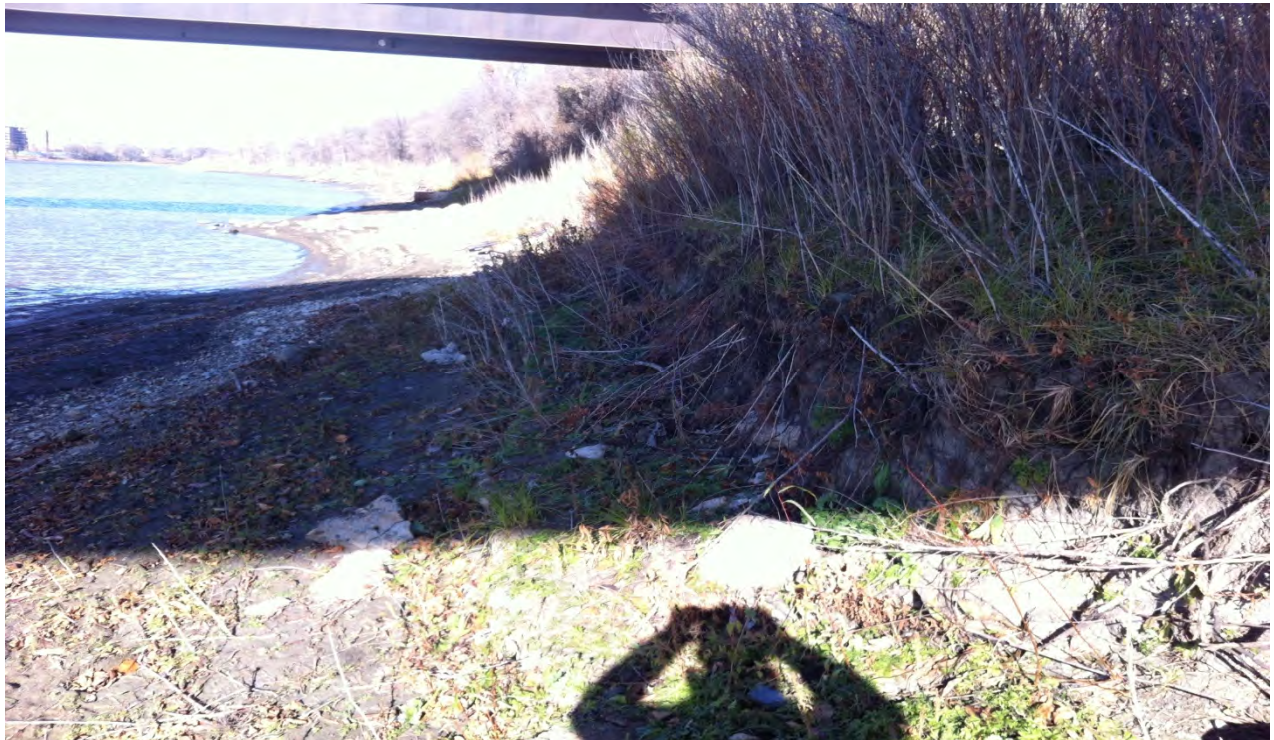
Photo 6: Erosion of riverbank toe, facing north.

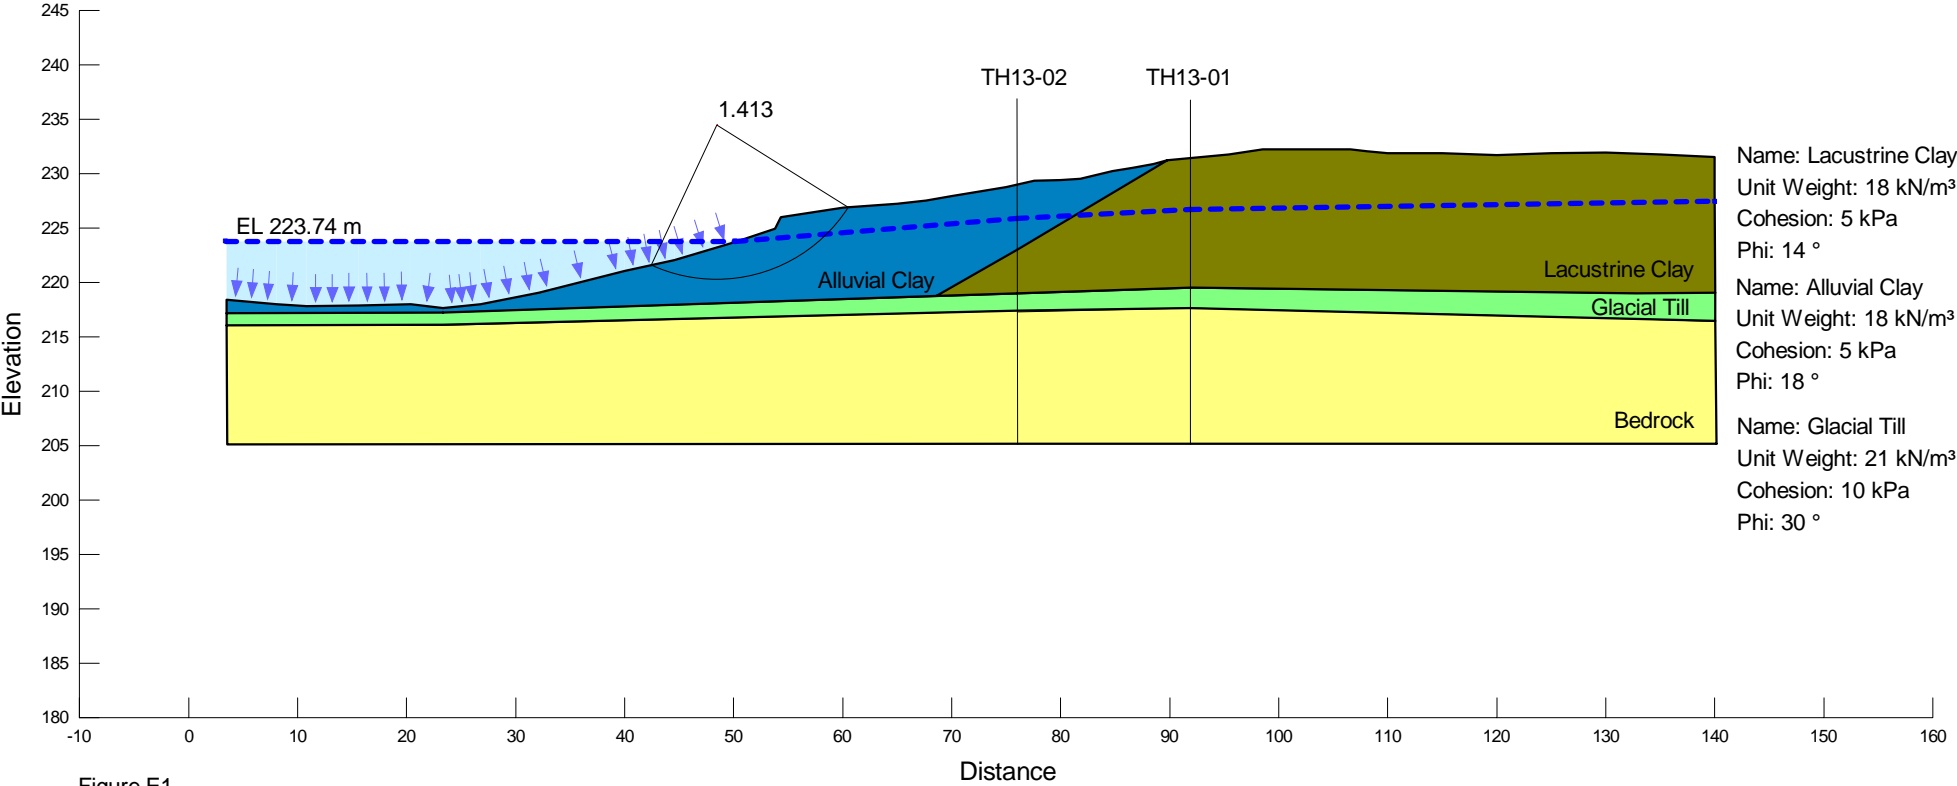
Figure E1

River Conditions	Global Slip Stability (GS)	Global Stability Engaging the Pipe (GS+P)	Toe Slip Surface (TS)	Reference
Normal Summer Water Level (NWWL)	1.41	1.41	>1.5	Figure E2, Appendix E
Normal Winter Water Level (NSWL)	1.37	1.37	> 1.5	Figure E3, Appendix E
Rapid Drawdown	1.19	1.19	> 1.5	Figure E4, Appendix E

Stability assessment was performed by analysing three different river condition scenarios as shown in Table 5-2. As illustrated by the results presented in Table 5-2, stability of the current slope generally falls within the accepted design range of 1.3 to 1.5 as discussed in Section 6.2 of this Memorandum. However, during and directly following rapid drawdown events (e.g., spring melt, transition from summer to winter river levels), the stability of riverbank slope decreases significantly towards an FS of 1.0 (or unity). As the soil remains saturated during drawdown, the hydrostatic force (i.e., river level) supporting the riverbank is lost, and therefore this results in significantly lower stability values as shown by an FS of 1.19.

Current Slope Conditions (Summer River Elevations)

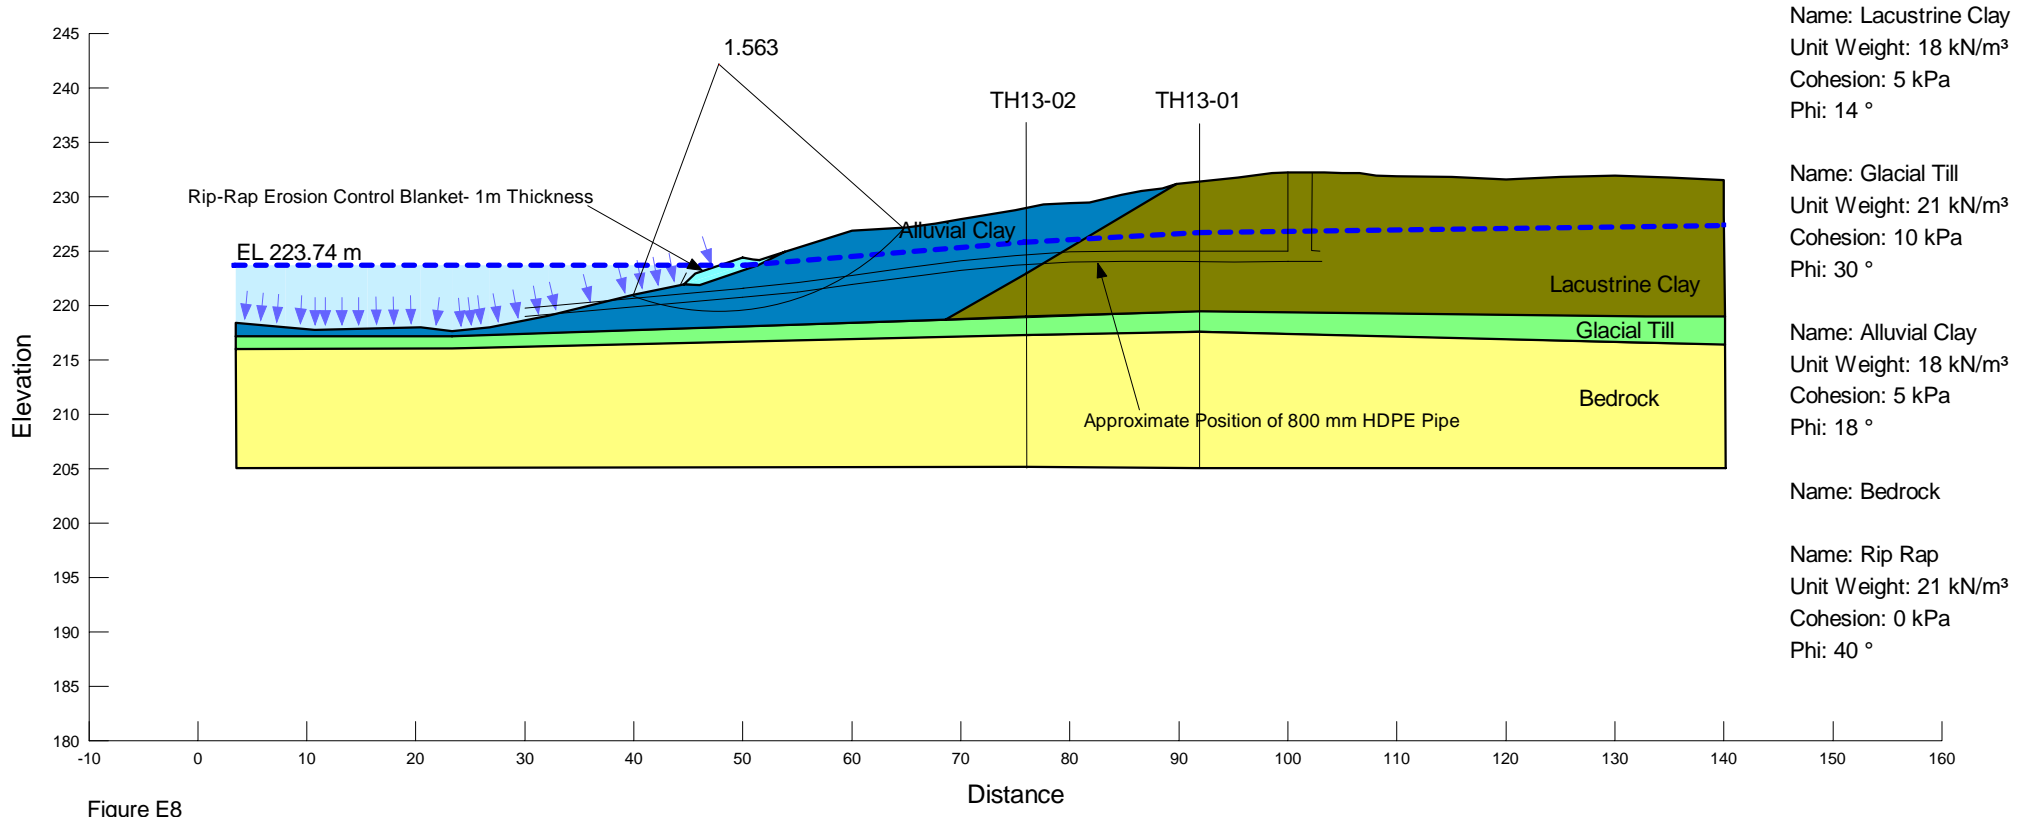
Figure E8

The estimated Factors of Safety determined as part of this analysis are summarised in Table 6-2 below. Assessment has also be undertaken to determine the FS of the riverbank slope during temporary conditions associated with the construction phase as discussed in Sections 6.3.1 and 6.3.2 of this Memorandum. Stability of the riverbank during this period has been calculated with a FS of greater than 1.3, therefore this is considered adequate.

Riverbank Protection Measures- Rip Rap Erosion Control Blanket and Toe Regrade (Summer Elevations)
