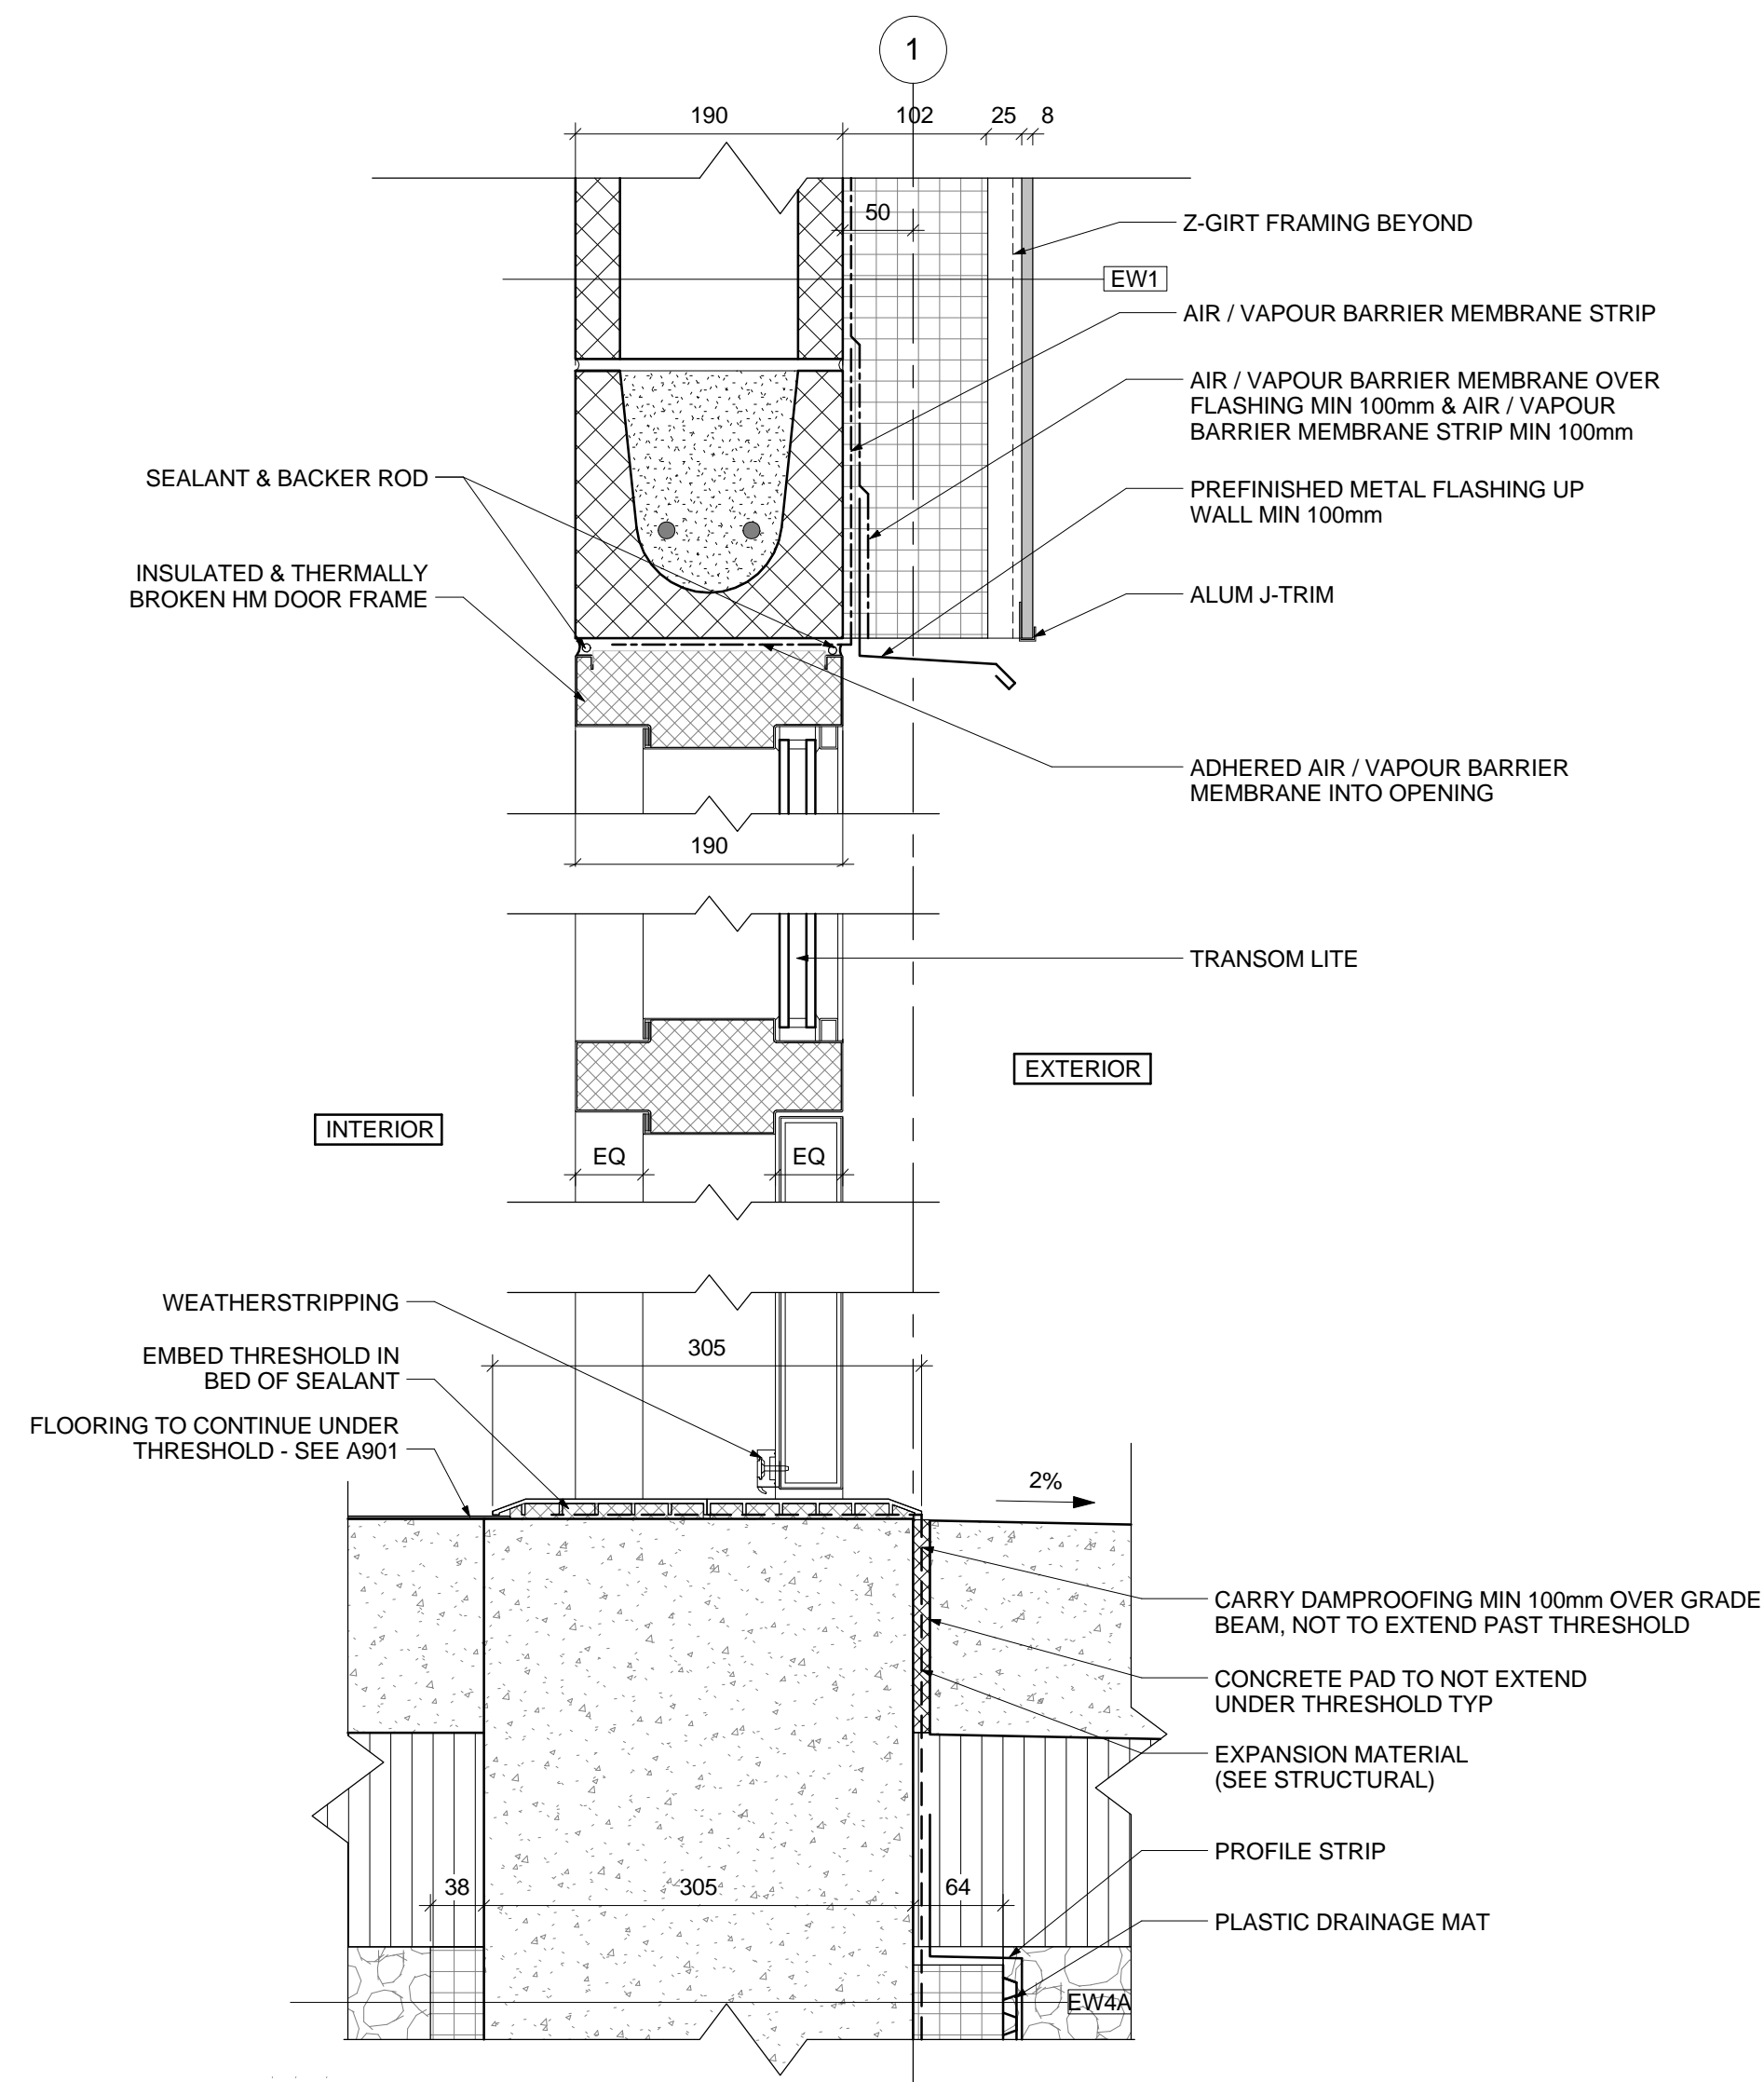
1 MAN DOOR @ GYM
1:5

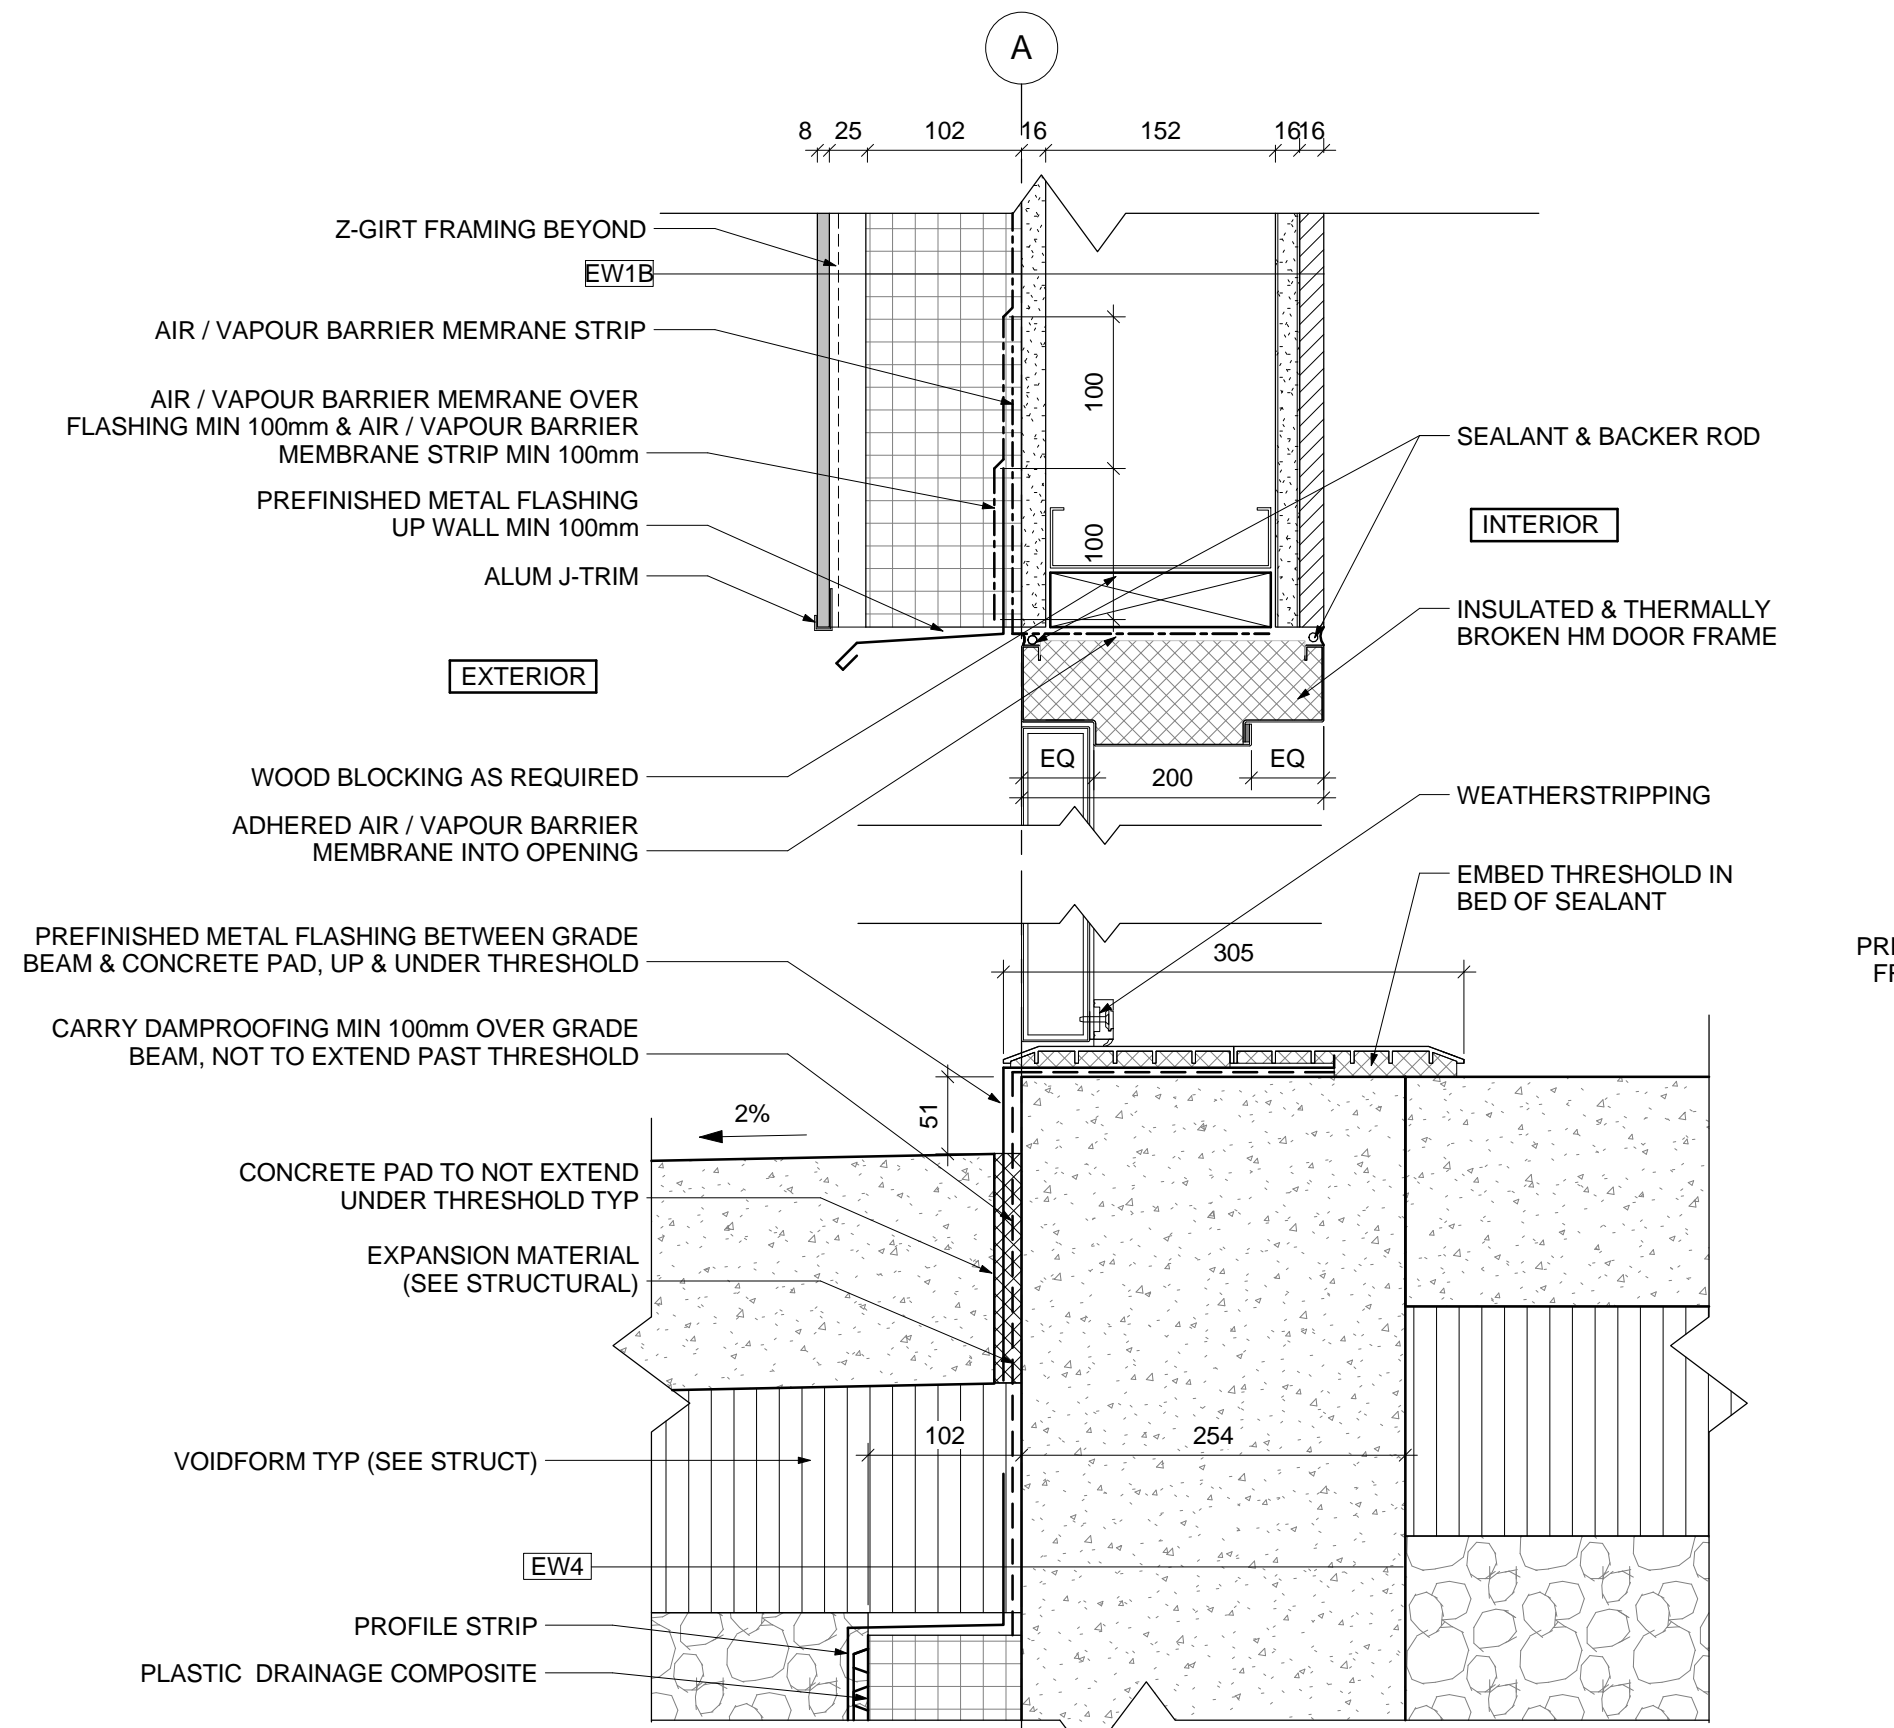
2 MAN DOOR @ SERVICE AREA
1:5

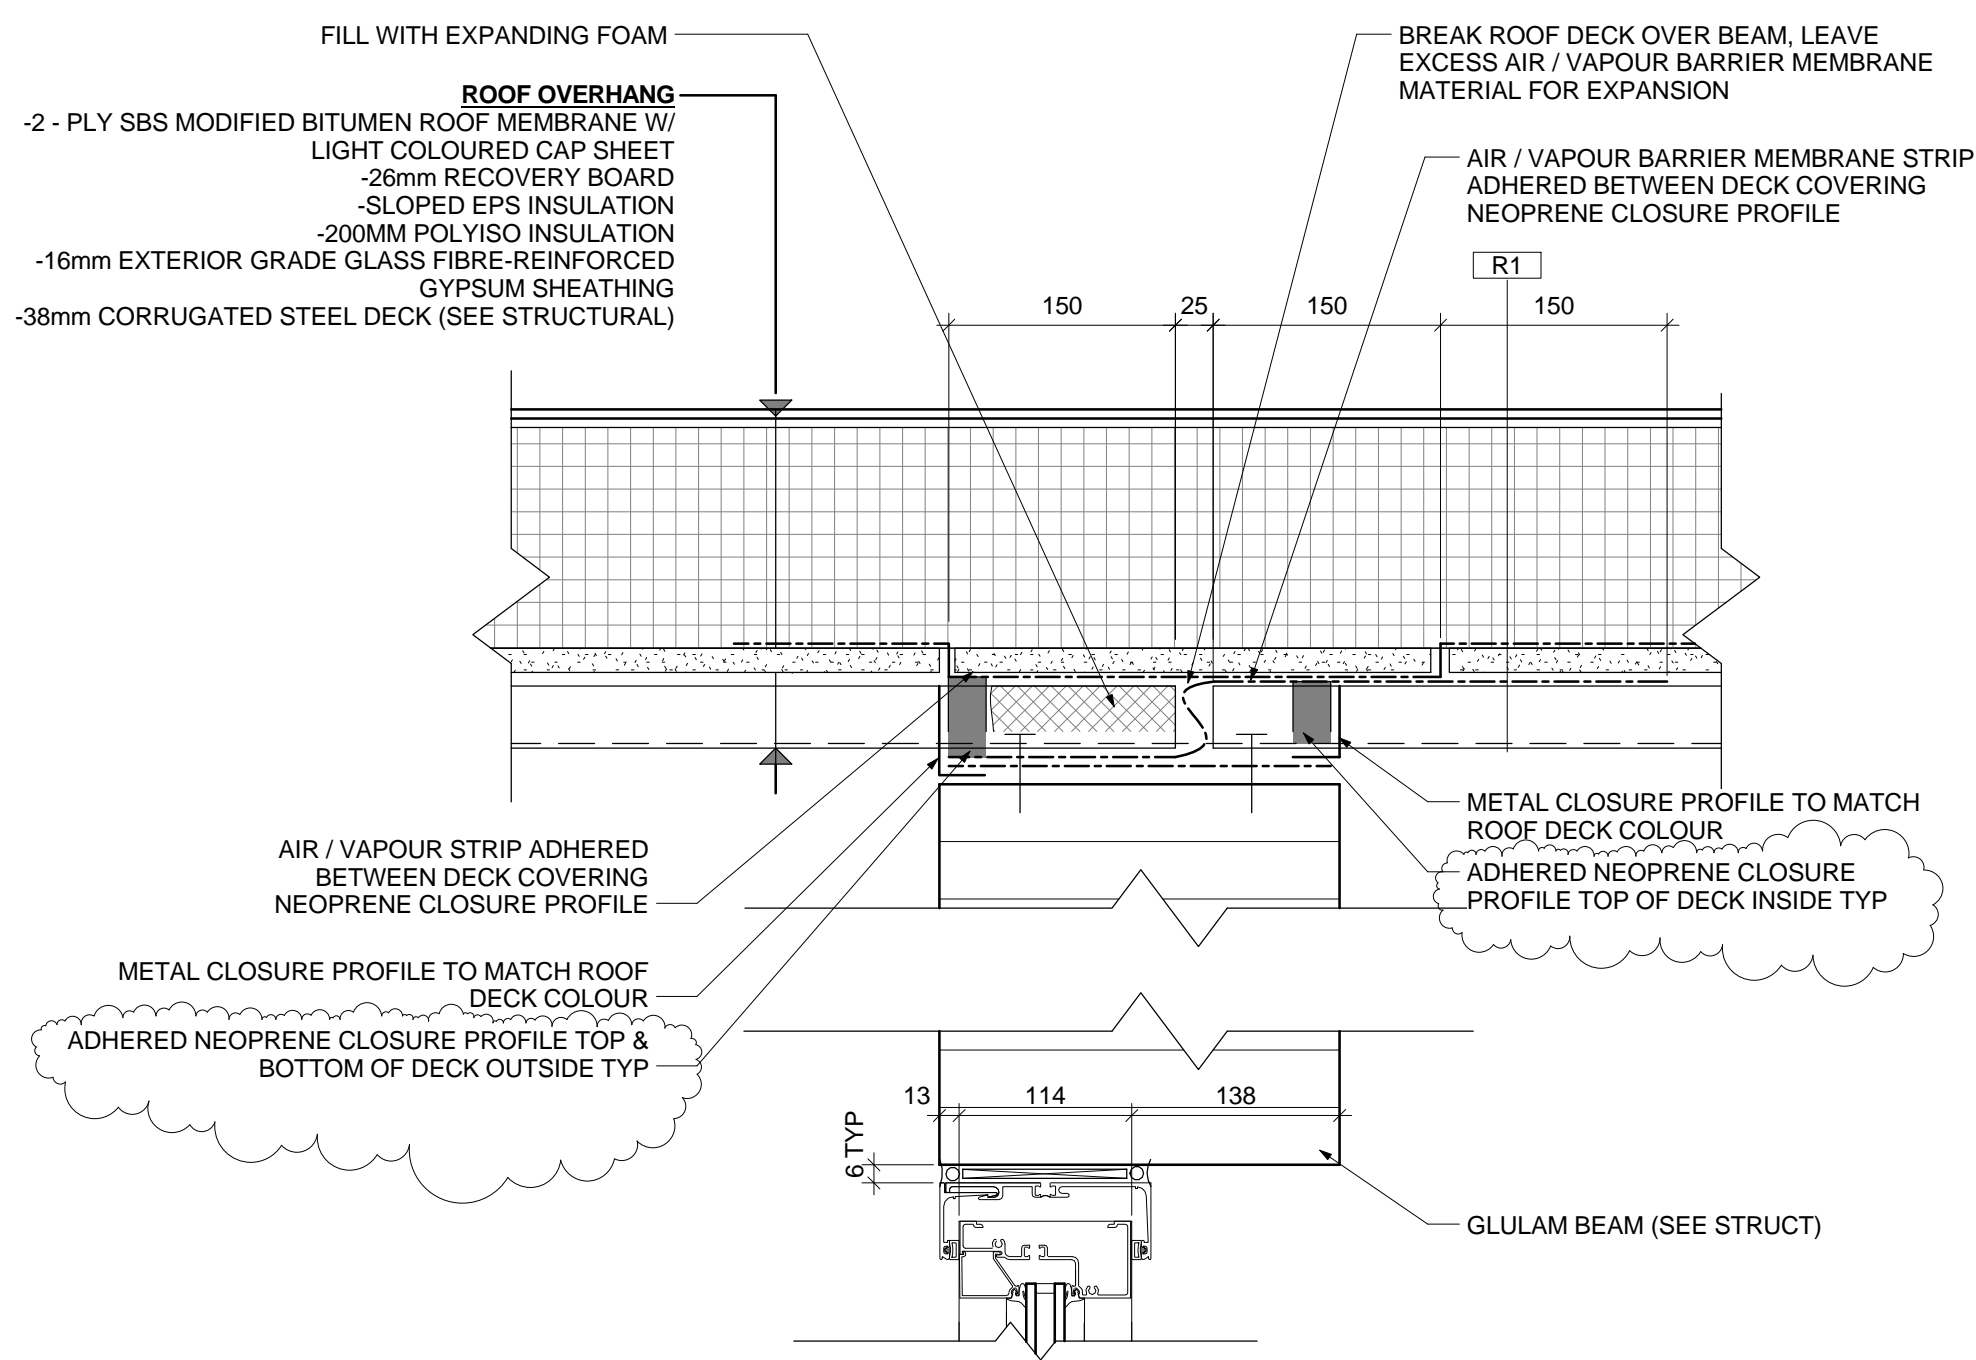
3 ENTRANCE STOREFRONT GLAZING
1:5

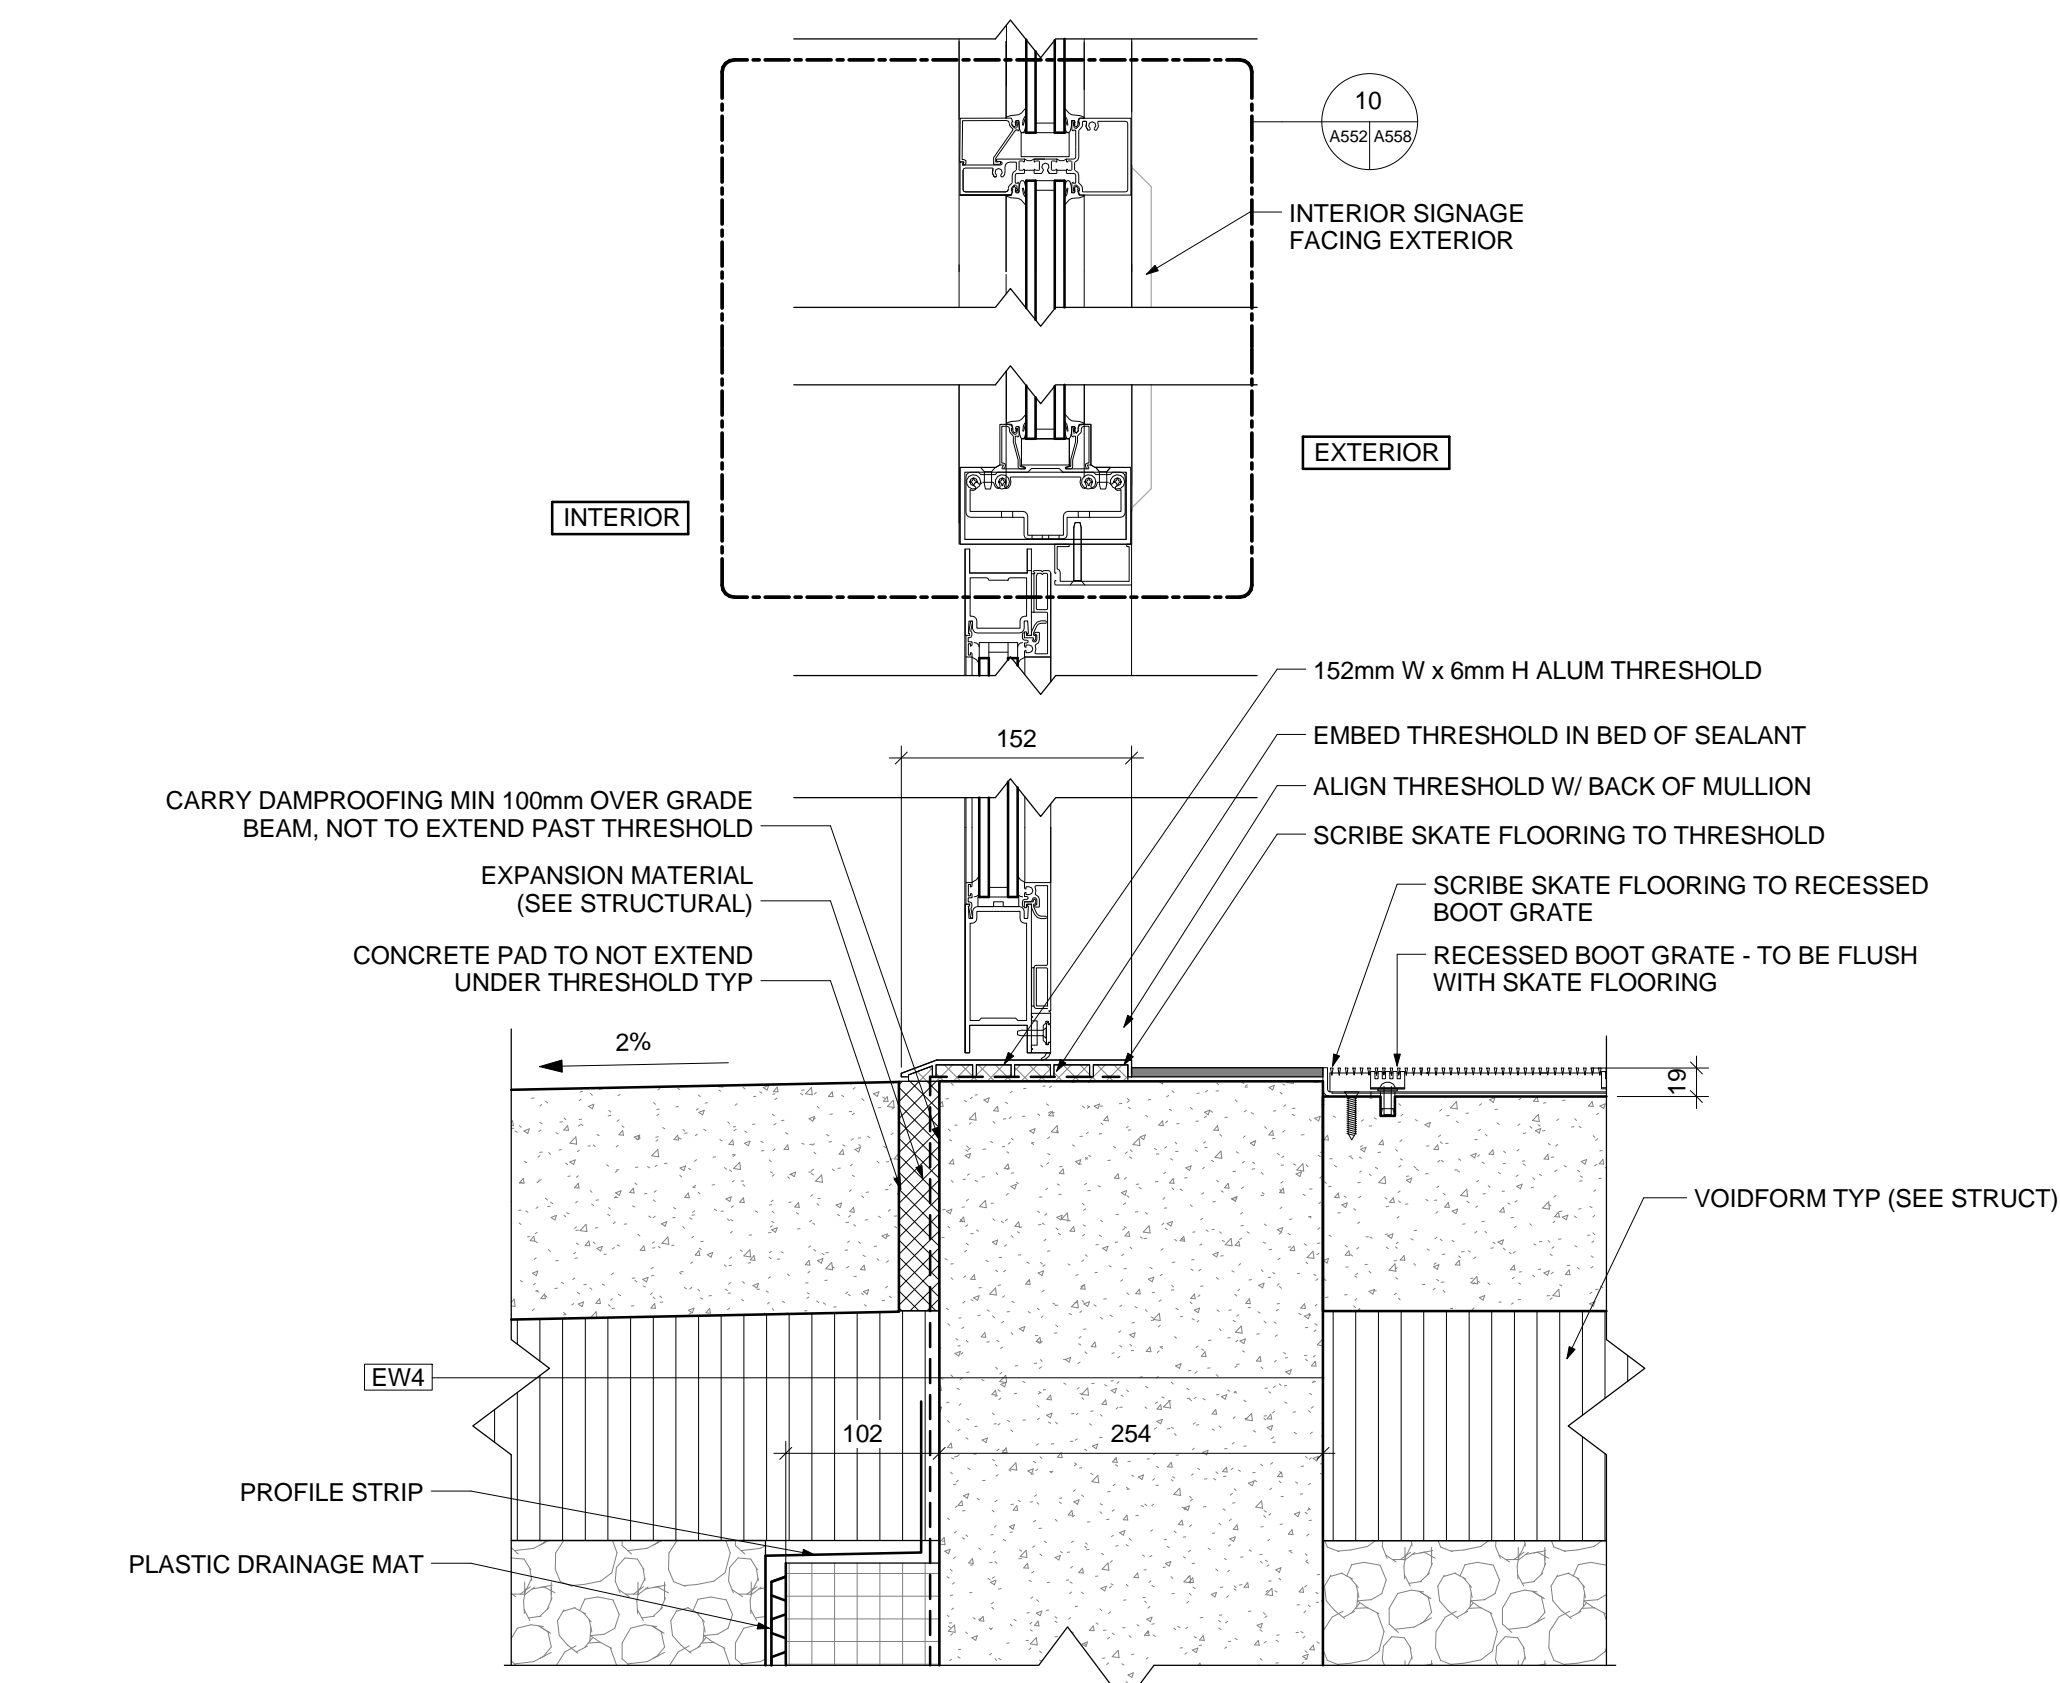
4 SECTION DETAIL - OH DOOR
1:5

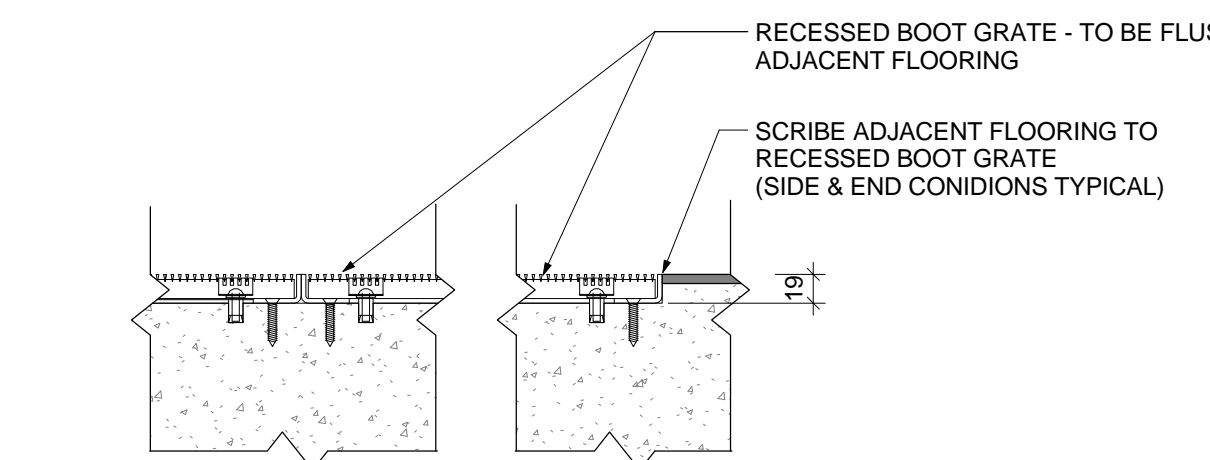
5 RECESSED BOOT GRATE
1:5

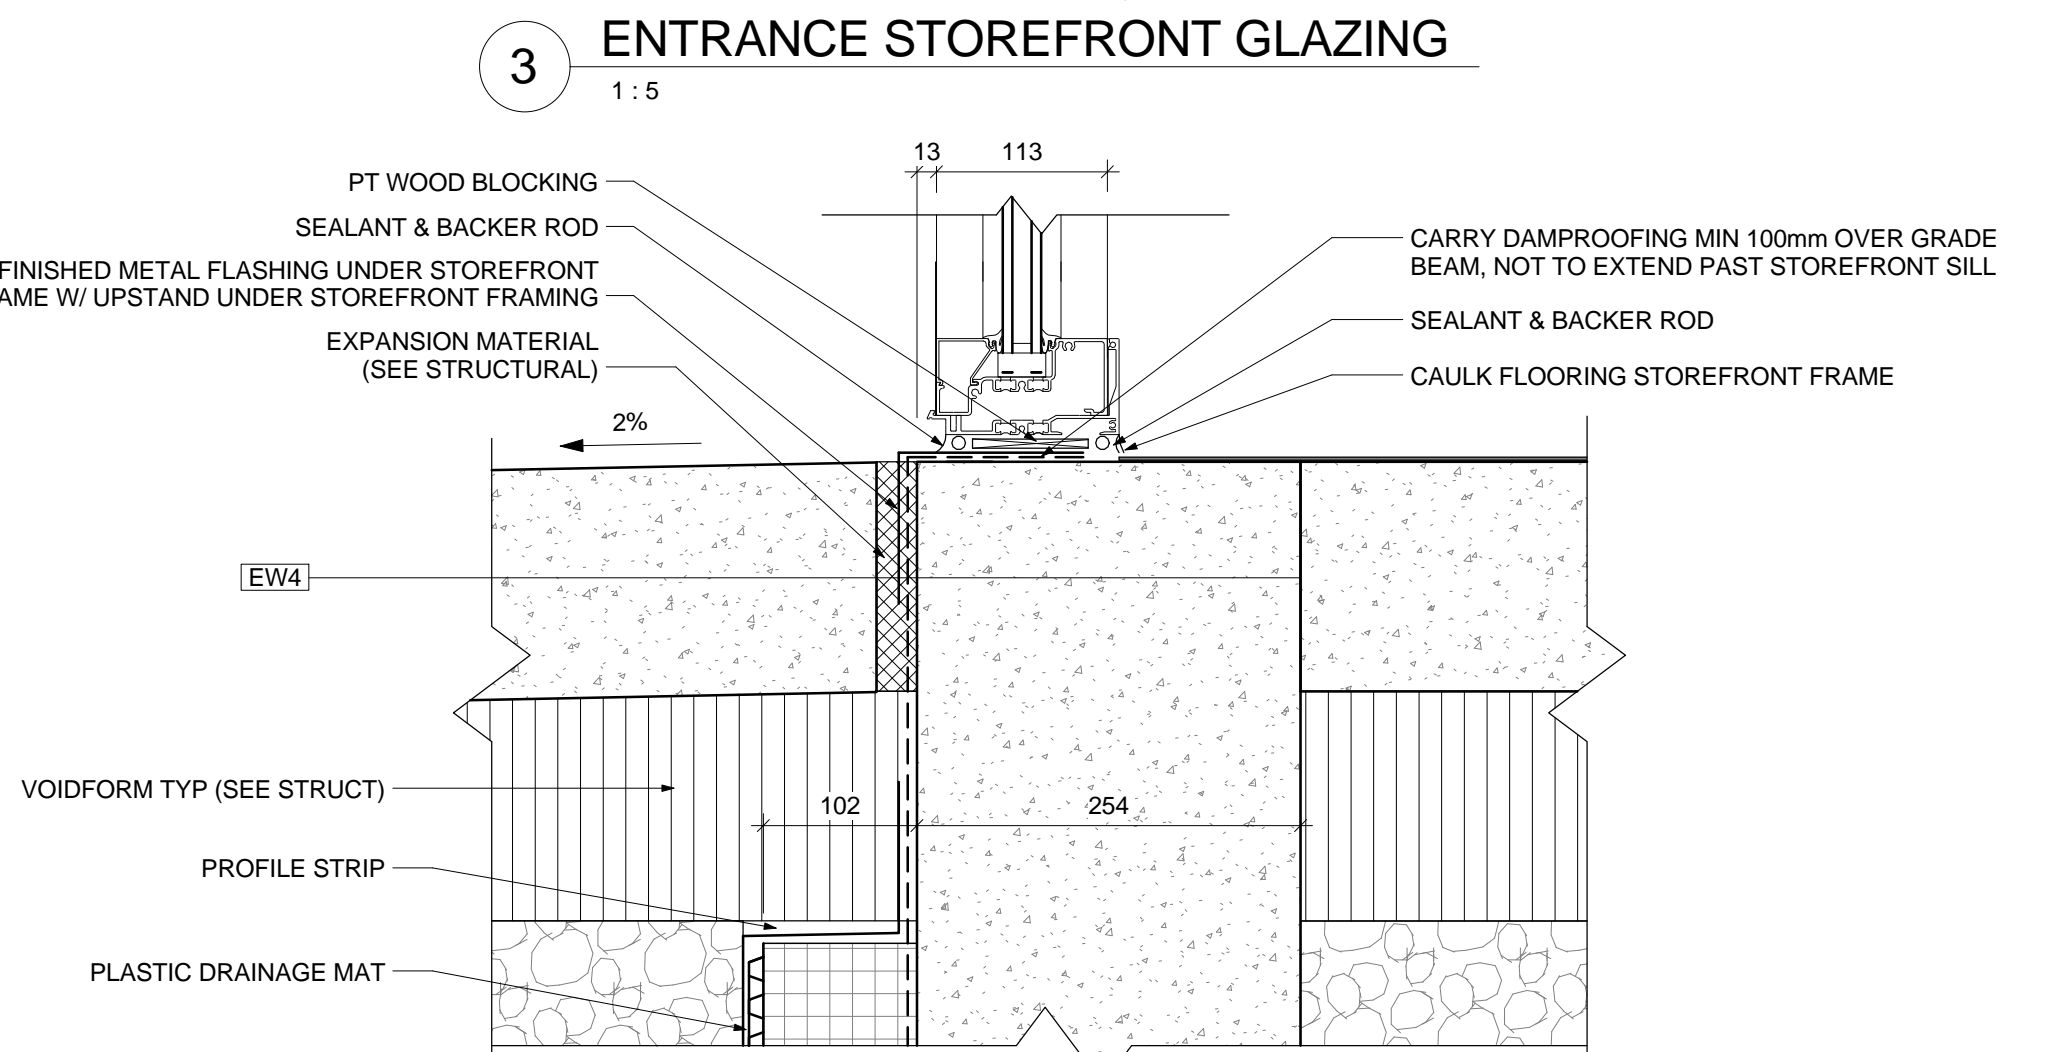
6 STOREFRONT GLAZING @ EXT WALK
1:5

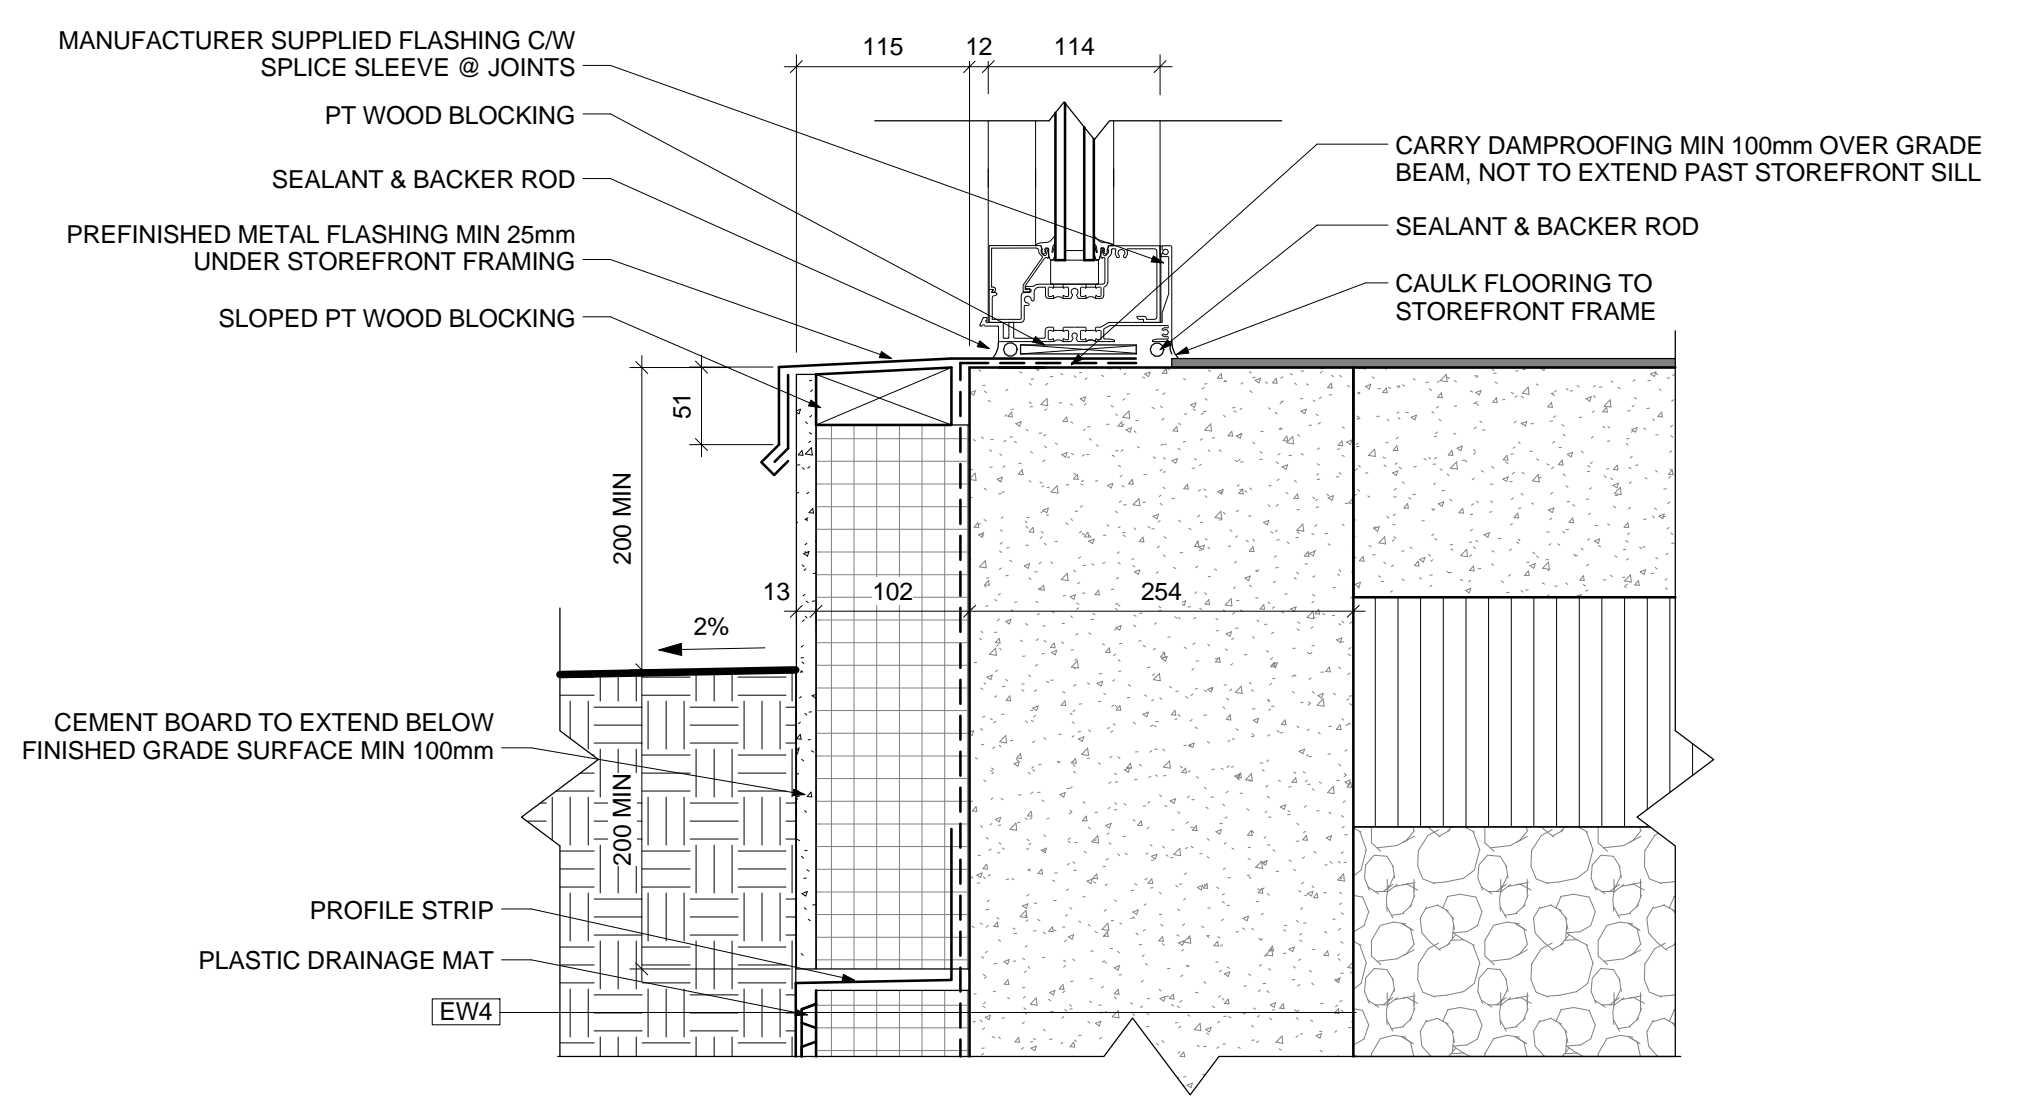
7 STOREFRONT GLAZING @ GRADE
1:5
