City of Winnipeg

**Wellington Crescent Riverbank Assessment –
Lamont Boulevard to Academy Road
Geotechnical Investigation, Instrument Monitoring
and Existing Stability Report**

0015 017 00

January 22, 2018

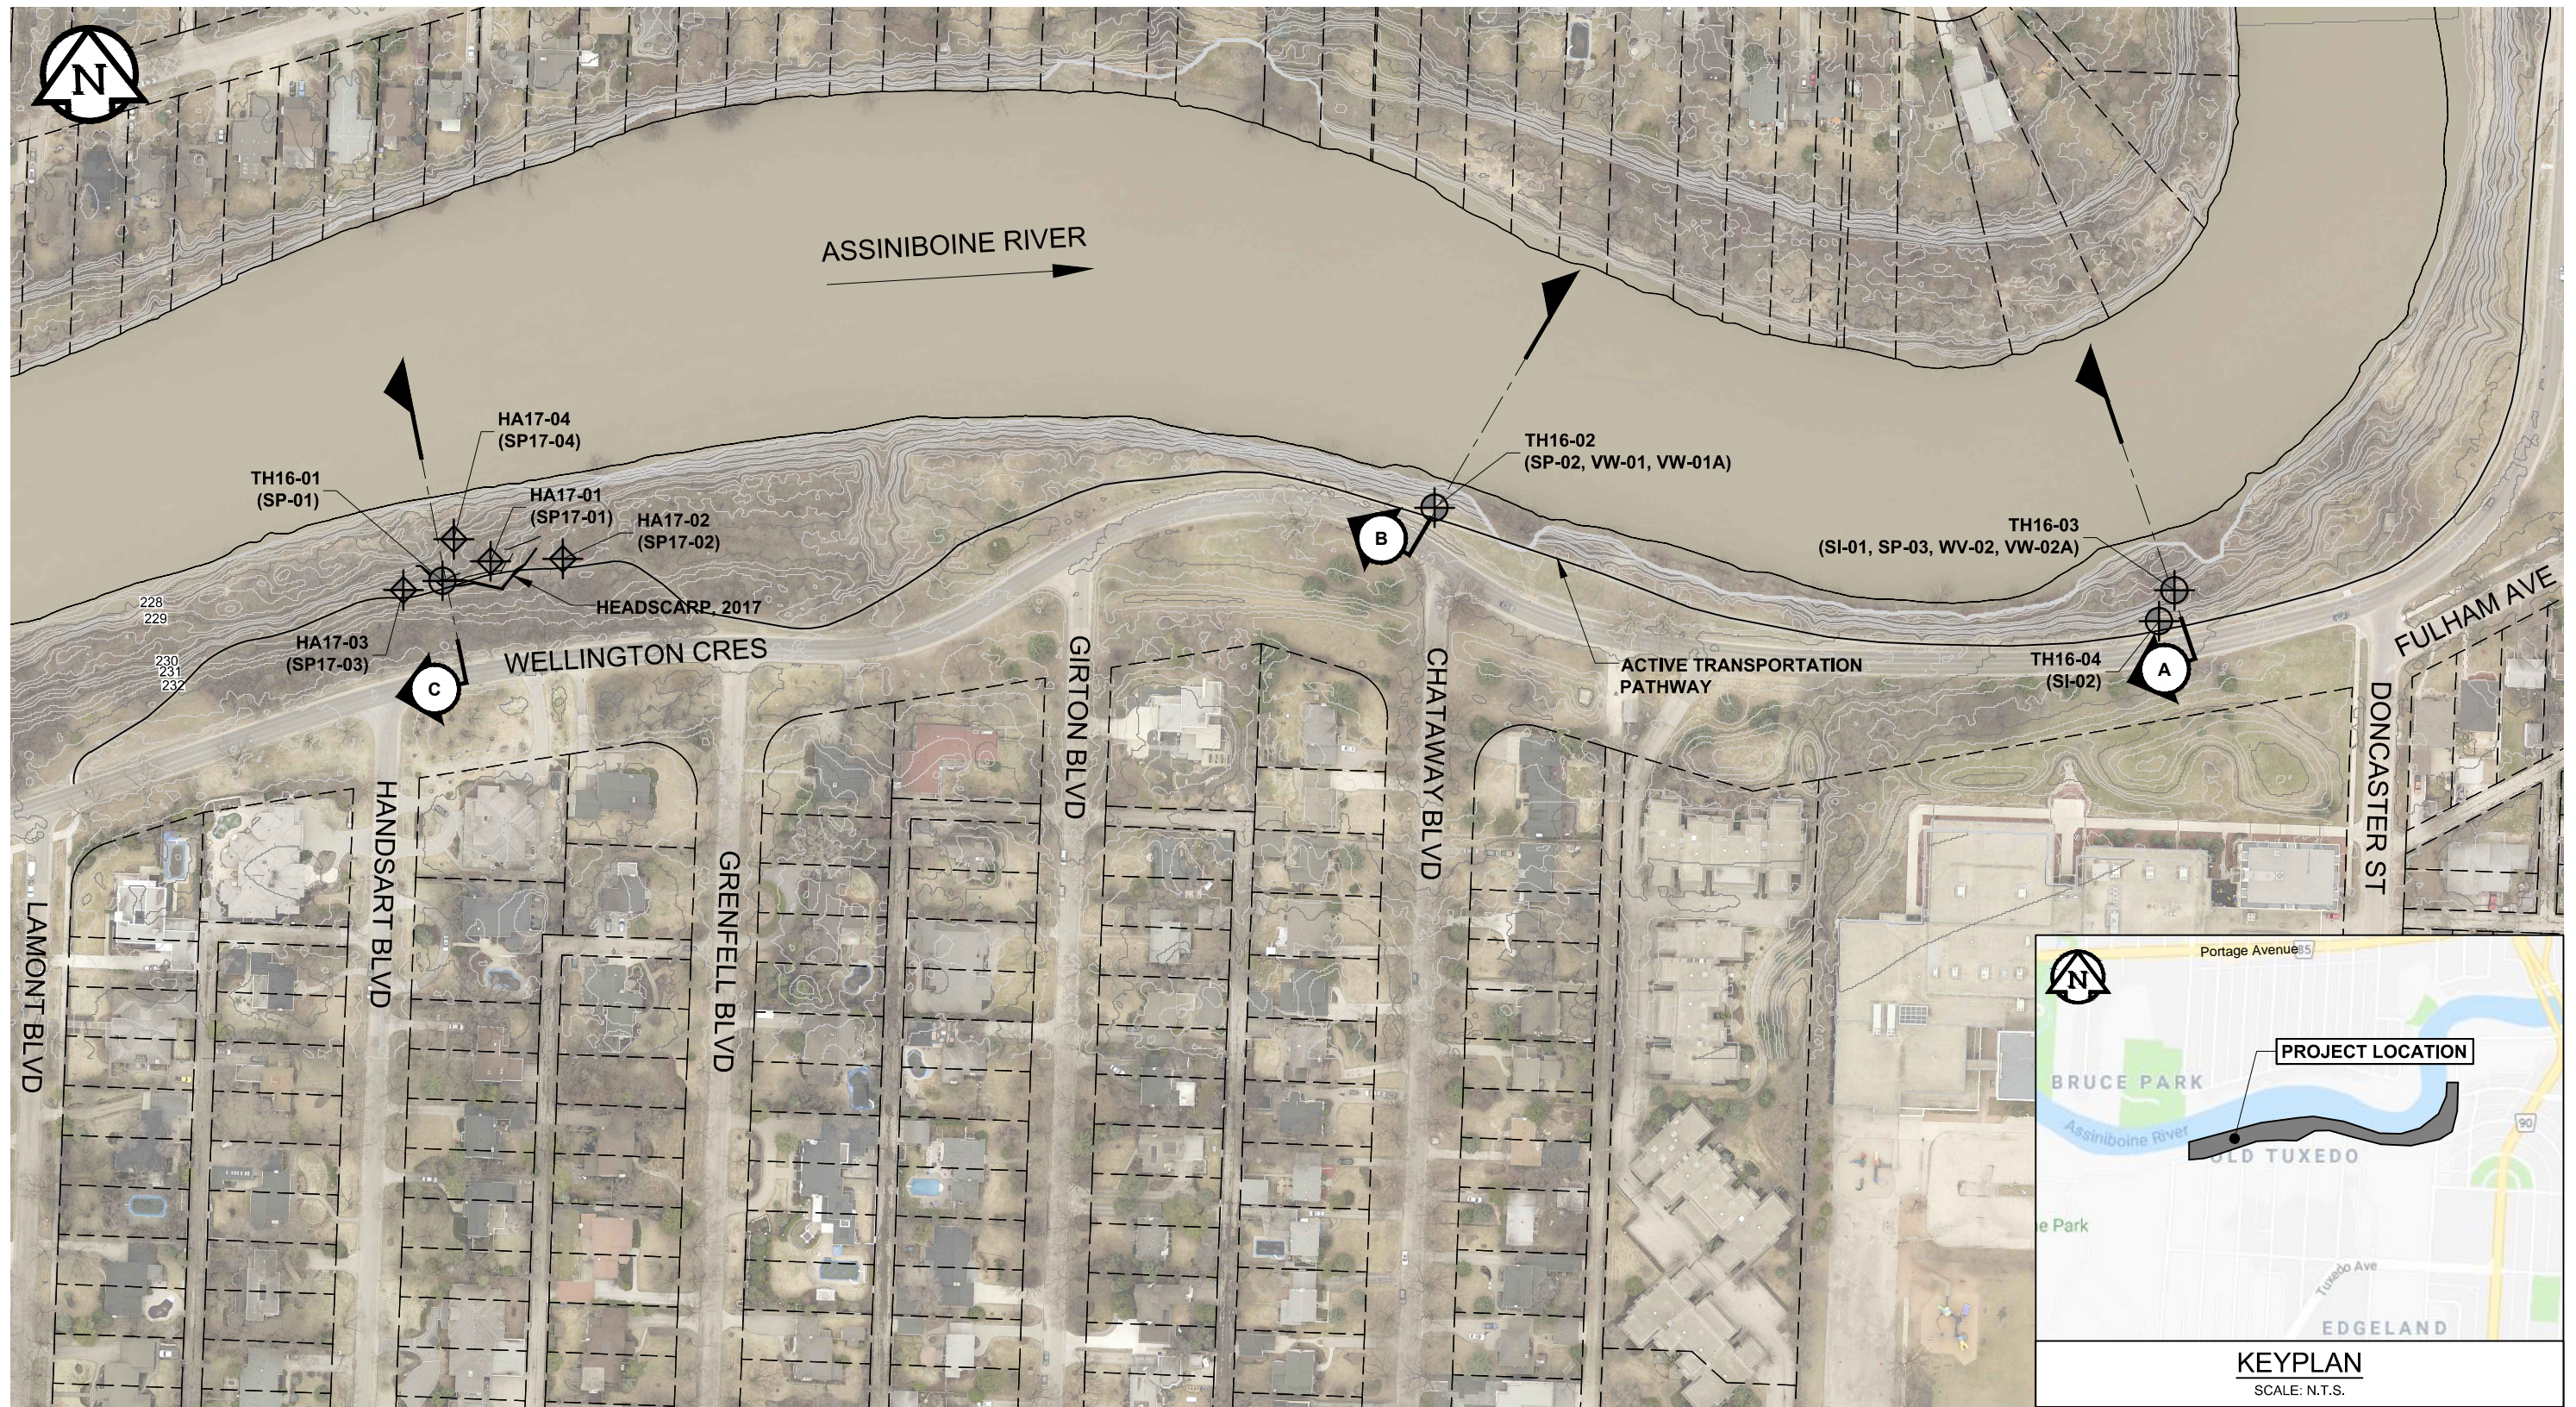
Figure 01

Test Hole Location and Instrumentation Plan

section C was modeled to represent conditions at the time riverbank movements occurred. The location of each Cross-section (A to C) is shown in plan on Figure 01.

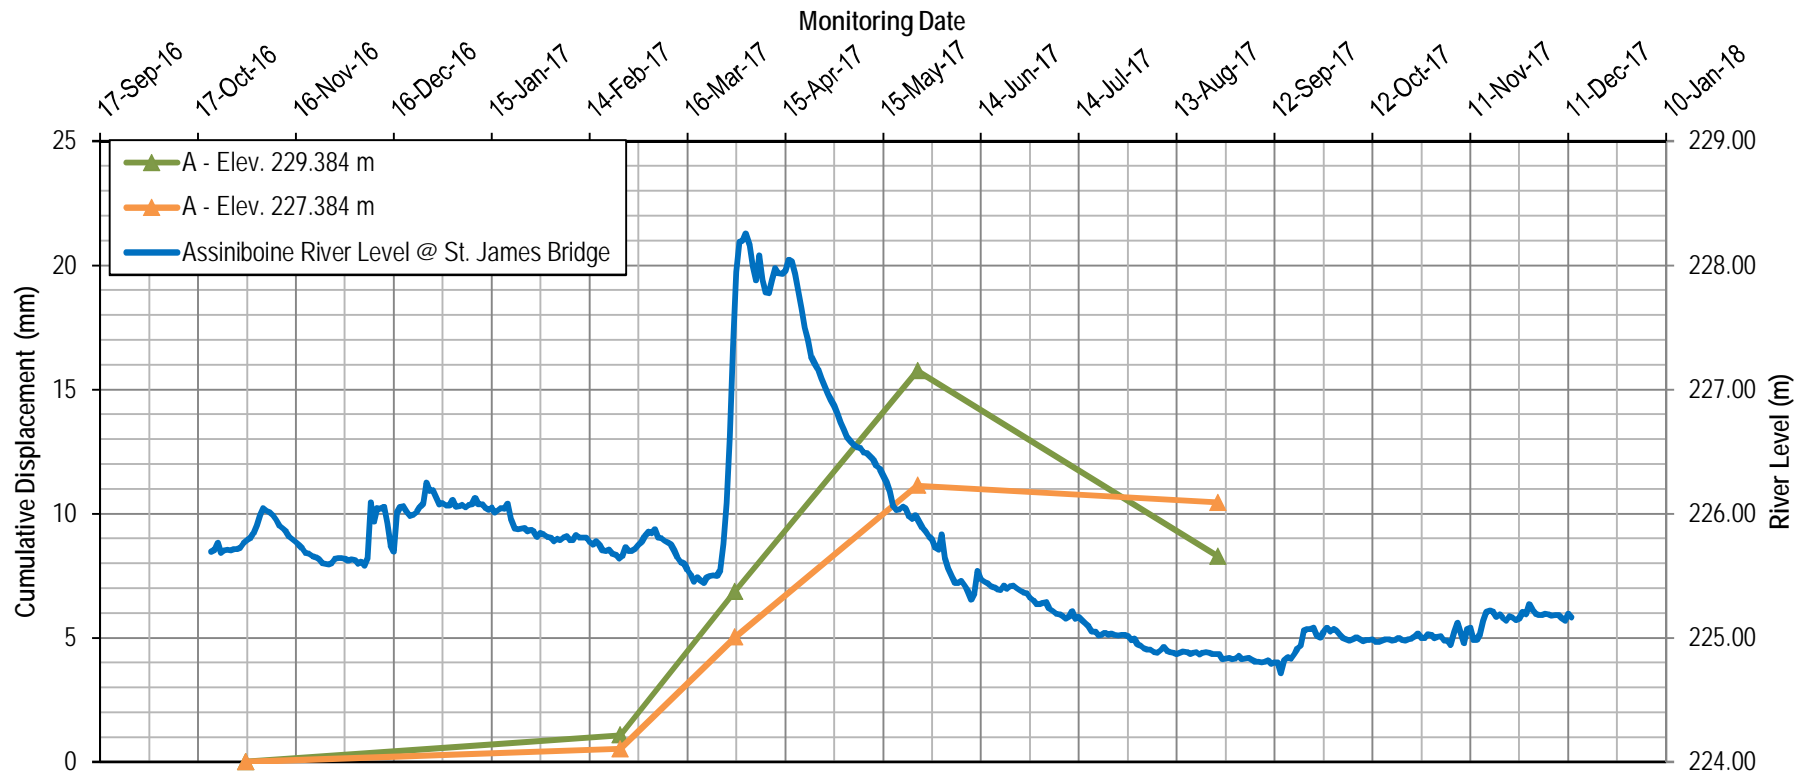
Figure 04

SLOPE INCLINOMETER RATE PLOT

SI-01

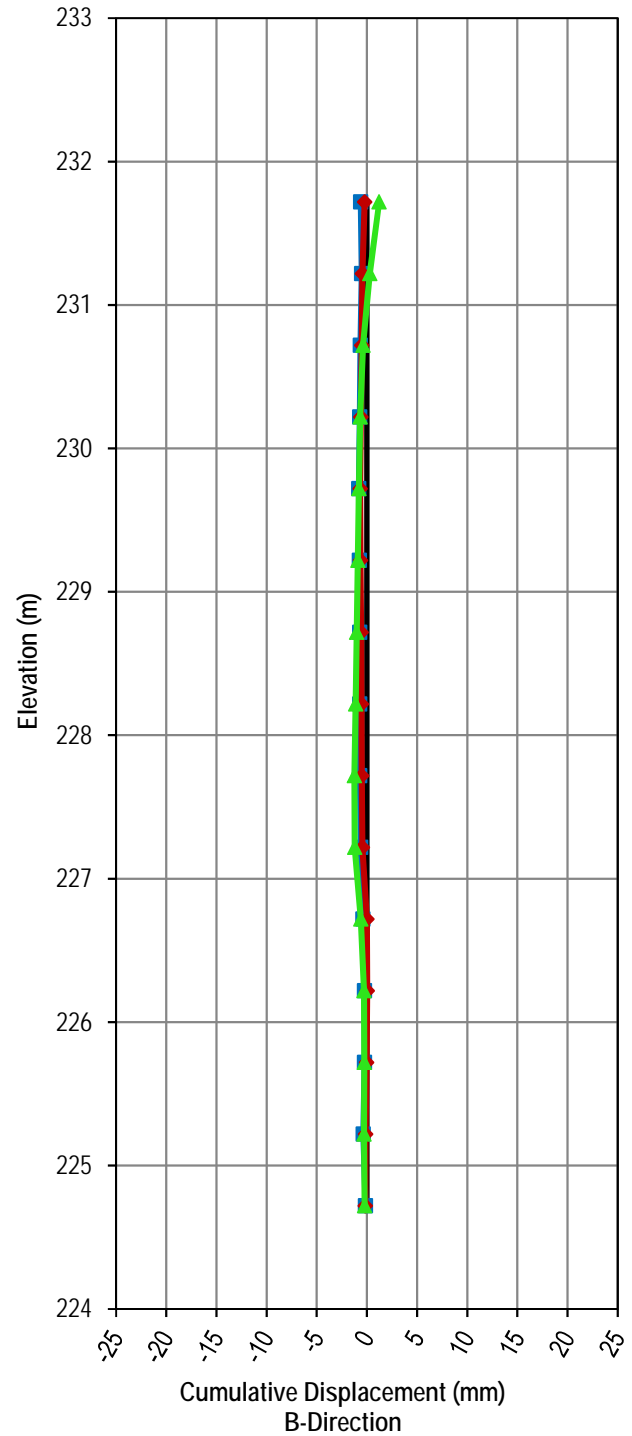
Figure 05

SLOPE INCLINOMETER WORKSHEET

SI-02

One apparent zone of movement has been observed at elevation 227.2 m which is approximately 0.9 m above the silt till contact (Elev. 226.3 m). 5 mm of total cumulative displacement has been observed at this elevation. Of this 5 mm, 1 mm appears to have occurred prior to the 2017 spring flood and the additional 4 mm occurred following recession of the flood river levels.

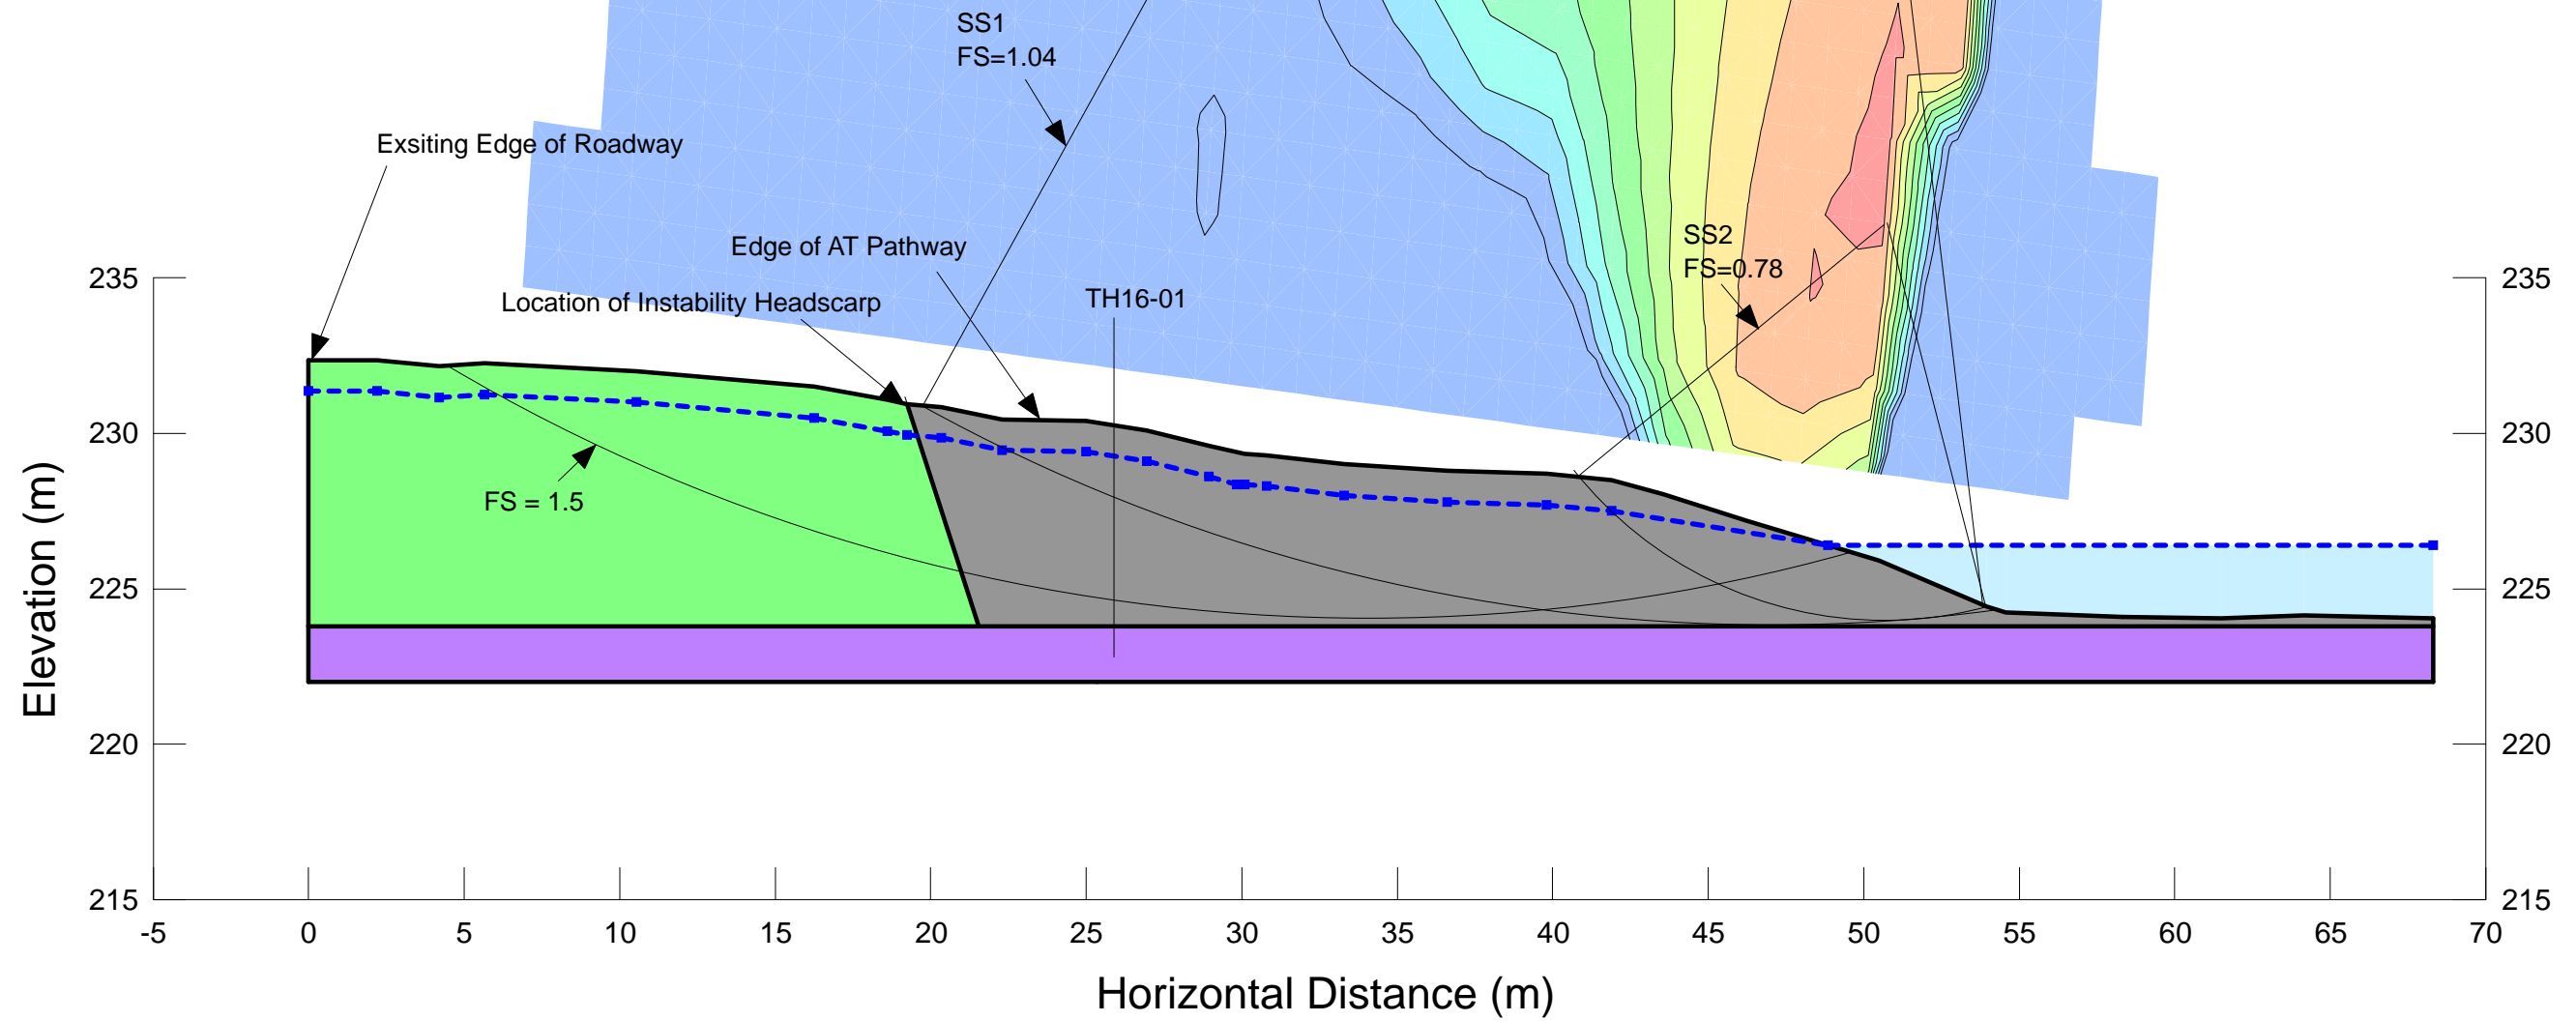
Figure 09
Cross Section C

Color	Name	Unit Weight (kN/m ³)	Cohesion' (kPa)	Phi' (°)
	Silty Clay - Lacustrine Fully Softened	17.5	5	17
	Silt Till	20	10	30
	Silty Clay - Lacustrine Residual	17.5	1.5	12

Cross-Section	Geometry Case	River Elevation	Groundwater Level	Slip Surface	Description	FS	Figure No.
A	Existing Geometry	227.2 m	230.5 m Upper Bank 228.1 m Lower Bank	SS1 (Circular)	Critical FS Back Analysis through the zone of observed movement	0.99	07
				SS2 (Block)	Back Analysis through the zone of observed movement	1.02	
				SS3 (Circular)	At the existing edge of roadway	1.02	
B	Existing Geometry	227.2 m	227.7 m Upper Bank	SS1 (Circular)	Critical FS	1.01	08
				SS2 (Circular)	At existing AT pathway edge (corresponds to the closest distance between the top of riverbank and the roadway, 25 m west of Section B)	1.12	
				SS3 (Circular)	At the existing edge of roadway	1.47	
C	Prior to June 2017 Slope Movements	226.4 m	1 m Below Ground Surface	SS1 (Circular)	Critical FS	0.78	09
				SS2 (Circular)	Approximate zone of observed movement	1.04	
				-	At the existing edge of roadway	>1.5

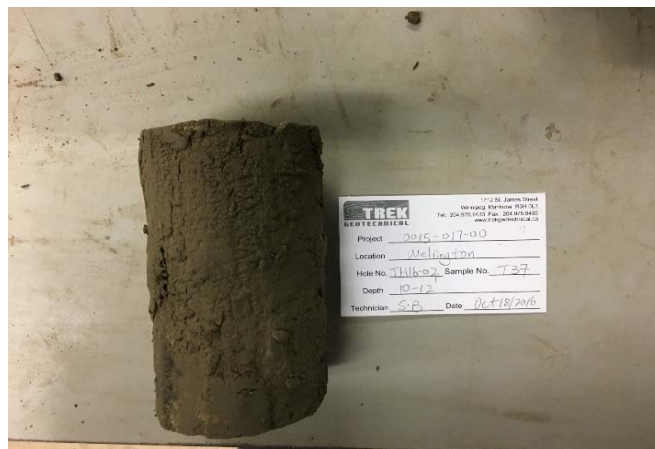
Photo:

Unconfined Compression Test Graph
