Reference: Geotechnical Investigation for City of Winnipeg Roblin Boulevard Pavement Renewal – Winnipeg, Manitoba

Reference: City of Winnipeg Roblin Boulevard Pavement Renewal – Roblin Boulevard From Windmill Way to Dieppe Road - Winnipeg, Manitoba

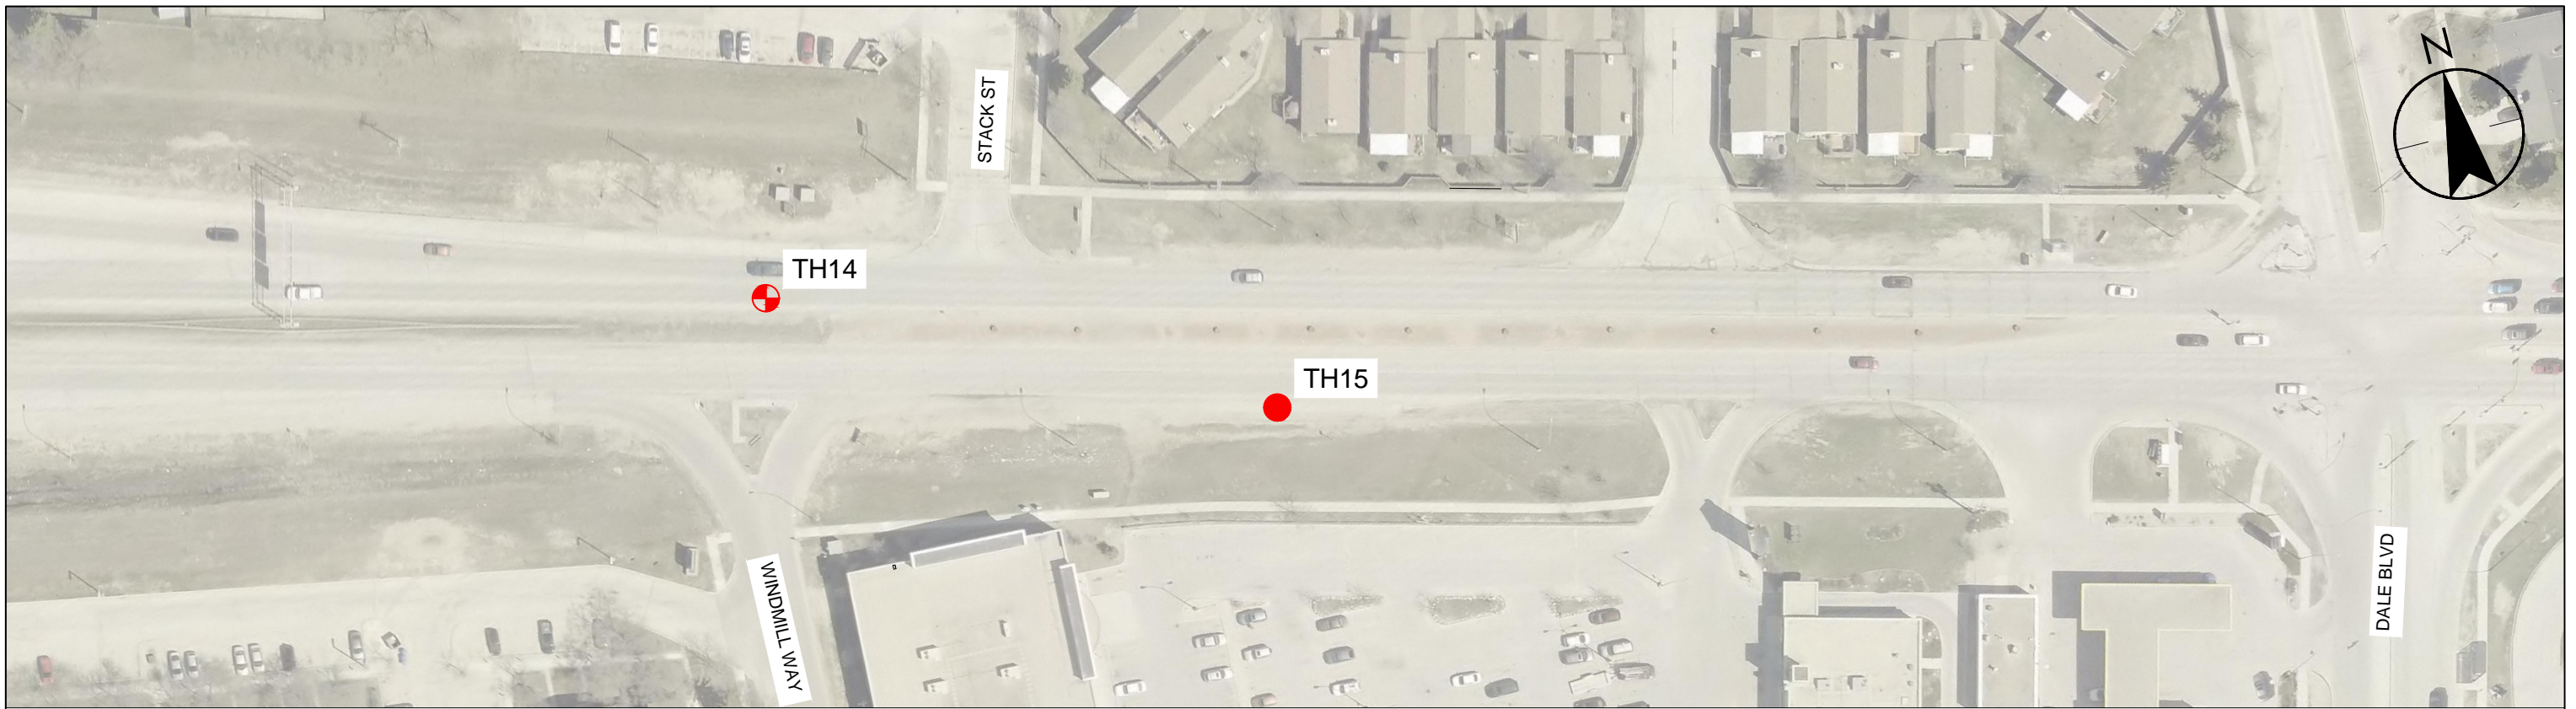
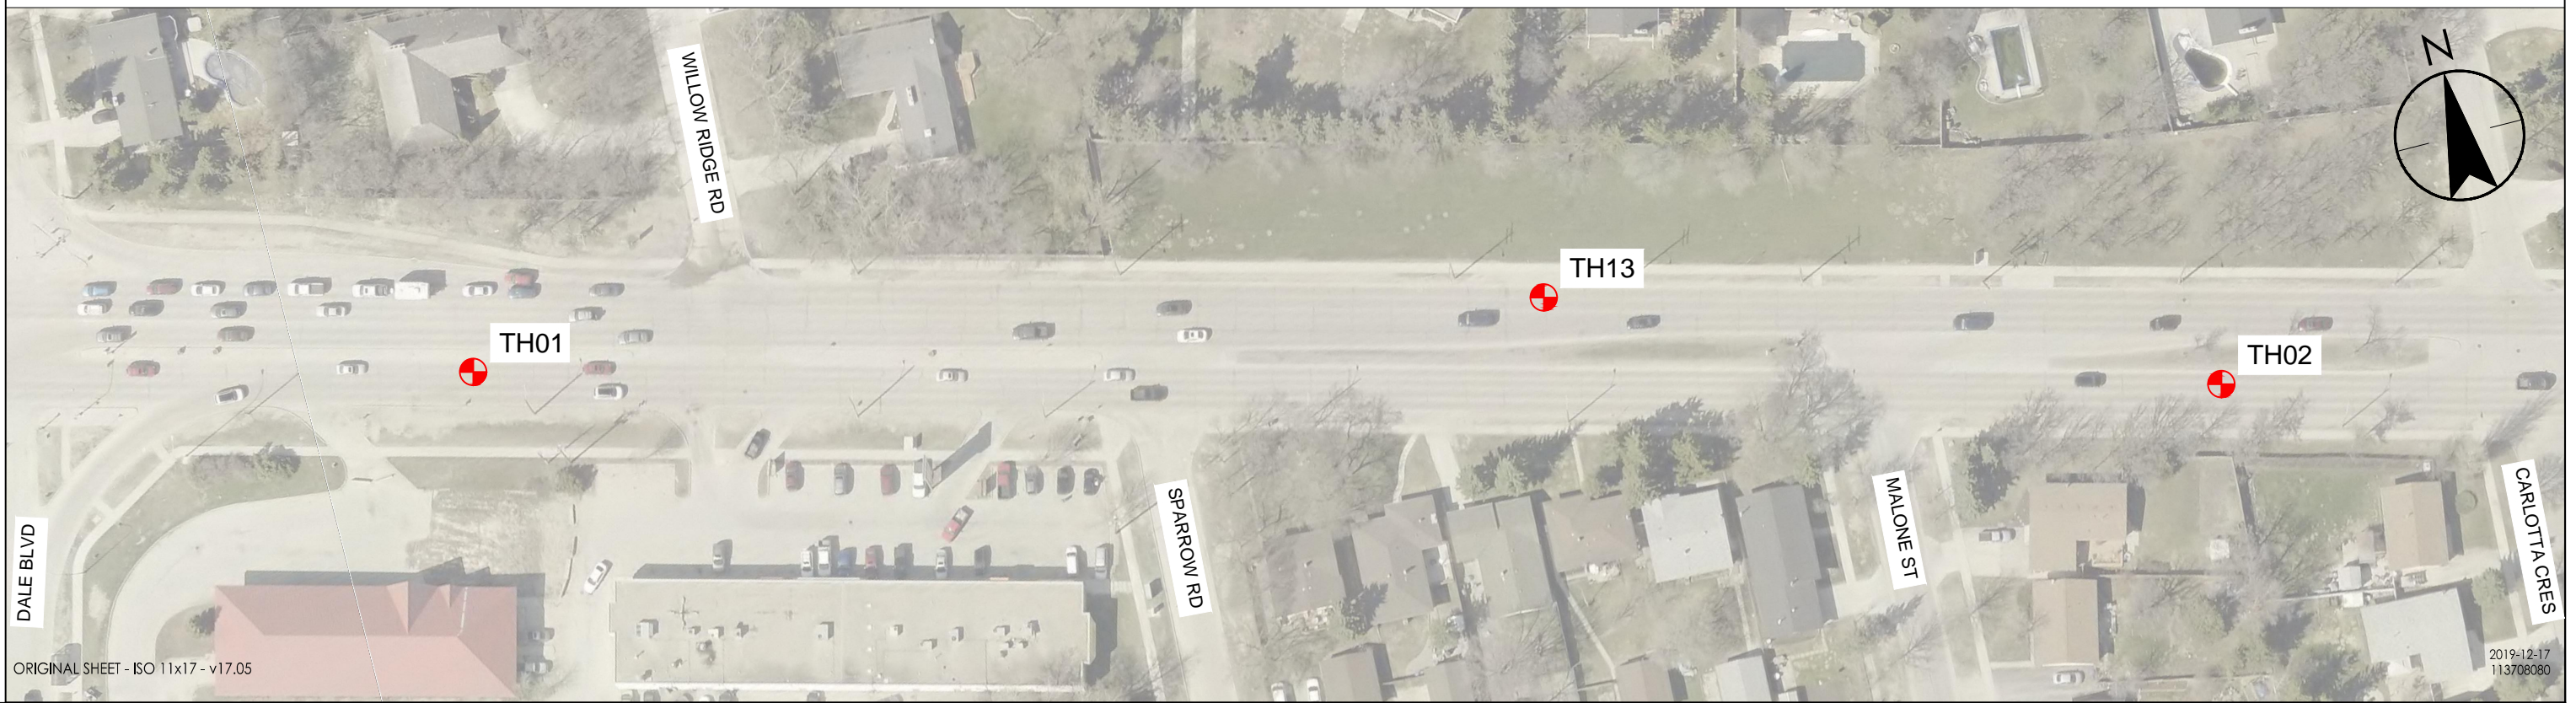
Client/Project
CITY OF WINNIPEG
ROBLIN BOULEVARD PAVEMENT RENEWAL
WINNIPEG, MB
Figure No.
1
Title
TESTHOLE LOCATION PLAN

On December 3 and 4, 2019, 14 pavement cores were collected and one testhole was drilled to 2.1 m on Roblin Boulevard from Windmill Way to Dieppe Road (noted as TH01 to TH15 on the attached figures 1, 2, 3, and 4). The locations for the cores and testhole were selected by Rebecca Hewett of Stantec. No pavement core was required at testhole TH15, therefore a core was not obtained for this testhole. The purpose of the geotechnical investigation was to determine the underlying soil, groundwater conditions, and thickness of pavement. Upon completion of the work, testhole TH15 was backfilled with bentonite and clay cuttings and all holes were topped with cold mix asphalt. Testhole log and the laboratory test reports are also provided in the attachments. A laboratory testing program was completed as part of this project which included moisture contents on all collected soil samples as well as selected samples were tested for Atterberg limits and particle size analysis. The laboratory testing results are summarized in the tables below and included on the attached testhole record.

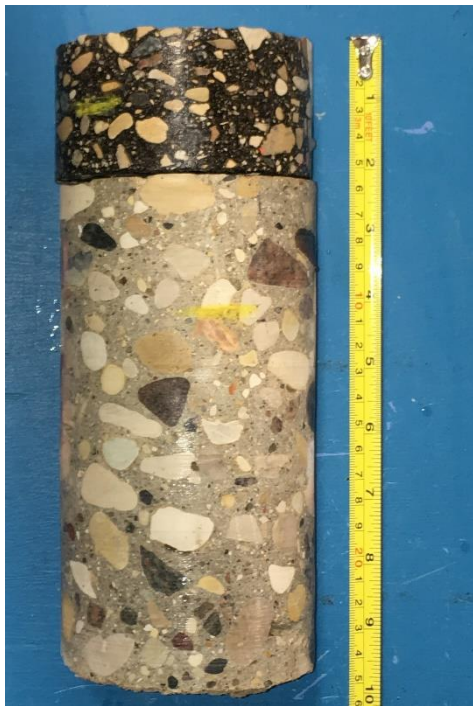
TH01 Core

Testhole ID	Testhole Location	Pavement Surface		Comments
		Type	Thickness (mm)	
TH01	Roblin Boulevard Eastbound Median Lane, 65 m east of Dale Blvd 1 m south of median curb	Asphalt	55	• crushed limestone below concrete pavement
		Concrete	190	
TH02	Roblin Boulevard Eastbound Median Lane, 45 m east of Malone St 1 m south of median curb	Asphalt	85	• crushed limestone below concrete pavement
		Concrete	185	
TH03	Roblin Boulevard Eastbound Curb Lane, 132 m east of Charleswood Dr 1 m north of south curb	Asphalt	165	• crushed limestone below concrete pavement
		Concrete	175	
TH04	Roblin Boulevard Eastbound Curb Lane, 132 m east of Berkley St 1 m north of south curb	Asphalt	155	• crushed limestone below concrete pavement
		Concrete	165	
TH05	Roblin Boulevard Eastbound Median Lane, 14 m east of Scottswood Dr 1 m south of median curb	Asphalt	65	• crushed limestone below concrete pavement
		Concrete	165	
TH06	Roblin Boulevard Eastbound Curb Lane, 22 m west of Pepperloaf Way 1 m north of south curb	Asphalt	130	• crushed limestone below concrete pavement

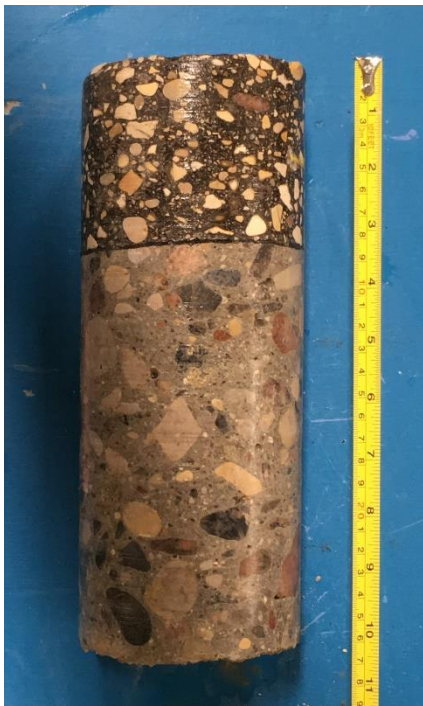
TH07 Core

Concrete	150	
TH07	Roblin Boulevard Eastbound Median Lane, 40 m west of Dieppe Rd 1 m south of median curb	Asphalt	80	• crushed limestone below concrete pavement
		Concrete	175	
TH08	Roblin Boulevard Westbound Median Lane, 65 m west of Dieppe Rd 5 m south of north curb	Asphalt	75	• crushed limestone below concrete pavement
		Concrete	185	
TH09	Roblin Boulevard Westbound Curb Lane, 18 m west of William Marshall 1 m south of north curb	Asphalt	60	• crushed limestone below concrete pavement
		Concrete	175	
TH10	Roblin Boulevard Westbound Median Lane, 16 m east of Scottswood Dr 6 m south of north curb	Asphalt	65	• crushed limestone below concrete pavement
		Concrete	195	
TH11	Roblin Boulevard Westbound Curb Lane, 13 m east of Municipal Rd 1 m south of north curb	Asphalt	85	• crushed limestone below concrete pavement
		Concrete	150	
TH12	Roblin Boulevard Westbound Median Lane, 12 m west of Charleswood Dr 5 m south of north curb	Asphalt	45	• crushed limestone below concrete pavement

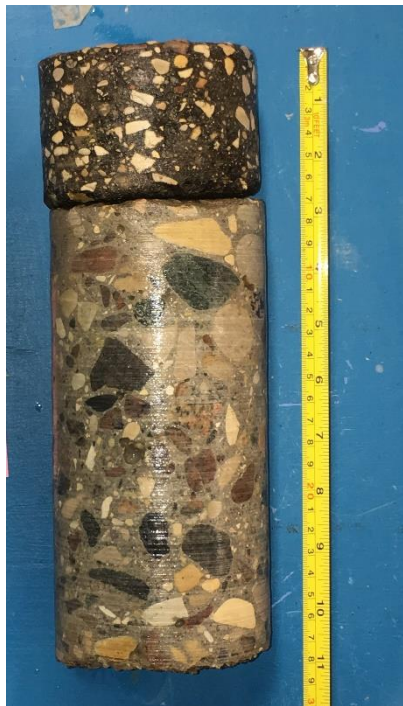
TH13 Core

Concrete	185	
TH13	Roblin Boulevard Westbound Curb Lane, 19 m east of Malone St 1 m south of north curb	Asphalt	70	• crushed limestone below concrete pavement
		Concrete	205	
TH14	Roblin Boulevard Westbound Median Lane, 25 m west of Stack St 1 m north of median curb	Asphalt	90	• crushed limestone below concrete pavement
		Concrete	155

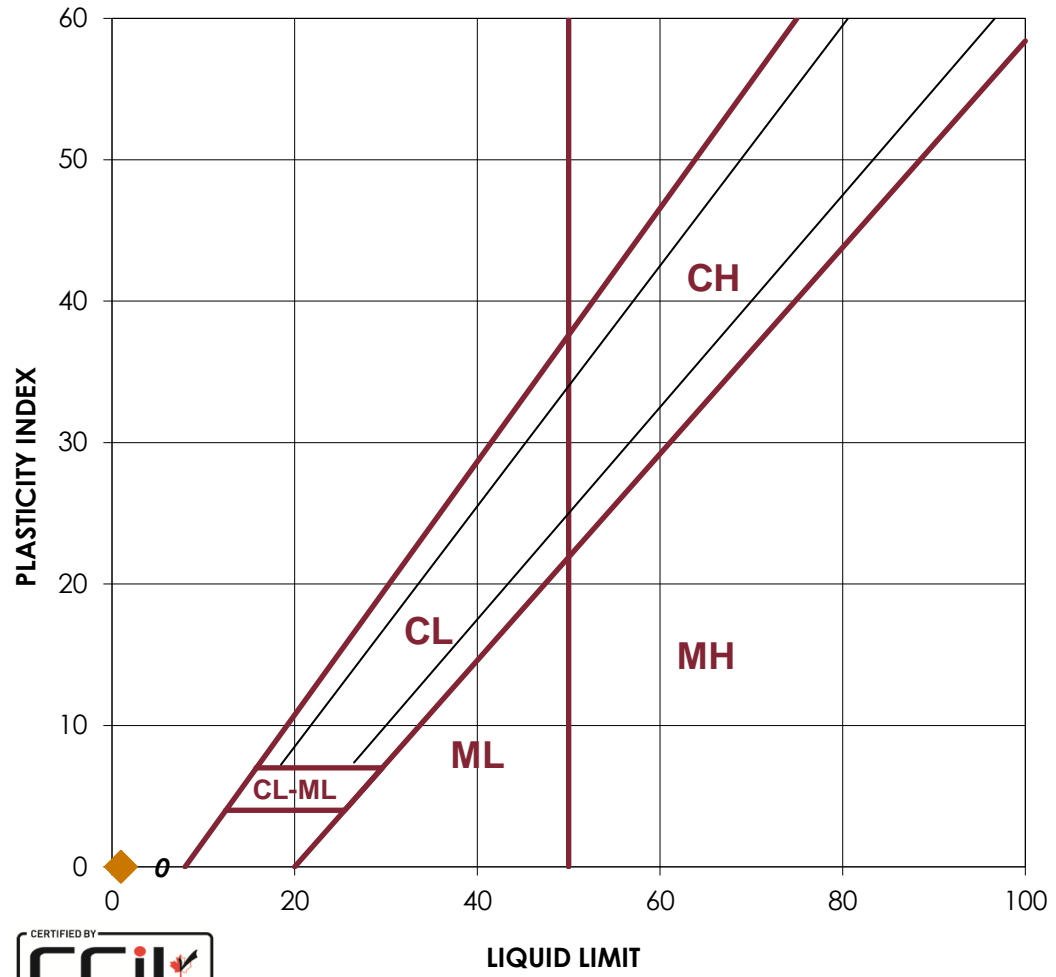
Atterberg Limits
 ASTM D4318
 Method B- One Point

Sample:		Sample:	
TH01 @ 3.5'			
LIQUID		LIQUID	
1	2	Trial No.	1 2
27	28	Number of Blows	
308	182	Container Number	
37.39	35.50	Wt. Sample (wet+tare)(g)	
29.20	27.63	Wt. Sample (dry+tare)(g)	
20.00	18.82	Wt. Tare (g)	
9.2	8.8	Wt. Dry Soil (g)	
8.2	7.9	Wt. Water (g)	
89.0%	89.3%	Water Content (%)	
89.9%	90.6%	Corrected Water Content (%)	
PLASTIC		PLASTIC	
1	2	Trial No.	1 2
256	186	Container Number	
27.26	26.87	Wt. Sample (wet+tare)(g)	
26	25.39	Wt. Sample (dry+tare)(g)	
20.36	19.25	Wt. Tare (g)	
5.6	6.1	Wt. Dry Soil (g)	
1.3	1.5	Wt. Water (g)	
22.3%	24.1%	Water Content (%)	
AVERAGE VALUES		AVERAGE VALUES	
1	2	1	2
LL	90	LL	
PL	23	PL	
PI	67	PI	
Natural MC (%)	32.3%	Natural MC (%)	
CLASSIFICATION		CLASSIFICATION	
CH		NON-PLASTIC

Testhole No.	Sample Depth	Soil Type	Liquid Limit	Plastic Limit	Plasticity Index
TH15	1.0 m	Clay	90	23	67
