February 21, 2020

Our File No. 0013 023 00

**RE: Shoal Lake Aqueduct Preservation  
Priority 3 Task 11 – Land Drainage Improvements at Mile 77.6 Railway Yard  
Geotechnical Investigation Summary Report**

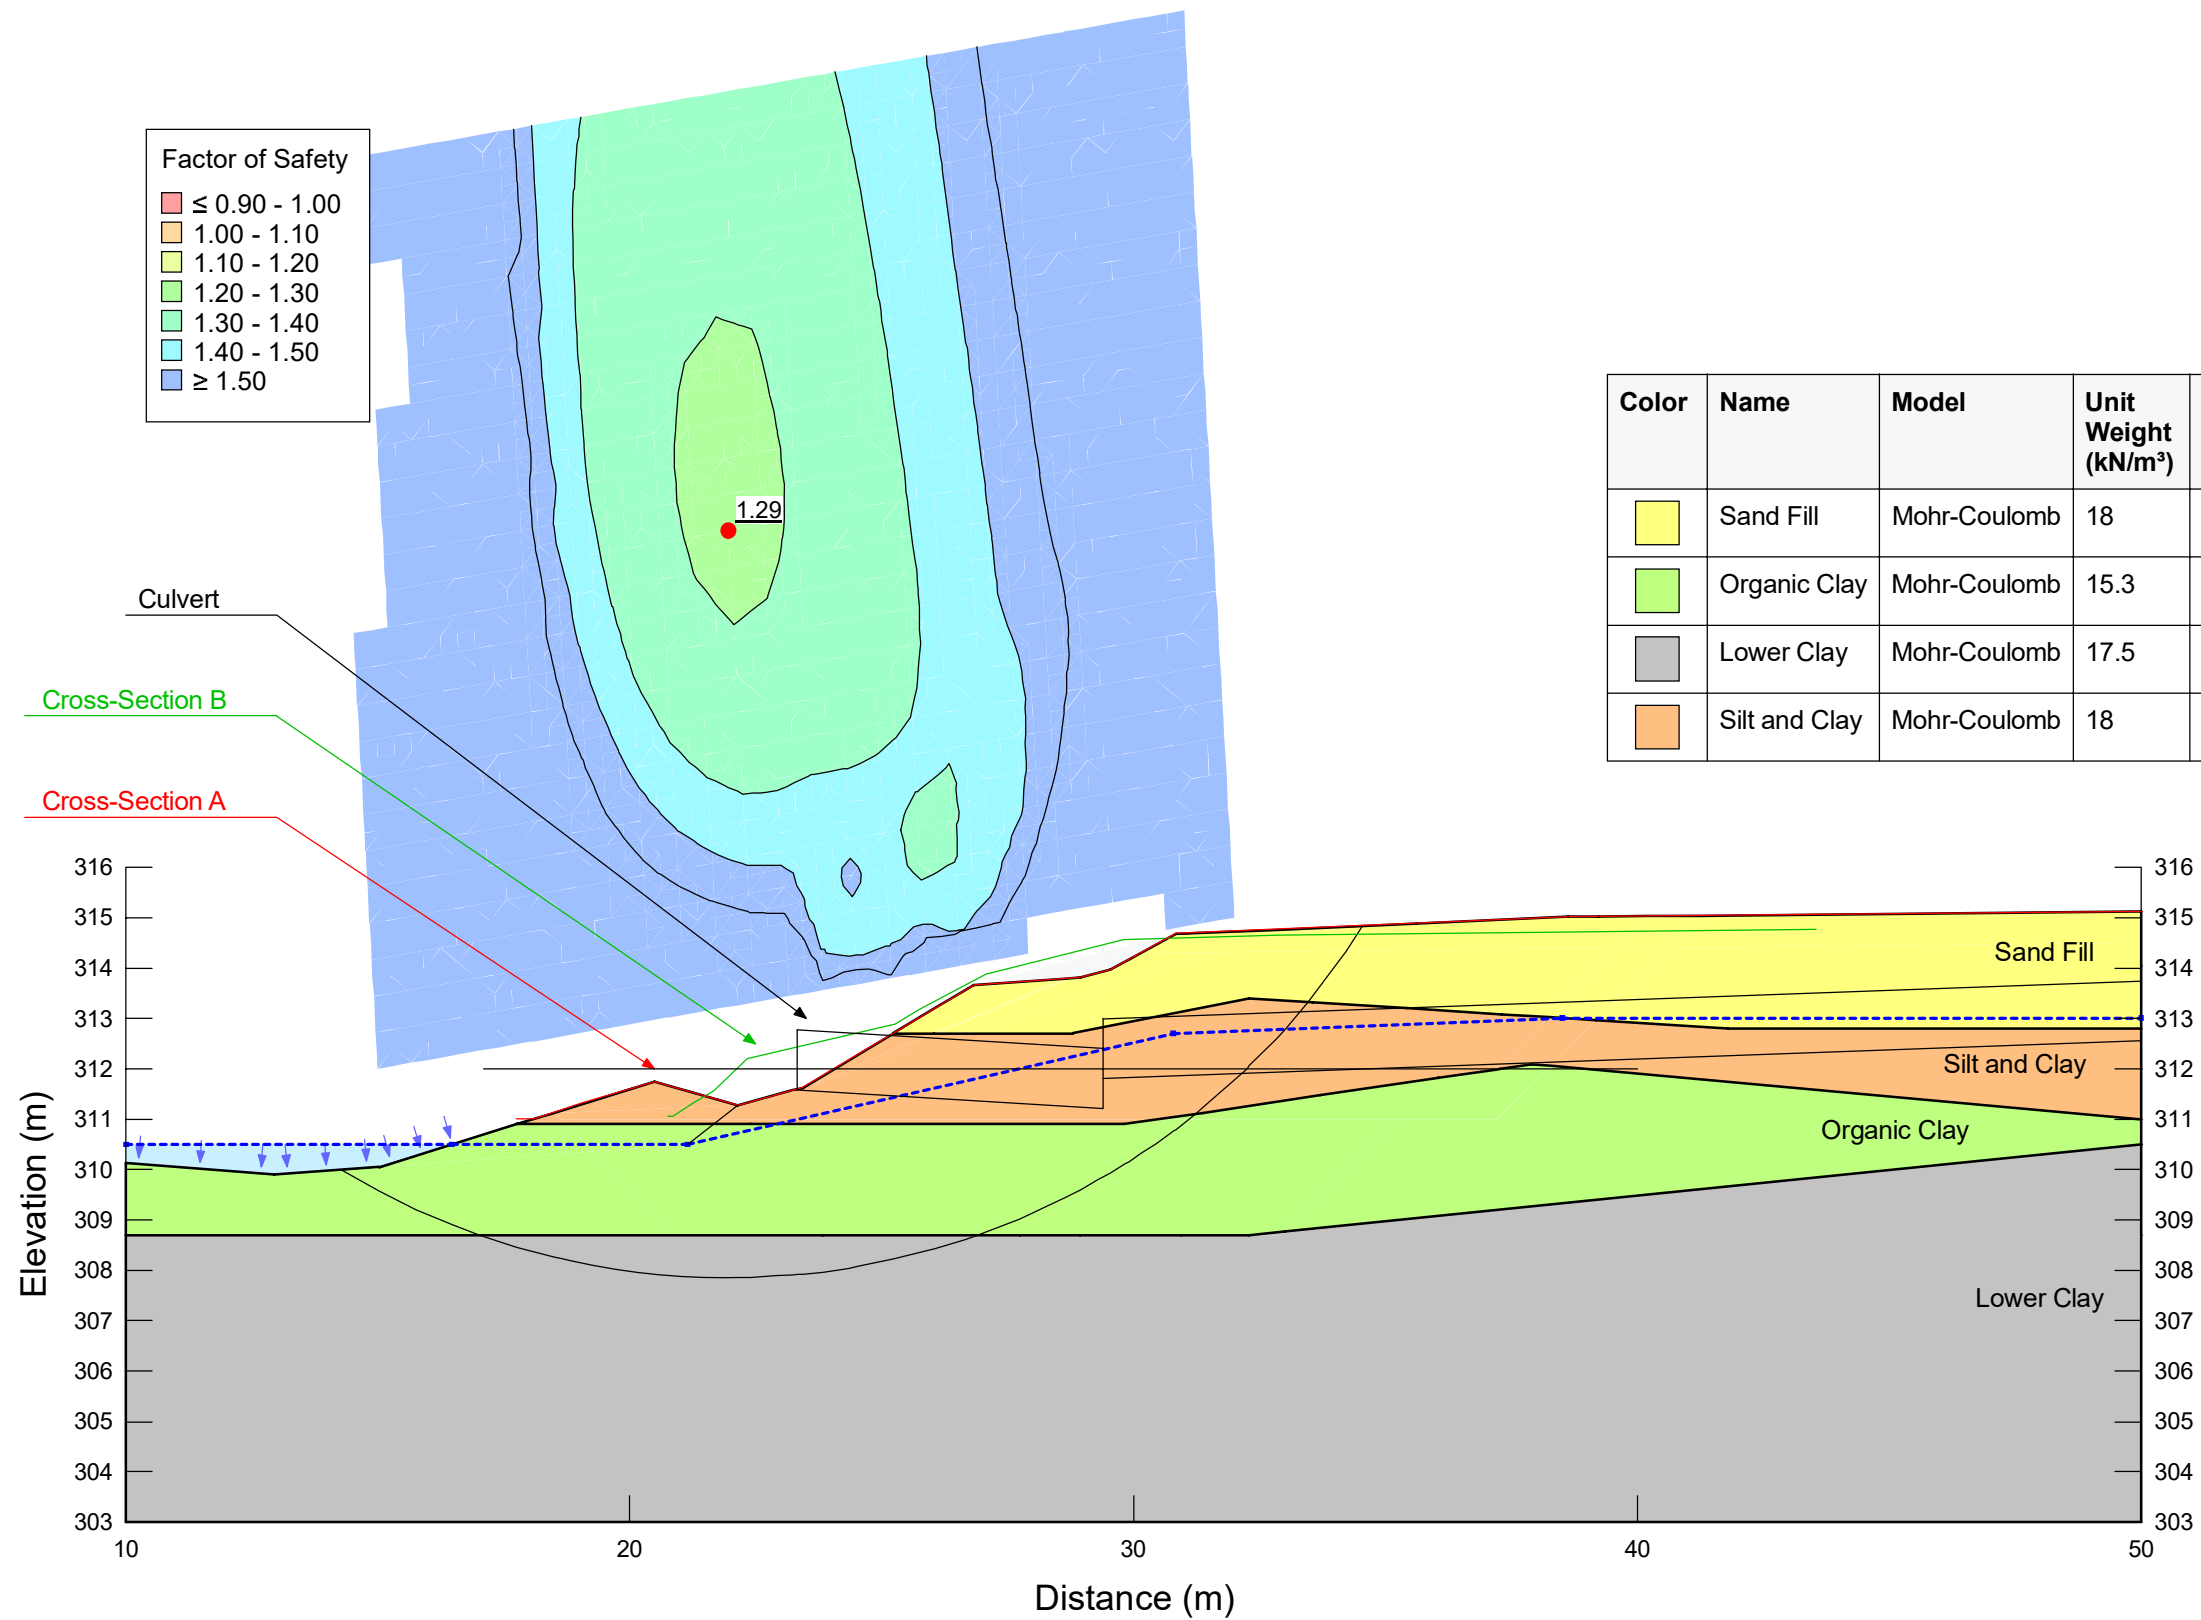
A - Existing Stability

The outputs of the slope stability analyses are presented as factors of safety (FS) related to the stability of the slope. With respect to factor of safety targets, the probability of riverbank instabilities occurring increases as values approach unity (FS=1.0). Riverbanks with a FS greater than 1.3 are considered relatively stable and this was the selected design target for remedial measures. Temporary excavation stability was assessed assuming short term (undrained) conditions in cohesive material; temporary excavations with a minimum short-term FS of 2.0 are considered stable.
