**80 LOMBARD AVENUE – THOMAS BLACK BUILDING**  
*Unknown, 1896; Unknown, 1898; Hooper & Walker, 1907*

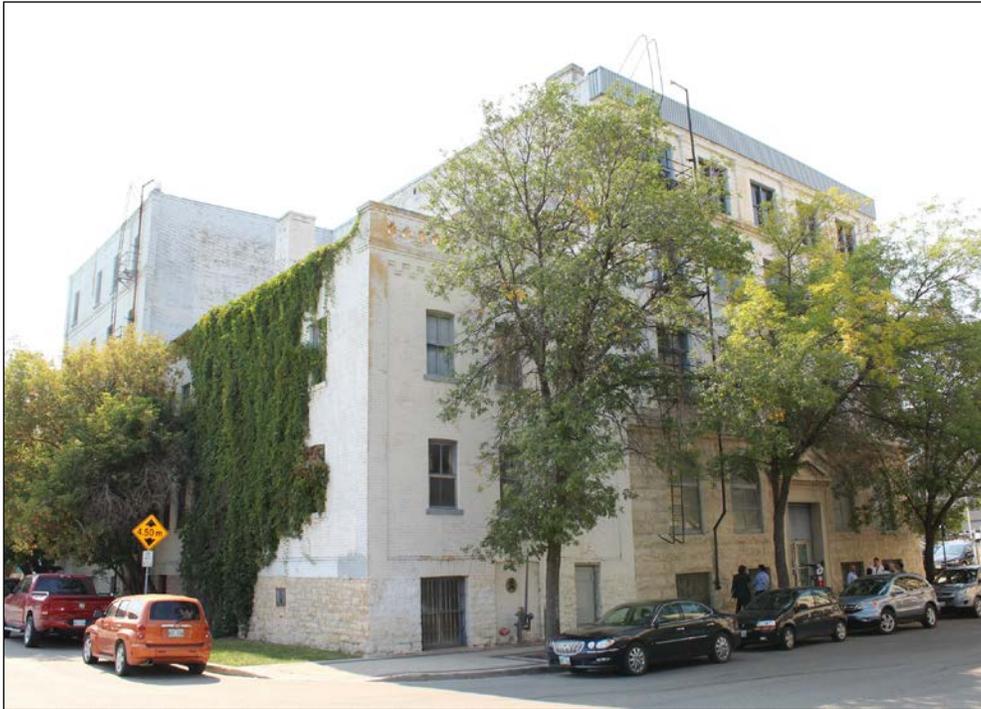
The original 1896 warehouse is an unadorned, modest warehouse – the front (north) façade has a rough cut stone base, ornamental brick work around window and door openings and a brick cornice with raised central area, corbelling and open geometric shapes. The building's east side is a continuation of the basic design.

The northwest building of 1907 is the most ornate, with rough and smooth cut stone accenting, a heavily embellished central main entrance on the main (north) façade and stone cladding to the second storey with a smooth cornice leading to the brick walls above. Windows on the upper

floors are rectilinear and a modest cornice divides the third and fourth floors. This upper storey includes attached, unfluted brick columns with modest capitals. A heavy overhanging metal cornice finished the block but it has since been removed.
