145 MARKET AVENUE – STANLEY BROCK BUILDING
John Hamilton Gordon Russell, 1916

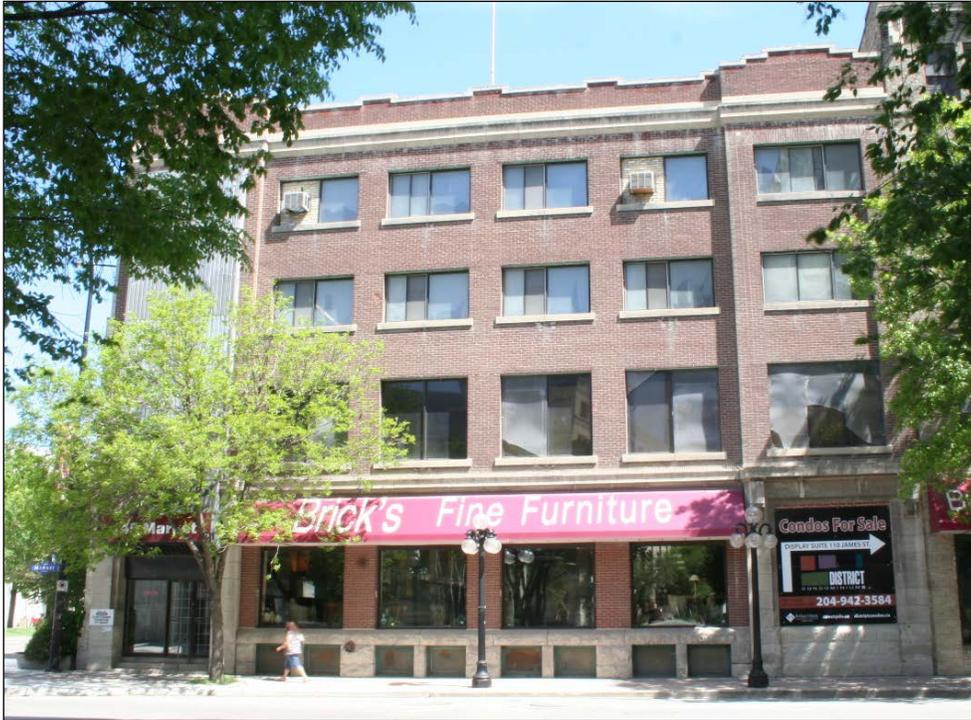
The main (south) façade features rusticated stone cladding a grade leading to the dark red brick superstructure with cut stone accenting around doors and windows. A stone cornice and stepped, stone-capped parapet highlight the flat roof. The east façade is hidden by the neighbouring building, the west façade is plainly designed, as is the rear (north) façade, which originally looked out on a back lane that included a spur rail line. Some alterations to the original design have occurred, including the replacement of the original window units.

- Four-storey brick and stone warehouse with main façades facing south onto Market Avenue and west onto Lily Street;
- Main (south) façade with its rusticated stone cladding at grade, dark red brick superstructure, smooth cut stone entablature as belt course dividing the first and second floors and bracketed above the main entrance (west end) and former interior driveway (east end), the upper three storeys with large, squared windows in openings with stone lug sills, a stone cornice above the fourth floor windows and the stepped and stone capped parapet at roof level; and
- The rear (north) façade with a ladder-type fire escape and windows in arched openings with lug sills and radiating heads.
