3180 PORTAGE AVENUE – ASSINIBOIA MUNICIPAL HALL
Hooper & Hooper, 1911

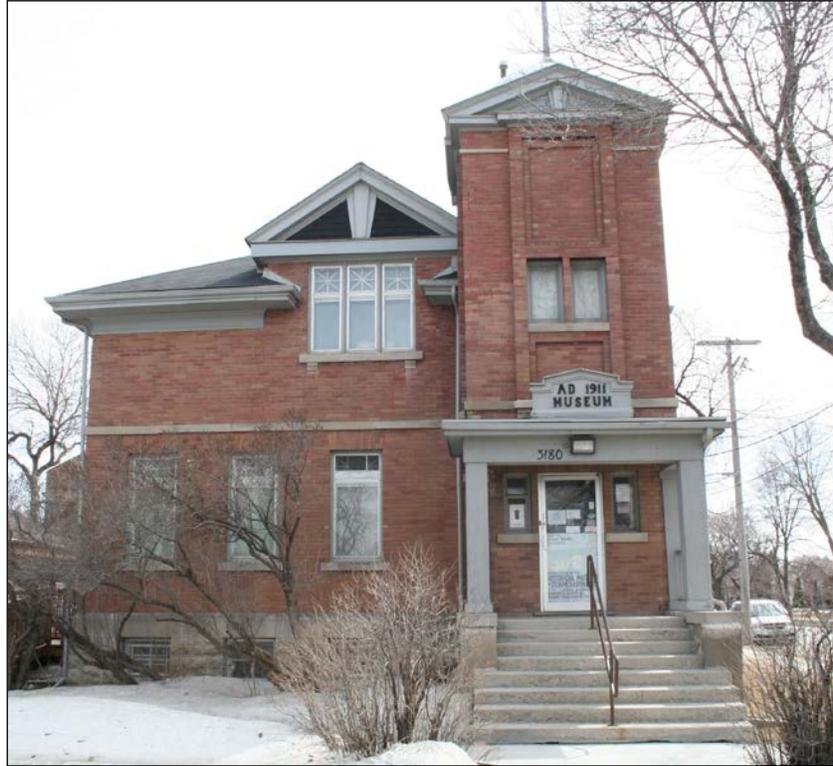
This solid brick, Classical Revival Style structure features a wealth of attractive architectural details including an asymmetrical front (north) façade with a raised entrance set in a shallow porch with square columns and small windows framing the doorway, squared window openings on the ground floor (with lug sills and radiating brick heads), the northwest corner tower with its

ornamental brickwork, stone accenting, small windows and unique pedimented domed roof with flag pole, a concrete belt course runs above the ground floor window openings and the hipped roof with heavy overhanging eaves, interrupted on all four sides by pedimented dormers above rectangular window openings with concrete lug sill and modest brackets. The rear (south) façade includes a unique metal tube fire escape from the second floor. Many of the smaller, upper windows are divided into small, pie-shaped panes – the upper pane opens in to allow for air circulation. Few alterations have been completed to the original exterior.

- The north facing structure located at the southeast corner of Portage Avenue and Banting Drive;
- The dark brick superstructure resting on a raised stone and concrete foundation (interrupted by basement windows) and concrete belt course encircling the building above the ground floor windows;
- The front (north) façade with its raised entrance set in a shallow porch with square wood columns and small windows framing the door;

- The northwest corner tower with ornamental brickwork, stone accenting, squared window openings and pedimented domed roof with flag pole;
- The rectangular windows with concrete lug sills (ground floor) and concrete lug sills with modest brackets (second floor) that include hinged top panes divided into pieszaped sections;
- The hipped roof with heavy overhanging eaves, interrupted on all four slopes by pedimented dormers;
- The east and west façades with rectangular window openings on the ground floor and pair openings on the second floor; and
- The rear (south) façade with its metal tube fire escape from the second floor.
