TENDER No. 291-2024

2024 BRIDGE MAINTENANCE
MAIN STREET AND NORWOOD BRIDGES

NORWOOD BRIDGE SOUTHBOUND
GIRDER CONCRETE REPAIR DETAILS

CITY DRAWING NUMBER
B-103-24-07

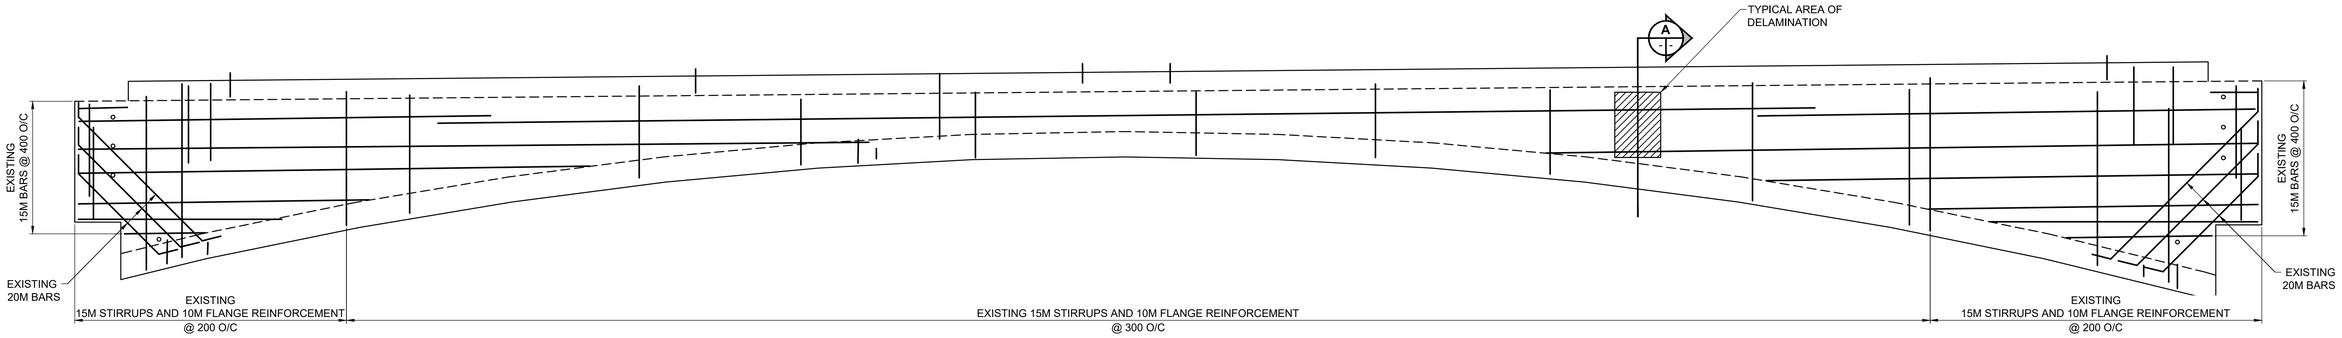
TYPICAL EXTERNAL GIRDER REINFORCING ELEVATION

TYPICAL DELAMINATION ON SOUTHBOUND BRIDGE SPANDREL WALL
