Photographs of Grit Aeration Unit No. 1
(taken December, 2010 when unit was out of service)

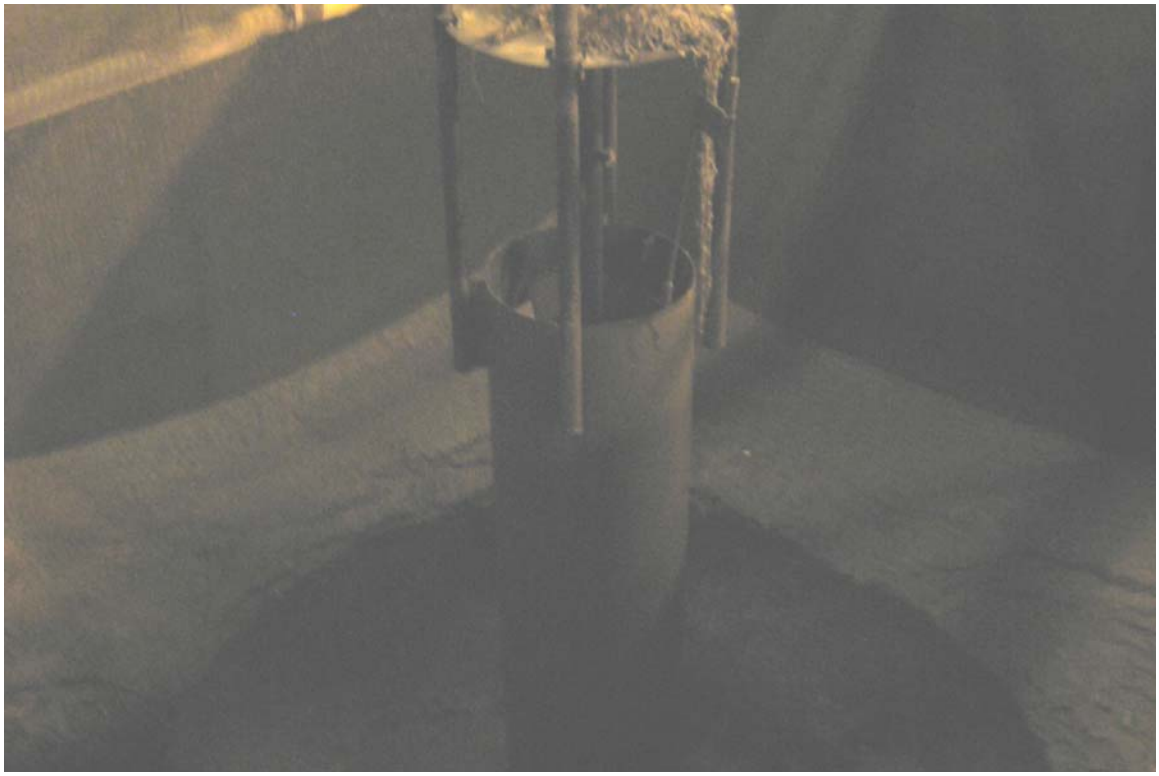
Eductor hanger support
channels to be replaced

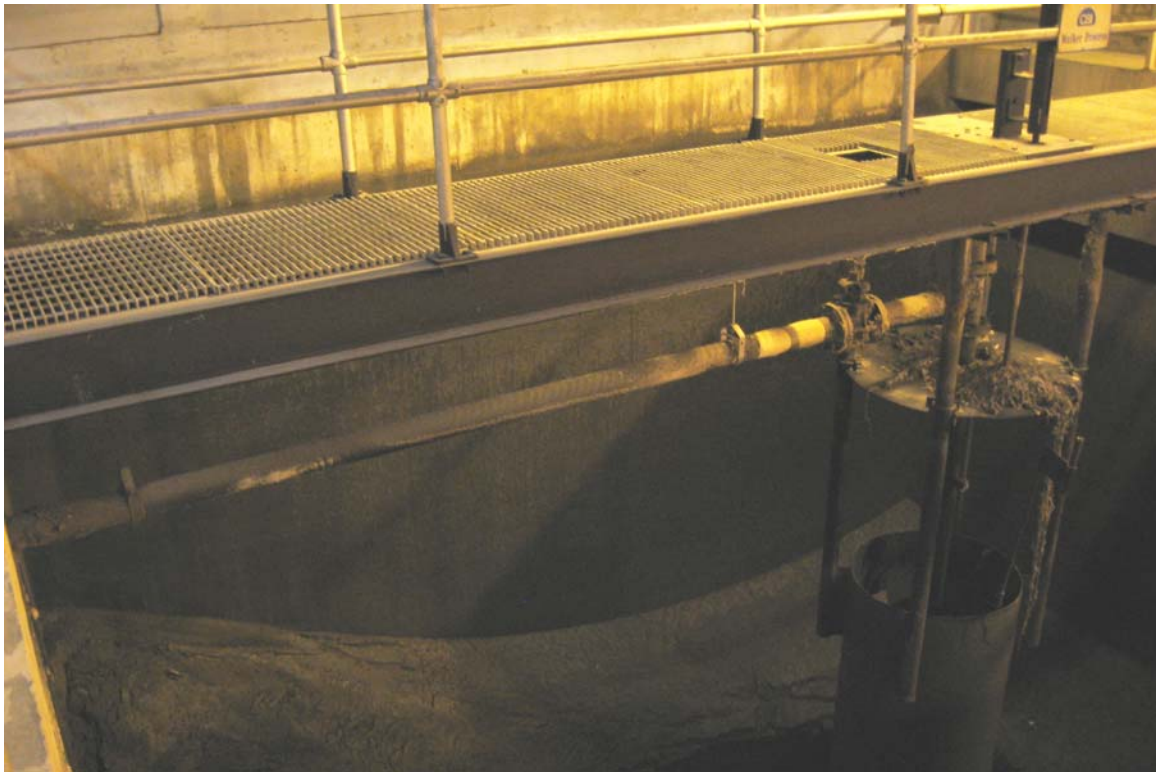
Sludge draw off pipe Item 19
