# **NorthEnd Water Pollution Control Centre Storage Tank #5**

## **Concrete and Corrosion Assessment**

*Prepared For: Water & Waste Department – Project Planning and Delivery*

*May, 2010*

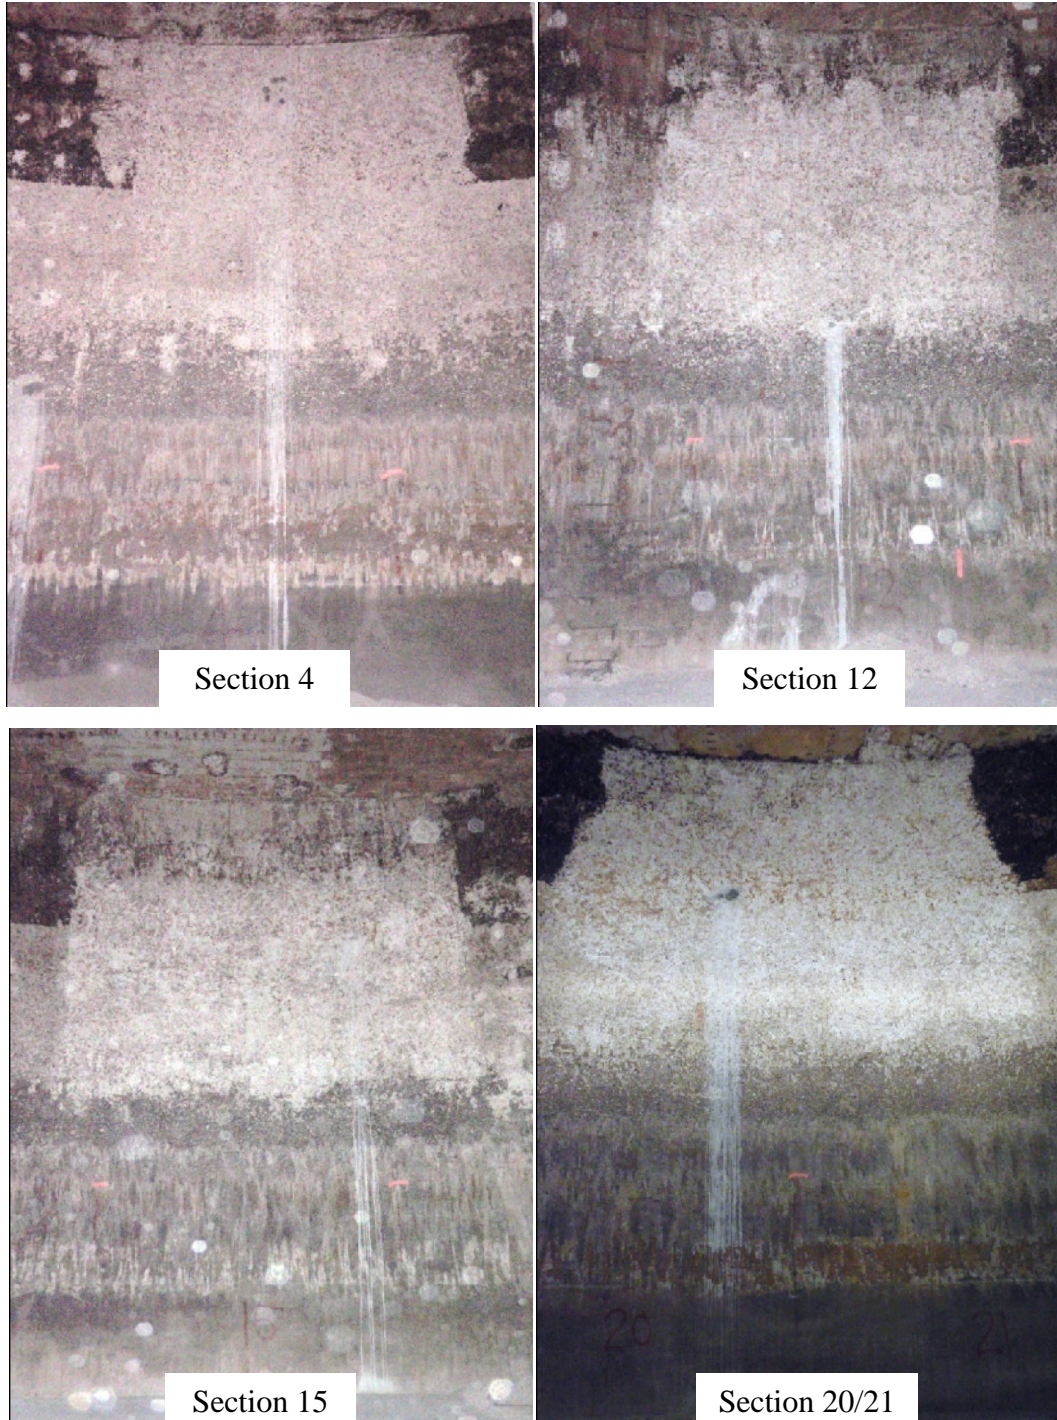
A full sounding survey was performed on the floor, finding no delaminations. A full sounding survey was also completed on Levels 1 to 3 on the walls and columns and only a small, 0.1m<sup>2</sup>, delamination was located on the wall in Section 7 approximately 2.4m above the floor level. Levels 4 and 5 are similar in deterioration: the expanded layer of decomposed cement paste found in these two layers was thick, as much as 50mm in some places. This type of deterioration is consistent with sulphate attack, common in waste water environments. Therefore, in addition to the sounding survey, we have also investigated the thickness of the softened material and the condition of the concrete beyond the softened material. Four (4) areas were scraped by hand to remove the expanded material in order to complete an additional sounding survey on the concrete underneath. These areas were sections 4, 12, 15 and 20/21.

In these four (4) sections, no delaminations were found in Levels 4 & 5.

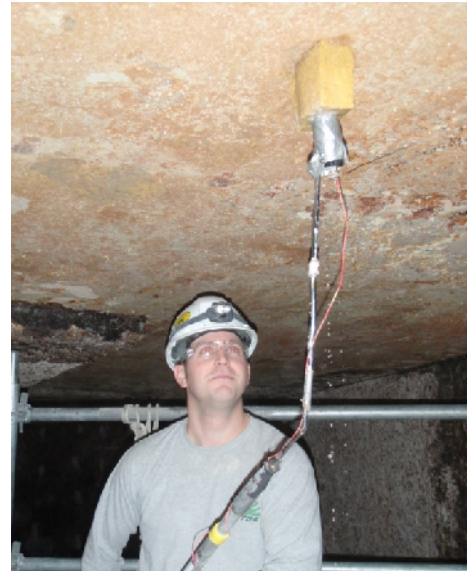
Half-Cell Measurements on Ceiling

Corrosion potential readings were obtained from all elements of the structure. Even in Levels 4 and 5 where the softened concrete was preventing obtaining a proper electrolytic connection between the half-cell and the concrete surface, spot scraping was done to expose the sound concrete underneath to perform the test. The results of the corrosion potential testing are outlined in the table below.

Very little of the readings taken were in the active range or the uncertain range, with the exception of the floor. Nearly two thirds of the readings were in the uncertain range, but there too were few readings in the active corrosion range. In general, the readings obtained indicated that only a miniscule amount of active corrosion is present in the reinforcing steel in the concrete structure.

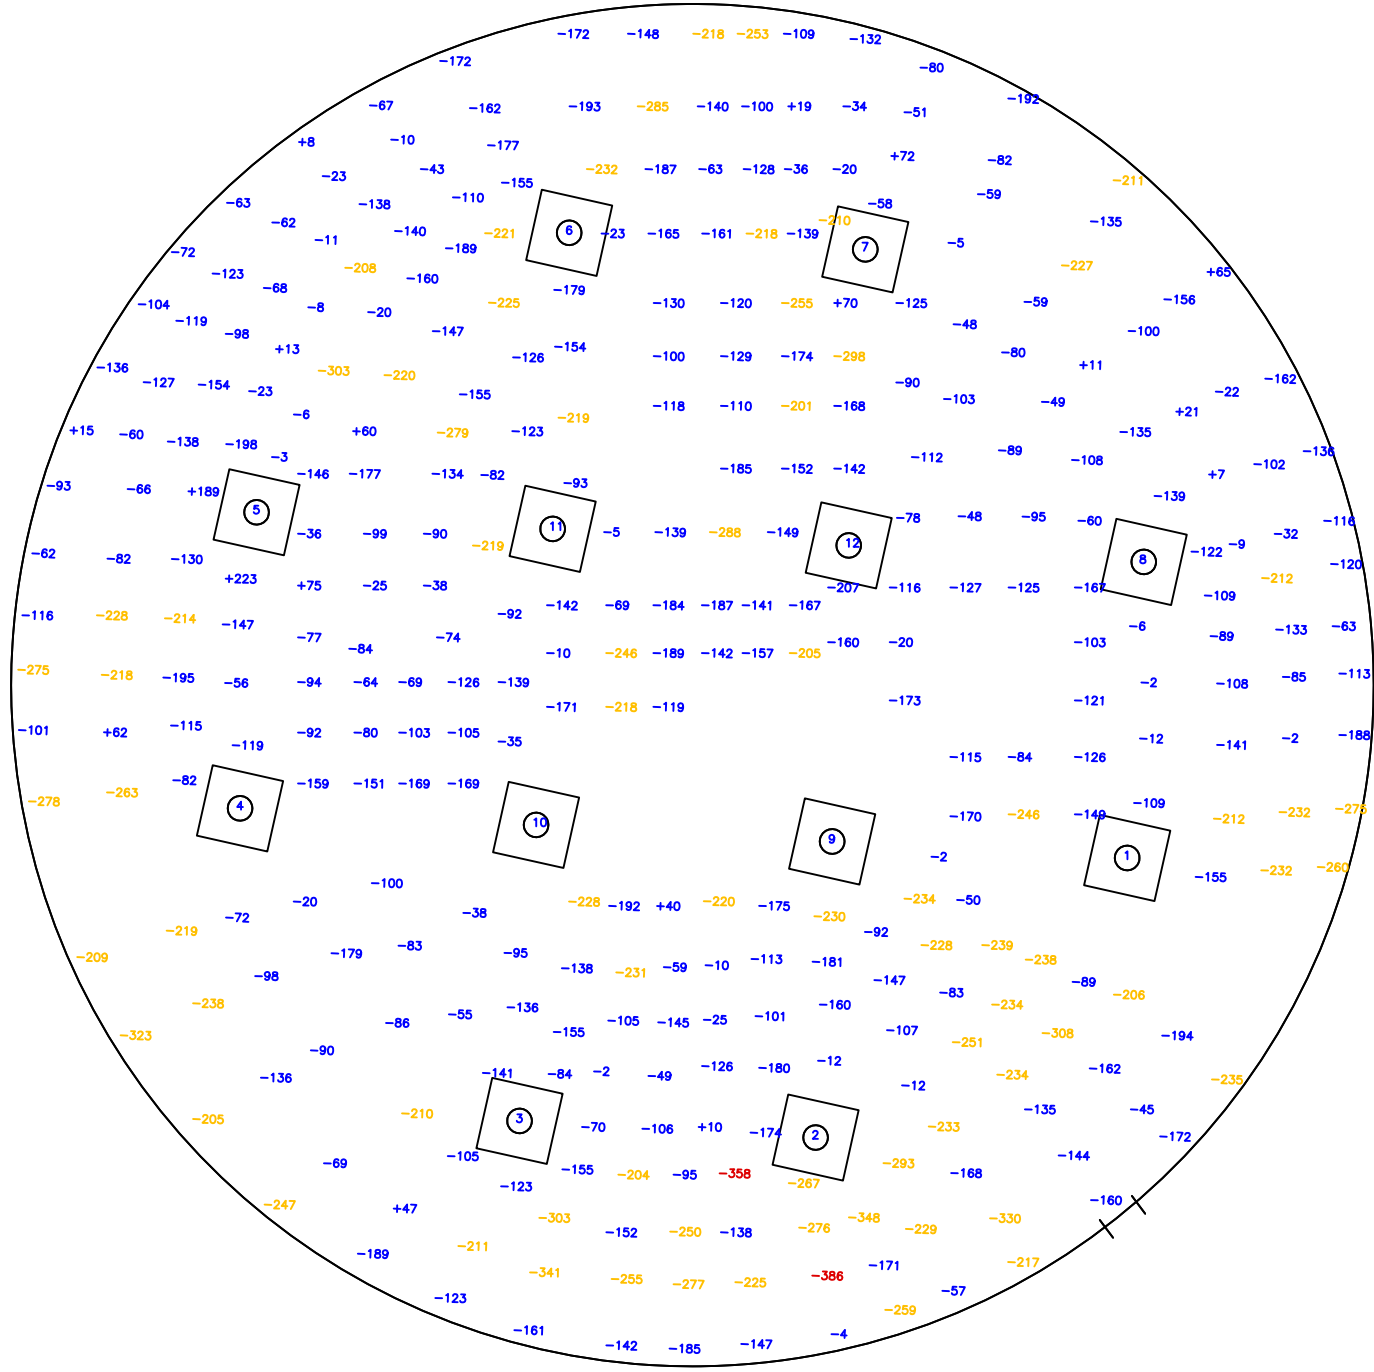
Half Cell  
Corrosion Potentials

3] IF POTENTIALS OVER AN AREA ARE IN THE RANGE OF -200 TO -350 mV CSE, CORROSION ACTIVITY OF THE REINFORCING STEEL IN THAT AREA IS UNCERTAIN.

4] IF POTENTIALS OVER AN AREA ARE MORE NEGATIVE THAN -350 mV CSE, THERE IS A GREATER THAN 95% PROBABILITY THAT REINFORCING STEEL CORROSION IS OCCURRING IN THAT AREA AT THE TIME OF THE MEASUREMENT.
