OSBORNE BRIDGE
2009 CONDITION SURVEY
Winnipeg, Manitoba

Prepared By:
TBT Engineering Limited
110 Paramount Road
Winnipeg, Manitoba, R2X 2W3

October 14, 2009

Project No. 09-571

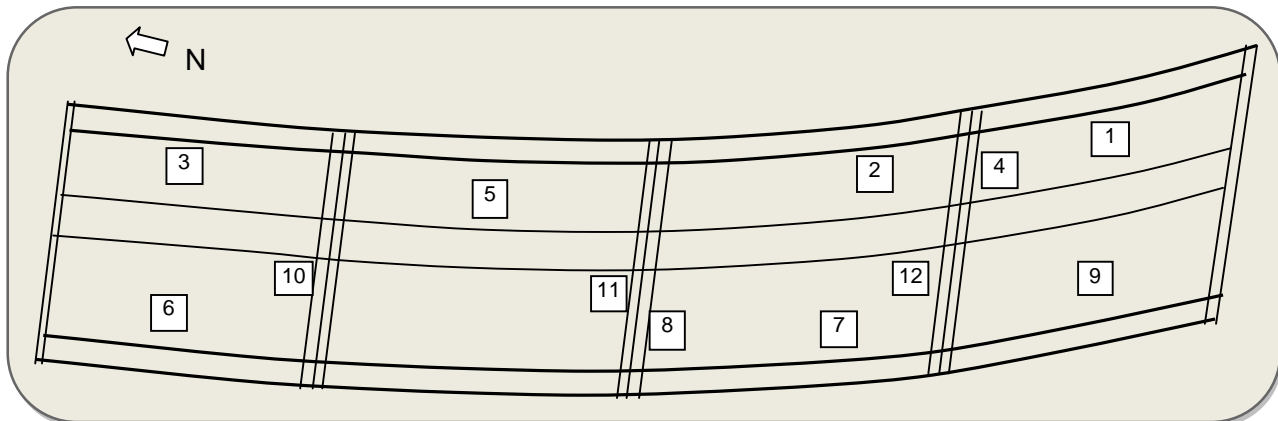
LOCATION OF SAWN SAMPLES

No evidence of moisture was observed in the surface of the concrete deck beneath the asphalt pavement. Concrete distress in the form of delamination and cracking was observed at the sawn locations in the north bound curb lane (Sawn Sample No. 1 to 3) and at one location at the northbound median lane (Sawn Sample No. 7). It was observed that the bottom surface of the asphalt samples recovered from these locations were covered with approximately 15 to 20% concrete from the underlying deck ranging from 5 to 15 mm in depth. Sound concrete surfaces were observed after removal of asphalt pavement sawn samples from the southbound lanes of the bridge deck. The thickness of the asphalt pavement taken during pavement sawing ranged from 52 to 91 mm with an average value of 73 mm. The depths of concrete cover over the reinforcing steel at these locations ranged from 38 to 49 mm with an average value of 44 mm.

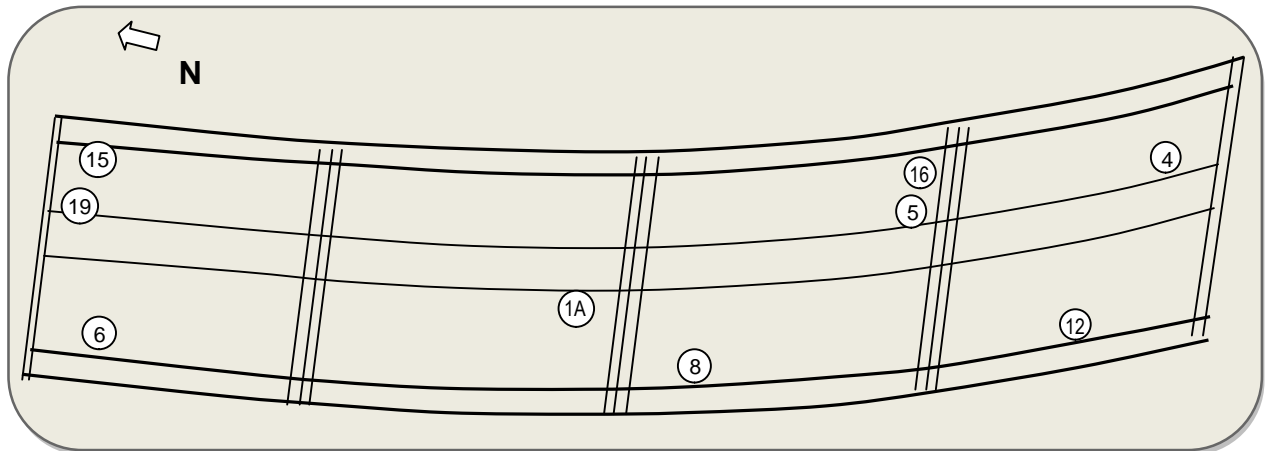
LOCATION OF CORES TESTED FOR CHLORIDE

The chloride content results obtained from core slices taken at 20 to 30 mm depth and one slice from 30 to 40 mm exceeded the threshold value (0.157 to 1.030%). With one exception, the chloride contents below the 30 mm level were lower than the threshold value of 0.15% by mass of cement. This is consistent with the indication of little corrosion given by the half-cell potential and corrosion rate readings.

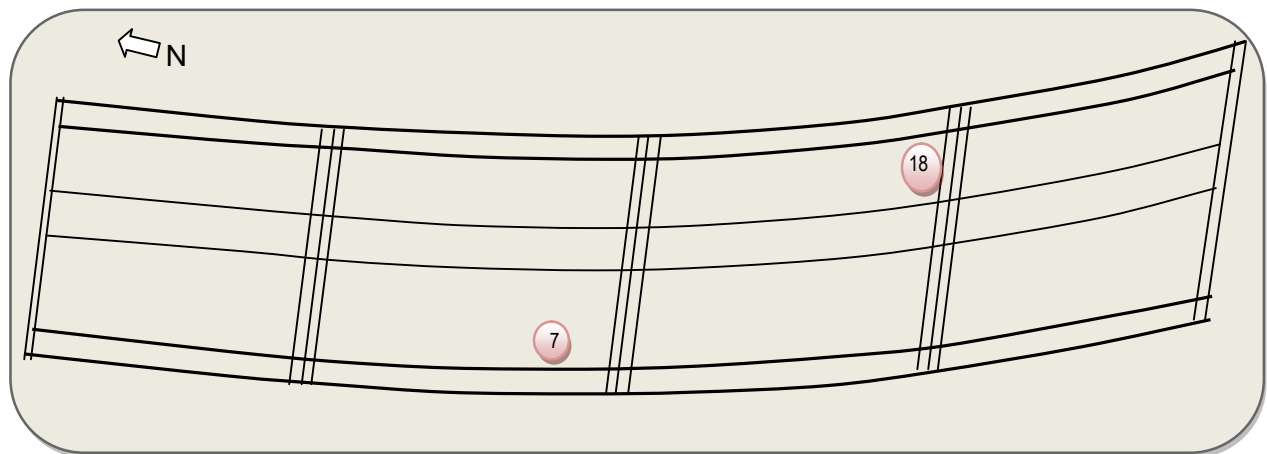
LOCATION OF CORE SAMPLES TESTED FOR AIR VOID PARAMETERS

Parameters	Core No. 7	Core No. 18
total air content (%)	8.9	7.0
specific surface (mm ⁻¹)	29.14	20.26
spacing factor (mm)	0.092	0.182
