**– FEASIBILITY STUDY TO RELOCATE THE ST. JAMES ASSINIBOIA 55+ CENTRE
TO THE ST. JAMES CIVIC CENTRE**

– PREPARED BY 1X1 ARCHITECTURE INC. – SEPTEMBER 21, 2012

Winnipeg, Manitoba
September 21 2012

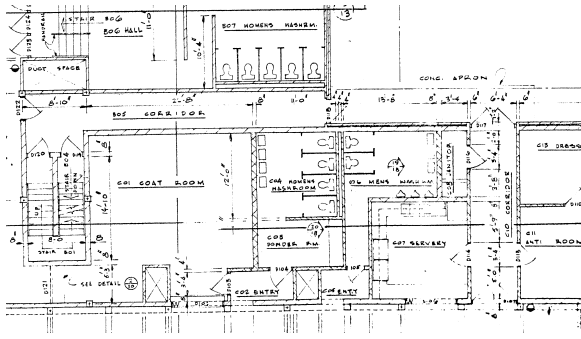
It is our understanding that the original design met the Building Code standards at the time of construction. In fact the original design of the east stair appears to meet

Blow-up of 1965 floor plan
Original East stair exit configuration

the 2010 NBC requirement of an exit as the stair exits into a fire rated corridor that leads straight to the exterior of the building. With the addition of the staff room and a new entry from this corridor into the boardroom, this corridor is now used to access programmed space and does not meet the intent of the NBC.

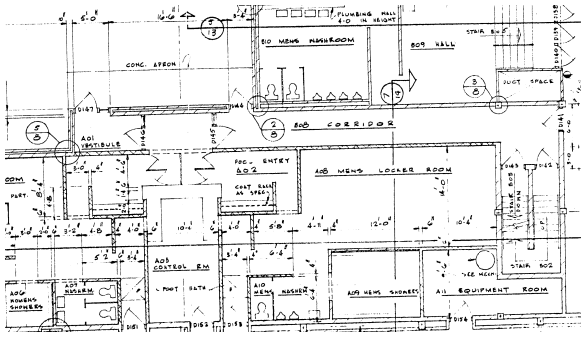
Blow-up of 1965 floor plan
Original West stair exit configuration

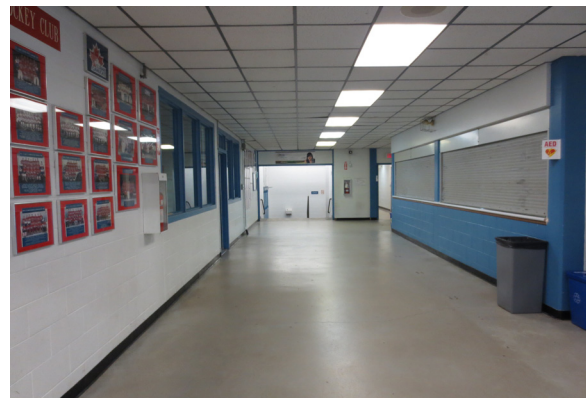
The canteen sits in the middle of the area and is built of concrete block walls. The concrete block is in good condition, access to the interior of the canteen was not made available at the time of the walkthrough. The canteen is privately operated and City of Winnipeg staff indicated that it is underutilised due to the lack of large crowds in the hockey arena. City staff indicated that the canteen can be demolished in any future development and the facility would operate without this service.

Above: Waiting area with canteen on the right. Windows on the left have view to the hockey arena.

City of Winnipeg staff recommended that this entire area be reconsidered as a social hub and meeting place for patrons of the facility. The gathering space at the North Centennial Recreation and Leisure Facility was recommended as a good precedent for this space.

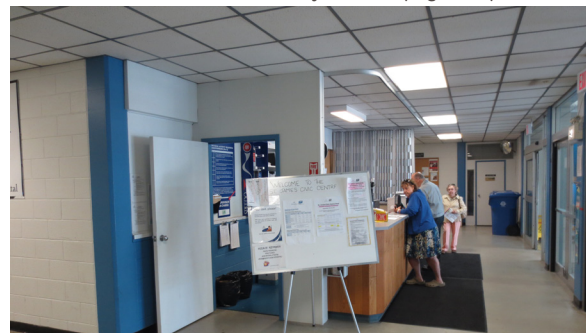
The City of Winnipeg reception desk sits in the southern portion of this area. The reception desk is large enough for two persons and is appropriately located for patrons to show City of Winnipeg passes and purchase tickets for the programs available in the building. The desk does not meet current barrier free standards as indicated in section 3.3. City staff indicated that the reception can be demolished and replaced with new in any future development of this area.

Below: City of Winnipeg Reception Desk

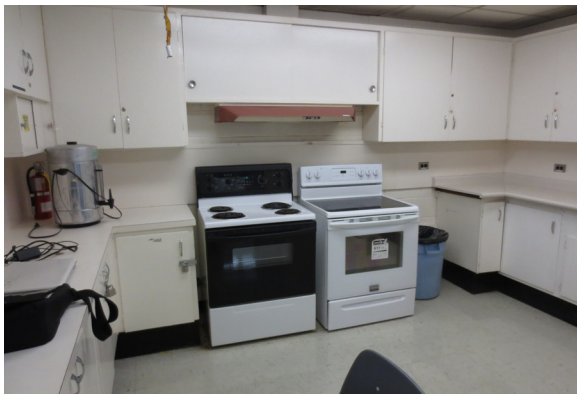
The kitchen houses two electric ranges, a sink and a refrigerator. The millwork is in relatively good condition but is out of date. Providing a higher quality kitchen could attract new patrons to rent the space.

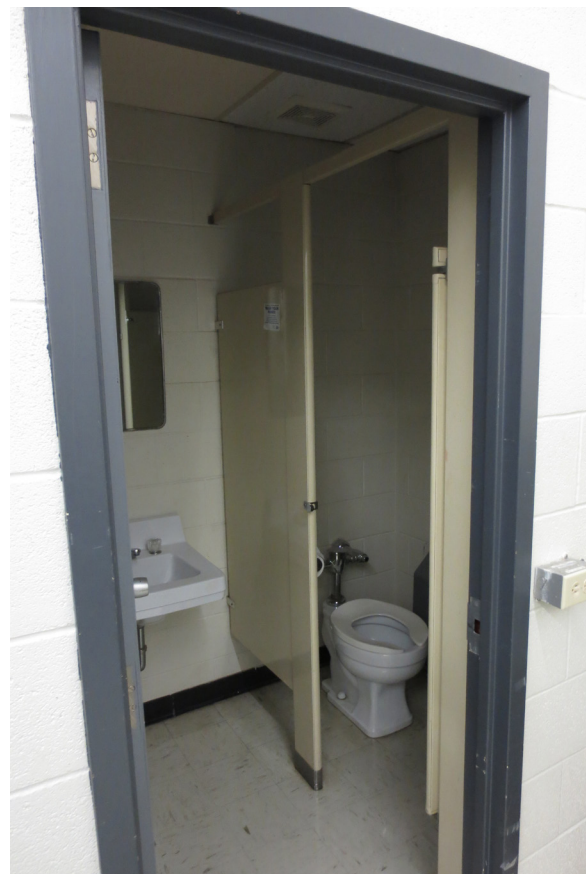
Washroom

It is anticipated that the floor tiles may contain Asbestos Containing Materials.

This washroom serves the purpose as a backstage washroom for people utilising the stage. The washroom appears to be in good working condition.

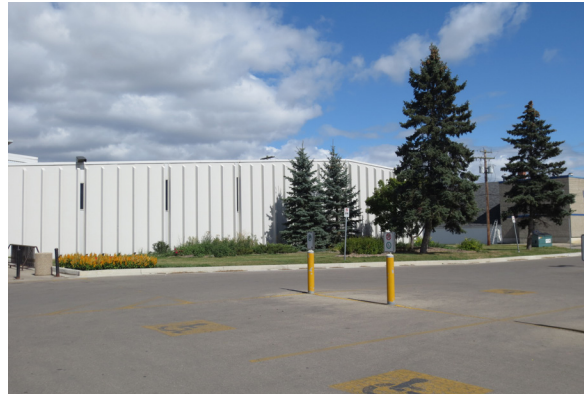
- Does not provide access to basement or second floor;
- Eliminates one row of public parking on south side parking lot;
- Requires demolition of mature trees

The mature trees south of the auditorium
