## **CITY OF WINNIPEG**

WASTEWATER LIFT STATION CONDITION ASSESSMENT PHASE II

Document VII: Metcalfe Lift Station Assessment

Date: March 16, 2020  
City File No.: S-1095  
MPE Project No.: 8400-001-00

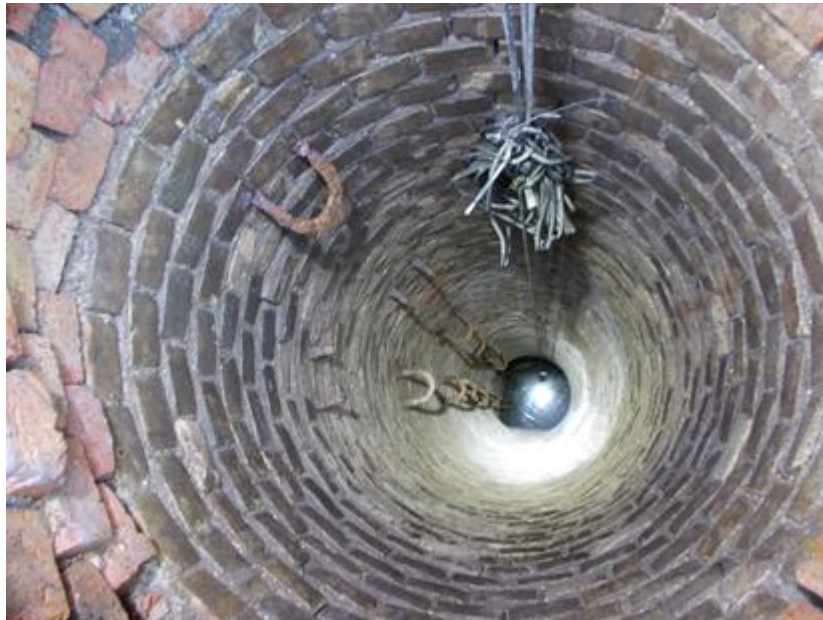
*Metcalfe Wet Well*

Sewage enters the north side of the wet well through a 300 mm diameter secondary sewer pipeline and is directed to the pump suction lines located on the south side of the wet well. The wet well is long and sloped towards the sump suction lines which prevents solids build up in the edges of the wet well. The 200 mm diameter pump suction lines are located at the bottom of the wet well. Operational staff noted that there are no noticeable issues with solids buildup in the wet well.

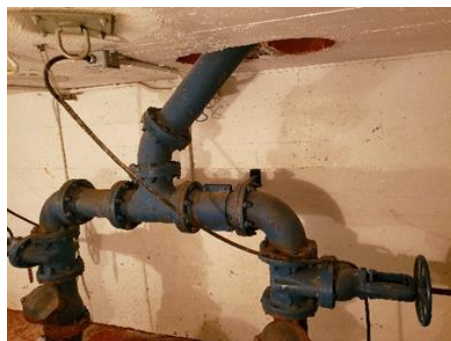
The valves were installed in 1992. The manually actuated gate valves are used for isolation of equipment for maintenance and are not regularly exercised. The check valves are critical to the operation of the lift station and are exercised regularly through operation. In general, valves are in “Poor” to “Fair” condition. The check valves have frequent clogging issues. Table 7.5 provides a summary of the condition of the valves at the Metcalfe Lift Station.

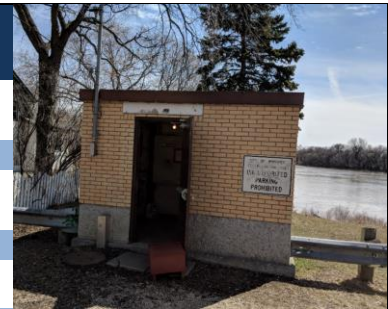
As part of the condition assessment of the equipment and installation methods at the Metcalfe Lift Station, MPE reviews equipment and installations to assess whether standards set forth in applicable codes and regulations are met. The Canadian Electrical Codes CSA C22.1-15 and NFPA 820 are of particular relevance for wastewater lift station electrical systems. According to the NFPA 820 Table 4.2 Row 17, a below grade or partially below grade wastewater pumping station dry well that is ventilated with fewer than 6 air changes per hour is to be classified as a Zone 2 (or Class 1 Division 2) space. The dry well and above grade building are connected through the dry well access and are therefore considered a single air space. This air space is not ventilated continuously to the minimum standards to achieve an unclassified rating. Currently, the electrical equipment within the station is not rated for use in a Zone 2 space, therefore it is recommended that the ventilation system be upgraded to provide the necessary air changes to achieve an unclassified rating. Row 1 of Table 9.1.1.4 in the NFPA 820 requires a minimum of 12 air changes per hour to classify a wet well as a Zone 2 (or Class 1 Division 2) space. This lift station wet well is unable to meet the required number of air changes per hour and is classified as a Zone 1 space. The transformer currently does not have the required clearance from a combustible as per the CEC. It is recommended to affix a steel plate behind the transformer as per CEC.

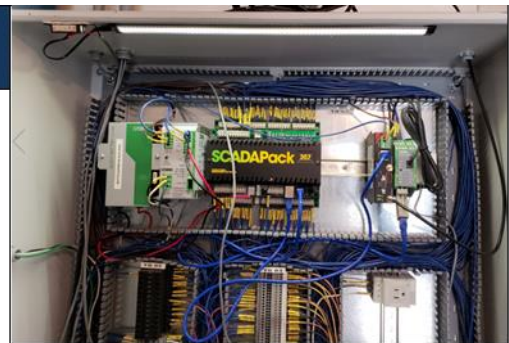
The Metcalfe Lift Station monitoring is handled by SCADAPack 357. The RTU is used for monitoring and reporting only. Pump control is done via a Milltronics Ultrasonic Level Transmitter. In the event of a level sensor submersion or fail the Float Level Switch takes over level control. Currently, the station does not have control redundancy. This has been added to prior Lift Station upgrades and would be an expected upgrade at the Metcalfe Lift Station. Field devices include one Milltronics Ultrasonic Level Transmitter, and two FLYGT ball, one of which is no longer operational.

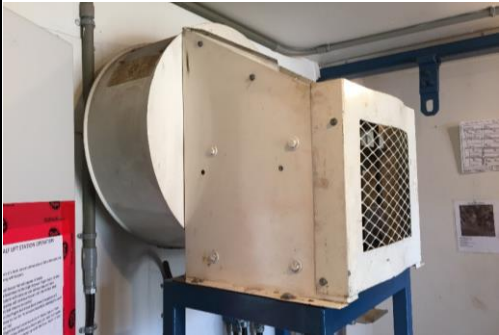
The Metcalfe Lift Station ventilation system includes one exhaust fan located on the main floor. The ventilation system is used intermittently when the building and dry well are occupied. The exhaust fan forces air into the dry well to create a positive pressure in the spaces. Air in the dry well is exhausted by gravity through a pipe that penetrates the roof of the building, connecting to the dry well. Fresh air is by the fan through a wall louvre. There is no permanent wet well ventilation system in place. No major ventilation upgrades have been carried out at the lift station since its original construction. In general, the equipment is showing signs of aging and is in “Fair” condition.

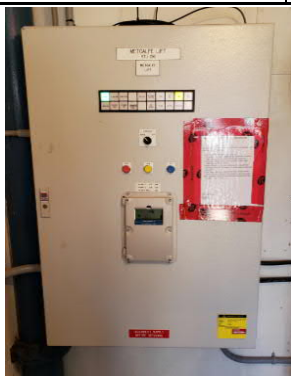
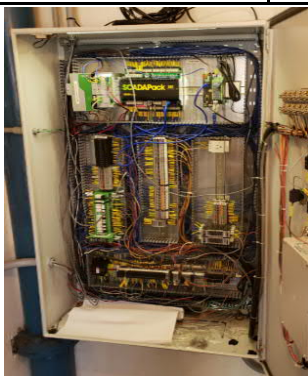
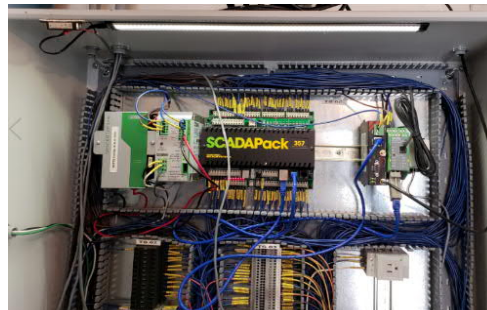
PHOTOGRAPHS

Control Logic is Appropriate for Installation: Issues for Discussion:	Rating 1 (Yes) Rating 3 (No - current standards) Rating 5 (No - legacy standards)	1	0.3	Install building alarms (heat, ambient temperature, intrusion, etc.)					
	Communications Equipment is Appropriate: Issues for Discussion:	Rating 1 (Yes) Rating 3 (No - current standards) Rating 5 (No - legacy standards)	1	0.1						
	Equipment Remaining Service Life: Issues for Discussion:	Rating 1 (> 90% lifecycle remain) Rating 2 (> 75% lifecycle remain) Rating 3 (> 50% lifecycle remain) Rating 4 (> 25% lifecycle remain) Rating 5 (obsolete)	2	0.2
