CITY OF WINNIPEG

WASTEWATER LIFT STATION CONDITION ASSESSMENT PHASE II

Document II: St. Charles Lift Station Assessment

Date: March 16, 2020

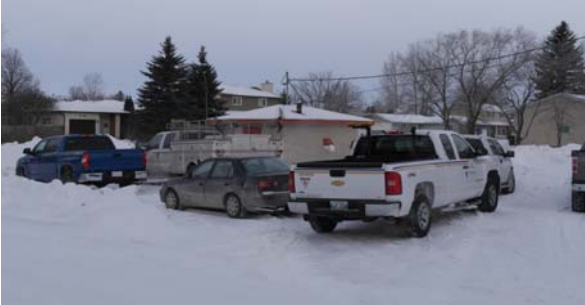
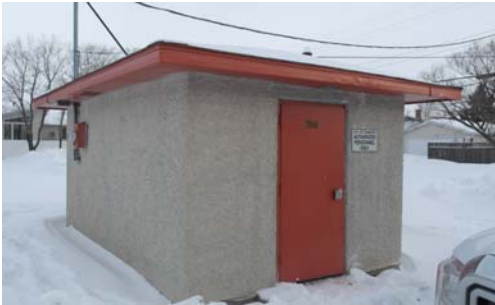
Fitness for Purpose	Site Grading & Landscaping: <i>Issues for Discussion:</i> - Suitability of landscaping for the community - Grading sufficient to drain site Rating 1 (Excellent - performs for intended purpose) Rating 2 (Good - well suited for intended purpose) Rating 3 (Functional - performs adequately) Rating 4 (Poor - not suitable for intended purpose) Rating 5 (Fail - does not meet any requirements)	4	0.2				
	Fitness for Purpose	Fencing & Signage: <i>Issues for Discussion:</i> - Signage reflect important information, emergency # - Fencing and gate appropriate or needed for security Rating 1 (Excellent - performs for intended purpose) Rating 2 (Good - well suited for intended purpose) Rating 3 (Functional - performs adequately) Rating 4 (Poor - not suitable for intended purpose) Rating 5 (Fail - does not meet any requirements)	3	0.4				
	Safety	Public and Operator Safety: <i>Issues for Discussion:</i> - Historical safety incidents, or potential conditions - Evacuation of personnel (davit, gear, hatch locations) Rating 1: No Public Safety issues Rating 3: No record of incidents, possible concerns Rating 5: Historic incidents or probable safety risks	3	1

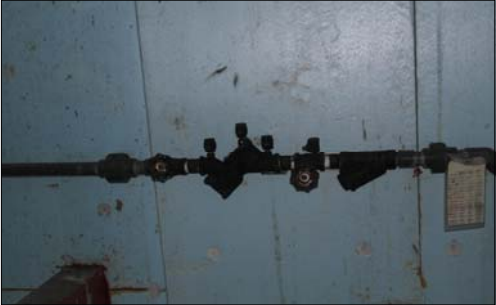
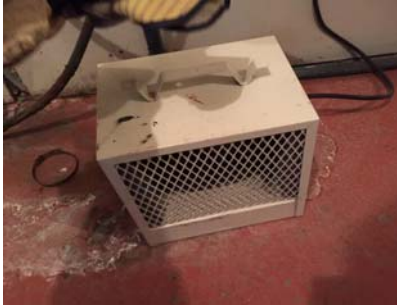
Fire Suppression Systems: <i>Issues for Discussion:</i>	Rating 1 (Excellent - performs for intended purpose) Rating 2 (Good - well suited for intended purpose) Rating 3 (Functional - performs adequately) Rating 4 (Poor - not suitable for intended purpose) Rating 5 (Fail - does not meet any requirements)	5	0.3								
	Safety	Public and Operator Safety: <i>Issues for Discussion:</i> - Monitors, Alarms	Rating 1: No Public Safety issues Rating 3: No record of incidents, possible concerns Rating 5: Historic incidents or probable safety risks	3	1								
	PHOTOGRAPHS

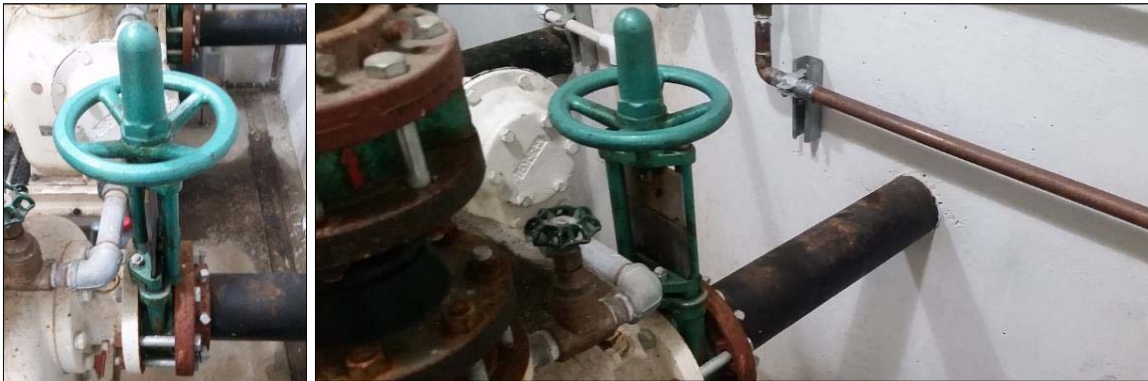
SECTION	ITEM	DATA	CONDITION RATING				AGE		
			CONDITION	SCORE	IMPORTANCE	ACTION	YEAR INSTALLED	EXPECTED SERVICE LIFE	REMAINING SERVICE LIFE
6.4 - Valves	Equipment Tag: Knife Gate Valve	Location: Dry well Lower Level	FAIR	3	4	4	0	25	0
		Description: Knife Gate Valve							
		Size: 100 mm							
		Valve Make: Orbinox							
		Valve Model: 10-2134R							
		Actuation: Manual - Hand wheel							
		Actuator Make: N/A							
		Actuator Model: N/A							
		Equipment Visual Inspection: No leaks Valve in fair condition	FAIR	3	<u>NOTES:</u>				
		Valve Corrosion Noted: Exterior corrosion noted on valve flanges and bolts	FAIR	3					
Condition of Valve Operator: Operator is in fair visual condition, however valve is not exercised regularly	FAIR	3							
Condition of Valve Accessories: N/A			<u>COMMENTS AND RECOMMENDATIONS:</u> Valve is used for manual isolation of Pump 101. Surface Corrosion has been noted on the valve.

Valve Performance/Ability to Seat: No issues identified, however valve is not exercised regularly	FAIR	3							
Operational Issues Identified: No issues identified	FAIR	3							
Equipment Remaining Service Life: Valve has exceeded its expected service life	POOR	2							
PHOTOGRAPHS

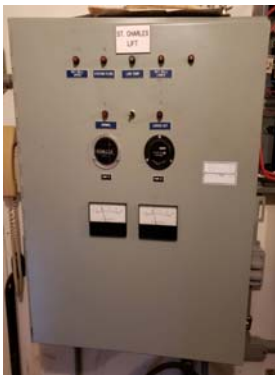
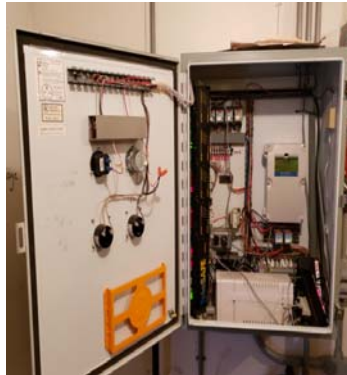
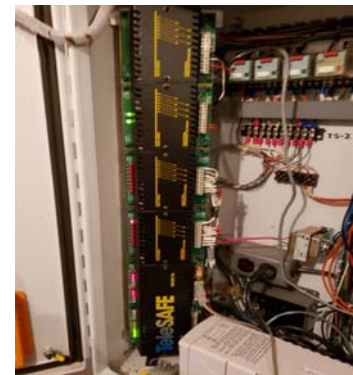
PHOTOGRAPHS

SECTION	ITEM	DATA	Assessment Scores				Component Age			
			Current Physical Condition	Fitness For Purpose			YEAR INSTALLED	EXPECTED SERVICE LIFE	REMAINING SERVICE LIFE	
Equipment Tag: IC_Panel Description: St.Charles Control Panel	GENERAL	Location: Dry Well, Main Level	3.3	2.8			1995	25	1	
		Description: St.Charles Control Panel								
		Function: Alarm Reporting								
		PLC Processor: SCADAPack Micro 16								
	UPS Protection: Yes	Rating	Weight	Recommended Frequency of Review: (In years, specify between 1-15)			4			
	Current Physical Condition	Equipment Visual Inspection: <i>Issues for Discussion:</i>	Rating 1 (Like New) Rating 2 (Minor Surface Corrosion) Rating 3 (Surface & Internal Corrosion) Rating 4 (Severe Corrosion) Rating 5 (Safety Concern)	2	0.1	NOTES & COMMENTS: Flow Meter Needed. New stations have control redundancy RECOMMENDATIONS: Replace with controls meeting current design guidelines. Relocate Control Panel Location. Move Milltronics outside of cabinet. Upsize Cabinet or move UPS to the exterior of cabinet. COST ESTIMATE \$ 40,000.00

Canadian Electrical Code Issues Identified: <i>Issues for Discussion:</i>	Rating 1 (No issues) Rating 3 (Non compliant - current code) Rating 5 (Non compliant - legacy code)	5	0.4					
		Control Wiring Terminations Visual Inspection: <i>Issues for Discussion:</i>	Rating 1 (Connections tight, labelled) Rating 2 (Missing Labels) Rating 3 (Loose / Disorganized wiring) Rating 4 (Inappropriate wiring) Rating 5 (Combination of above)	3	0.1					
		Occurrences of Maintenance Issues: <i>Issues for Discussion:</i>	Rating 1 (None) Rating 2 (Intermittent) Rating 3 (Consistent but occasional) Rating 4 (Frequent) Rating 5 (Constant)	2	0.4					
		Controls Functioning as Expected: <i>Issues for Discussion:</i>	Rating 1 (Always) Rating 2 (More than half of time) Rating 3 (Half of the time) Rating 4 (Less often than half) Rating 5 (Never)	1	0.3					
Fitness for Purpose	Panel is Appropriately Designed: <i>Issues for Discussion:</i>	Rating 1 (Yes) Rating 3 (No - current standards) Rating 5 (No - legacy standards)	3	0.1

Control Logic is Appropriate for Installation: <i>Issues for Discussion:</i>	Rating 1 (Yes) Rating 3 (No - current standards) Rating 5 (No - legacy standards)	3	0.3						
	Communications Equipment is Appropriate: <i>Issues for Discussion:</i>	Rating 1 (Yes) Rating 3 (No - current standards) Rating 5 (No - legacy standards)	5	0.1						
	Equipment Remaining Service Life: <i>Issues for Discussion:</i>	Rating 1 (> 90% lifecycle remain) Rating 2 (> 75% lifecycle remain) Rating 3 (> 50% lifecycle remain) Rating 4 (> 25% lifecycle remain) Rating 5 (obsolete)	4	0.2
