POOL HEATING AND VENTILATION SYSTEM ASSESSMENT

**CINDY KLASSEN POOL - 999 SARGENT AVENUE
PHASE I STUDY - PROJECT NO. 2015-089**

KGS Group 17-0107-019
May 2018

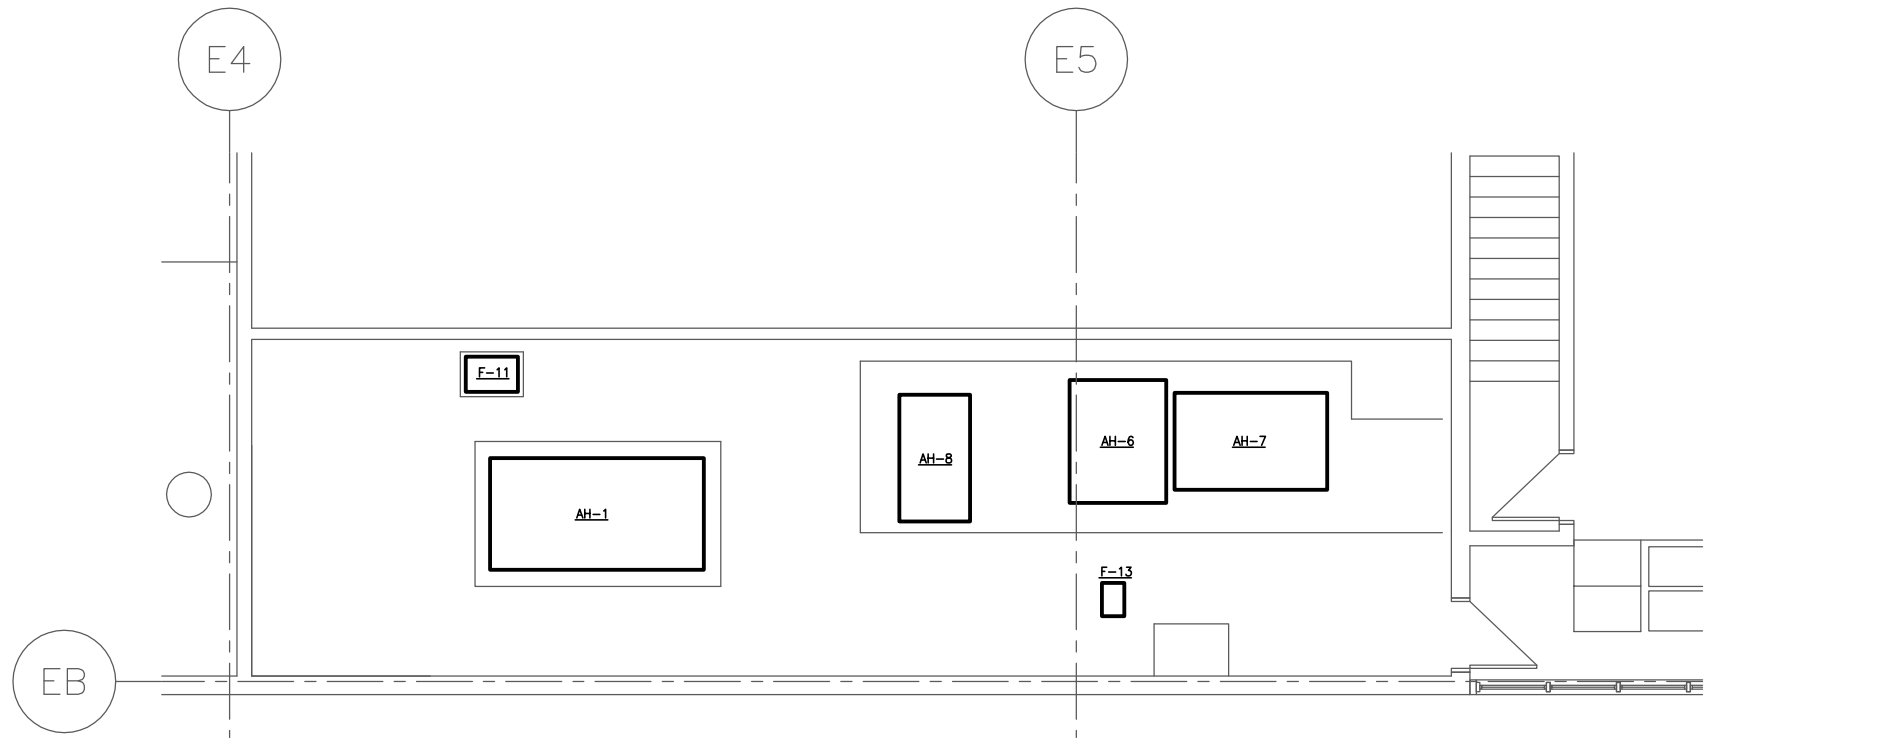
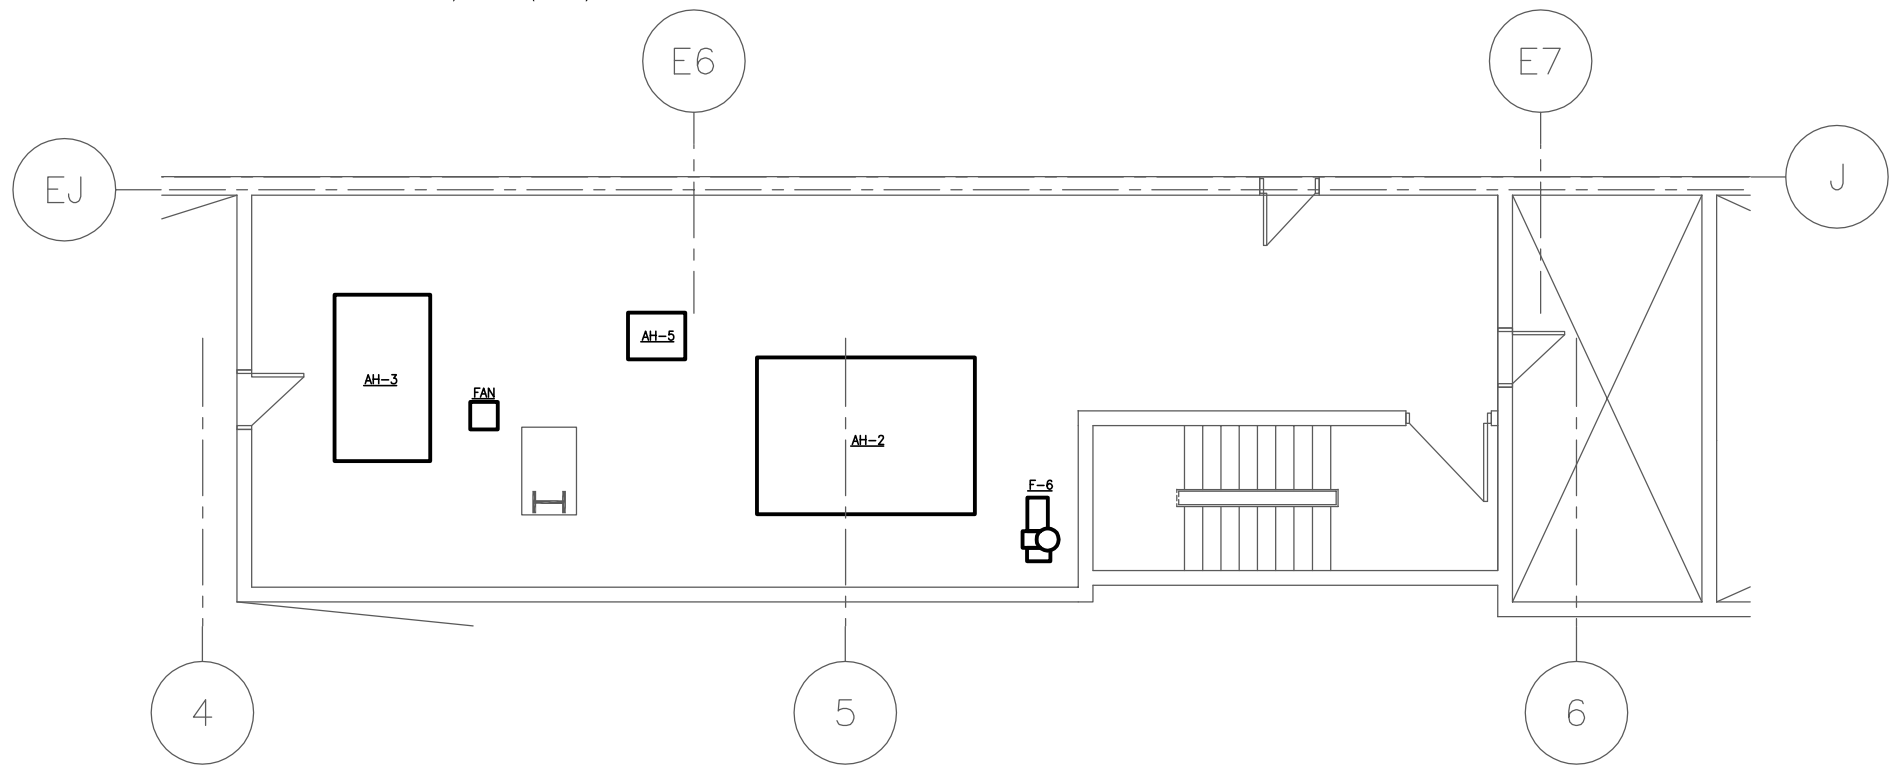
SCALE AS SHOWN PROJECT No: 17-0107-019 SHEET No: FIGURE 1

The equipment in the south mechanical room is described in this section. Figure 1 in Appendix A shows the physical location of the equipment.

The equipment in the north mechanical room is described in this section. Figure 1 in Appendix A shows the physical location of the equipment.
