# **GEOTECHNICAL REPORT**

**Re: 2023 City of Winnipeg Local Street Renewal Program  
Report of Geotechnical Investigation and Test Results**

This letter summarizes KGS Group’s geotechnical results for the 2023 City of Winnipeg (COW) Street Renewal Program in Winnipeg, Manitoba. KGS Group’s scope of services for this project was outlined in our proposal no. 22-000-1495 titled “2023 COW Local Street Renewal Program – Geotechnical Services” dated September 21, 2022.

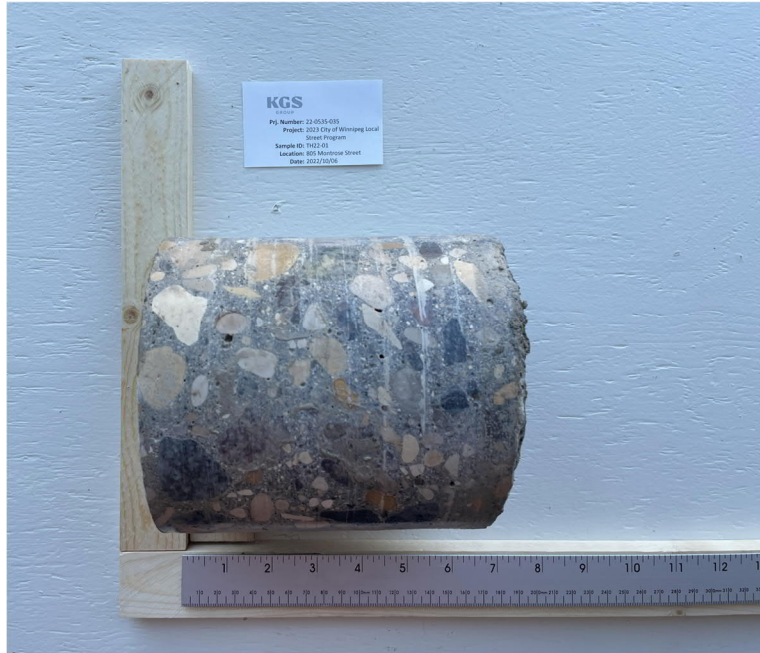
Photo 1: TH22-01

Four (4) cores were completed along Montrose Street; two (2) at joint locations (TH22-02 and TH22-04), and two (2) mid-slab (TH22-01 and TH22-03). The pavement surfacing consisted of concrete with a thickness of 159 to 203 mm (6.25 to 8 in.). Base material was only encountered in TH22-02 and consisted of 51 mm (2 in.) thick crushed limestone. Clay subgrade was encountered directly below pavement in the remaining test holes. Core hole locations are shown in Figure 1 attached.

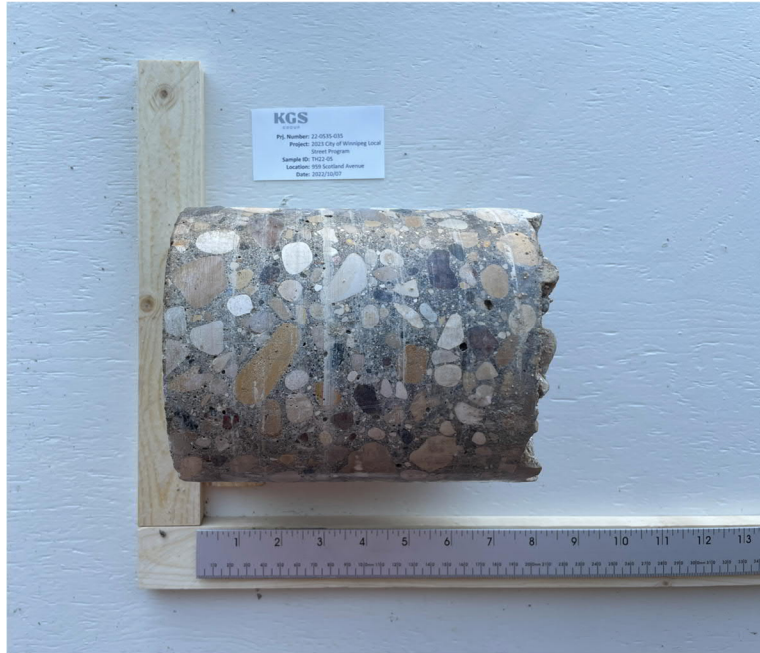
Photo 05: TH22-05

Five (5) cores were completed along Scotland Avenue; three (3) at joint locations (TH22-06, TH22-07 and TH22-09), and two (2) mid-slab (TH22-05 and TH22-08). Pavement surfacing consisted of concrete with a thickness of 171 to 222 mm (6.75 to 8.75 in.). Base material consisted of crushed limestone 25 mm (1 in.) thick in TH22-09, and granular 38 to 51 mm (1.5 to 2 in.) thick in TH22-07 and TH22-05. Clay subgrade was encountered directly below pavement in TH22-06 and TH22-08. Core hole locations are shown in Figure 2 attached.

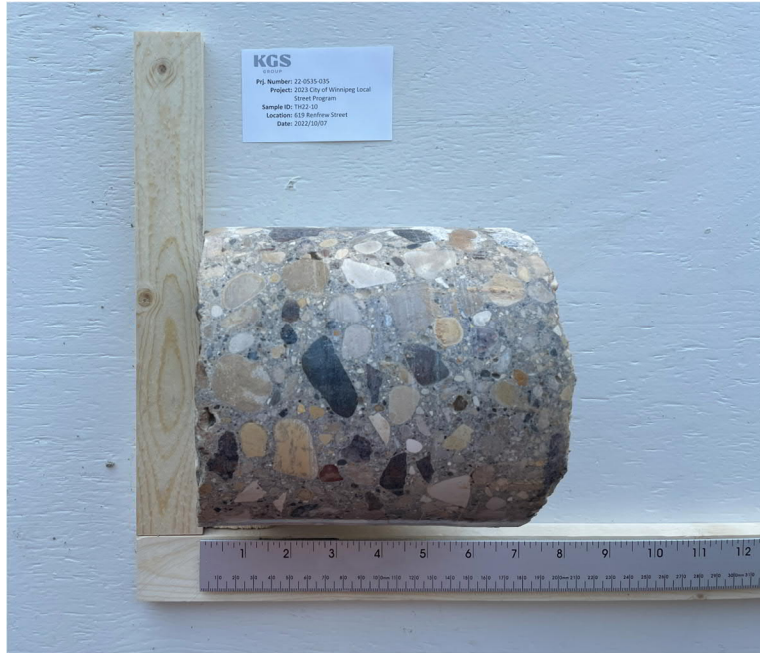
Photo 10: TH22-10

Four (4) cores were completed along Renfrew Street; two (2) at joint locations (TH22-11 and TH22-13), and two (2) mid-slab (TH22-10 and TH22-12). The pavement surfacing consisted of concrete ranging in thickness from 152 to 178 mm (6 to 7 in.). Base material consisted of crushed limestone 51 to 76 mm (2 to 3 in.) thick in TH22-10 and TH22-11, and granular 38 mm (1.5 in.) thick in TH22-13. Clay subgrade was encountered directly below pavement in TH22-12. Core hole locations are shown in Figure 3 attached.

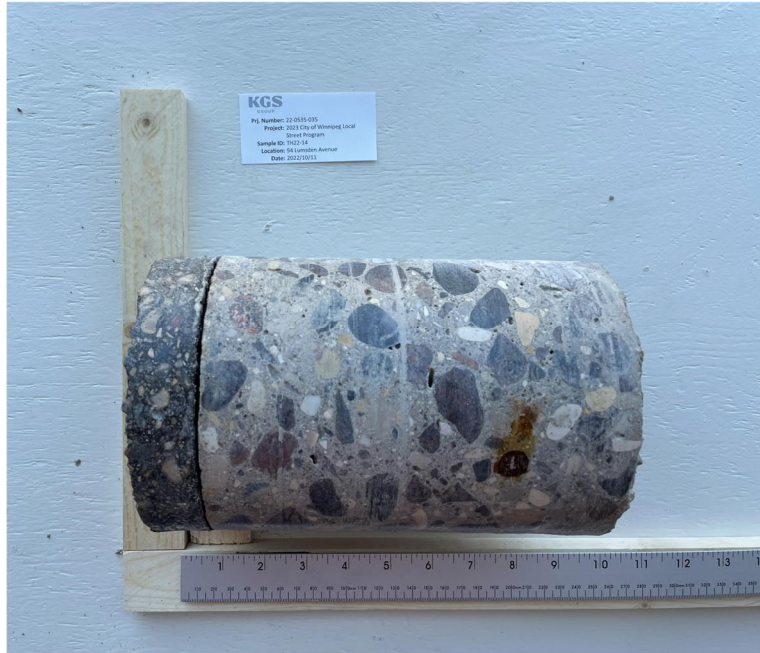
Photo 14: TH22-14

Four (4) cores were completed along Lumsden Avenue; two (2) at joint locations (TH22-15 and TH22-17), and two (2) mid-slab (TH22-14 and TH22-16). The pavement surfacing consisted of asphalt over concrete material. The asphalt and concrete were 38 to 48 mm (1.5 to 1.9 in.) and 184 to 222 mm (7.25 to 8.75 in.) in thickness respectively. Granular base material ranged in thickness from 38 to 137 mm (1.5 to 5.4 in.). Core locations are shown on Figure 4 attached.

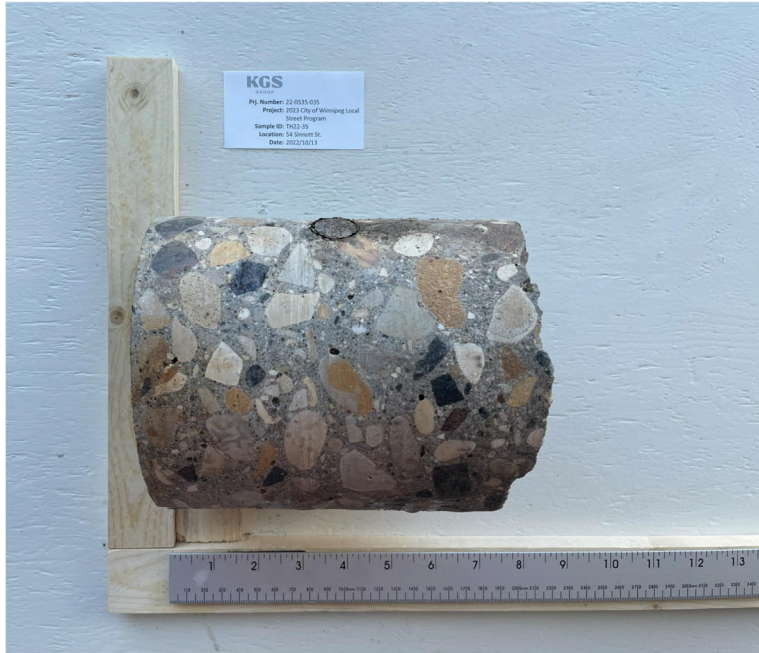
Photo 35: TH22-35

Three (3) cores were completed along Sinnott Street; two (2) at joint locations (TH22-35 and TH22-37), and one (1) mid-slab (TH22-36). The pavement surfacing consisted concrete with a thickness from 178 to 191 mm (7 to 7.5 in). Granular base material 76 mm (3 in) in thickness was encountered directly below pavement in TH22-35 and TH22-36. Clay subgrade was encountered immediately below pavement in TH22-37. Core locations are shown on the attached Figure 10.

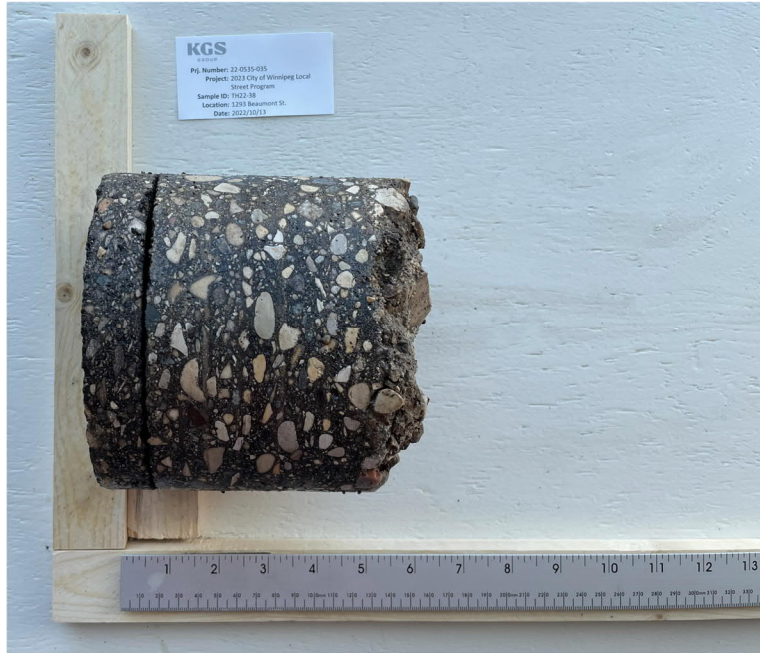
Photo 38: TH22-38

Three (3) cores were completed along Beaumont Street at mid-slab locations (TH22-38 to TH22-40). The pavement surfacing consisted of asphalt material 114 to 241 mm (4.5 to 9.5 in) thick, with two (2) distinct pavement layers encountered at TH22-38. Base material ranged in thickness from 254 to 343 mm (10 to 13.5 in.) and consisted of granular over sand in TH22-38 and TH22-39, and granular in TH22-40. Core locations are shown in Figure 11 attached.
