Water and Waste Department • Service des eaux et des déchets

September 7, 2005

Inspection: Avenue Lemay Land Drainage Sewer, Rue Landry to the Red River

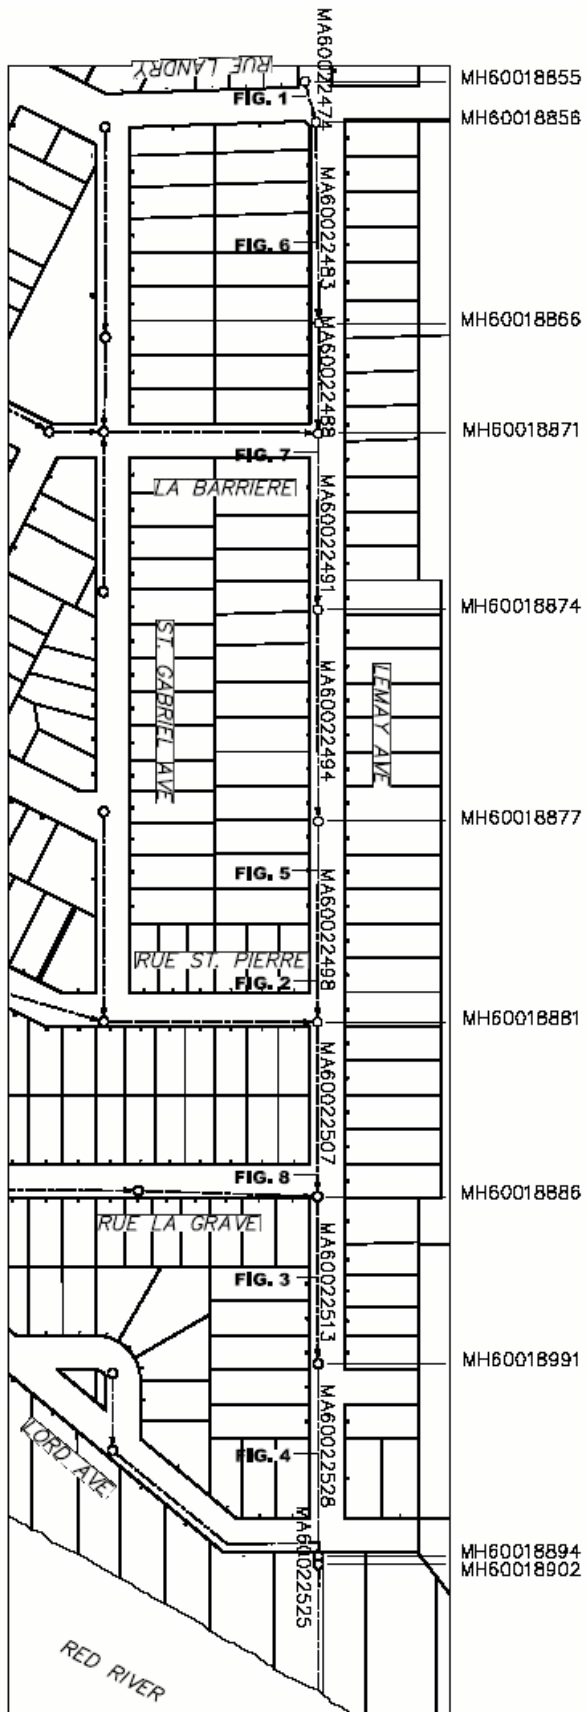
Figure 9 – Map of Lemay Land Drainage Sewer

Figure 9 shows the Avenue Lemay land drainage sewer and the connecting sewers from Avenue St. Gabriel, Rue La Barriere, Rue La Grave, Rue St. Pierre, and Avenue Lord.
