June 14, 2011

File No. 11-0107-01

RE: Harbourview Recreation Complex – Courtyard Restoration
• Site Investigation

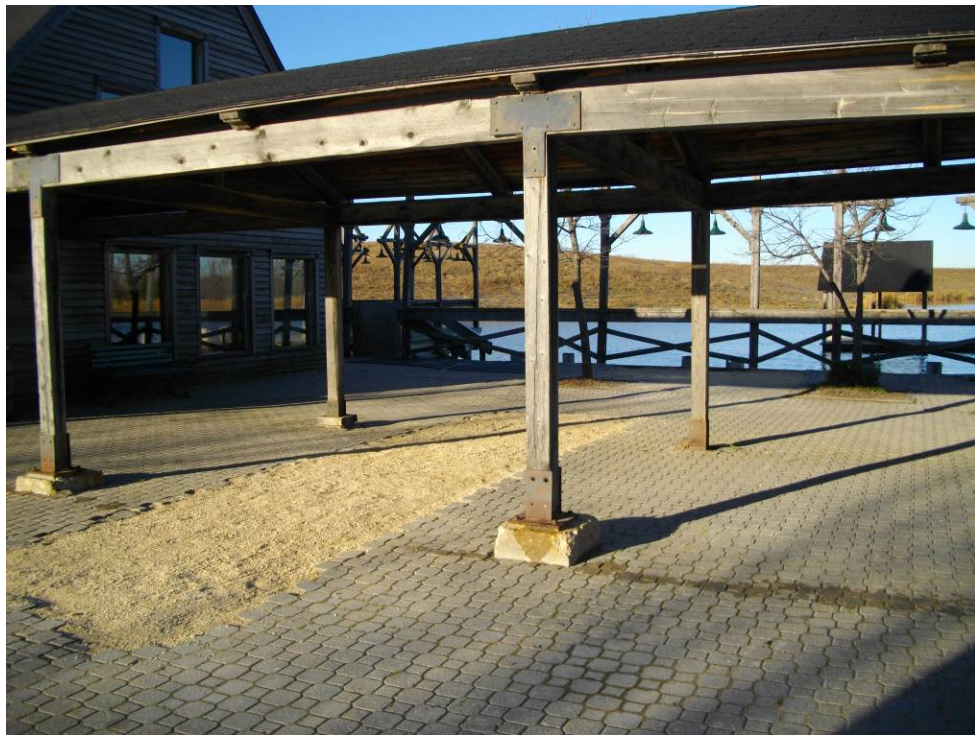
Photo 11

In a number of locations the wood handrails, light posts and canopy supports are in disrepair – Reference Photos 2, 3, 4, 5, 6, 10 and 11.

We recommend that the top 1400 mm of the piles supporting the canopy posts be exposed and be wrapped with a double layer of 20 mill polyethylene with grease between the layers. This work could also be completed when upgrading the paving. Consideration should also be given to replacing the concrete pile caps at the base of the columns (Ref. Photo 11).

We recommend replacing the handrail and light posts along the retaining wall and replacing the canopy posts which are in disrepair. The canopy posts which have experienced significant frost jacking should be shortened to level the canopy. As noted above a handrail will not be required with the embankment option. Short term remedial work should be provided to address safety concerns if the handrail is not replaced at this time. Providing a mesh similar that existing in other locations is an option for short term repair.

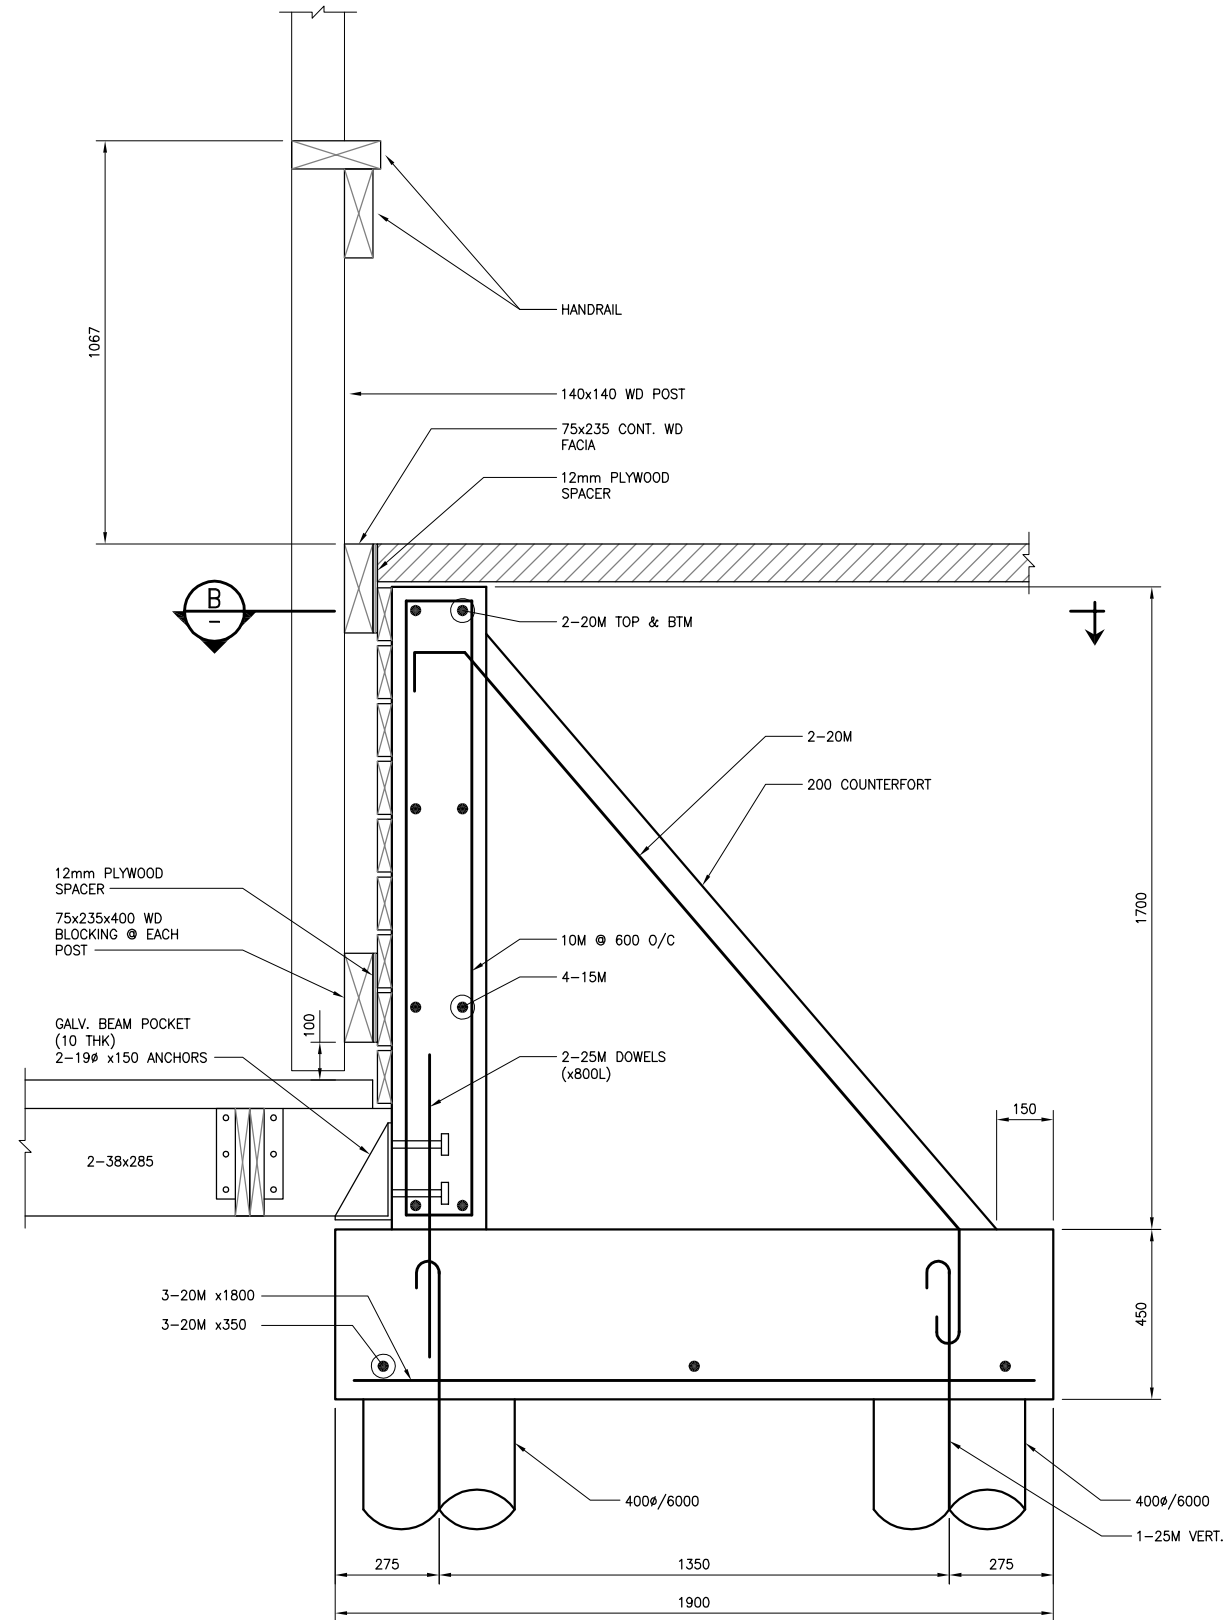
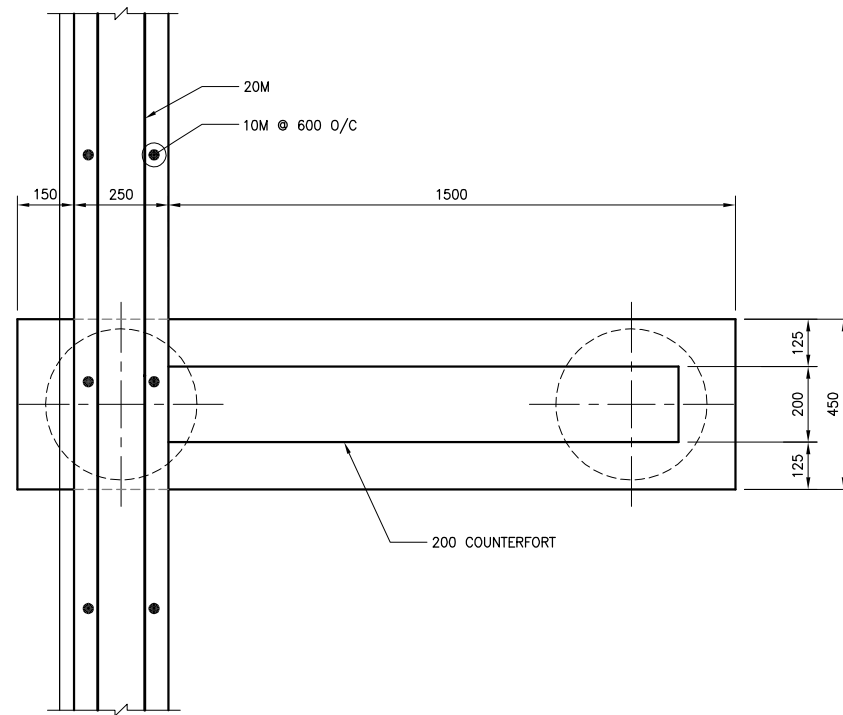
0	11/06/14	ISSUED WITH FINAL REPORT
NO.	YY/MM/DD	DESCRIPTION
REVISIONS / ISSUE		
KGS GROUP CONSULTING ENGINEERS		Winnipeg THE CITY OF WINNIPEG
HARBOUR VIEW RECREATION PROJECT FOUNDATION EVALUATION		
DOCK FOUNDATION TYPICAL SECTIONS		
JUNE 2011		FIGURE 2
		REV: 0

Figure 1 is a cross section through the retaining wall (also reference Photos 1 to 5). The counterfort and pile supports are spaced at 3400 mm o.c. The wall has rotated towards the retention pond to varying degrees along the length of the wall. With the assistance of Patio World, an area adjacent to the wall was excavated to

1. **Remedial Repair** – This option will minimize future wall movement but will not straighten the wall. Remedial work will consist of excavating behind the wall, placing a compressible low density Styrofoam on the inside vertical face of the wall and backfilling with a free draining granular fill. This work could be completed in conjunction with improvements to the paving. Overtime, with compression of the styrofoam, the benefits of this repair will be minimized. The estimated cost of this option is \$20,000.00

2. **Replacement** – The wall is constructed independent of the buildings at each end and can be removed and replaced without compromising these structures. The wall can be replaced with a new concrete wall with modifications to prevent frost movement. A concrete wall replacement is complicated by the need to draw down the retention pond or provide a cofferdam during construction. An earth berm is considered to be the most cost effective cofferdam option. A second wall option is a driven steel sheet pile wall or a wall constructed with driven steel soldier piles and lagging. The lagging could be pressure treated wood, concrete panels or composite material panels. This wall option will not require a cofferdam. The estimate cost of this is \$100,000.00 to \$150,000.00.
