HAZARDOUS MATERIALS SURVEY

WINNIPEG TRANSIT GARAGE
566 BRANDON AVENUE, WINNIPEG, MB

Type of document: FINAL REPORT

Project no.: Project No. 5516057-000-EN1
Date: February 2017

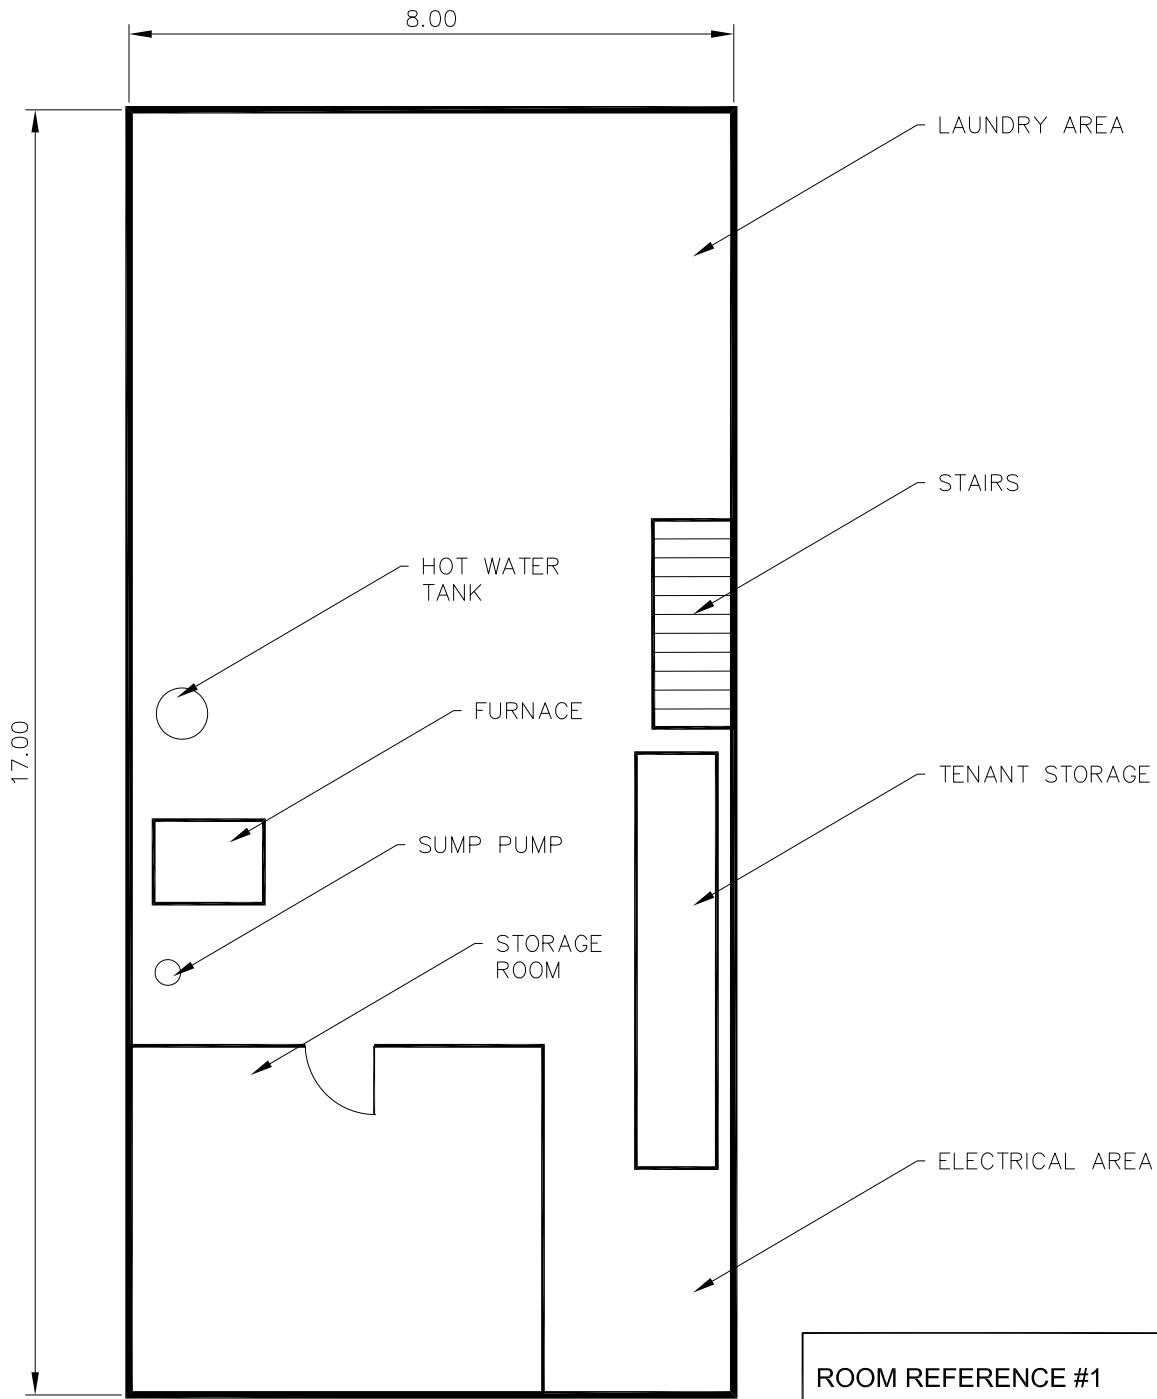
BASEMENT FLOOR PLAN
 HAZARDOUS MATERIALS SURVEY
 566 Brandon Avenue, Winnipeg

ROOM REFERENCE #1
ROOM DESCRIPTION:
 Basement, includes stairs.

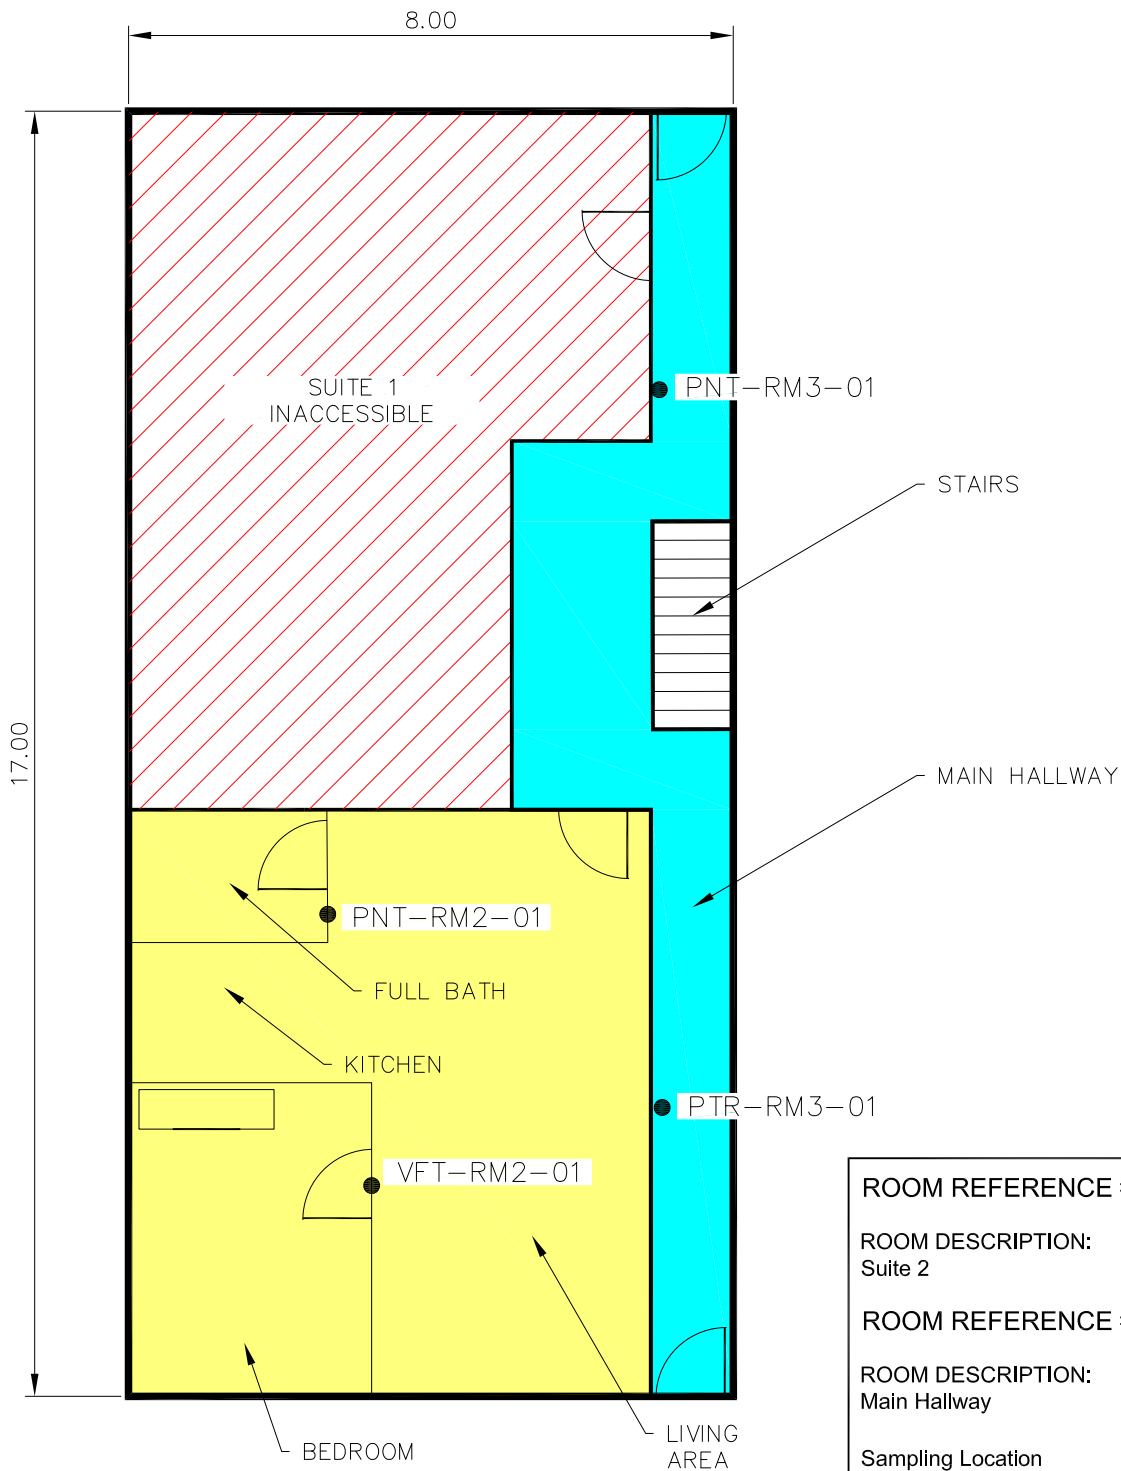
FIGURE 3
FIRST FLOOR PLAN WITH SAMPLING LOCATIONS
HAZARDOUS MATERIALS SURVEY
566 Brandon Avenue, Winnipeg

ROOM REFERENCE #2
