CITY OF WINNIPEG

WASTEWATER LIFT STATION CONDITION ASSESSMENT PHASE II

Document VIII: Riverbend Lift Station Assessment

Date: March 16, 2020

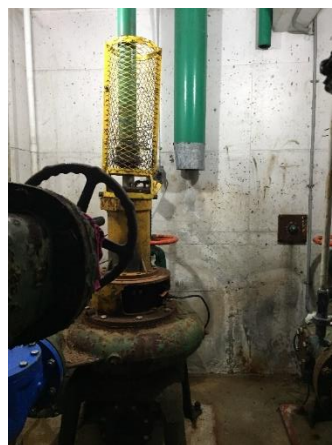
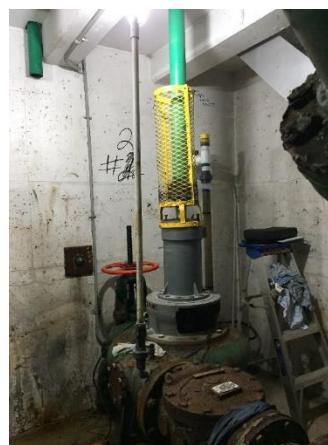
P-101 and P-102 are identical Fairbanks Morse B5414 pumps rated for 151.4 L/sec at a Total Dynamic Head (TDH) of 20.7 m and operate at a constant speed. Operational staff noted that there are concerns with solids and grease build up noted on the pumps and the pumps are small and difficult to clean.

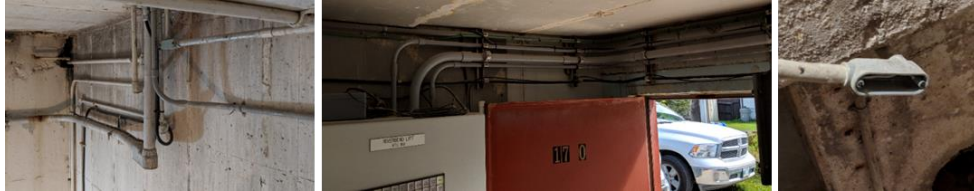
The wiring style in Riverbend Lift Station is a mixture of threaded rigid conduit, Teck cable, and RPVC. RPVC does not meet Zone 2 requirements. Threaded rigid conduit is showing signs of corrosion on sub grade levels. Some fitting covers are missing allowing moisture and gasses to enter the conduit.

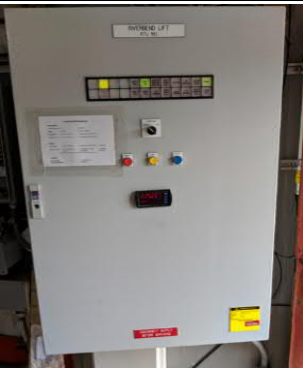
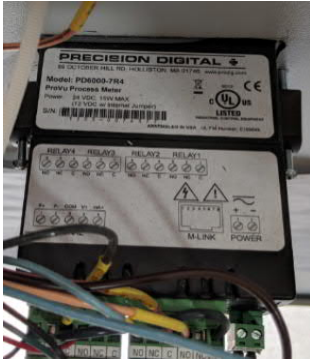
Control Wiring Terminations Visual Inspection: Issues for Discussion:	Rating 1 (Connections tight, labelled) Rating 2 (Missing labels) Rating 3 (Loose / disorganized wiring) Rating 4 (Inappropriate wiring) Rating 5 (Combination of above)	1	0.1					
		Occurrences of Maintenance Issues: Issues for Discussion:	Rating 1 (None) Rating 2 (Intermittent) Rating 3 (Consistent but occasional) Rating 4 (Frequent) Rating 5 (Constant)	2	0.4					
	Fitness for Purpose	Instrument/Measurement is Designed Appropriately: Issues for Discussion:	Rating 1 (Yes) Rating 3 (No - current standards) Rating 5 (No - legacy standards)	1	0.3	RECOMMENDATIONS: COST ESTIMATE				
		Instrument Redundancy is Required/Installed: Issues for Discussion:	Rating 1 (Yes or Not Required) Rating 3 (Required, non standard) Rating 5 (Required, not installed)	1	0.1					
		Instrument Range is Appropriate: Issues for Discussion:	Rating 1 (Yes) Rating 3 (No - current standards) Rating 5 (No - legacy standards)	1	0.1

Instrument Remaining Service Life: Issues for Discussion:		Rating 1 (> 90% lifecycle remain) Rating 2 (> 75% lifecycle remain) Rating 3 (> 50% lifecycle remain) Rating 4 (> 25% lifecycle remain) Rating 5 (obsolete)	2	0.5						
PHOTOGRAPHS

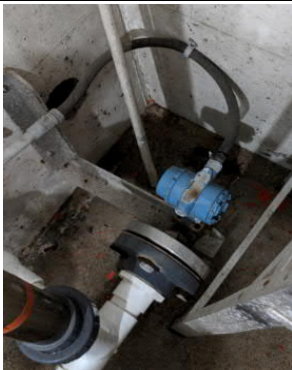
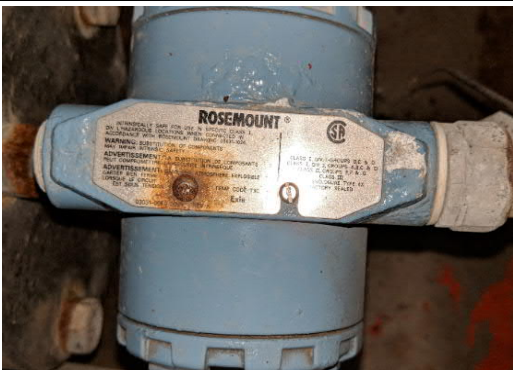
SECTION	ITEM	DATA	Assessment Scores				AGE		
			Current Physical Condition	Fitness For Purpose			YEAR INSTALLED	EXPECTED SERVICE LIFE	REMAINING SERVICE LIFE
Equipment Tag: IC_101_Level_Transmitter Description: IC_101_Level_Transmitter	GENERAL	Location: Dry Well, Sub Grade	1.5	2.4			2010	20	11
		Description: IC_101_Level_Transmitter							
		Make: Rosemount							
		Model: 1151 Pressure based level transmitter							
		Device Span: 0-150 in H2O							
		Input/Output: Input							
		Signal Type: 4-20mA							
	Rated Voltage: 24VDC	Rating	Weight	Recommended Frequency of Review: (In years, specify between 1-15)			4		
	Current Physical Condition	Equipment Visual Inspection: Issues for Discussion:	Rating 1 (Like new) Rating 2 (Minor surface corrosion) Rating 3 (Surface & internal corrosion) Rating 4 (Severe corrosion) Rating 5 (Safety concern)	2	0.1	NOTES & COMMENTS: Equipment is starting to show signs of surface corrosion and is in "Fair" Condition. Currently no level redundancy in the case of equipment failure.

Canadian Electrical Code Issues Identified: Issues for Discussion:	Rating 1 (No issues) Rating 3 (Non compliant - current code) Rating 5 (Non compliant - legacy code)	1	0.4				
Control Wiring Terminations Visual Inspection: Issues for Discussion:		Rating 1 (Connections tight, labelled) Rating 2 (Missing labels) Rating 3 (Loose / disorganized wiring) Rating 4 (Inappropriate wiring) Rating 5 (Combination of above)	1	0.1					
Occurrences of Maintenance Issues: Issues for Discussion:		Rating 1 (None) Rating 2 (Intermittent) Rating 3 (Consistent but occasional) Rating 4 (Frequent) Rating 5 (Constant)	2	0.4					
Fitness for Purpose	Instrument/Measurement is Designed Appropriately: Issues for Discussion:	Rating 1 (Yes) Rating 3 (No - current standards) Rating 5 (No - legacy standards)	1	0.3	RECOMMENDATIONS: Have a redundant Ultrasonic Level Transmitter installed.				
	Instrument Redundancy is Required/Installed: Issues for Discussion:	Rating 1 (Yes or Not Required) Rating 3 (Required, non standard) Rating 5 (Required, not installed)	5	0.1

Instrument Range is Appropriate: Issues for Discussion:	Rating 1 (Yes) Rating 3 (No - current standards) Rating 5 (No - legacy standards)	1	0.1					
	Instrument Remaining Service Life: Issues for Discussion:	Rating 1 (> 90% lifecycle remain) Rating 2 (> 75% lifecycle remain) Rating 3 (> 50% lifecycle remain) Rating 4 (> 25% lifecycle remain) Rating 5 (obsolete)	3	0.5					
PHOTOGRAPHS

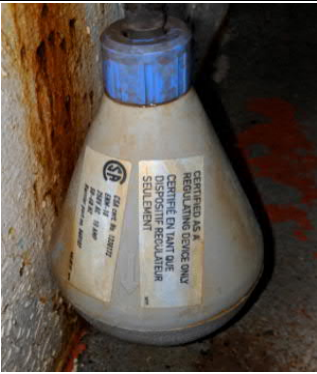
SECTION	ITEM	DATA	Assessment Scores			AGE			
			Current Physical Condition	Fitness For Purpose		YEAR INSTALLED	EXPECTED SERVICE LIFE	REMAINING SERVICE LIFE	
Equipment Tag: IC_101_FLYGT Description: IC_101_FLYGT	GENERAL	Location: Dry Well, Sub Grade	1.5	2.0			2010	20	11
		Description: IC_101_FLYGT							
		Make: Xylem							
		Model: ENM-10							
		Device Span: 0.95-1.10g/cm3							
		Input/Output: Input							
		Signal Type: Discrete							
	Rated Voltage: 250VAC	Rating	Weight	Recommended Frequency of Review: (In years, specify between 1-15)			4		
	Current Physical Condition	Equipment Visual Inspection: Issues for Discussion:	Rating 1 (Like new) Rating 2 (Minor surface corrosion) Rating 3 (Surface & internal corrosion) Rating 4 (Severe corrosion) Rating 5 (Safety concern)	2	0.1	NOTES & COMMENTS: Equipments appears to be in "Fair" condition. Associated fastening hardware is severely corroded RECOMMENDATIONS: Maintain routine maintenance checks to ensure device is operational. Replace Flygt Ball as required. COST ESTIMATE

Canadian Electrical Code Issues Identified: Issues for Discussion:	Rating 1 (No issues) Rating 3 (Non compliant - current code) Rating 5 (Non compliant - legacy code)	1	0.4				
Control Wiring Terminations Visual Inspection: Issues for Discussion:		Rating 1 (Connections tight, labelled) Rating 2 (Missing labels) Rating 3 (Loose / disorganized wiring) Rating 4 (Inappropriate wiring) Rating 5 (Combination of above)	1	0.1					
Occurrences of Maintenance Issues: Issues for Discussion:		Rating 1 (None) Rating 2 (Intermittent) Rating 3 (Consistent but occasional) Rating 4 (Frequent) Rating 5 (Constant)	2	0.4					
Instrument/Measurement is Designed Appropriately: Issues for Discussion:		Rating 1 (Yes) Rating 3 (No - current standards) Rating 5 (No - legacy standards)	1	0.3					
Fitness for Purpose	Instrument Redundancy is Required/Installed: Issues for Discussion:	Rating 1 (Yes or Not Required) Rating 3 (Required, non standard) Rating 5 (Required, not installed)	1	0.1

Instrument Range is Appropriate: Issues for Discussion:	Rating 1 (Yes) Rating 3 (No - current standards) Rating 5 (No - legacy standards)	1	0.1					
	Instrument Remaining Service Life: Issues for Discussion:	Rating 1 (> 90% lifecycle remain) Rating 2 (> 75% lifecycle remain) Rating 3 (> 50% lifecycle remain) Rating 4 (> 25% lifecycle remain) Rating 5 (obsolete)	3	0.5					
PHOTOGRAPHS

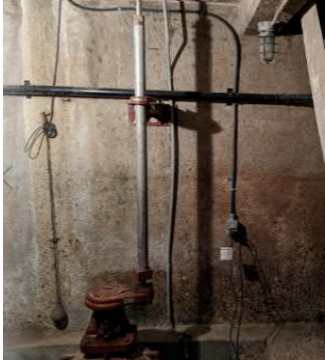
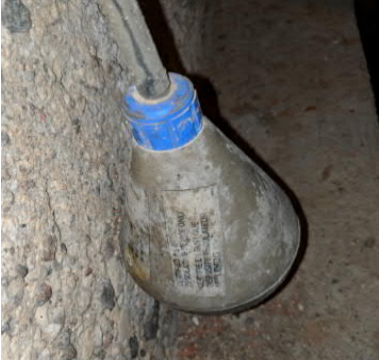
SECTION	ITEM	DATA	Assessment Scores				AGE			
			Current Physical Condition	Fitness For Purpose			YEAR INSTALLED	EXPECTED SERVICE LIFE	REMAINING SERVICE LIFE	
Equipment Tag: IC_102_FLYGT Description: IC_102_FLYGT	GENERAL	Location: Comm Room	1.5	2.0			2010	20	11	
		Description: IC_102_FLYGT								
		Make: Xylem								
		Model: ENM-10								
		Device Span: 0.95-1.10g/cm3								
		Input/Output: Input								
		Signal Type: Discrete								
	Rated Voltage: 250VAC	Rating	Weight	Recommended Frequency of Review: (In years, specify between 1-15)			4			
	Current Physical Condition	Equipment Visual Inspection: Issues for Discussion:	Rating 1 (Like new) Rating 2 (Minor surface corrosion) Rating 3 (Surface & internal corrosion) Rating 4 (Severe corrosion) Rating 5 (Safety concern)	2	0.1	NOTES & COMMENTS: Equipments appears to be in "Fair" condition. RECOMMENDATIONS: Maintain routine maintenance checks to ensure device is operational. Replace Flygt Ball as required. COST ESTIMATE

Canadian Electrical Code Issues Identified: Issues for Discussion:	Rating 1 (No issues) Rating 3 (Non compliant - current code) Rating 5 (Non compliant - legacy code)	1	0.4					
		Control Wiring Terminations Visual Inspection: Issues for Discussion:	Rating 1 (Connections tight, labelled) Rating 2 (Missing labels) Rating 3 (Loose / disorganized wiring) Rating 4 (Inappropriate wiring) Rating 5 (Combination of above)	1	0.1					
		Occurrences of Maintenance Issues: Issues for Discussion:	Rating 1 (None) Rating 2 (Intermittent) Rating 3 (Consistent but occasional) Rating 4 (Frequent) Rating 5 (Constant)	2	0.4					
		Instrument/Measurement is Designed Appropriately: Issues for Discussion:	Rating 1 (Yes) Rating 3 (No - current standards) Rating 5 (No - legacy standards)	1	0.3					
	Fitness for Purpose	Instrument Redundancy is Required/Installed: Issues for Discussion:	Rating 1 (Yes or Not Required) Rating 3 (Required, non standard) Rating 5 (Required, not installed)	1	0.1

Instrument Range is Appropriate: Issues for Discussion:	Rating 1 (Yes) Rating 3 (No - current standards) Rating 5 (No - legacy standards)	1	0.1					
Instrument Remaining Service Life: Issues for Discussion:		Rating 1 (> 90% lifecycle remain) Rating 2 (> 75% lifecycle remain) Rating 3 (> 50% lifecycle remain) Rating 4 (> 25% lifecycle remain) Rating 5 (obsolete)	3	0.5						
PHOTOGRAPHS

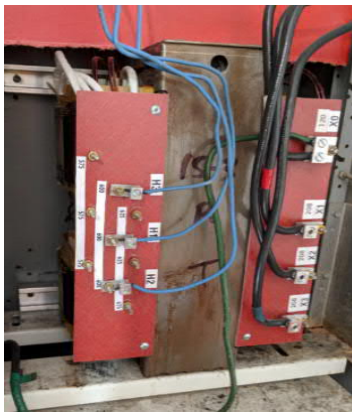
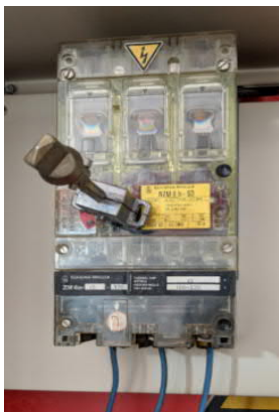
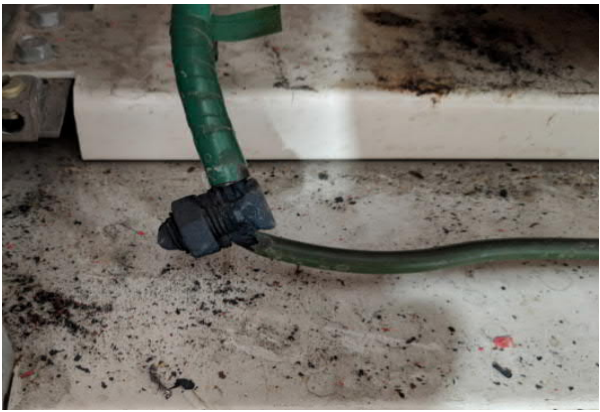
Canadian Electrical Code Issues Identified: Issues for Discussion:	Rating 1 (No issues) Rating 3 (Non compliant - current code) Rating 5 (Non compliant - legacy code)	5	0.4					
Wiring Terminations Visual Inspection: Issues for Discussion:		Rating 1 (Connections tight, labelled) Rating 2 (Missing labels) Rating 3 (Loose / disorganized wiring) Rating 4 (Inappropriate wiring) Rating 5 (Combination of above)	1	0.1						
Occurrences of Maintenance Issues: Issues for Discussion:		Rating 1 (None) Rating 2 (Intermittent) Rating 3 (Consistent but occasional) Rating 4 (Frequent) Rating 5 (Constant)	2	0.4						
Fitness for Purpose	Meets City Electrical Design Standards: Issues for Discussion:	Rating 1 (Yes) Rating 3 (No - current standards) Rating 5 (No - legacy standards)	1	0.2	RECOMMENDATIONS: Once ventilation requirements have been assessed and upgraded, it would be recommended as part of the electrical upgrade to install a new transformer.

Has the Capacity been Reached? Issues for Discussion:	Rating 1 (<75%) Rating 2 (<85%) Rating 3 (<95%) Rating 4 (At capacity) Rating 5 (Above capacity)	1	0.4						
	Equipment Remaining Service Life: Issues for Discussion:	Rating 1 (> 90% lifecycle remain) Rating 2 (> 75% lifecycle remain) Rating 3 (> 50% lifecycle remain) Rating 4 (> 25% lifecycle remain) Rating 5 (obsolete)	2	0.4						
PHOTOGRAPHS

COST ESTIMATE \$ 10,000.00
