# SEWPCC Upgrading/Expansion Preliminary Design Report

## SECTION 6 - BUILDING ENVELOPE / STRUCTURE ASSESSMENT

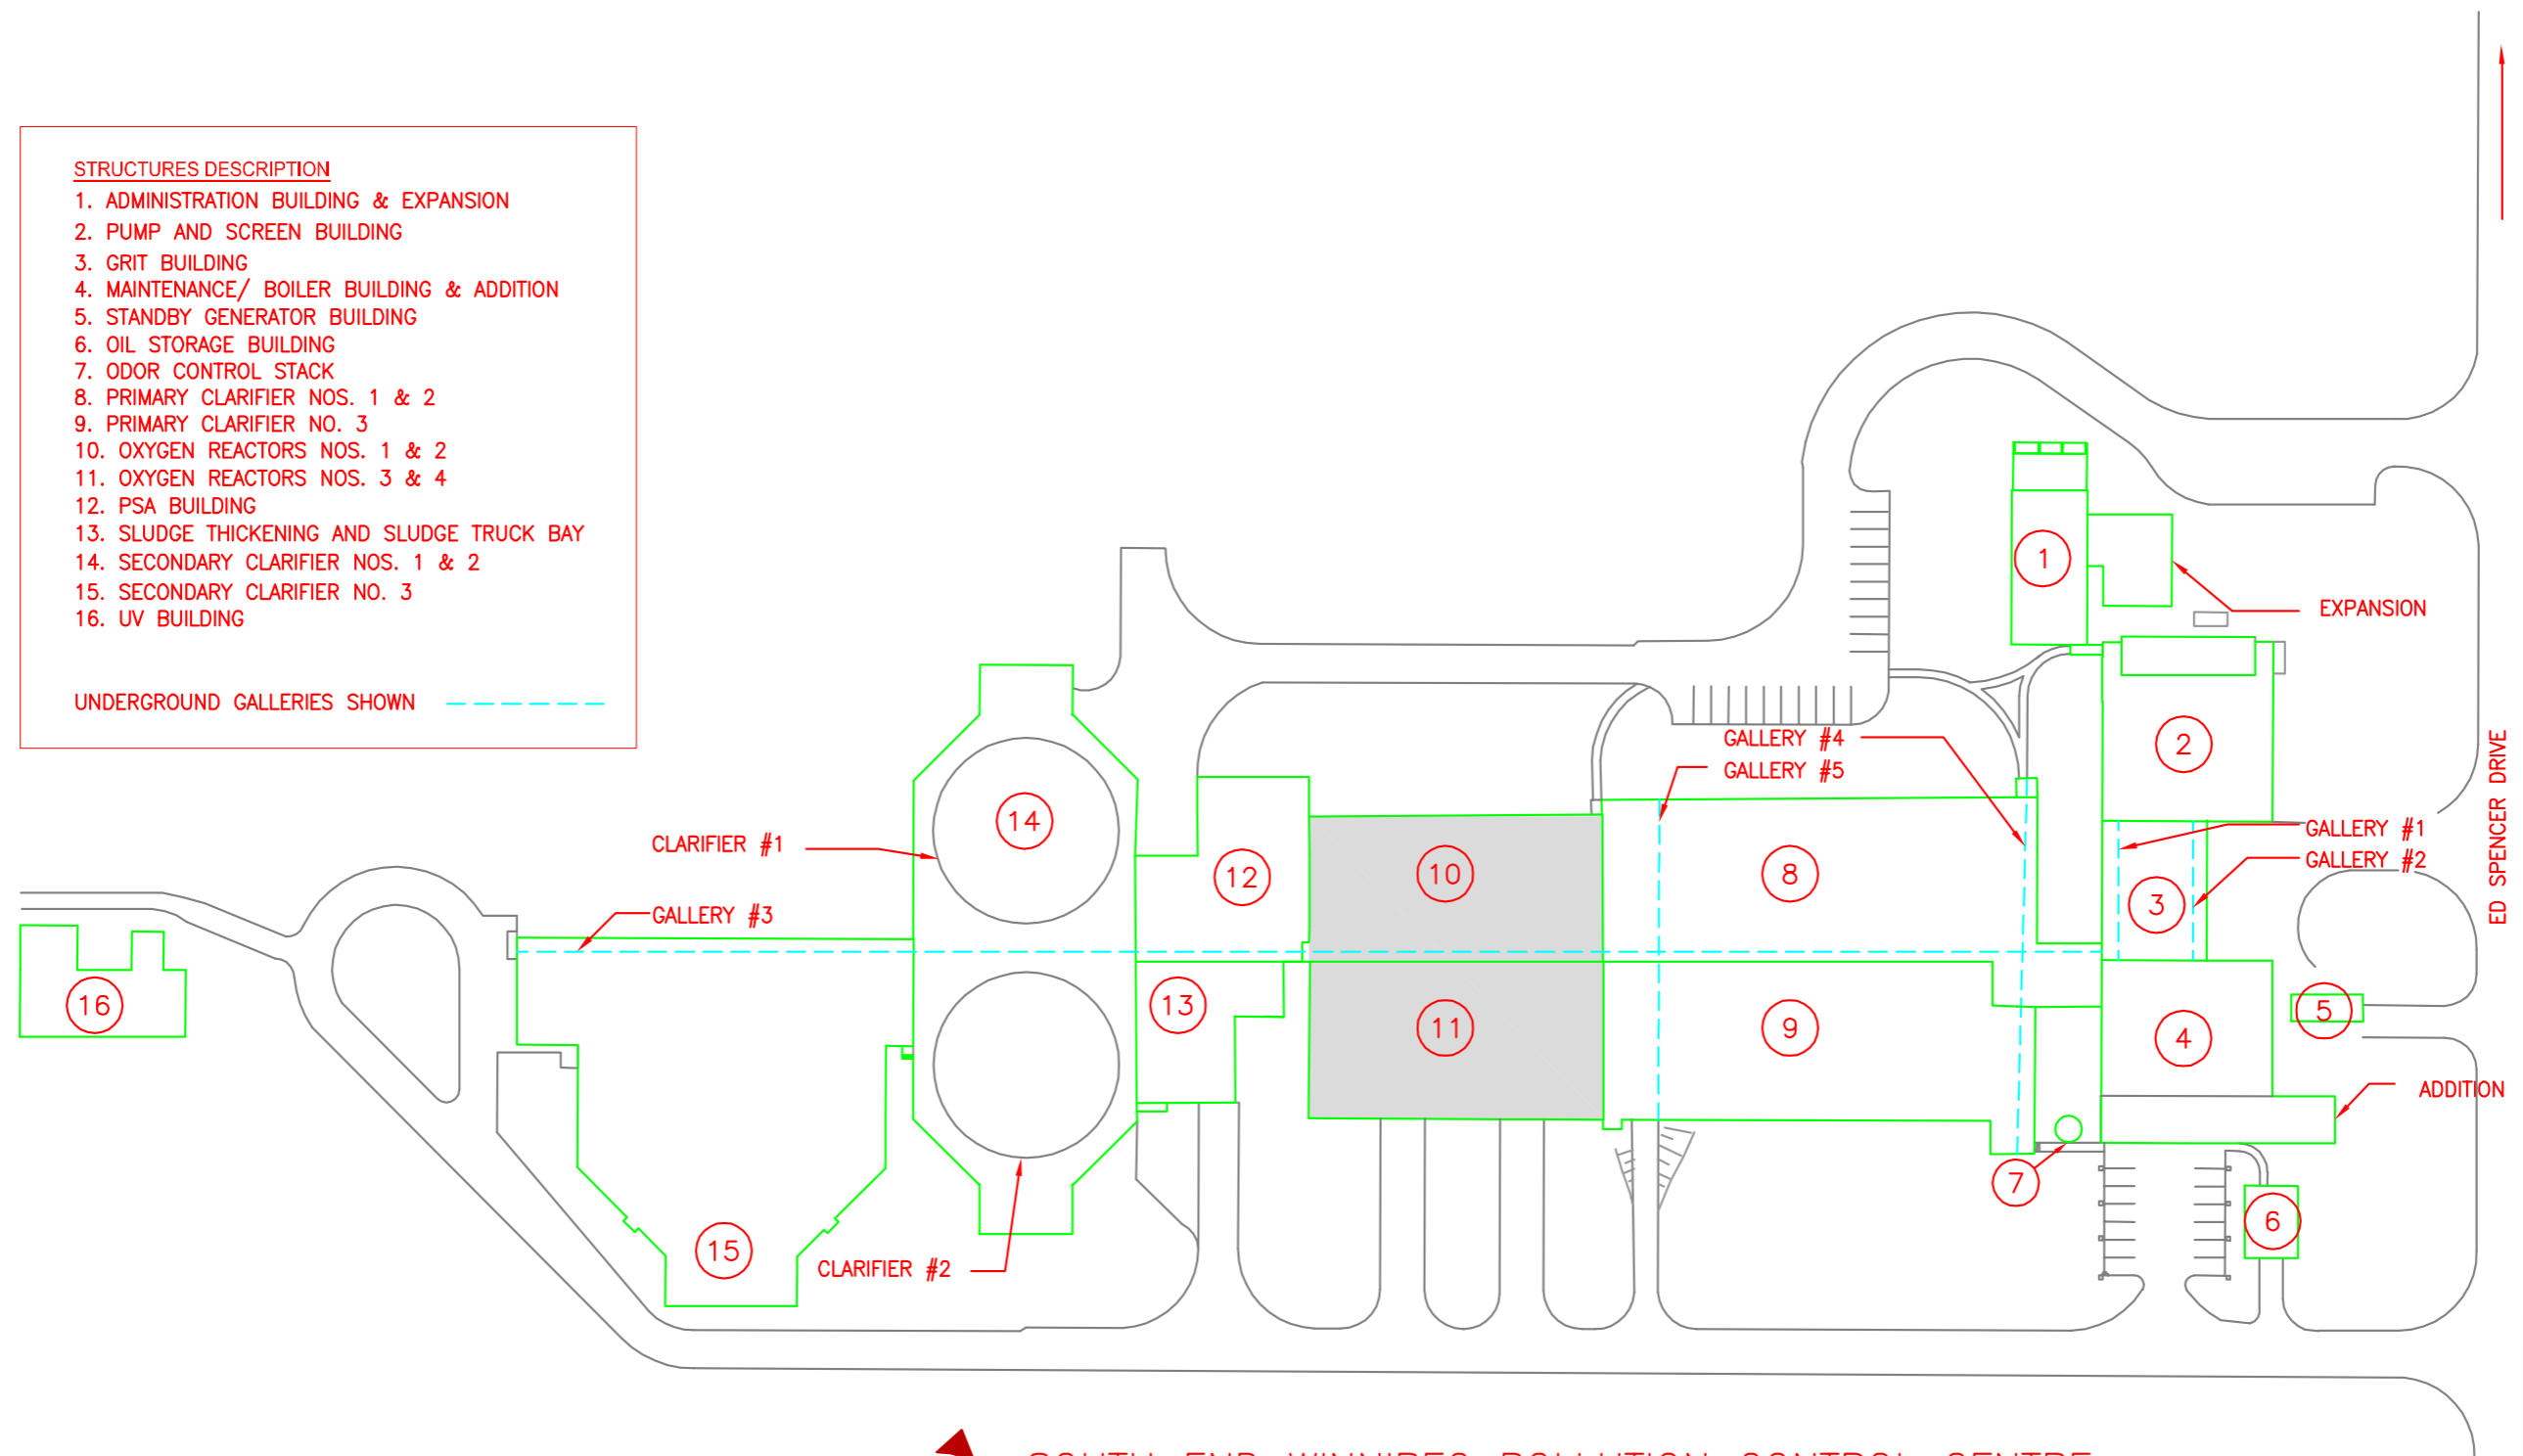
- STRUCTURES DESCRIPTION**
1. ADMINISTRATION BUILDING & EXPANSION
  2. PUMP AND SCREEN BUILDING
  3. GRIT BUILDING
  4. MAINTENANCE/ BOILER BUILDING & ADDITION
  5. STANDBY GENERATOR BUILDING
  6. OIL STORAGE BUILDING
  7. ODOR CONTROL STACK
  8. PRIMARY CLARIFIER NOS. 1 & 2
  9. PRIMARY CLARIFIER NO. 3
  10. OXYGEN REACTORS NOS. 1 & 2
  11. OXYGEN REACTORS NOS. 3 & 4
  12. PSA BUILDING
  13. SLUDGE THICKENING AND SLUDGE TRUCK BAY
  14. SECONDARY CLARIFIER NOS. 1 & 2
  15. SECONDARY CLARIFIER NO. 3
  16. UV BUILDING

UNDERGROUND GALLERIES SHOWN - - - - -

The SEWPCC consists of a number of structures constructed at various times between 1971 and 1998. For the purposes of this report, we have divided the SEWPCC facility into the divisions noted below, with the approximate dates of construction in parenthesis. A site plan indicating location of the building components is included in Figure 6.1. Photographs are included in Appendix C. (Please note that photograph numbers coincide with the corresponding sections, e.g., Photo No. 6.3.1-1 refers to the first photograph for Section 6.3.1.)
