## **APPENDIX C**

### **SUPPLEMENTARY FORCEMAIN INSPECTION INFORMATION**

Date: June 2007  
 To: Marv McDonald  
 From: Marshall Gibbons  
 Subject: WEWPCC Forcemain Twinning – Existing Forcemain Inspection  
 Project number: D265-202-01

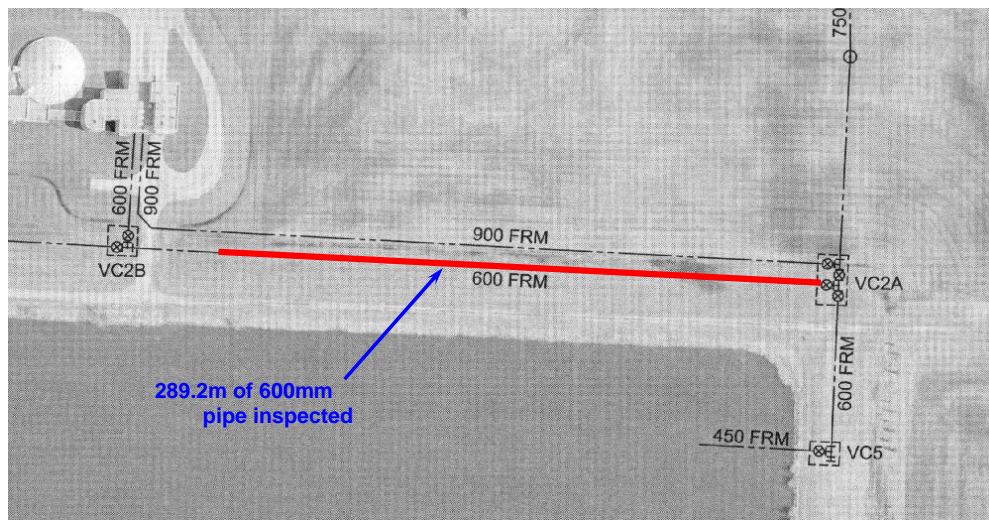
**Figure 1 - Forcemain Inspected on 27 Jan 2006 (bends near VC2A not shown)**

Please note the following conditions:

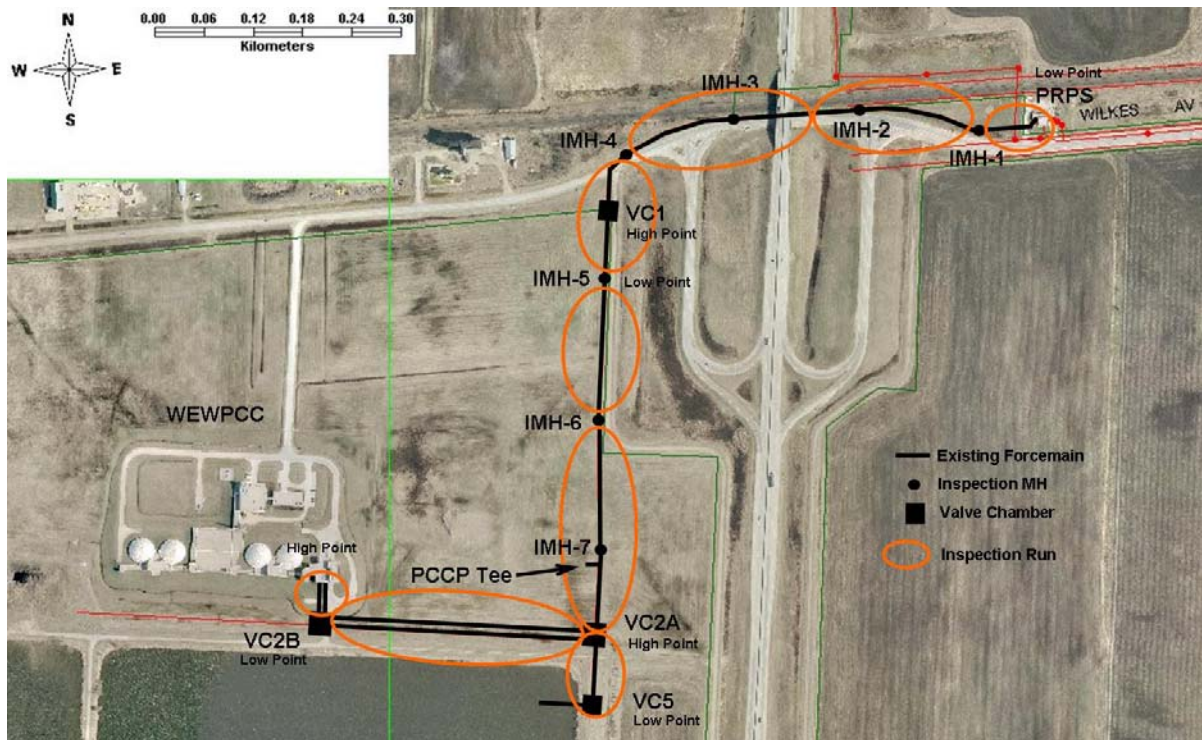
**Figure 2 - Proposed CCTV Inspection runs for WEWPCC Forcemain**

A detailed listing of forcemain features, including all inspection manholes and valve chambers, is attached to this memo. High and low points on the forcemain are shown on Figure 2. The maximum range of CCTV inspection equipment has been assumed to be 300m.

Forcemain inspection should proceed as outlined below, based on access points and forcemain elevations. All inspection manholes should be exposed for external inspection, but it should not be necessary to remove all the blind flanges for access. Those that must be removed can be temporarily closed daily using plywood covers. Sewer inspection contractor will need assistance removing and installing the blind flange in VC5.
